# National Transportation Safety Board

ERA24LA229

## ENGINE EXAMINATION SUMMARY

Location: Bennett Field (1N5), Salisbury, MD  
Date: May 26, 2024  
Time: 12:00 Local  
16:00 Zulu  
Aircraft: N818K Great Lakes 2T-1  
Engine: Menasco Super Pirate D-4-87

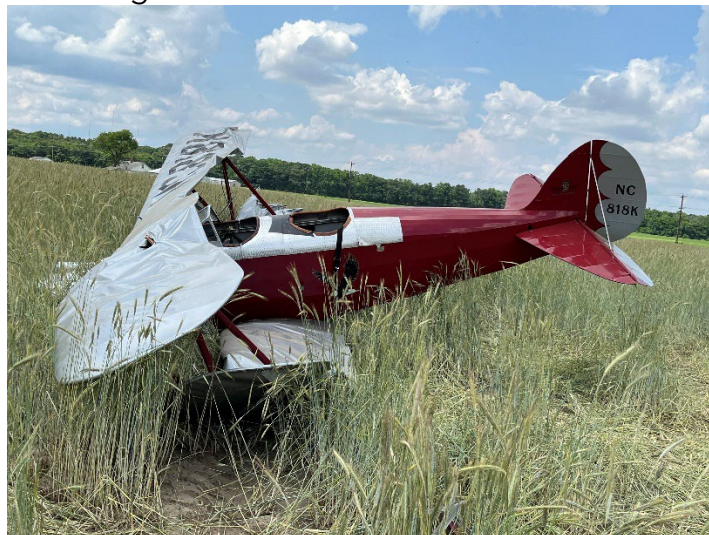
**Figure 1 Aircraft Before Recovery**

On May 26, approximately 12:00 the Great Lakes N818K departed Bennett Field, turned right, then impacted the ground off the end of runway 35. Aircraft sustained substantial damage, figures 1 and 2. The examination of this engine revealed no evidence of pre-accident damage or anomalies that would have precluded the normal operation of the engine.

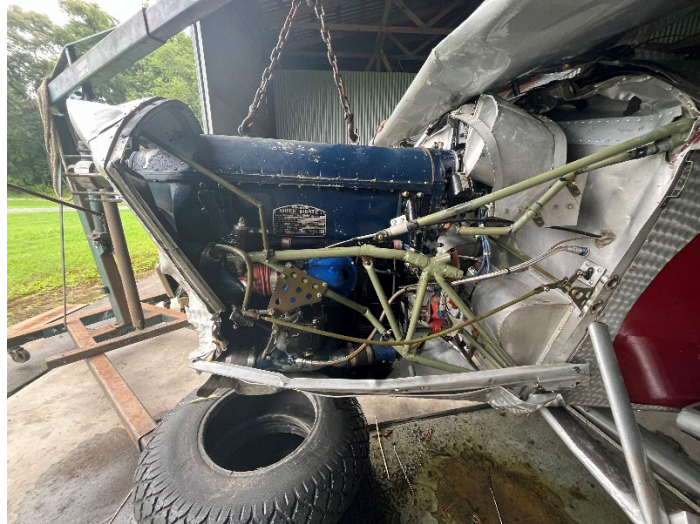
Figure 3 Menasco Super Pirate

The engine was a Menasco Super Pirate model number D-4-87, engine number 4342, figure 3 and 4. The engine had no noticeable damage other than from impact with the ground. The engine was complete with all components still attached. The oil tank was ruptured leaving oil on the hangar floor. The propeller was badly splintered and broken into many small pieces, figure 5. The engine mount was bent and broken in many locations as well.

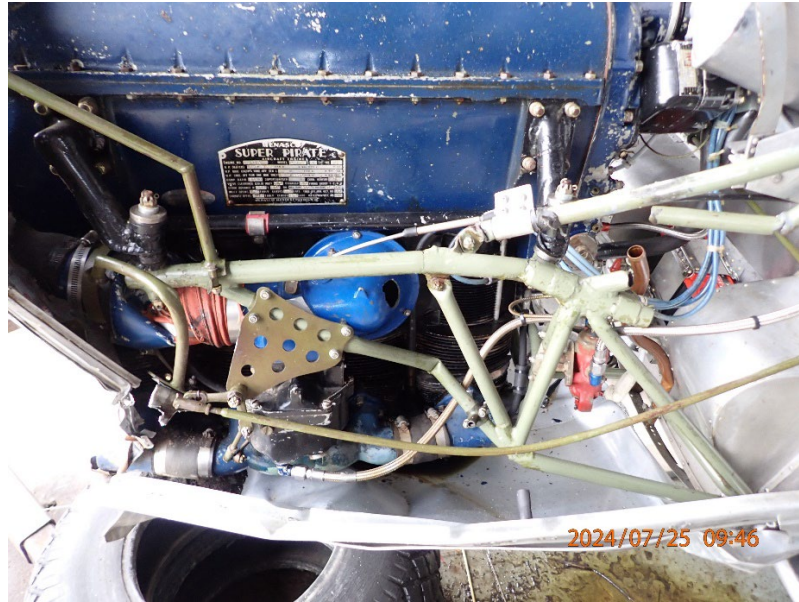
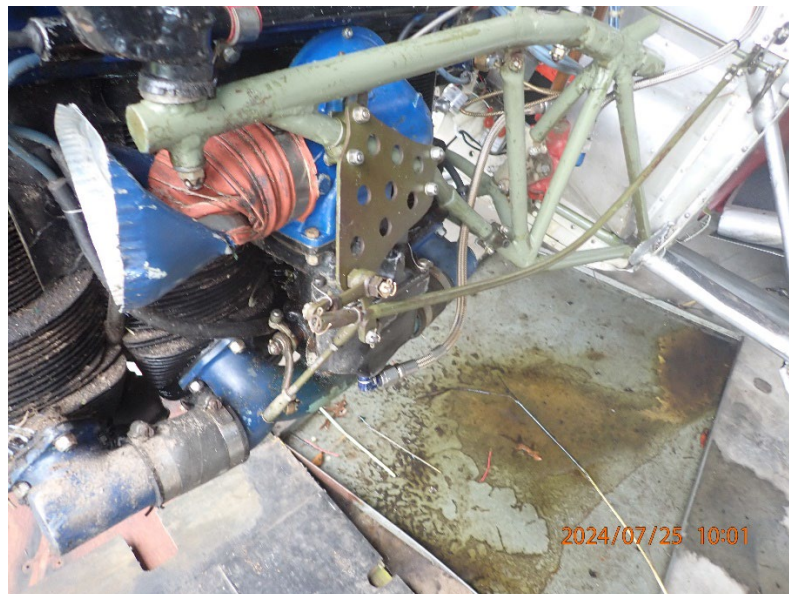
The propeller was removed so the nose cowling could be removed. The top cowl was removed and both side cowlings. This exposed the lifting eyes for the engine. The engine and aircraft were lifted so the nose bowl and bottom cowl could be removed. Examination of the engine controls followed. Figures 6 and 7.

- Mixture not installed on this aircraft. The carburetor was equipped with a mixture control, but it had been safety wired into the full rich position and remained secured full rich.
- Throttle was found full open, and continuity was confirmed to the cockpit control.
- Carburetor heat control found in the off position and continuity to the cockpit control confirmed.

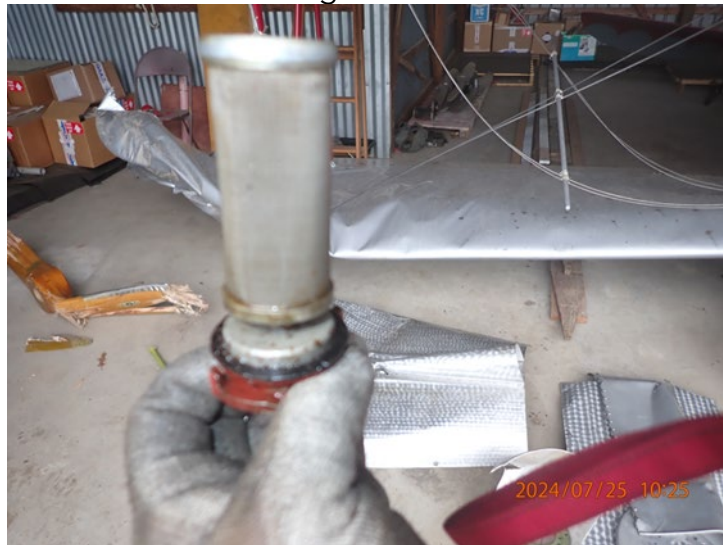
**Figure 8 Fuel Screen**

The fuel strainer was drained and mixture of 100LL and automotive gas was obtained. The sample contained considerable amounts of debris. The greenish color along with the smell indicated the mixture of fuels. The fuel strainer screen was removed and found to be free of debris. Figure 8.

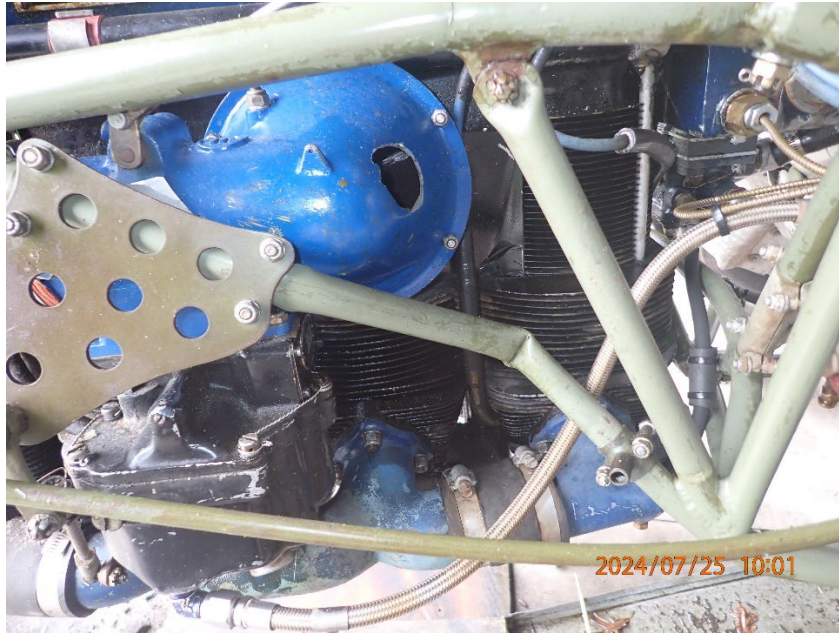
**Figure 9 Carb Heat Box Damage**

Removed the air filter from the intake system to gain access to the carburetor. The filter was clean but suffered impact damage. Also attached to the carburetor was the carb heat box that also contained a clean inlet filter. The carb heat box was also impact damaged. Part of the engine mount formed a hole in the rear portion of the box. Figure 9.

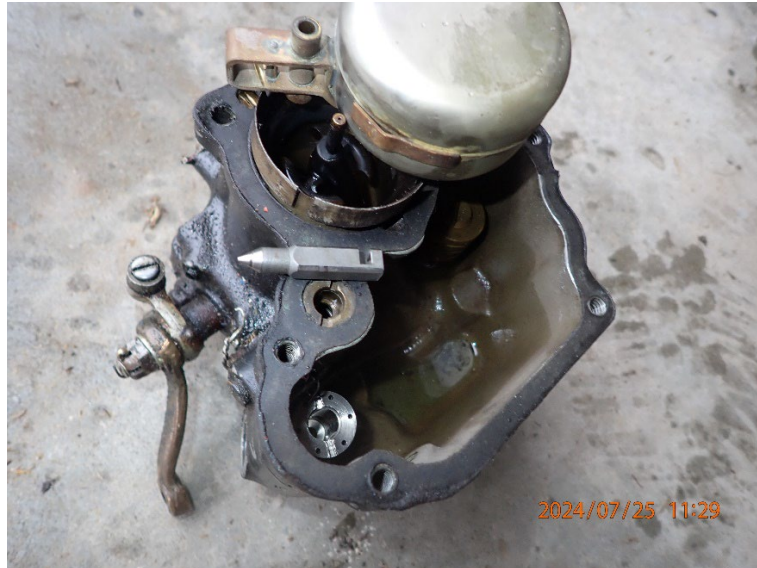
**Figure 10 Carburetor Bowl**

Internally the carburetor appeared to be in good serviceable condition. A small amount of debris was found in the bowl. The needle, seat, and float were all in good condition. The float was silent when it was shaken indicating it was not leaking, figure 10. The float also had a slight yellow tint on the bottom portion, the part in the fuel, consistent with the use of auto fuel, figure 11.

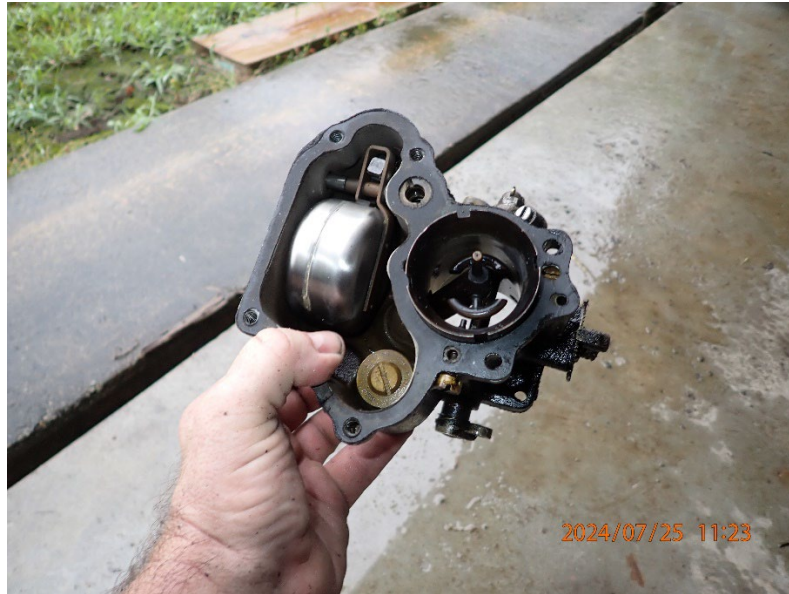
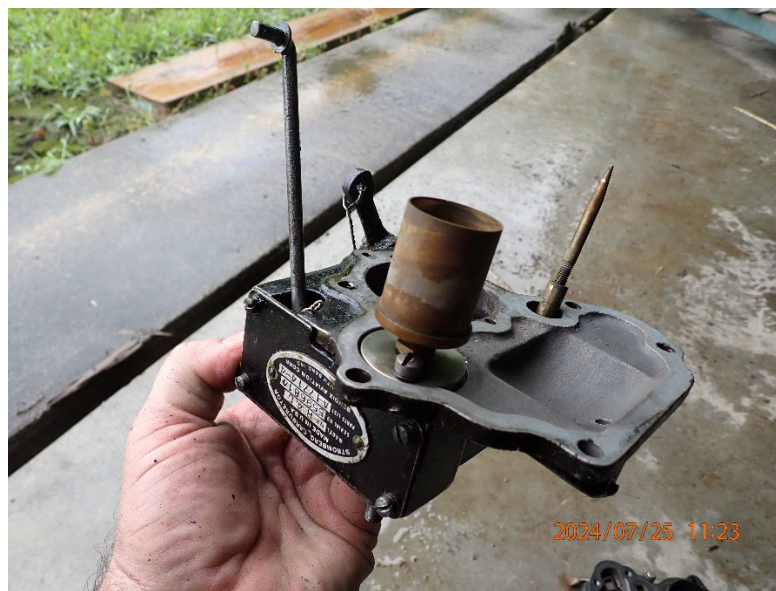
The venturi and the accelerator pump each appeared to be in good condition. The venturi was tight in the carburetor housing. The main jet was in good condition and tight in the carburetor housing. Figures 12 and 13.

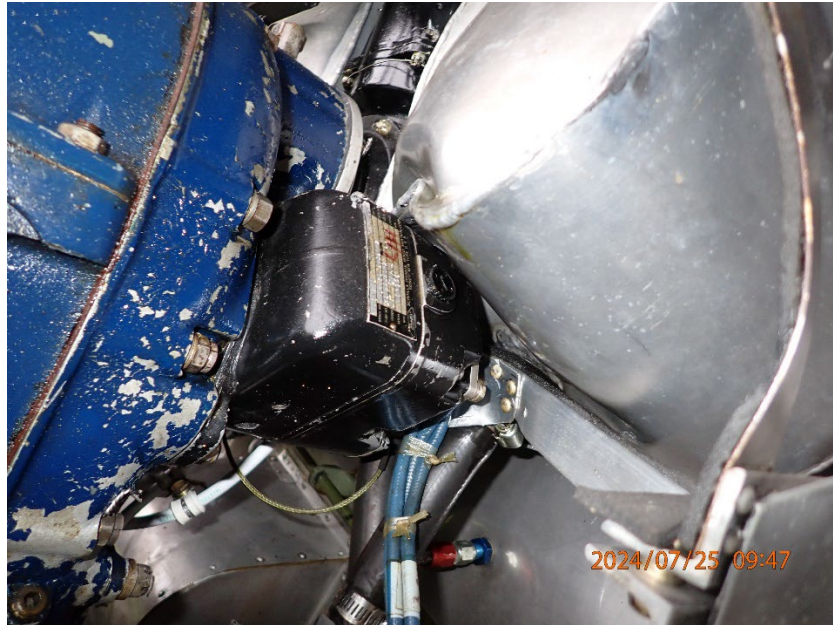
**Figure 14 Left Magneto and Oil Tank**

Both magnetos had remained on the engine. The ignition harnesses for left and right systems had been damaged due to the top wing impacting the top cowling, pressing into the engine bay, and crushing the oil tank and tank mount into the back of the magnetos. This also damaged the engine starter. Figures 14 and 15.

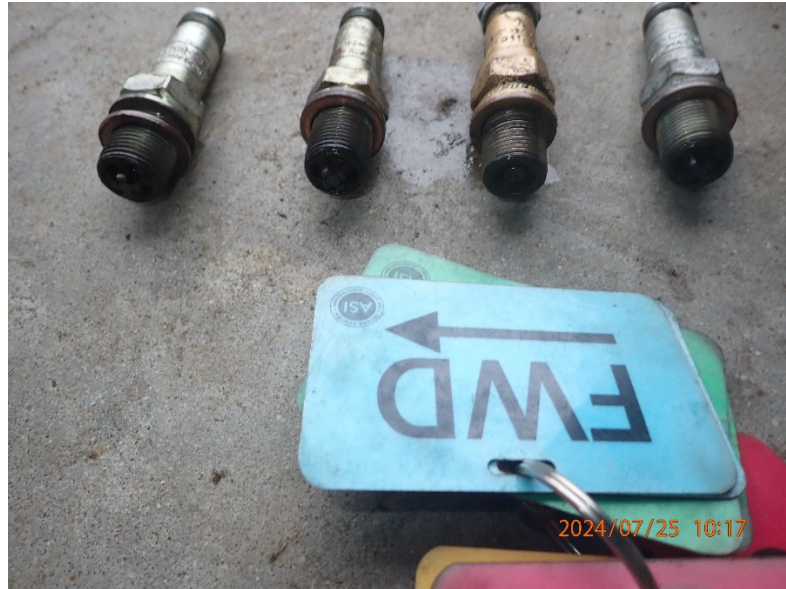
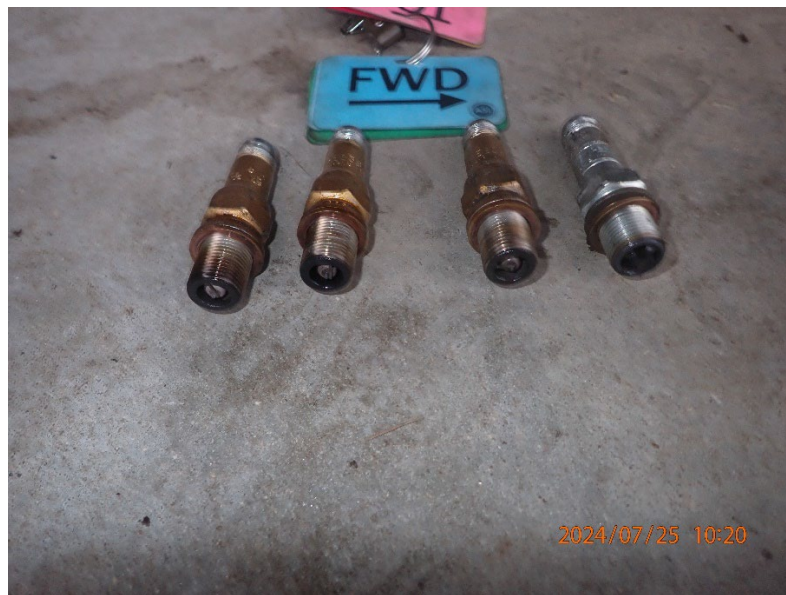
There was a mixture of mass electrode and fine wire plugs in the engine. Cylinder numbers 1, 2 forward plugs, and cylinder number 4 rear plug were mass electrode. Cylinder numbers 3 and 4 forward, along with cylinder numbers 1, 2, and 3 rear contained fine wire plugs. All plugs showed normal wear and were not fouled, figures 16 and 17.

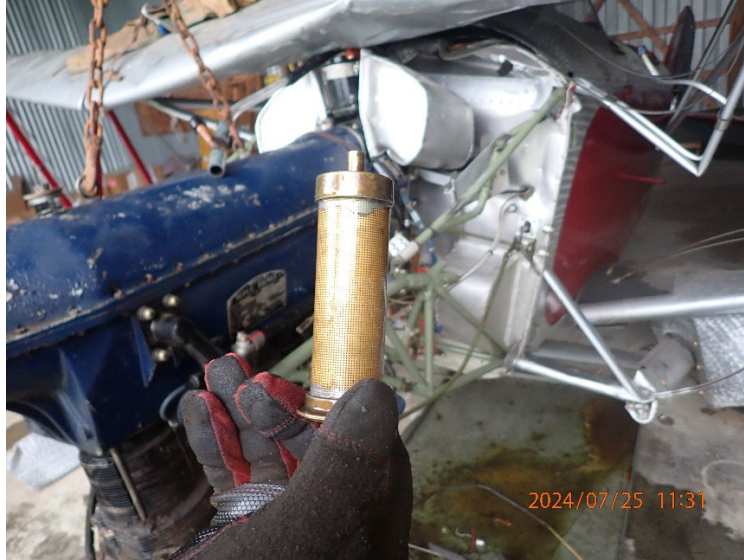
**Figure 18 Oil Screen**

The engine oil tank had been ruptured at impact due to the top wing crushing the cowling. The oil screen was removed and found free of contaminants, figure 18. All oil lines and hoses remained attached to their respective locations on the engine and oil tank.
