ERA24LA230

## INVESTIGATION PHOTOGRAPHS

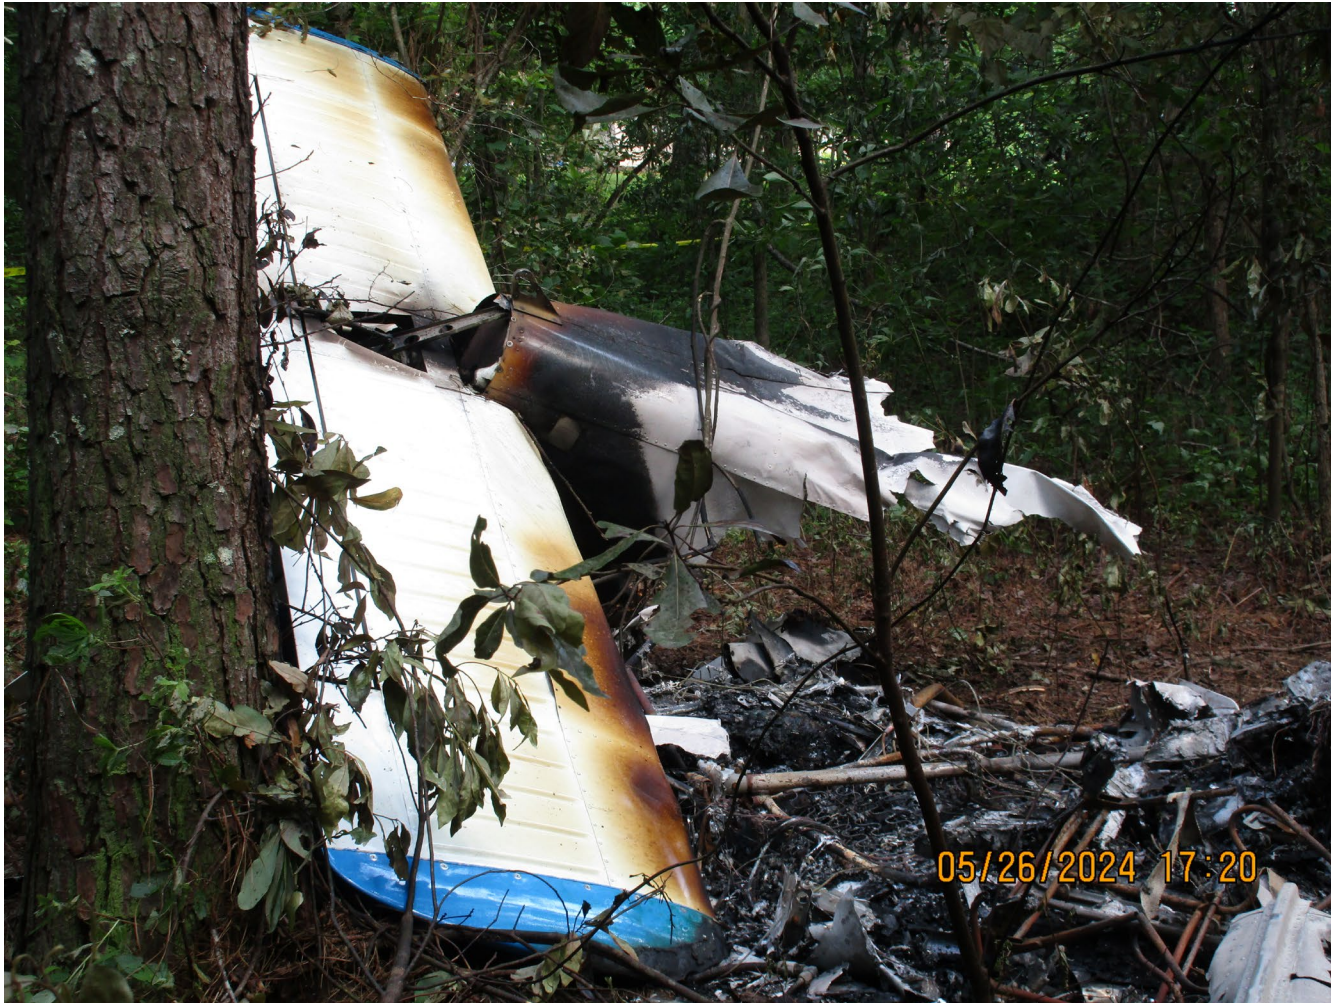
**Photograph 1 - Empennage and wreckage at the site. (Courtesy of FAA)**

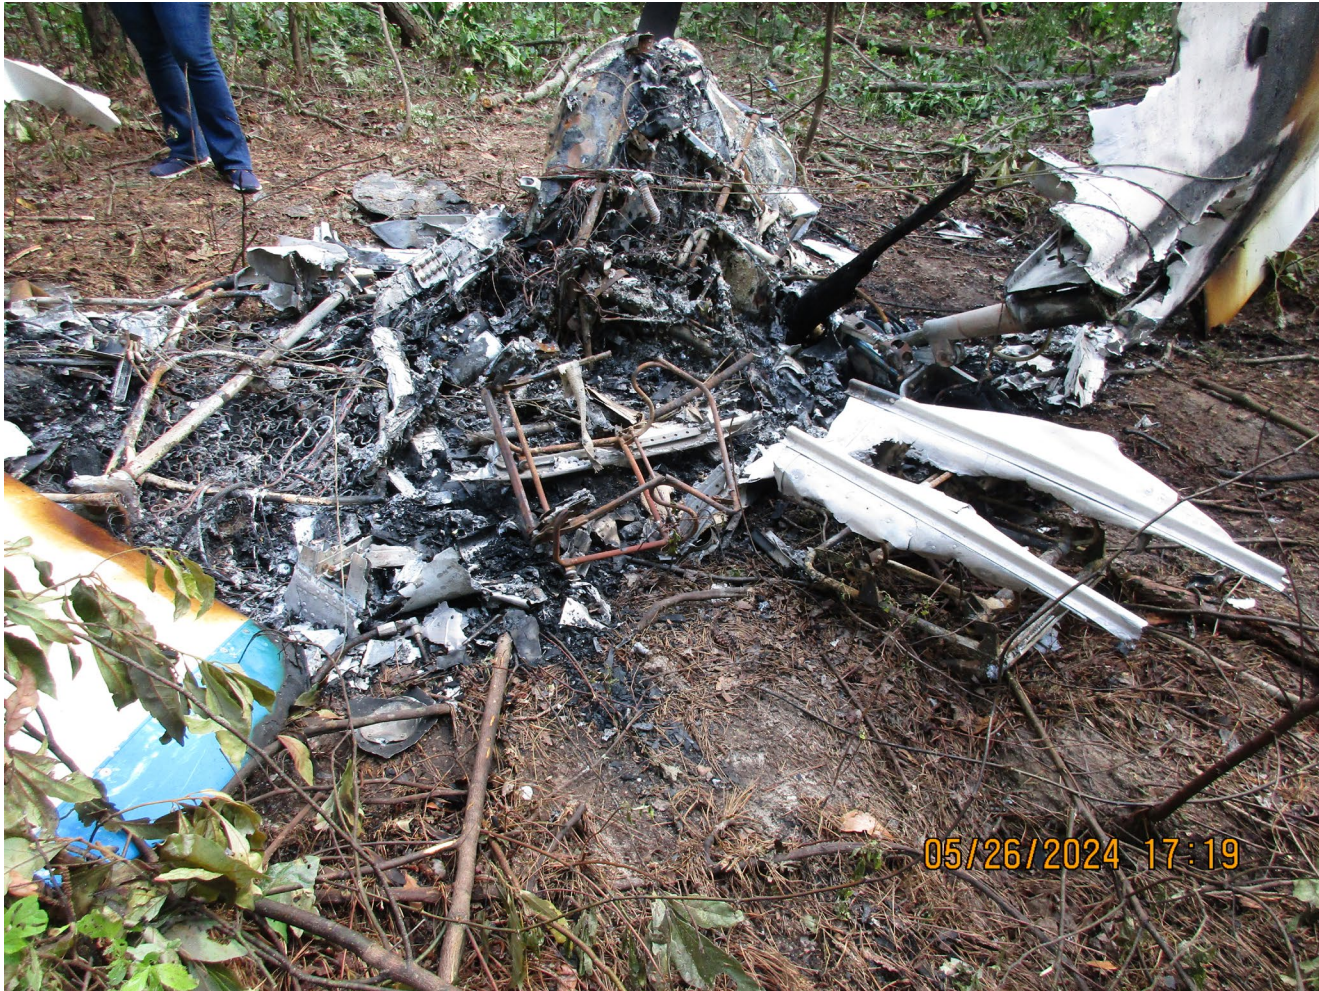
**Photograph 2 - View of fuselage wreckage at the accident site. (Courtesy of FAA)**

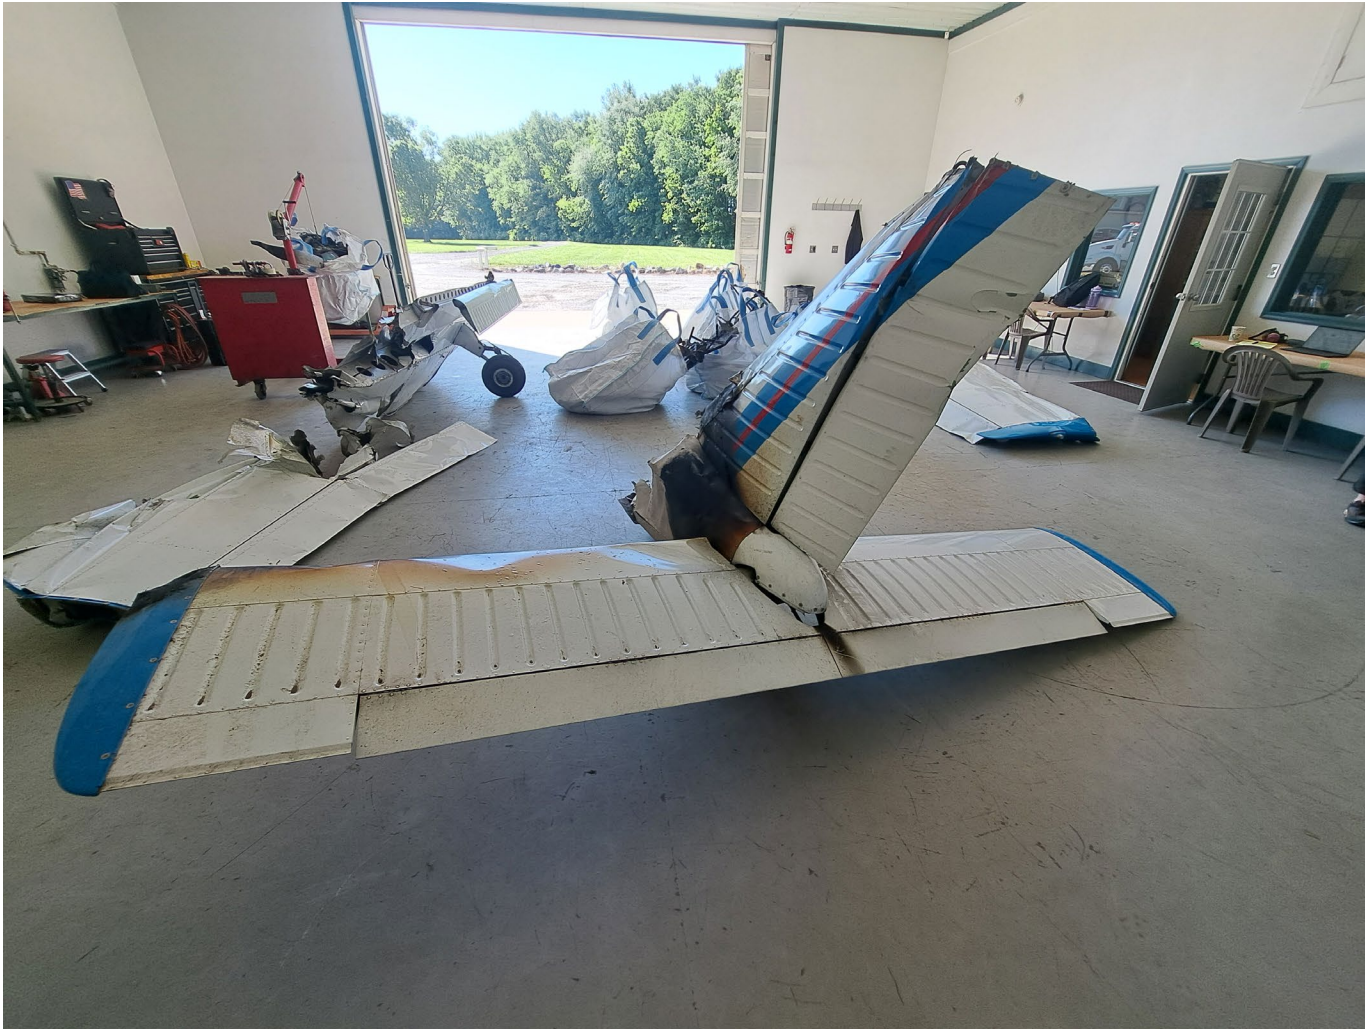
**Photograph 3 - View of wreckage at hangar facility. (NTSB)**

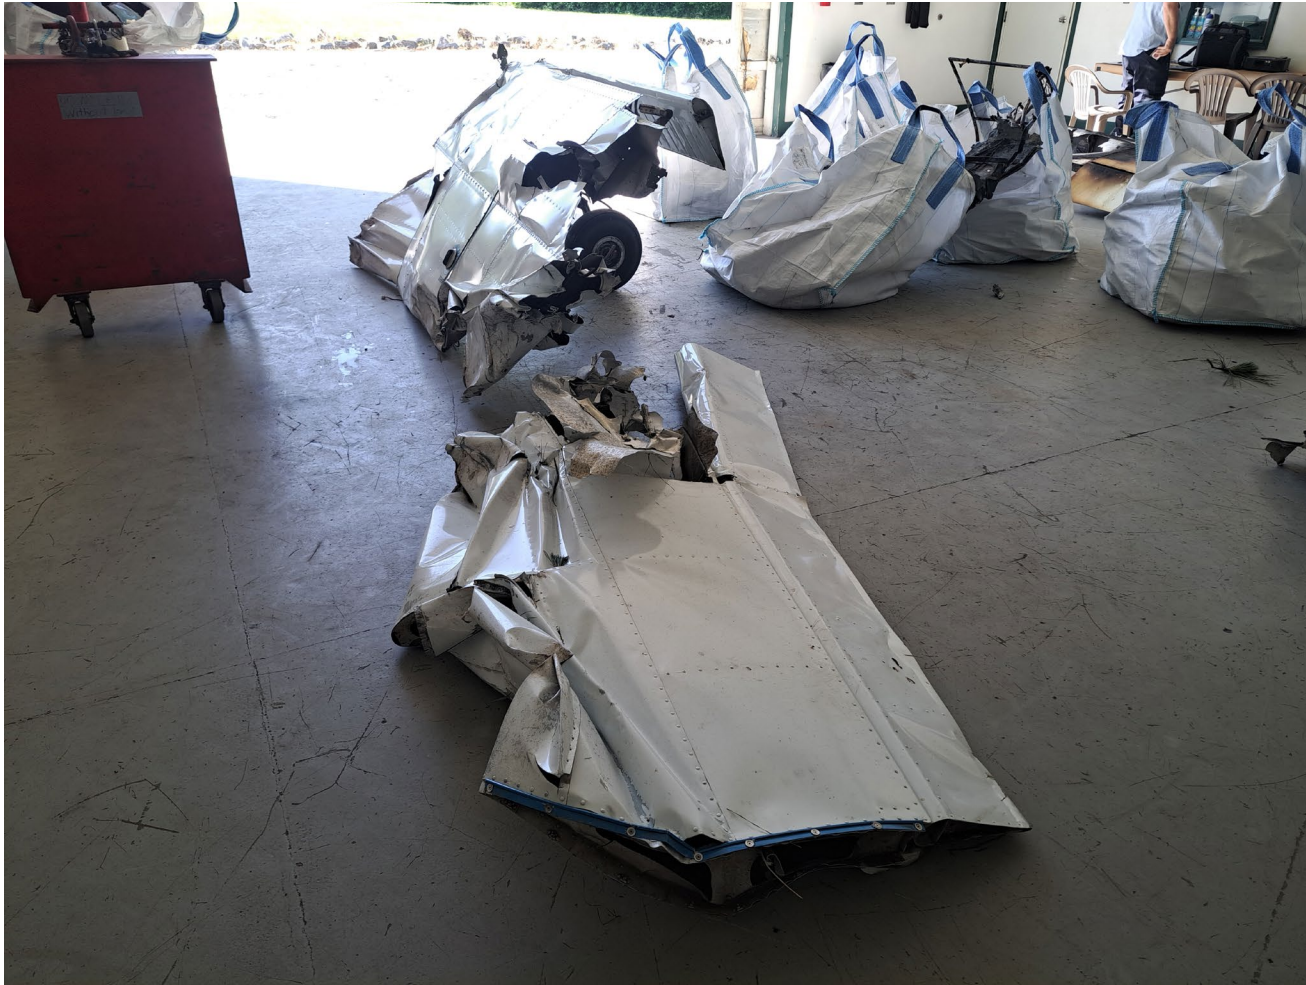
**Photograph 4 - View of left wing at hangar facility (NTSB)**

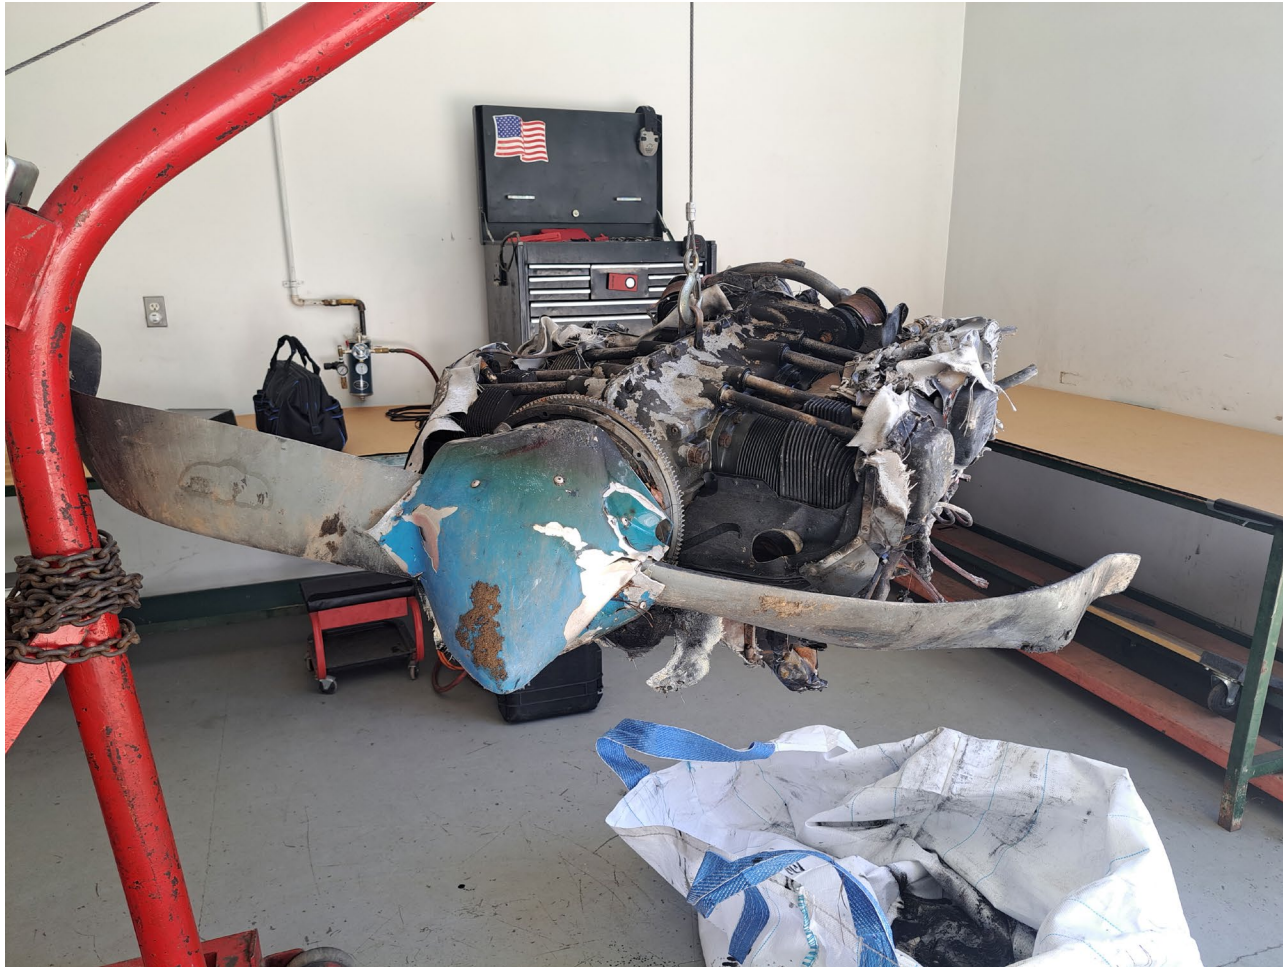
**Photograph 5 - View of propeller assembly and engine on hoist. (NTSB)**

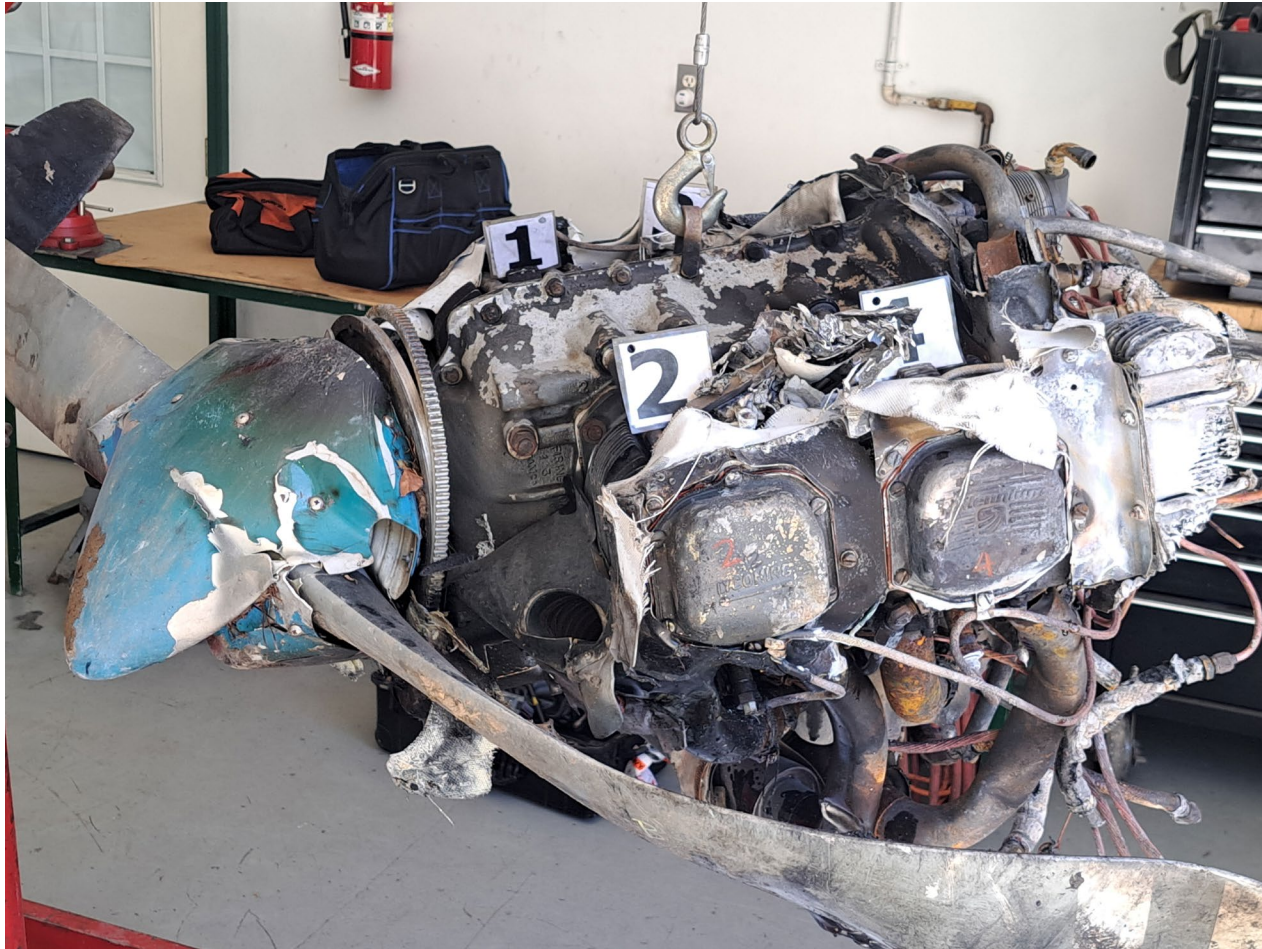
**Photograph 6 - View of number 2 and 4 side of engine. (NTSB)**

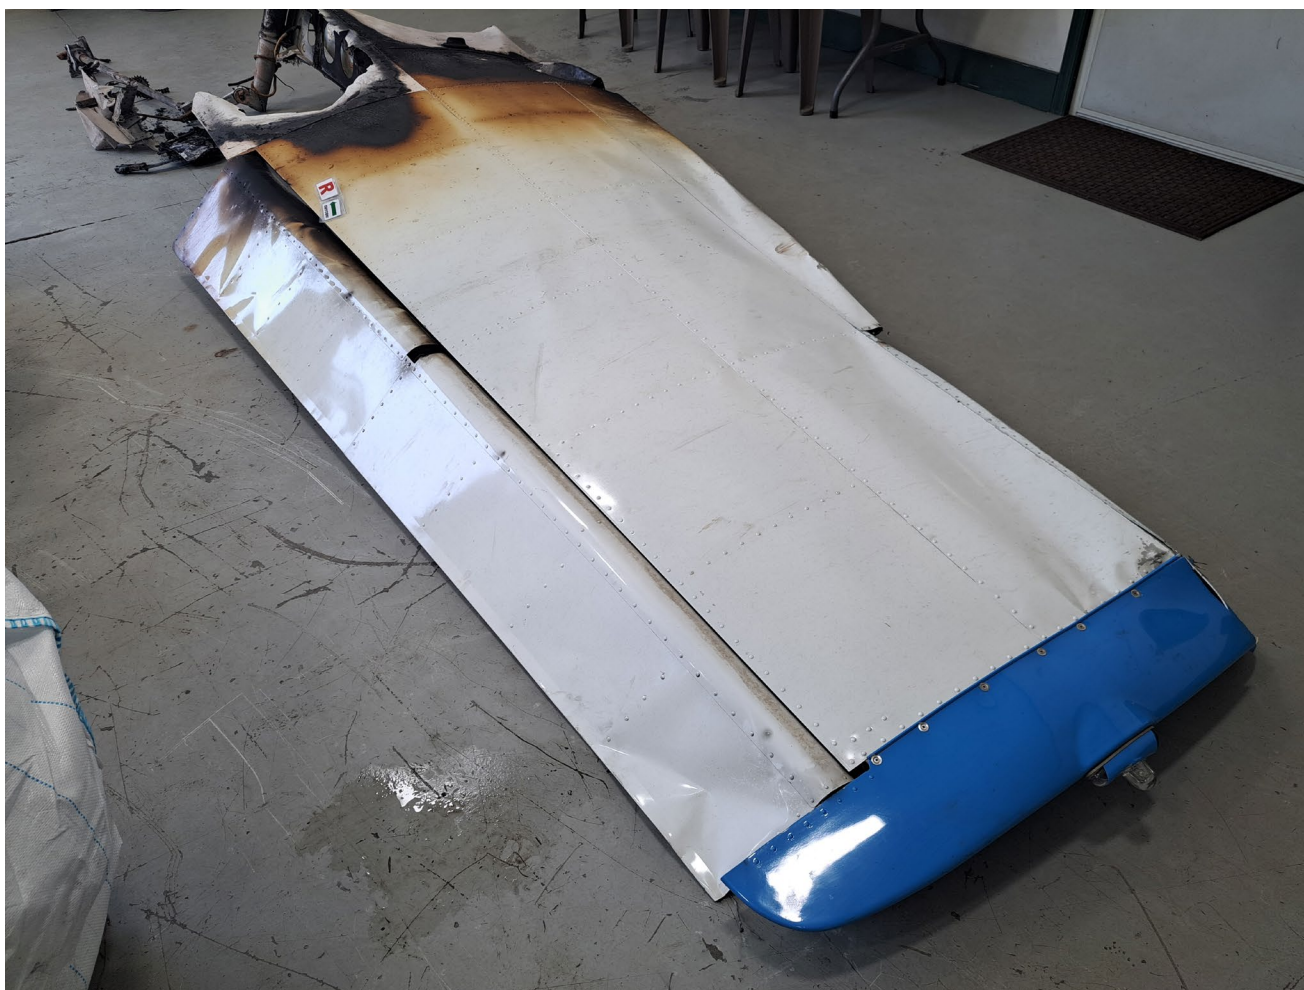
**Photograph 7 - View of right wing damage at hangar facility. (NTSB)**

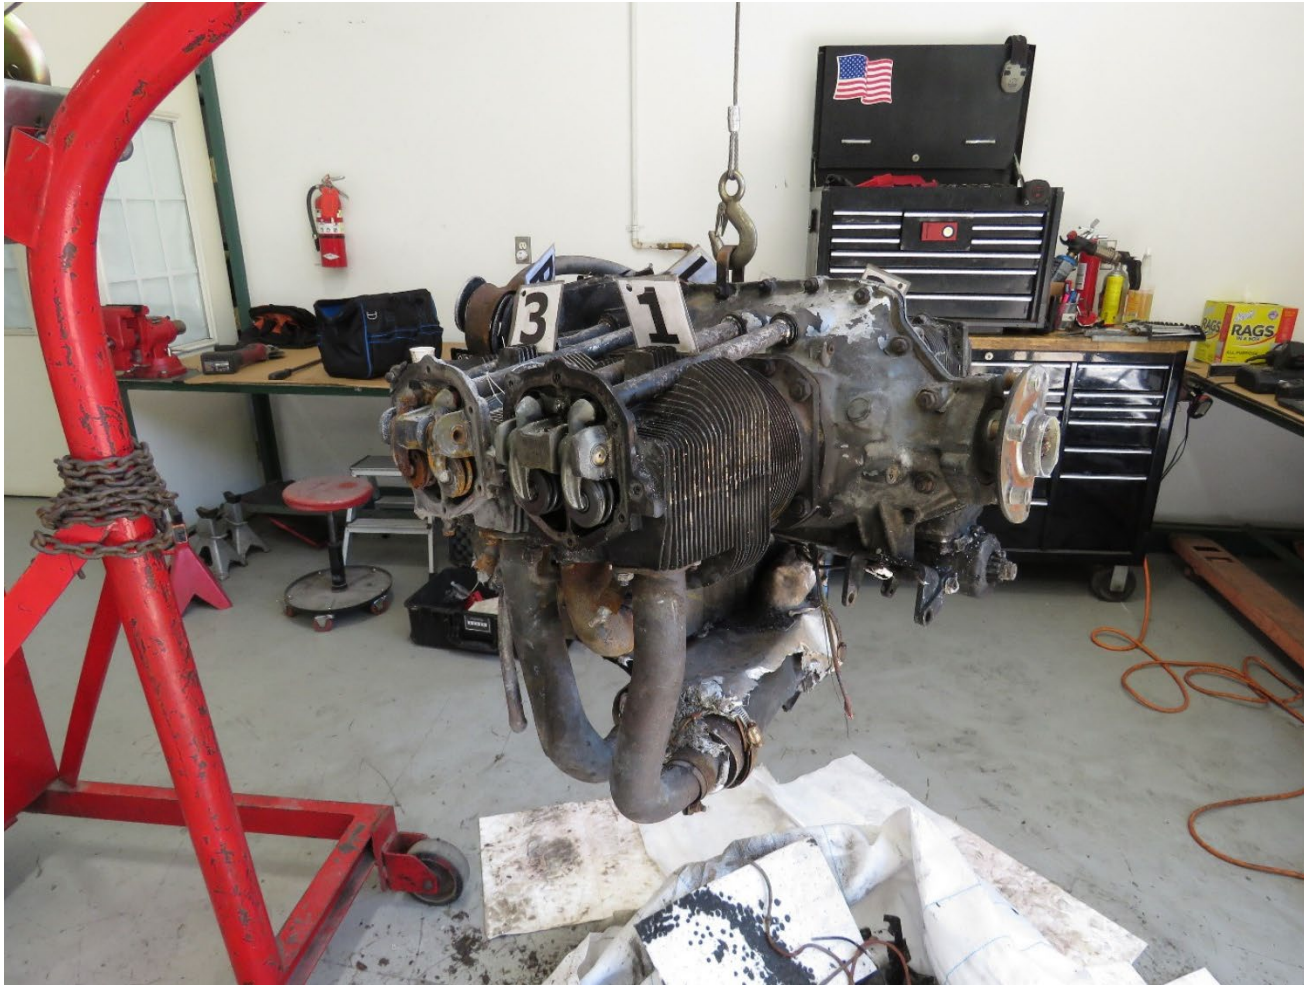
**Photograph 8 - View of number 1 and 3 side of engine on hoist. (NTSB)**

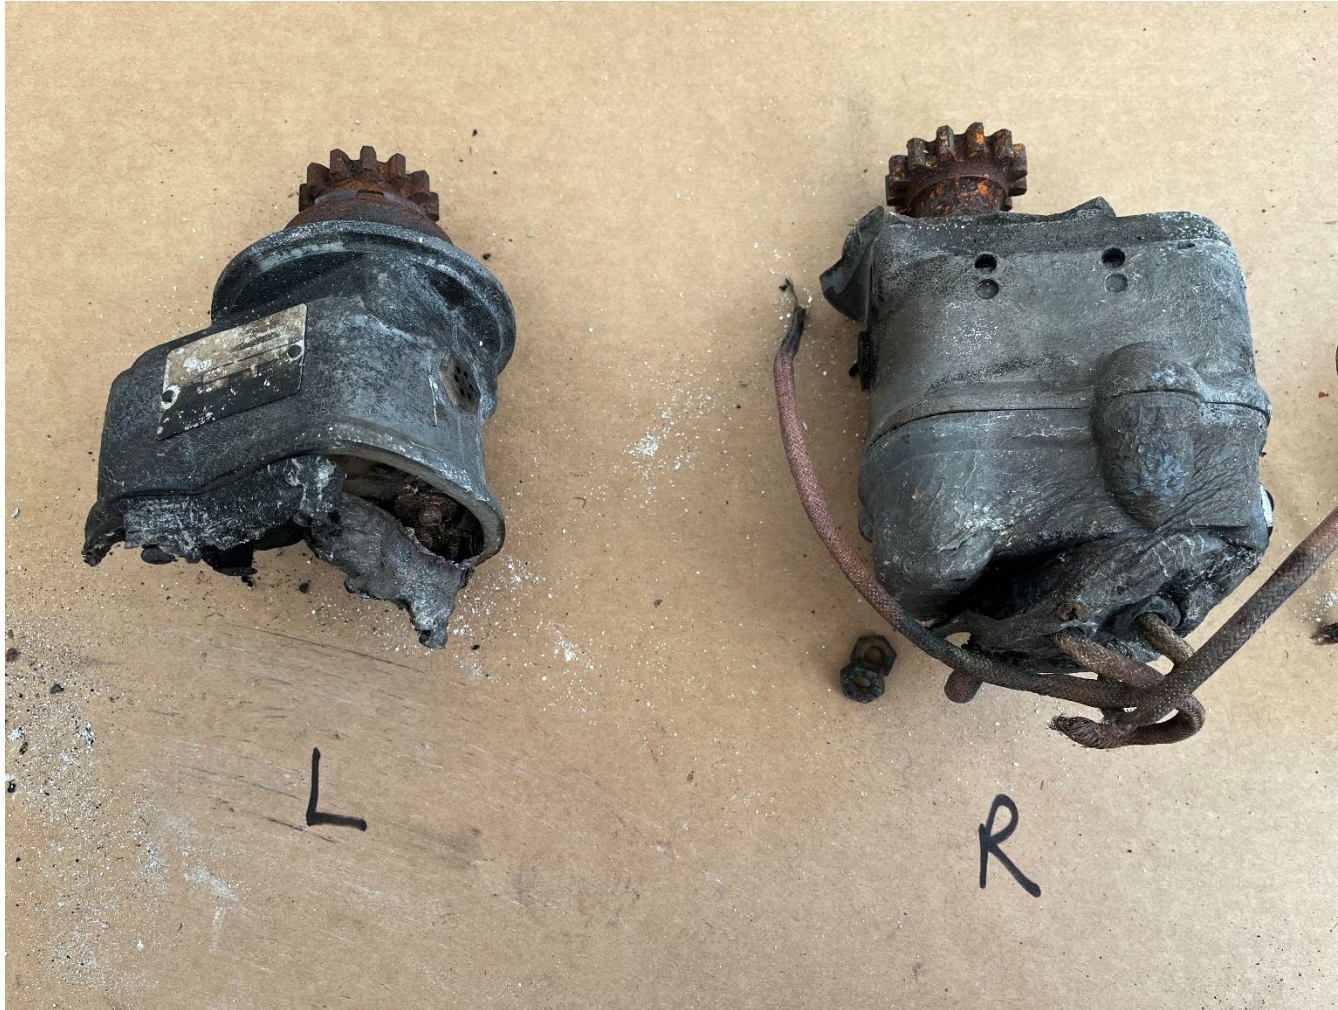
**Photograph 9 - View of damaged magnetos. (Courtesy of Lycoming)**

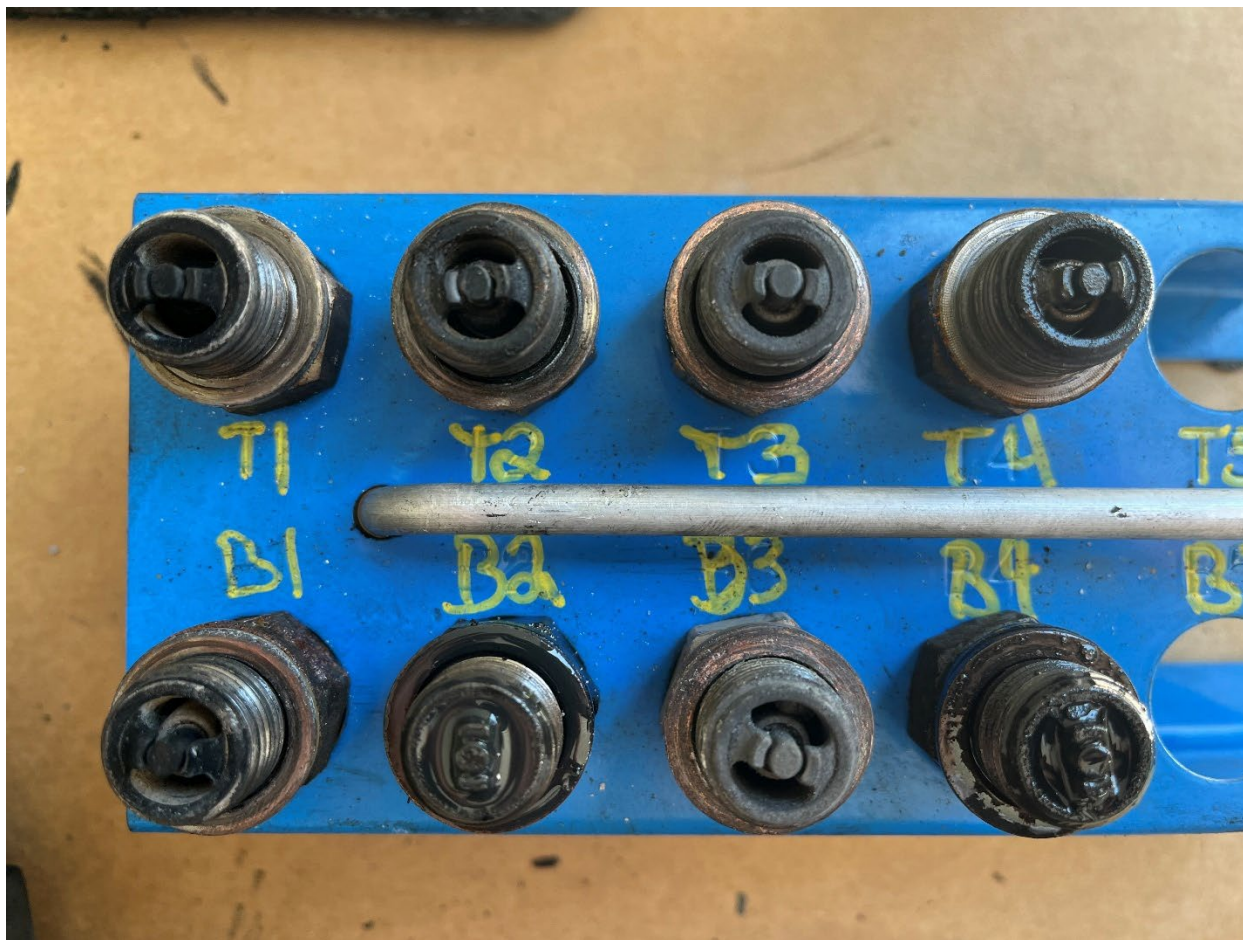
**Photograph 10 - View of spark plugs. (Courtesy of Lycoming)**

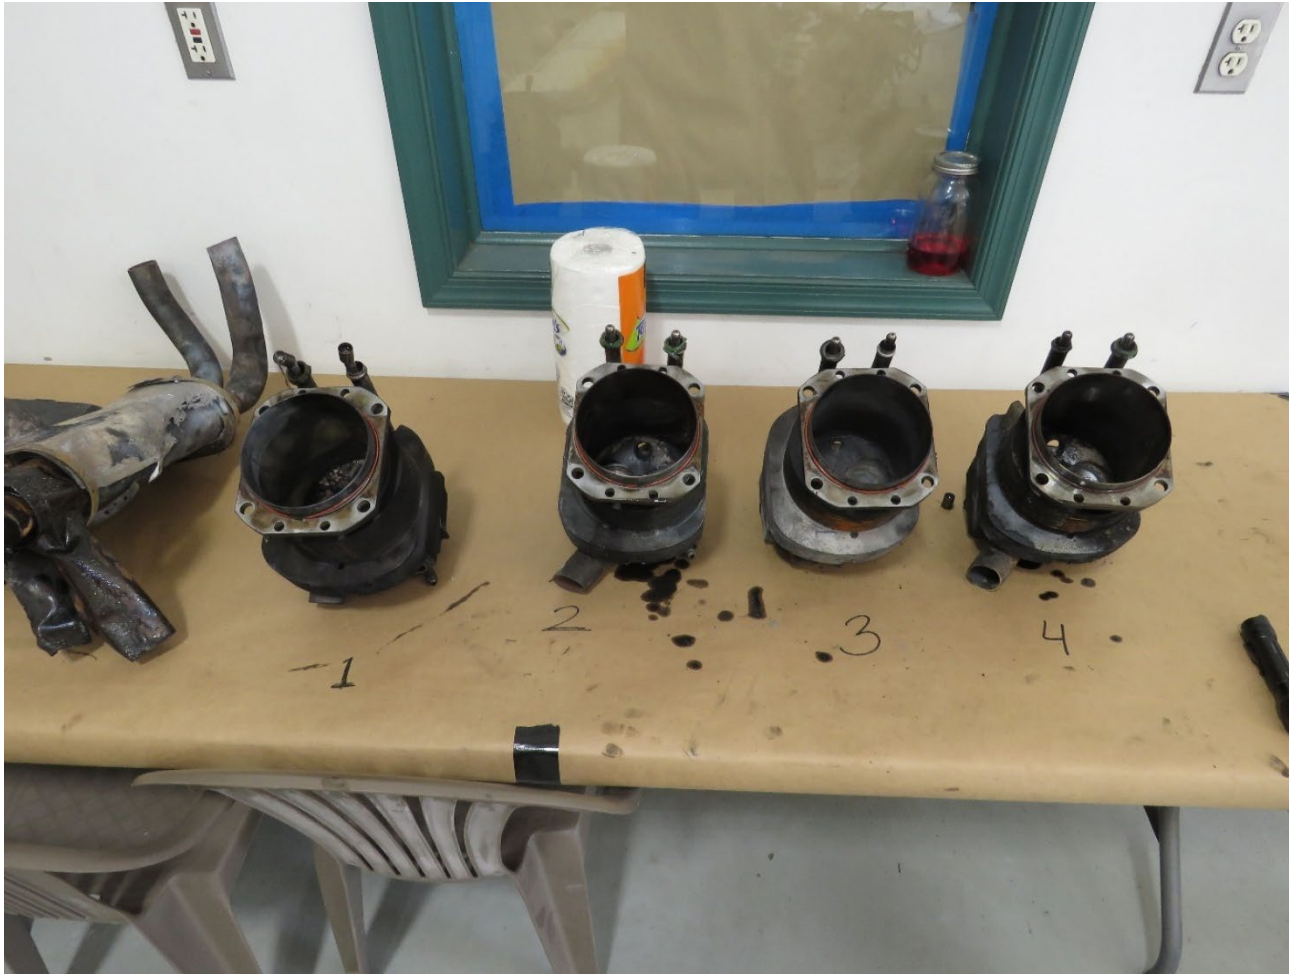
**Photograph 11 - View of removed cylinder assemblies. (NTSB)**
