# National Transportation Safety Board

ERA24LA230

## ACCIDENT INVESTIGATION EXAMINATION REPORT

Location: Hope Mills, North Carolina ; Grays Creek Airport (2GC),  
Date: May 26, 2024  
Time: 1100  
1500 UTC  
Airplane: Piper PA-28-151, N33563

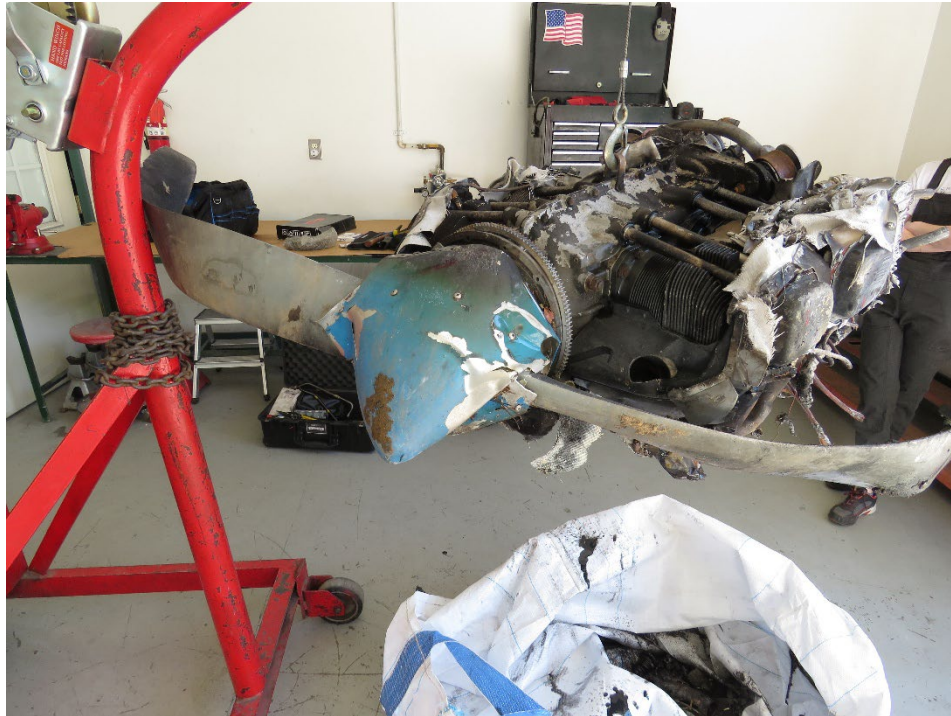
**Figure 1; Propeller.**

The airplane impacted heavily wooded terrain consisting of 50 to 75 ft tall pine trees about 3/4 mile from the departure end of runway 35. There was substantial damage to the airframe; the fuselage was consumed by fire. Both wings and the empennage were separated from the fuselage. The metal two-bladed fixed pitch propeller remained attached to the engine's crankshaft propeller flange. The propeller blades exhibited varying degrees of leading-edge damage, and chordwise scratching with torsional twisting and s-bending on both blades. The engine was subjected to postimpact fire, and the exterior was damaged by thermal forces and impact. (Figure 1)

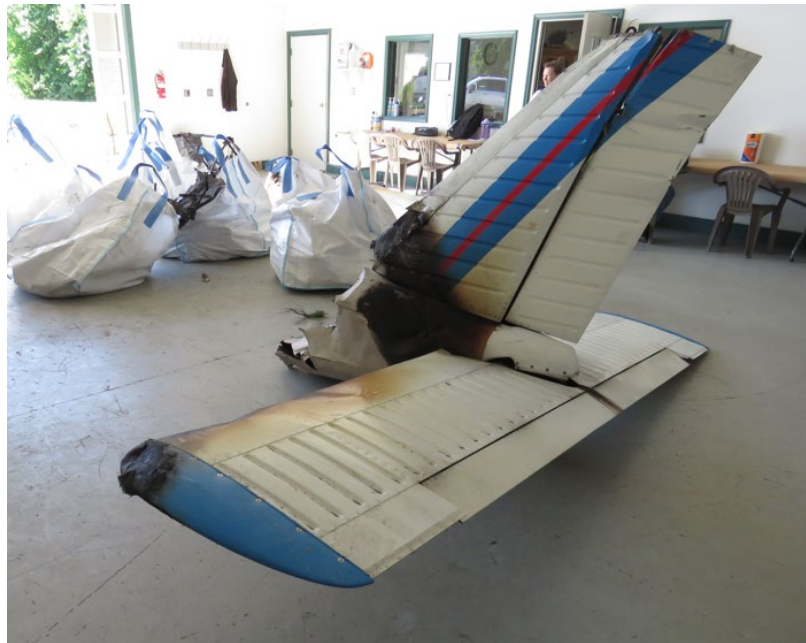
**Figure 2; Empennage.**

The empennage separated from the aft fuselage. Fire damaged the tail section and lower forward section of the vertical stabilizer. The vertical stabilizer remained attached to the empennage. The rudder remained attached to the vertical stabilizer at all hinges. The vertical stabilizer displayed leading edge damage along the entire span. The stabilator remained attached to the aft fuselage at all hinges. The left side leading edge of the horizontal stabilator had slight impact and fire damage. The stabilator trim surface remained attached to the stabilator at all hinges. The stabilator balance weight remained attached to the stabilator control tube. The stabilator trim actuator shaft measured 1.5 inches of extension on the top portion above the drum with 14 threads visible. This equates to nose up trim. (Figure 2)

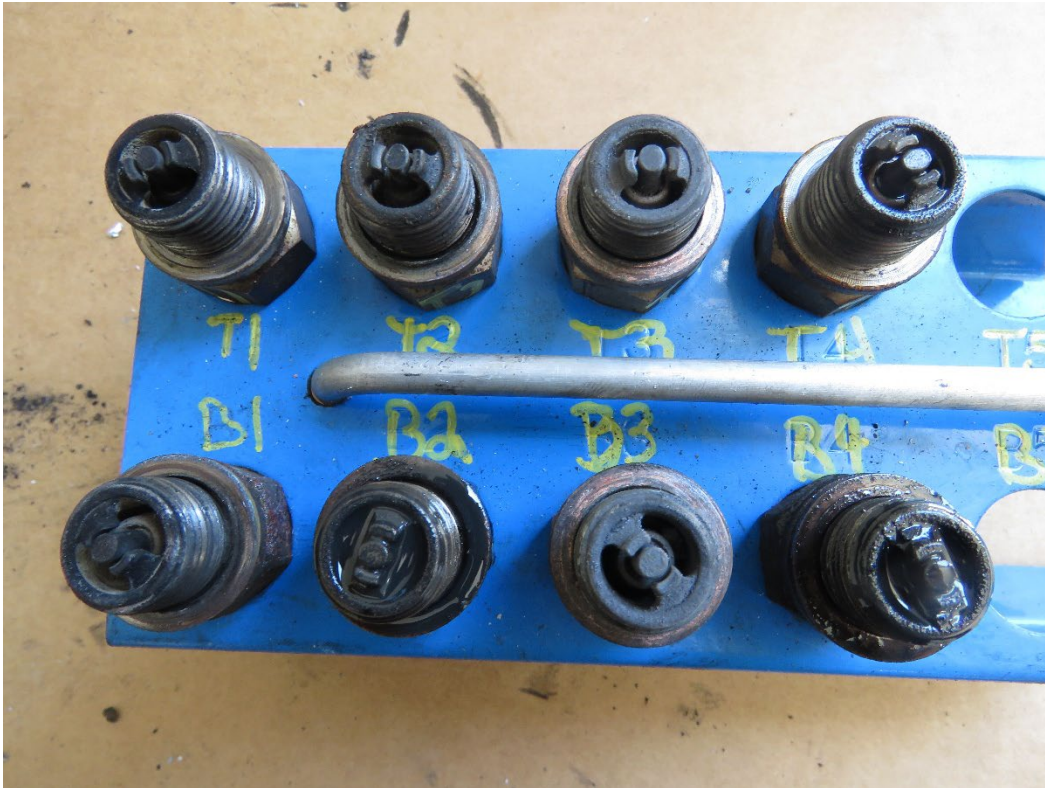
**Figure 3; Spark Plugs**

All sparkplugs remained secured in the cylinders. The sparkplugs were removed and photo documented. The following was noted in reference to the champion aerospace aviation check-a-plug with the spark plugs: (Figure 3)

- Top 1 – carbon fouled. (Significant)
- Bottom 1 – carbon fouled. (Significant)
- Top 2 – carbon fouled.
- Bottom 2 – oil soaked.

- Top 3 – normal, gray in color.
- Bottom 3 – normal, gray in color.
- Top 4 – Oil fouled.
- Bottom 4 – oil soaked.

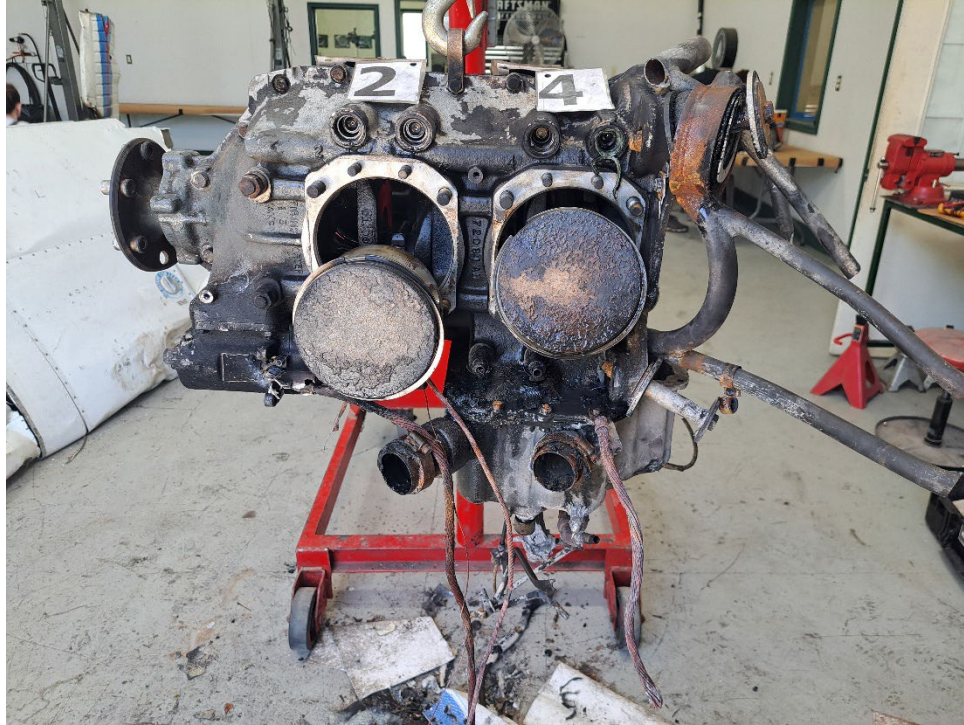
**Figure 4; Engine; The Nos 2 and 4 Side**

The engine's crankshaft would not rotate. The propeller and fragmented starter ring gear were removed, the crankshaft would not rotate in either direction when applying hand pressure to the crankshaft flange. The right-hand idler gear was freed from its idler shaft; the crankshaft rotated manual hand pressure through several 720° of rotation.

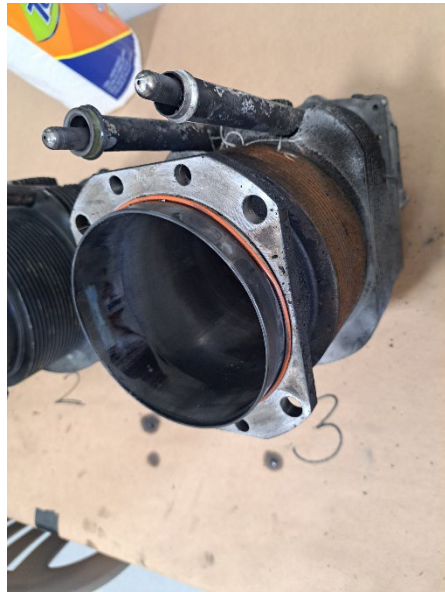
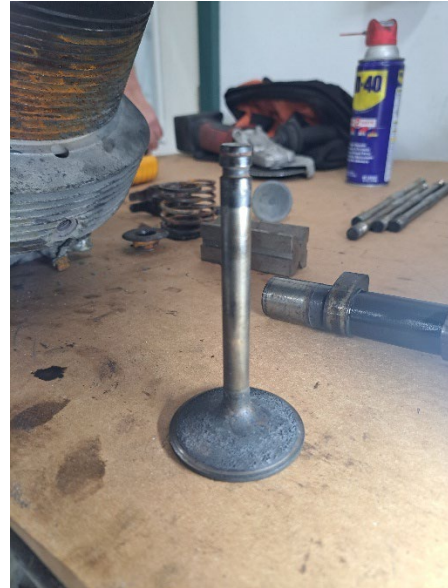
**Figure 5; No 3 Cylinder and intake valve.**

All four cylinders were removed. Impact damage was noted on the No. 3 cylinder, the cylinder's intake shroud tube and pushrod, and the rocker box cover. In addition, the No. 3 cylinder was exposed to high thermal forces.

A light was shone under the intake valve and light was noted going past the intake valve's seat, indicating it was not fully seating and likely the cause of the lack of compression and suction observed on the No. 3 cylinder. The exhaust valve and intake valve were examined; the exhaust valve came free of the guide with gravity alone. The intake valve moved with hand pressure until the stem tip enter the valve guide, which then required significant hand pressure to pull the intake valve free of the intake valve guide. The intake valve guide was rolled along the edge of the table and in v-blocks, it was not bent and rotated smoothly (Figure 5)

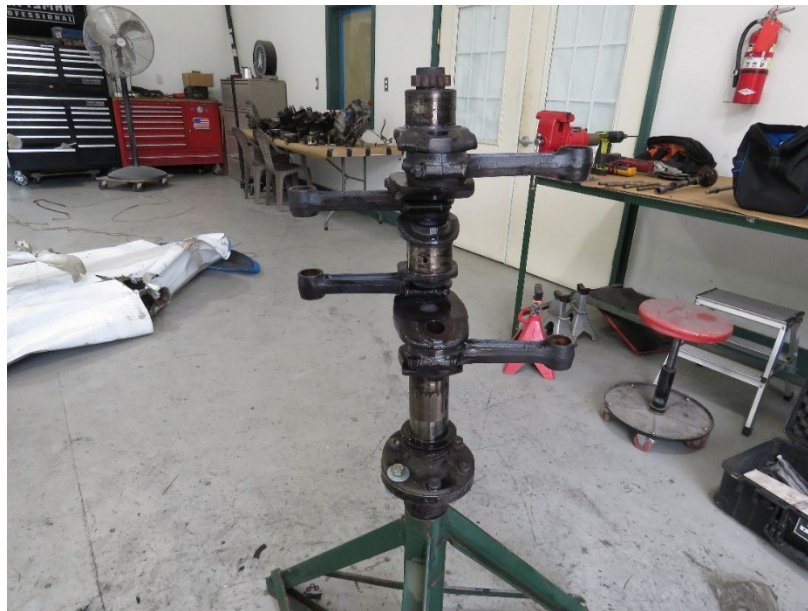
**Figure 6; Crankshaft.**

The crankcase was disassembled, the faces of each flat tappet appeared whole and undamaged, no corrosion or pitting was noted. The camshaft was whole and undamaged, no excessive wear was noted on any of the lobes. (Figure 6)
