ERA24LA234

## INVESTIGATION PHOTOGRAPHS

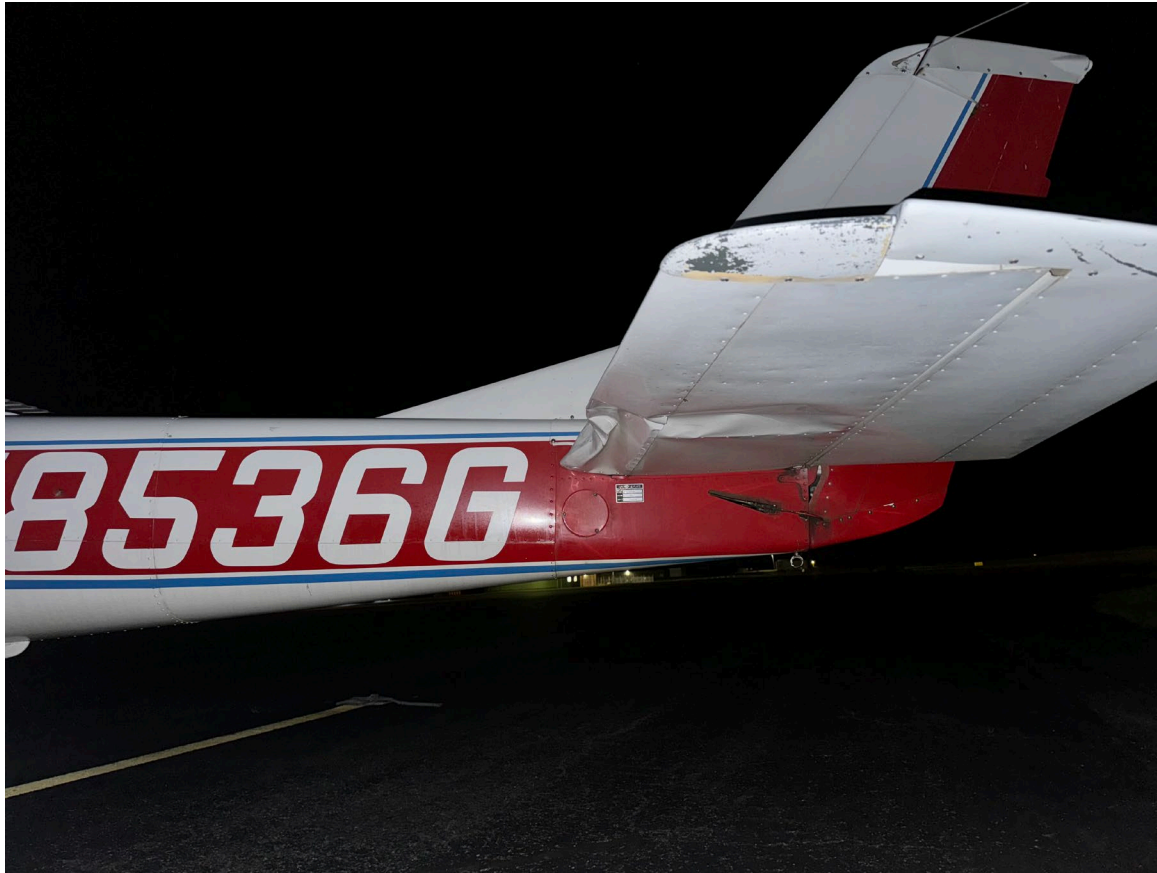
**Photograph 1 - View of left horizontal stabilizer showing leading edge damage (Courtesy of FAA)**

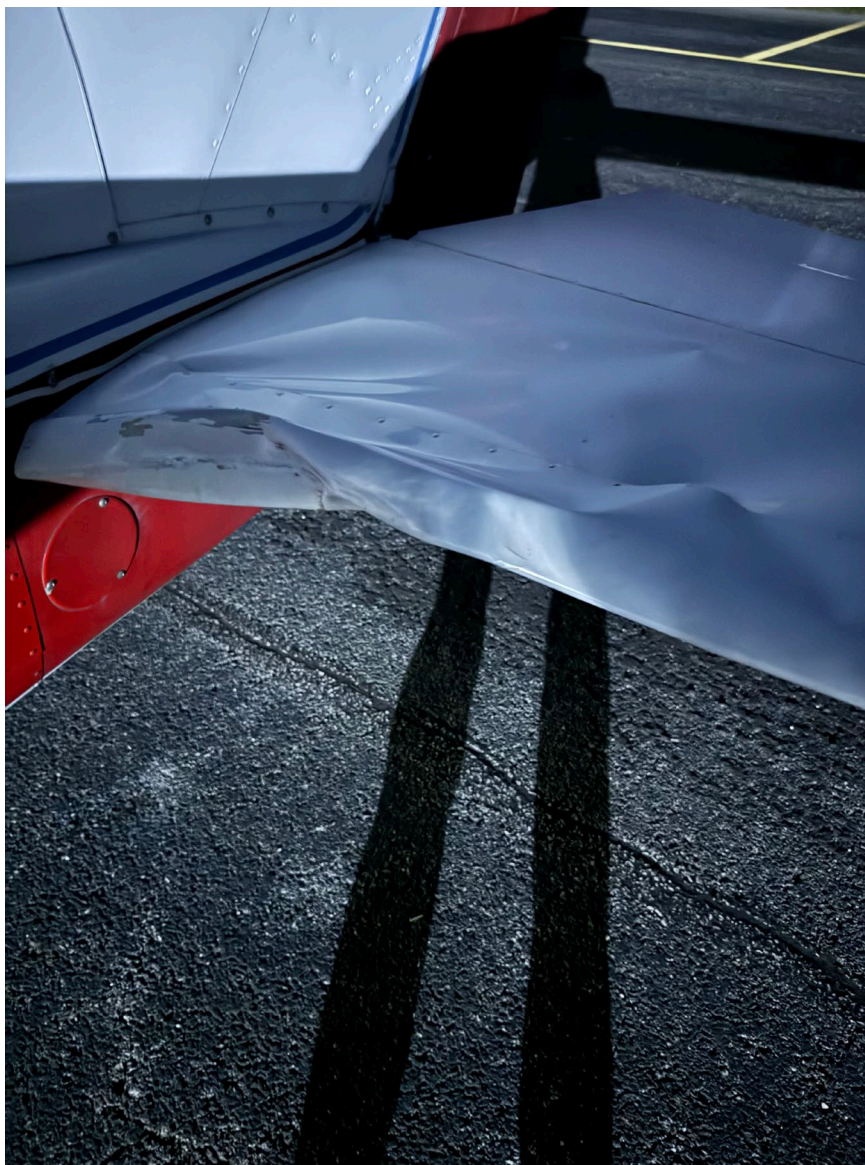
**Photograph 2 - Close up view of damaged left horizontal stabilizer (Courtesy of FAA)**
