ERA24LA238

## INVESTIGATION PHOTOGRAPHS

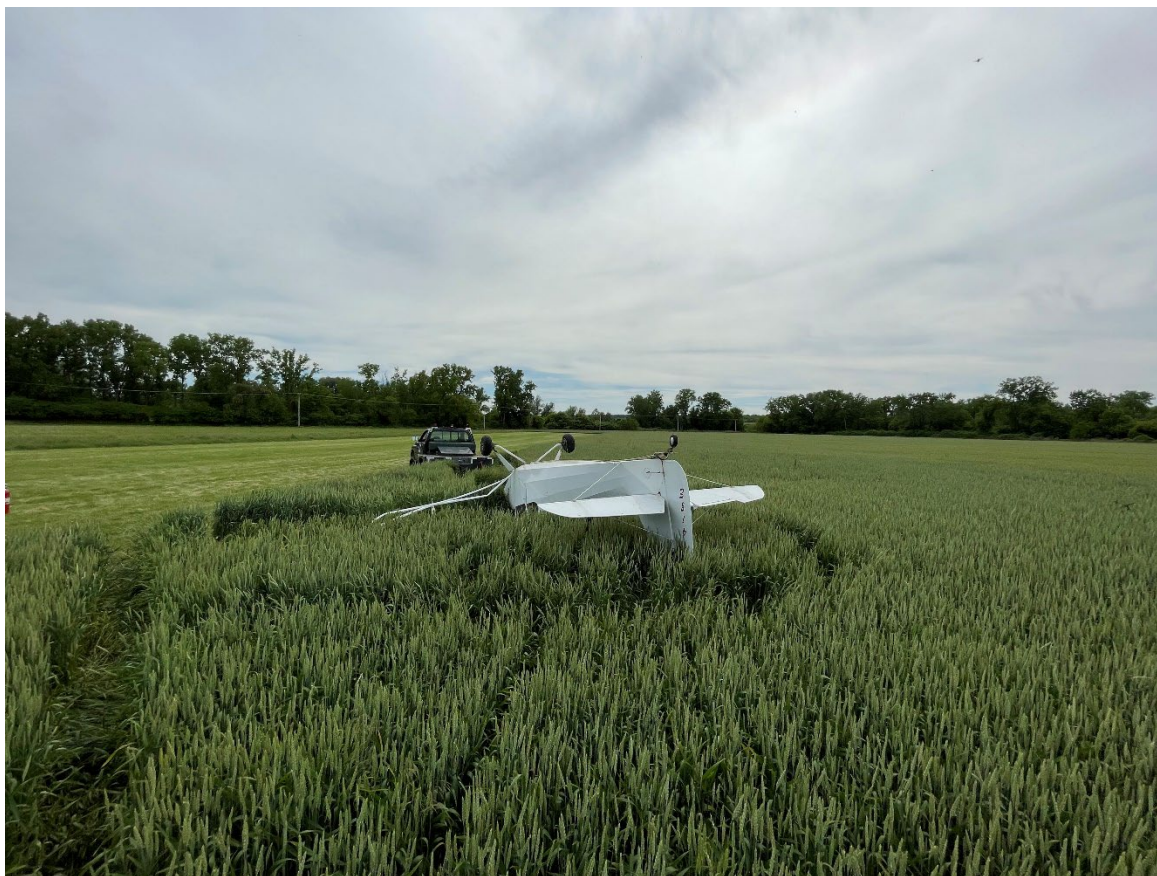
**Photograph 1 - FAA Digital Photograph. Rear View of the Inverted Airplane at the Accident Site**

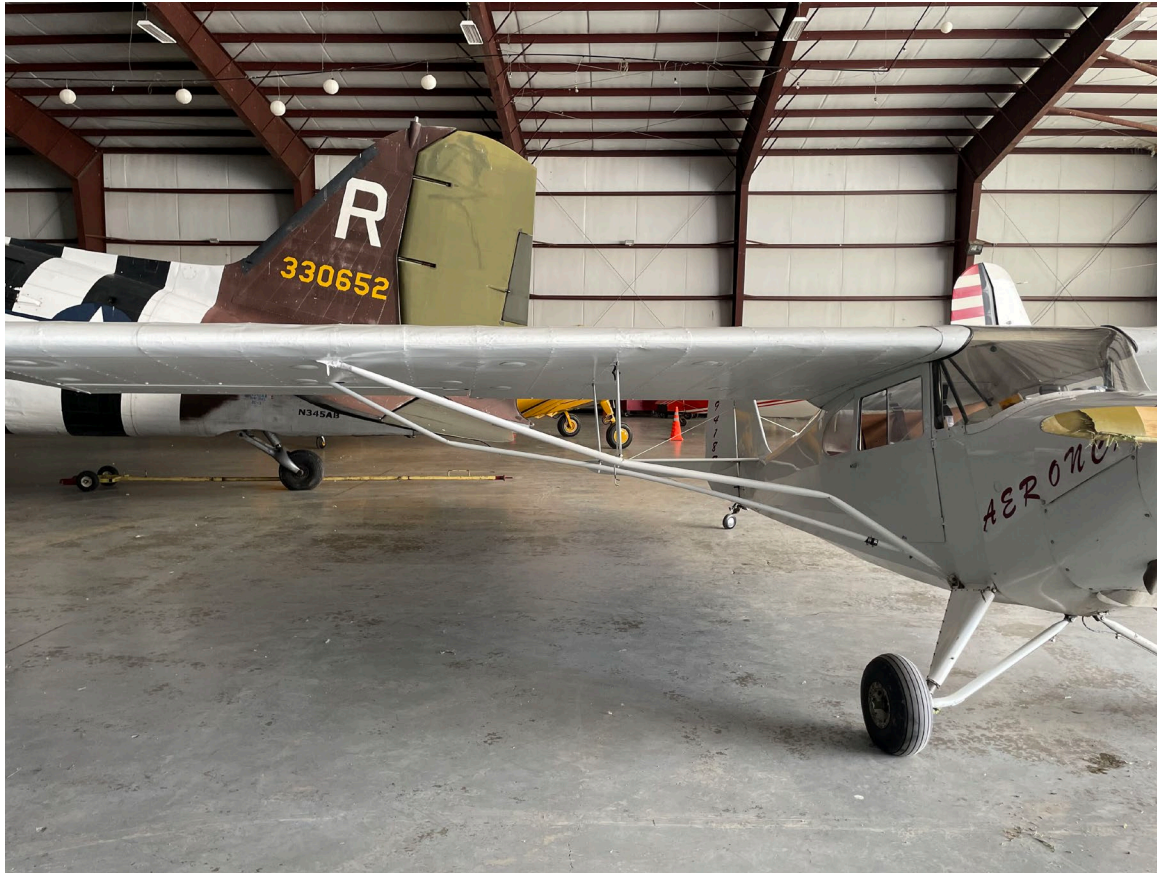
**Photograph 2 - FAA Digital Photograph. Right Quartering View of the Right Side of the Fuselage and Portion of Right Wing. Note both Wing Lift Struts damaged**

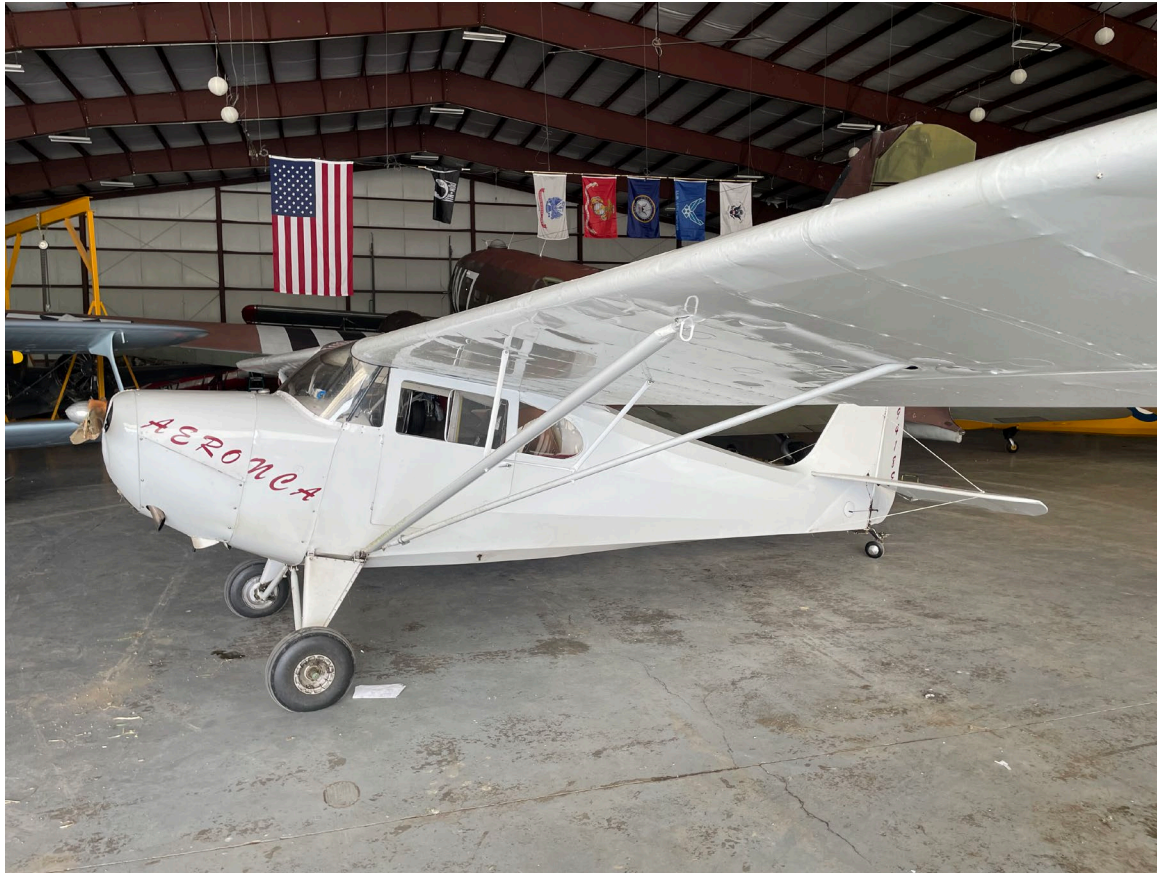
**Photograph 3 - FAA Digital Photograph. Left Quartering View of the Left Side of the Fuselage and Portion of the Left Wing**
