# National Transportation Safety Board

ERA24LA239

## **MATERIALS LABORATORY**

Factual Report 24-083

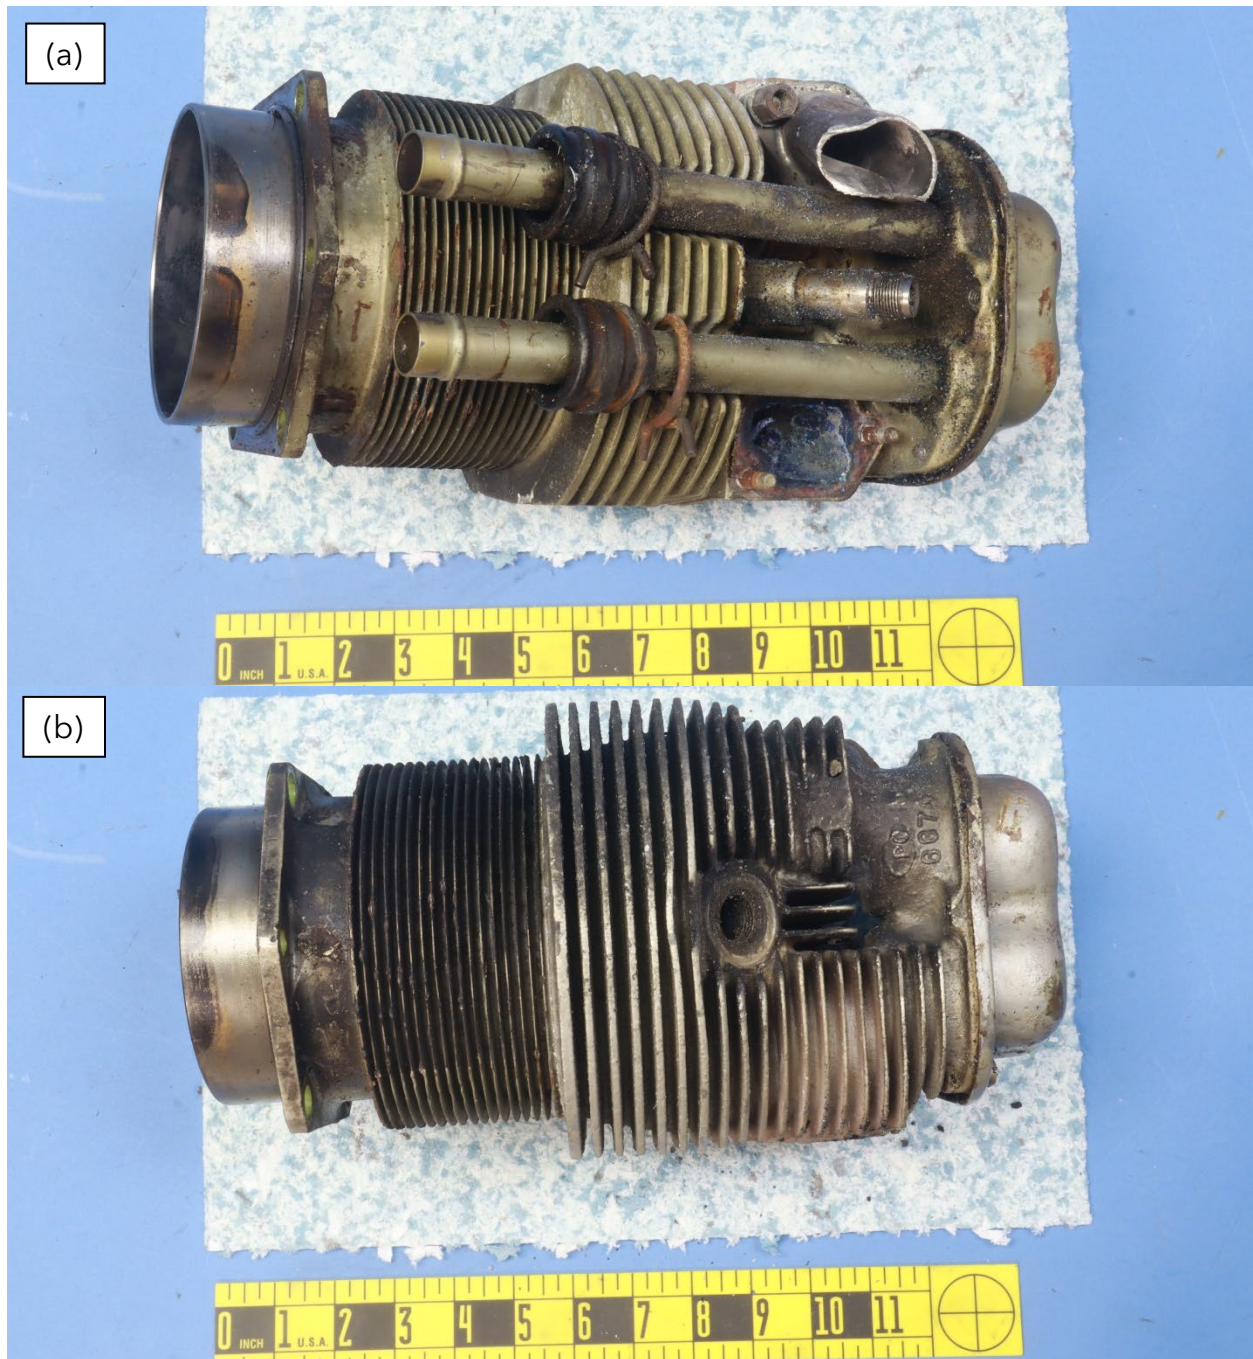
The components received by the Materials Laboratory were from the #2-cylinder assembly of the Continental O-200-A engine. The cylinder assembly is shown from different perspectives in Figure 1 and Figure 2. The piston was absent, and one of the spark plugs (shown in Figure 1b) had been removed. There was no indication of

Figure 1. View of the #2 cylinder from the (a) pushrod and (b) opposite side.

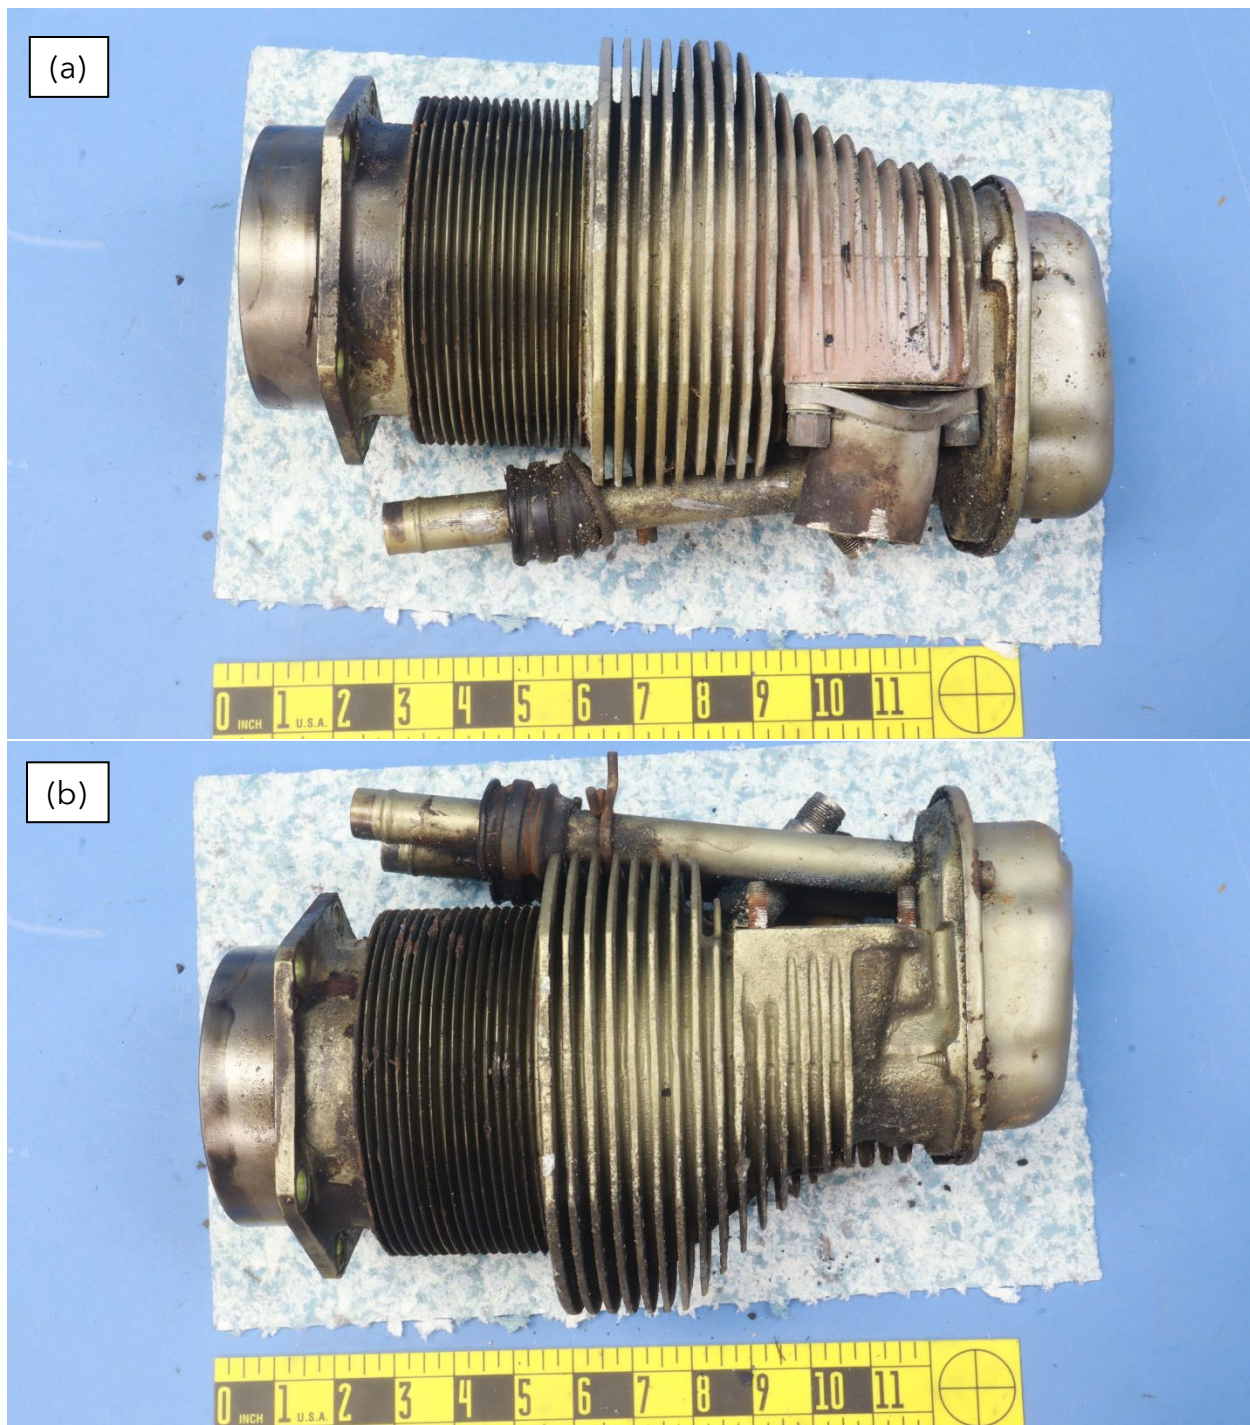
Figure 2. Side views of the #2-cylinder assembly.

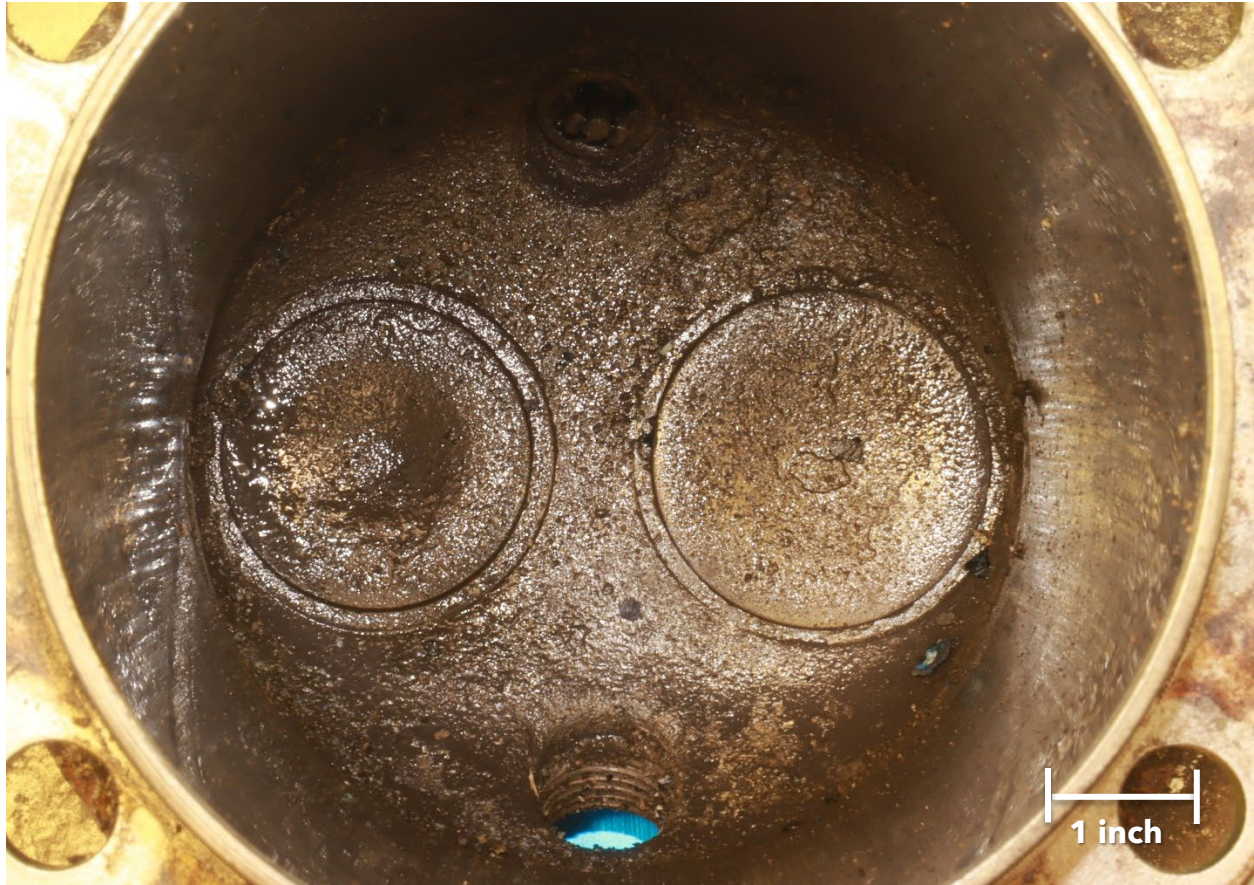
plastic deformation on the cooling fins or pushrods. Figure 3 shows the interior of the cylinder, showing the condition of the valve heads and adjacent seats. Dark brown compounds were present on these surfaces, consistent with combustion compounds typical of avgas reciprocating engines. There was also oil inside the cylinder interior.

Figure 3. View of the cylinder interior, as received, showing the two valve heads.

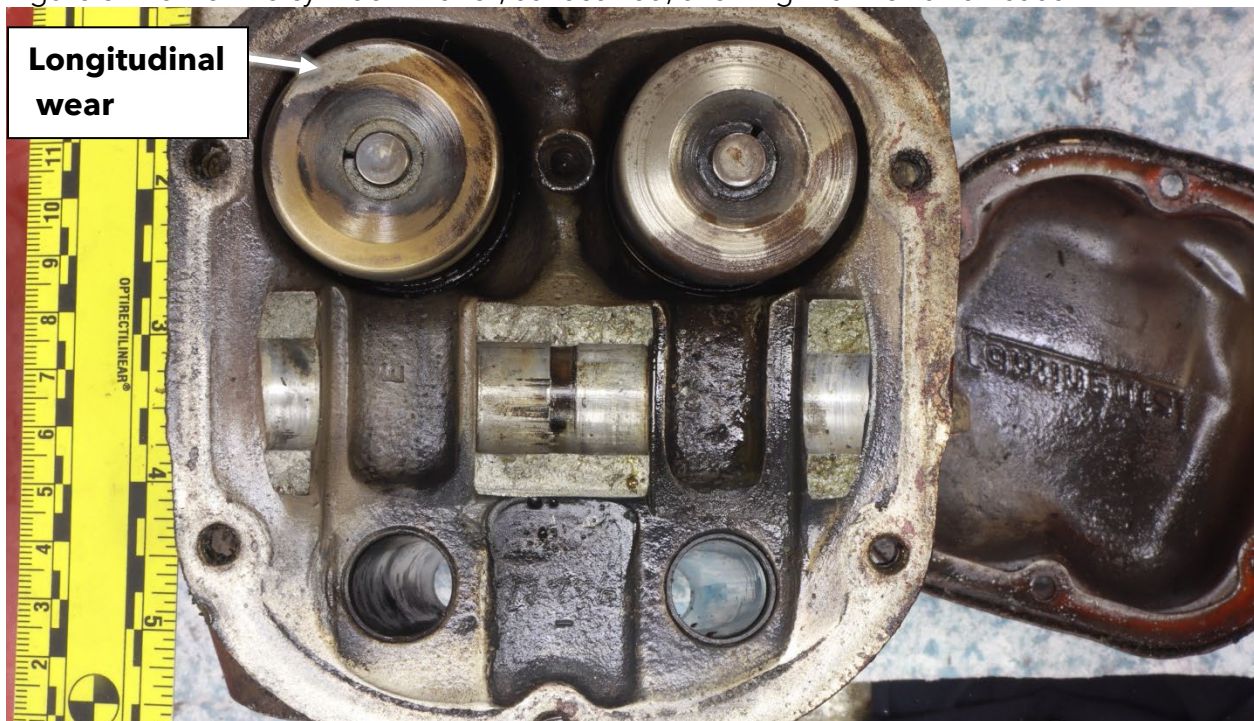
Several fragments and components had been removed from the upper housing of the cylinder, though the housing cover was in place when received. These separate pieces indicated that the housing cover had been removed and reinstalled between the accident and delivery to the Materials Laboratory. Figure 4 shows the cylinder assembly after the housing removal in the laboratory, revealing intact assemblies of the valves, retainers, and springs. This interior also exhibited an absence of the rocker arms and shaft, with six fracture surfaces along the rocker housing bores.

The intake valve retainer exhibited some wear marks, most notably the sector-shaped mark on the upper left (upper left of Figure 4). There were also longitudinal streaks on the intake valve peripheral face, which were longitudinal, rather than circumferential, like the machine marks on the exhaust retainer to the right in the figure. The ends of the valve stems exhibited oval or comet-shaped wear patterns, consistent with off-center contact with the adjacent rocker arms.

Figure 4. Top of the cylinder, after housing removal, showing the fractured rocker housing.

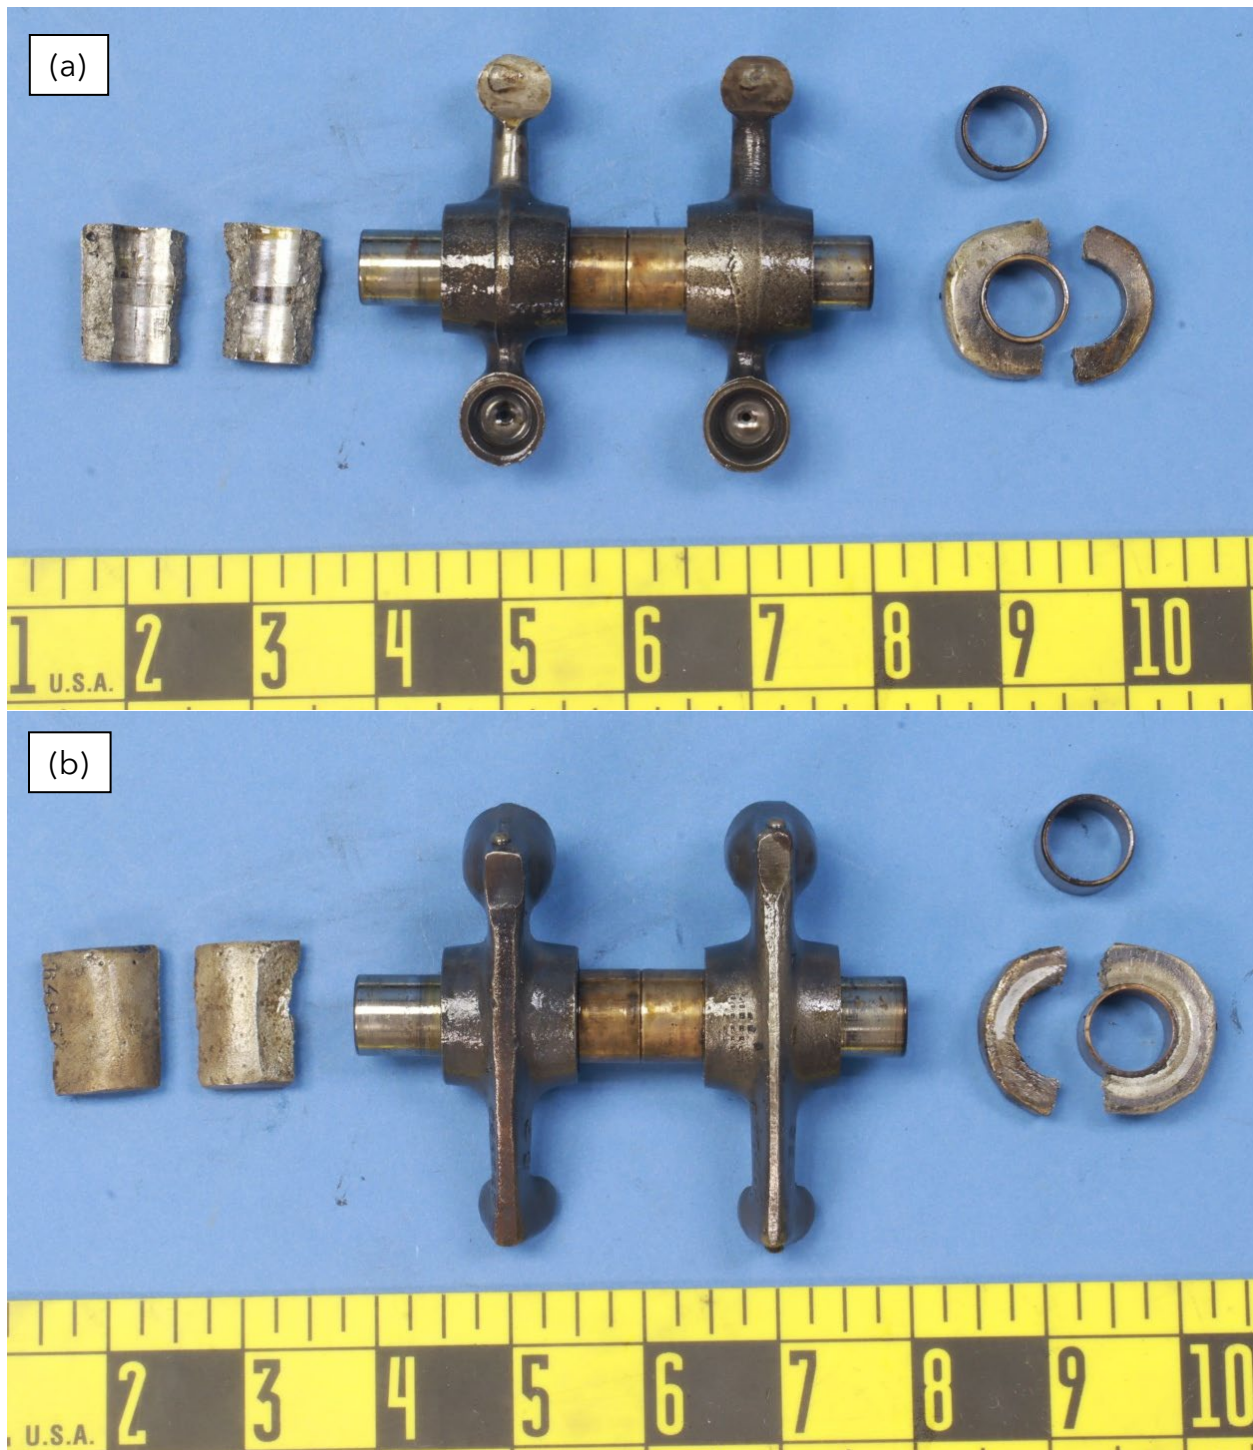
Figure 5 shows the two rockers on the shaft, with the central bushing as received. Also in the figures are the fragments of the fractured housing, with the center bore pieces on the left and the left and right small fragments on the right. Figure 6 shows the two contact faces of the rocker arms. These faces exhibited comet-shaped wear features, consistent with the off-center wear marks observed on the stem faces of the valves in Figure 4 and Figure 7.

Figure 5. View of the rocker arms and bushing on the shaft, with fractured and separated pieces of the housing, viewed from opposite sides.

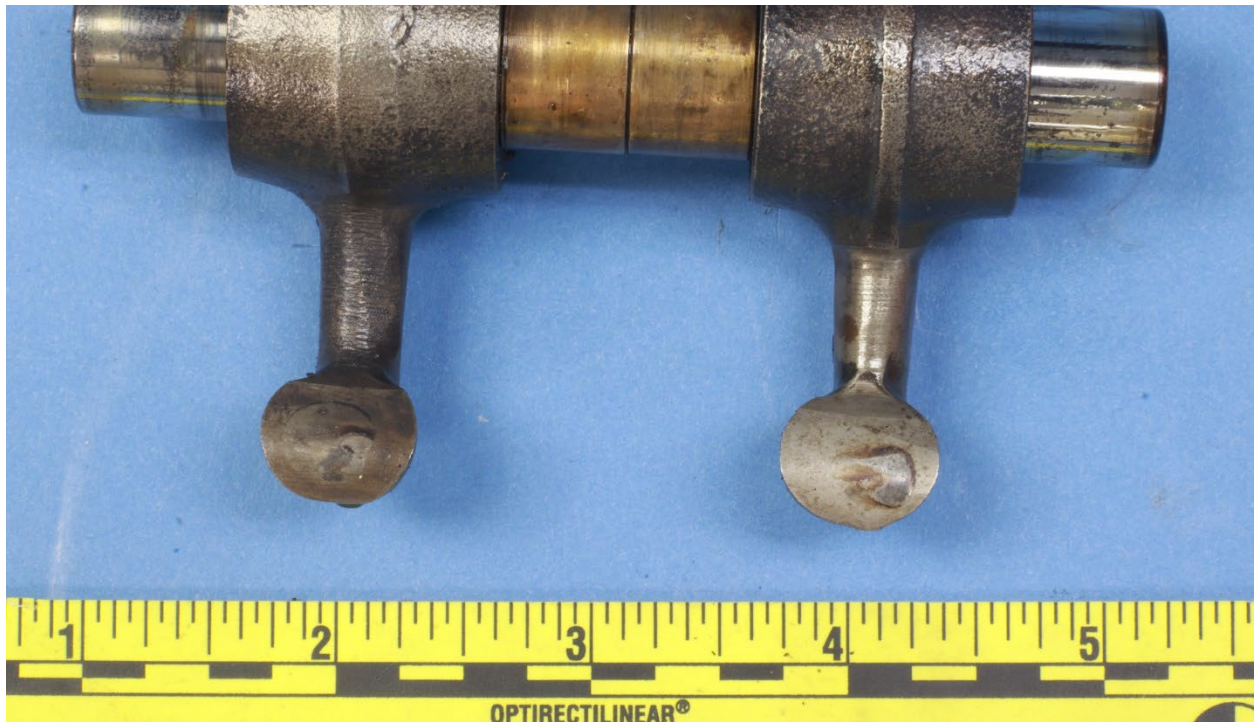
Figure 6. Closer view of wear marks on the valve stem faces of the rocker arms.

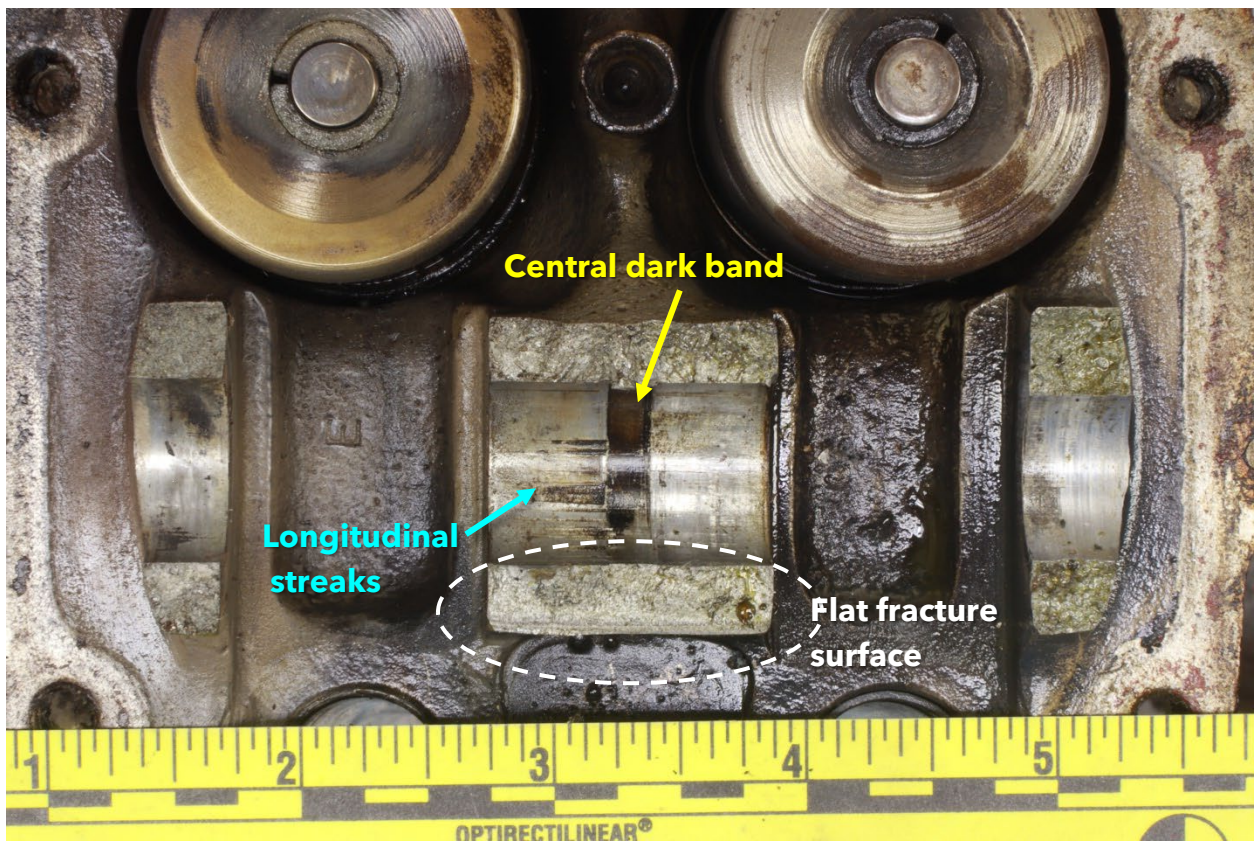
Figure 7 shows the fractured boss areas, annotated to show areas of wear. The bores exhibited circumferential streaking consistent with rotational wear typical of service conditions. There were also higher contrast wear areas in the central, largest bore, exemplified by a dark circumferential band. This band corresponded with a central protrusion on the fractured bosses and a band on the shaft when placed back in the bore (see Figure 8).

Five of the six fracture surfaces of the housing fragments exhibited rough, fibrous surface textures with dull lusters. These features were consistent with the overstress fracture of aluminum castings. However, the circled fracture surface in Figure 7 exhibited a flatter fracture surface, as highlighted in Figure 16. This fracture surface was subsequently cleaned in an ultrasonic bath with acetone (Figure 17a) and a chromic-acid aluminum cleaner (Figure 17b).

Figure 7. Closer view of the fractured rocker arm housing, with the pre-existing cracking circled.

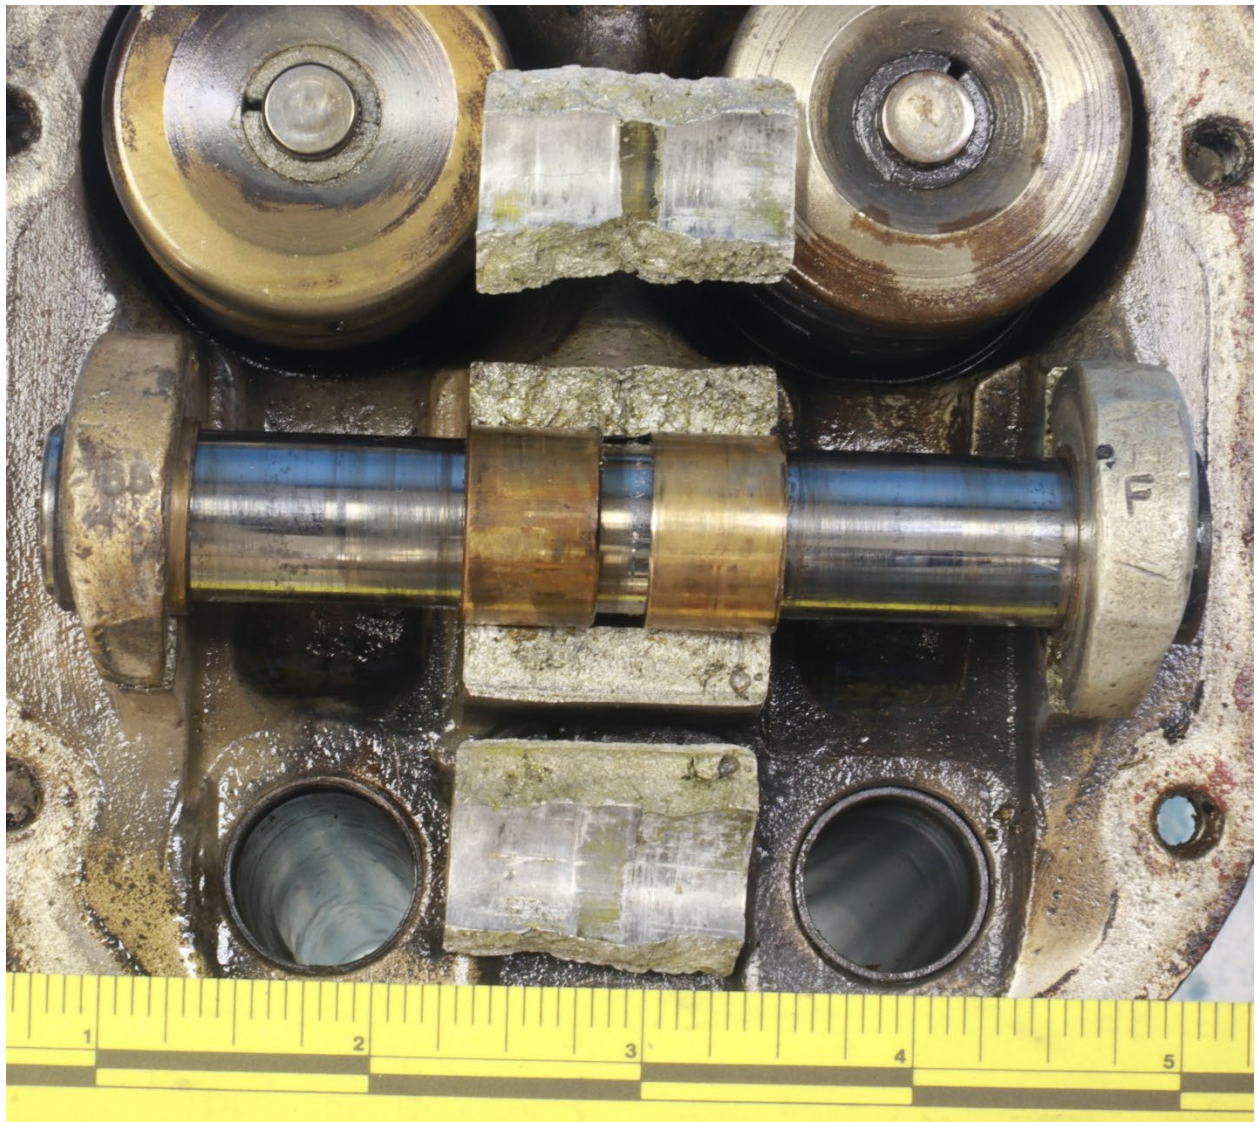
Figure 8 shows the rocker arm shaft and the central bushings, along with the fractured boss pieces, positioned as they were at the time of fracture. The central band on the housing bores corresponded with the gap between the bushings, also indicated on the shaft. The outer diameter (OD) surfaces of the bushings exhibited wear patterns consistent with those on the inside surfaces of the fractured housing remnants.

Figure 8. View of the area in Figure 7, with the rocker shaft and bosses positioned in the bore.

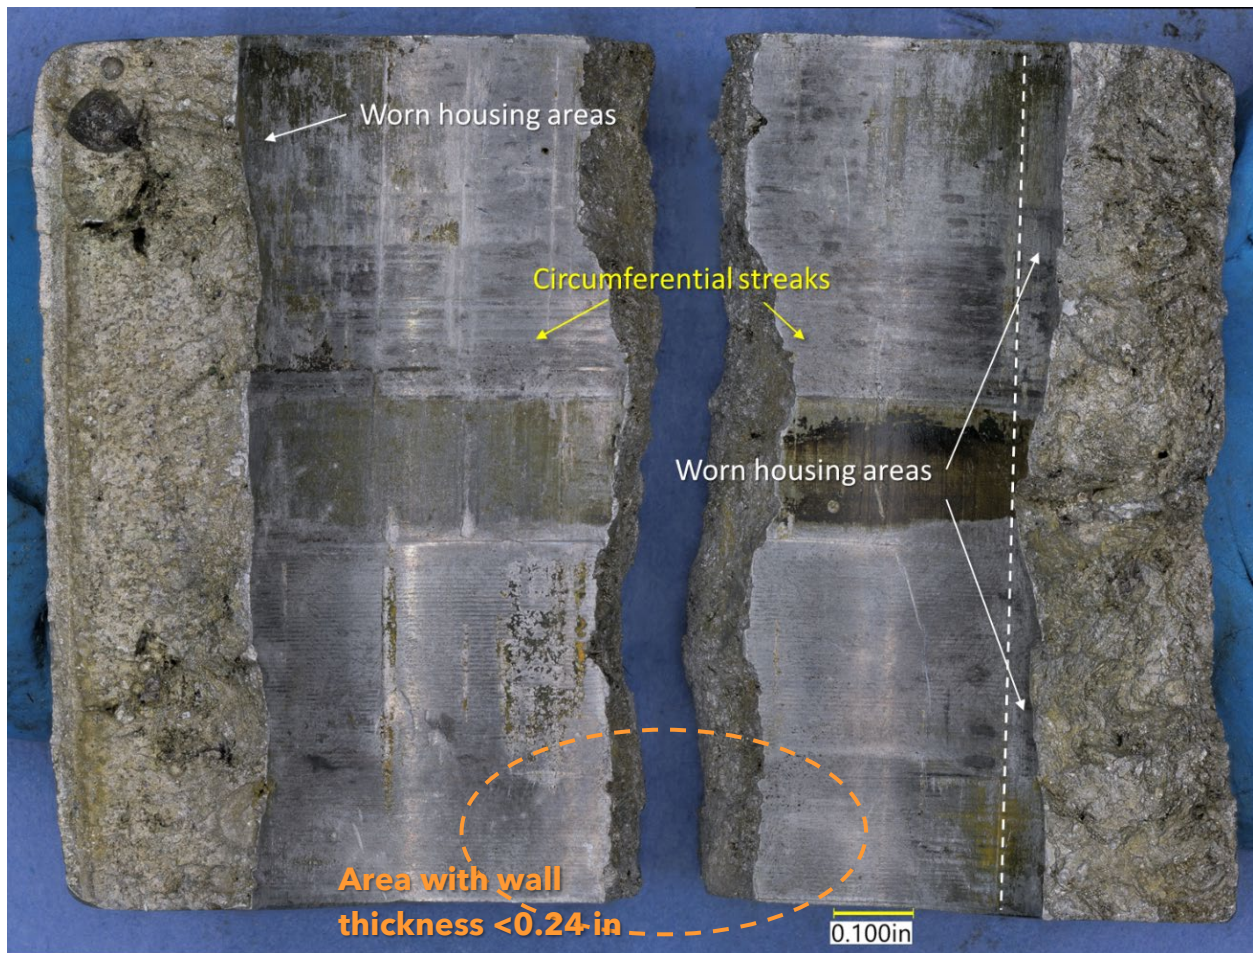
Figure 9 shows the bore of the fractured housing remnants after cleaning with acetone. The center band corresponded with a protrusion of the housing fragment positioned on the right in the figure. The edges about and below that band were

recessed, consistent with material loss on the bore. There were also worn areas of the housing material in some places on the left fragment on the left side in Figure 9. This material loss corresponded with the locations of the bushings, as shown in Figure 8. The bore area above the central band exhibited circumferential streaks, as identified in Figure 9. This upper half of the housing also exhibited wear on the opposite left fragment, which showed a flat fracture surface and arrest marks.

Table I - Measurements of the boss walls of the fractured housing fragments, with the locations denoted as positioned in Figure 9. The red measurements were less than the minimum thickness for reaming during maintenance (0.240 inches)

Figure 9. Inner diameter surfaces of the fractured central housing, showing worn areas and circumferential streaks.

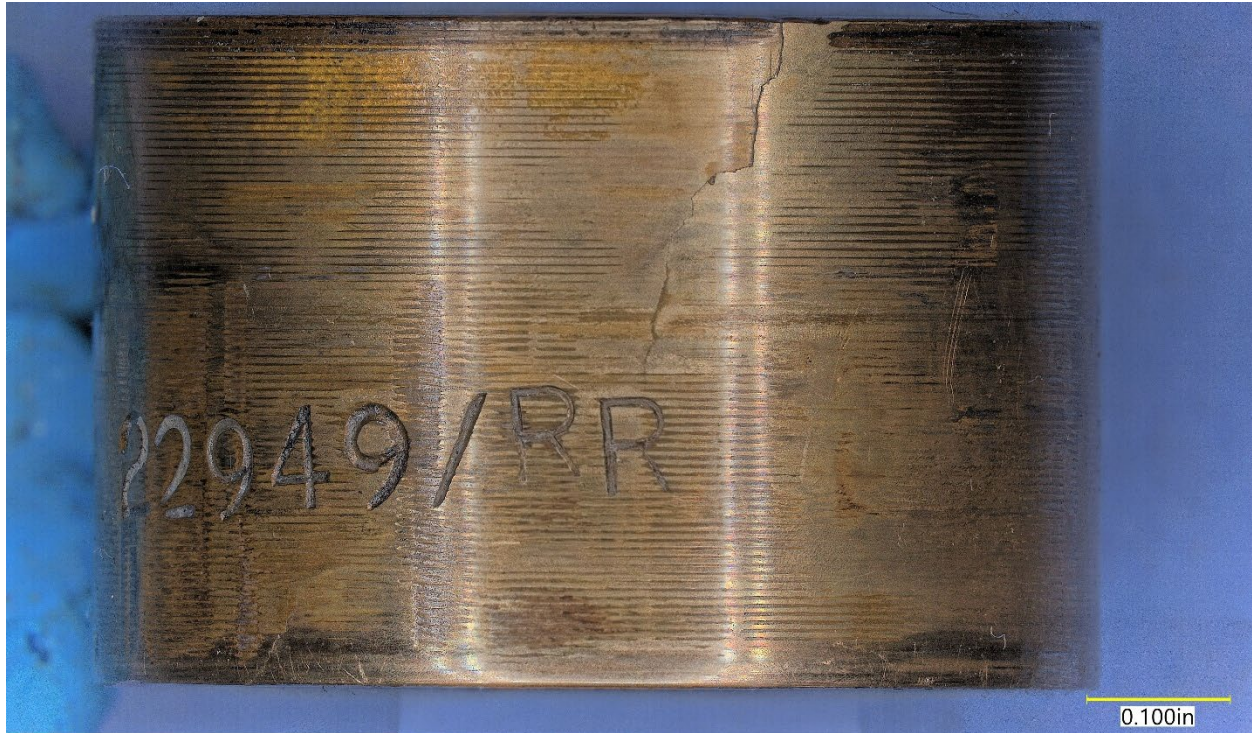
Figures 10 through 13 show the rocker arm shaft bushings after removing surface greases and oils. They are labeled left and right based on their positions in Figure 8. The right bushing, shown in Figure 10, exhibited the repeating circumferential marks consistent with machining marks. This bushing exhibited a stamped marking stating "22949/RR". This bushing also exhibited a crack that originated at one edge and progressed more than halfway through the longitudinal cross-section. Figure 11 shows an angled view of the bushing crack, three gouge marks on the edge face, and an oval flat spot on the inner diameter.

Figure 10. The outside diameter surface of the right bushing from the shaft in Figure 8.

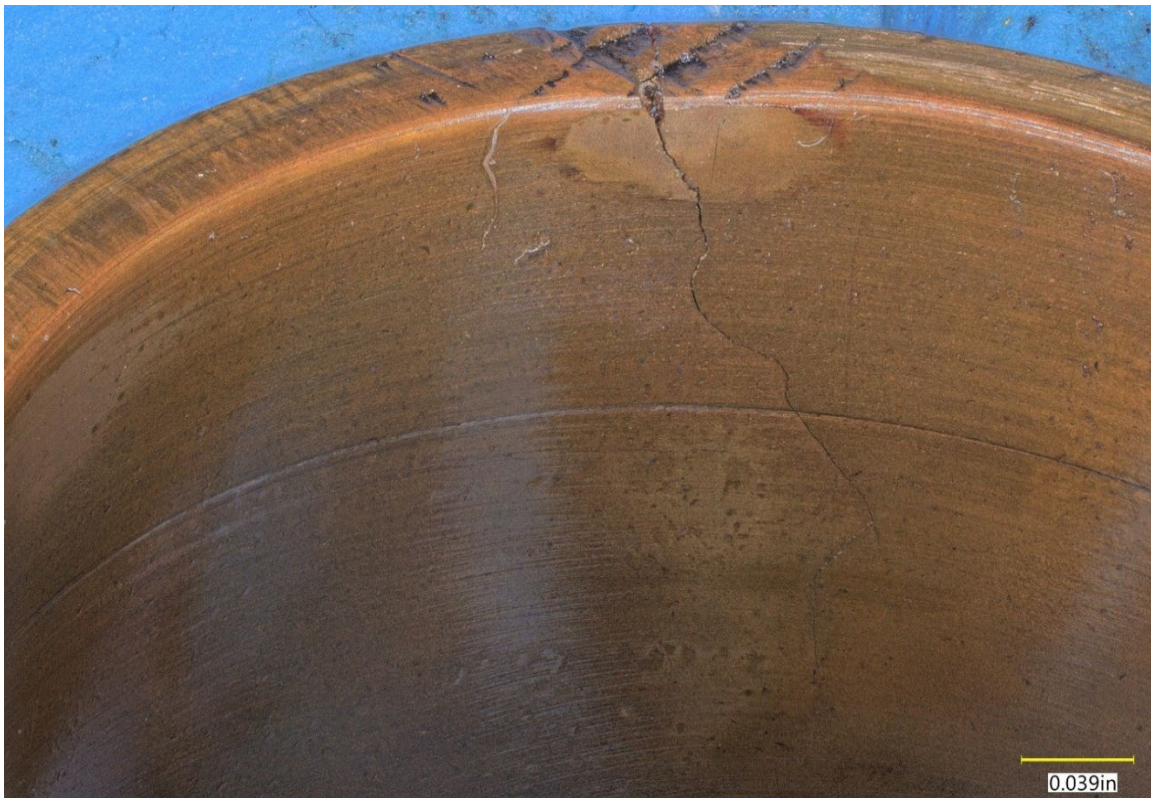
Figure 11. Angled inside diameter view of the right bushing, showing an ovoid wear depression and crack emanating from the edge.

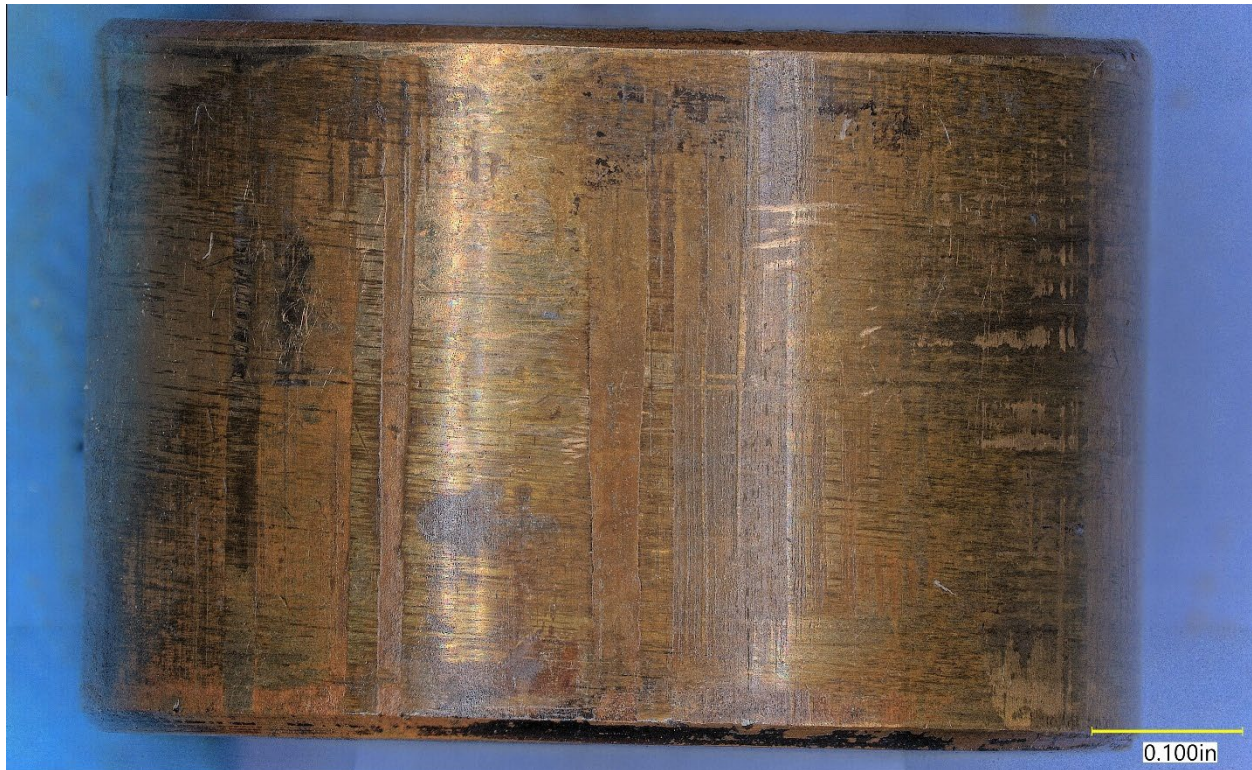
The left bushing, as positioned in Figure 8, is shown in Figures 12 and 13. While absent cracks, the outer diameter surface of this bushing exhibited wear and chatter marks in longitudinal and circumferential directions. These marks were consistent with the bushing movement against the housing boss bore. The interior surfaces of this bushing also exhibited mottled areas of disparate hues of brass, consistent with uneven wear of the bushing surface. There were also many pockmarks on the surface of the bushing, consistent with spalled material lost from wear.

Figure 12. Outside diameter of the left shaft bushing from Figure 8.

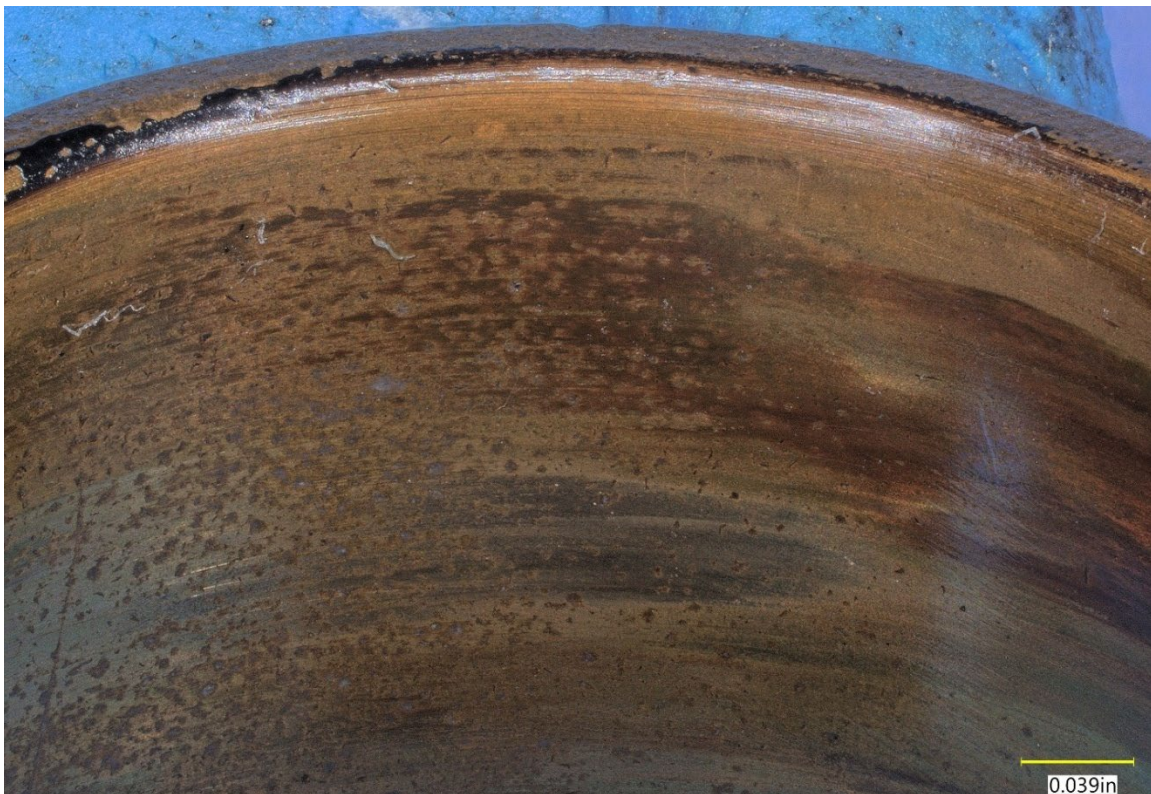
Figure 13. Angled view of the inside diameter of the left bushing, showing variable wear streaks and small pock marks.

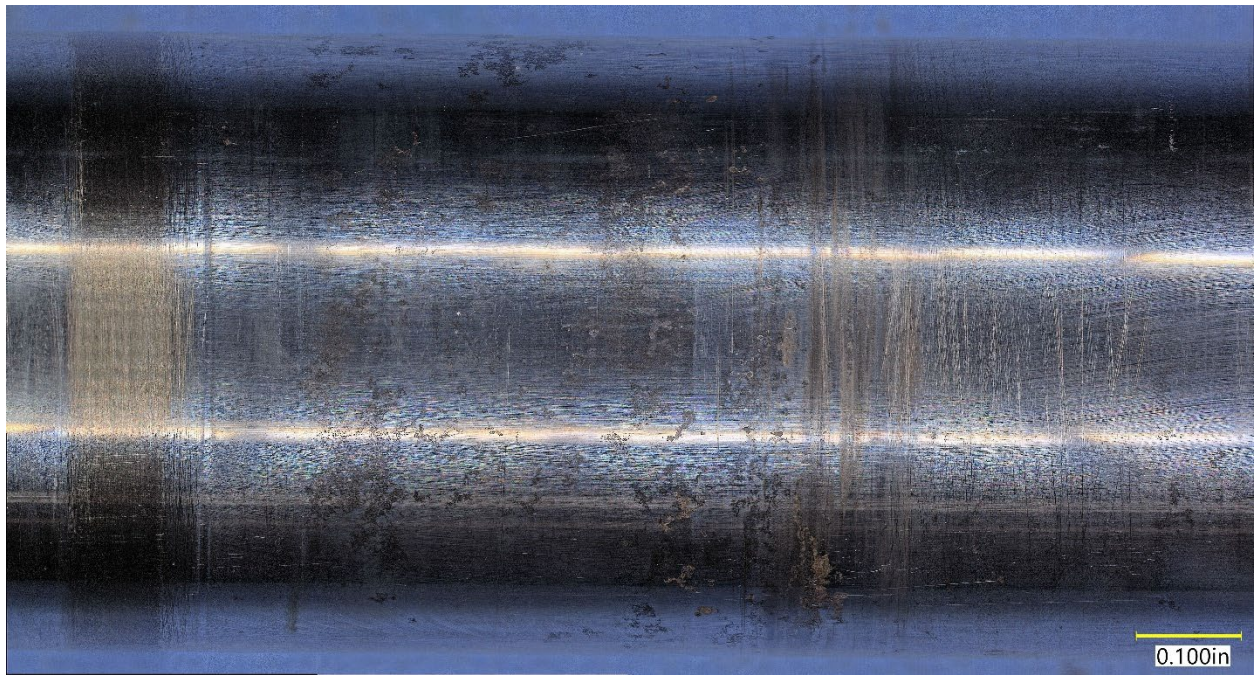
Figure 14 shows the mating surface of the rocker arm shaft. This view shows the central band on the left, along with circumferential wear scars toward the right. The central area exhibited chatter marks and pock marks consistent with those observed on the inner surface of the corresponding left bushing. Figure 15 shows a closer view of the spalling and wear scars on the shaft.

Figure 14. Outside diameter view of the rocker shaft where the right bushing had sat.

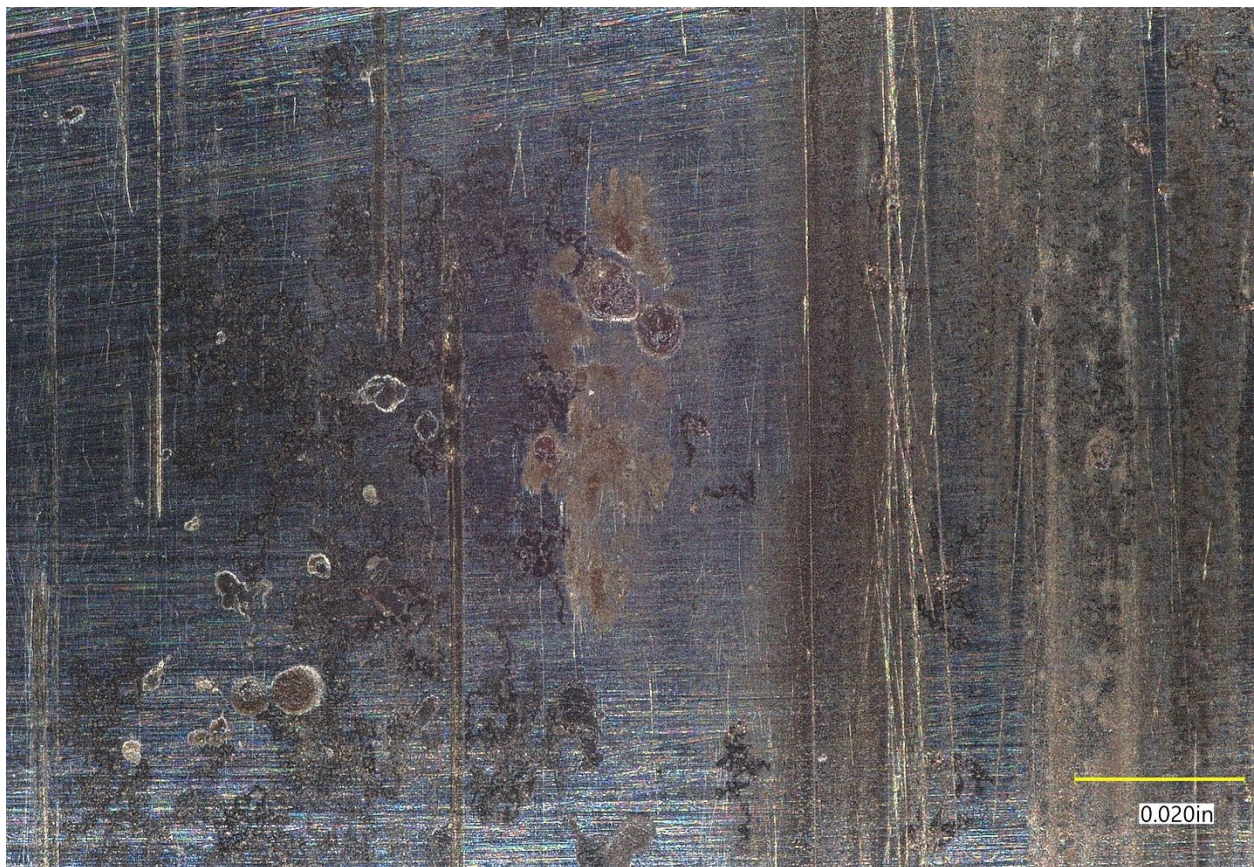
Figure 15. Spallation and circumferential wear scars on the shaft surface.

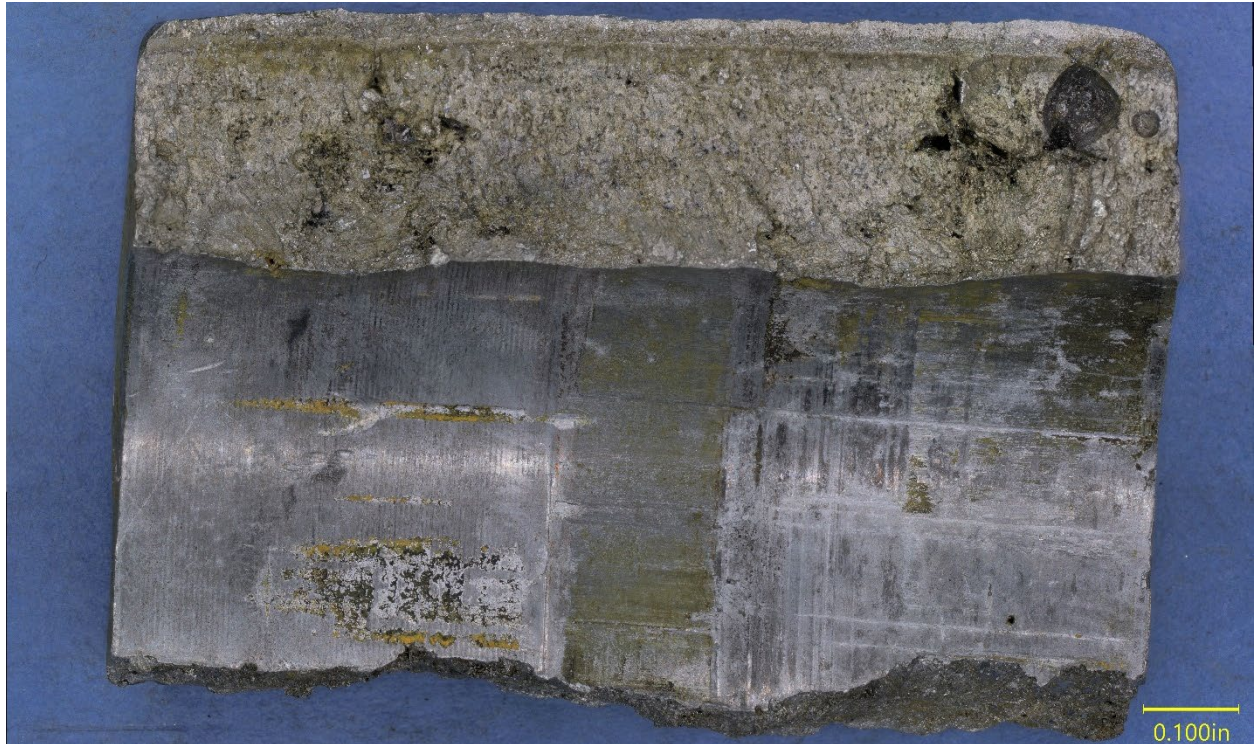
In all the figures, a prominent series of porosity or voids was present in the upper right area of the fracture surface, indicated by a larger circular void, a smaller spherical void, and an oblong feature left of these. There were other areas of macro and microscopic porosity along this fracture surface.

The main feature of the fracture was the flat surface on the lower 90%, as oriented in Figure 16 and Figure 17. The surface exhibited faint crack arrest marks emanating from the bore, as articulated in Figure 17a. River patterns radiated outward from the bore edge, as illustrated in Figure 18. These features indicated crack propagation from the bore surface into the housing.

Figure 16. Overall view of the flat fracture surface on the center boss fragment.

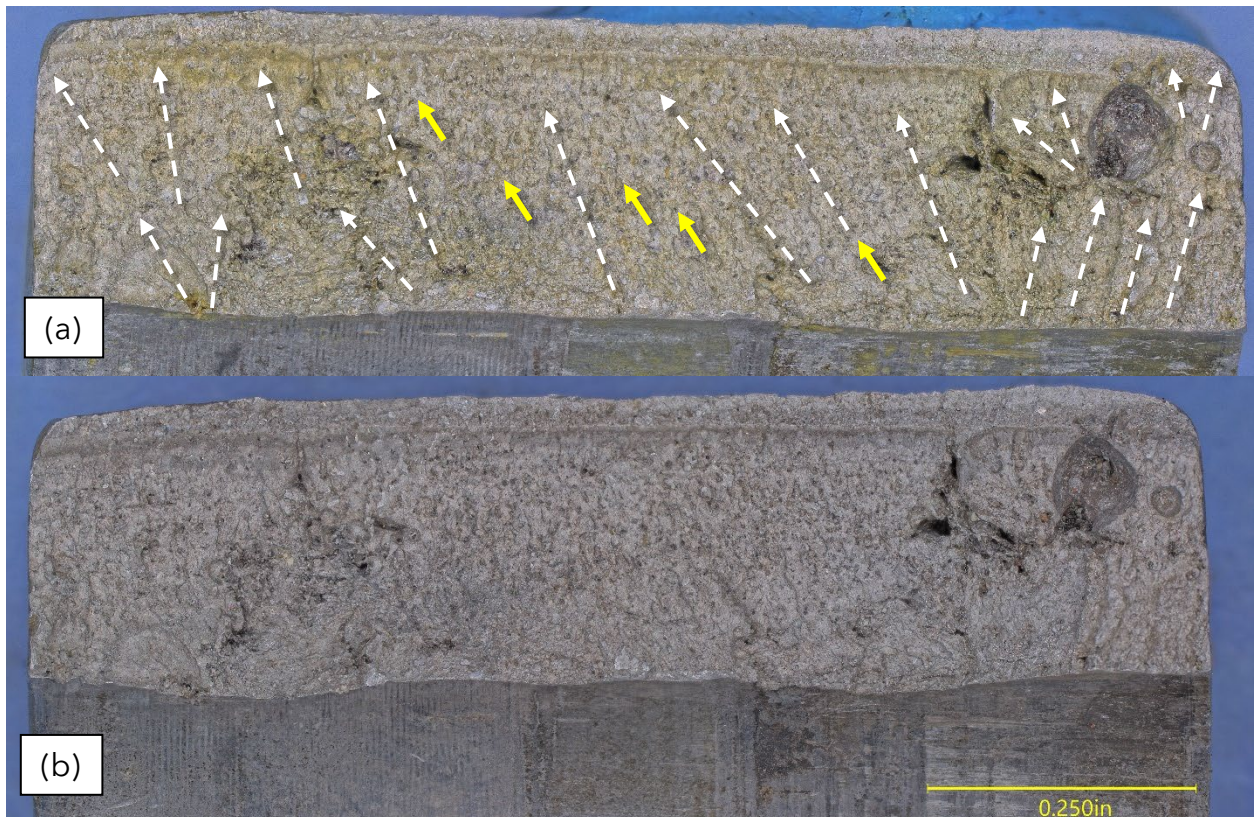
Figure 17. View of the fracture surface after (a) cleaning with acetone and (b) after acidic aluminum cleaner. Yellow arrows denote arrest marks; white are growth directions.

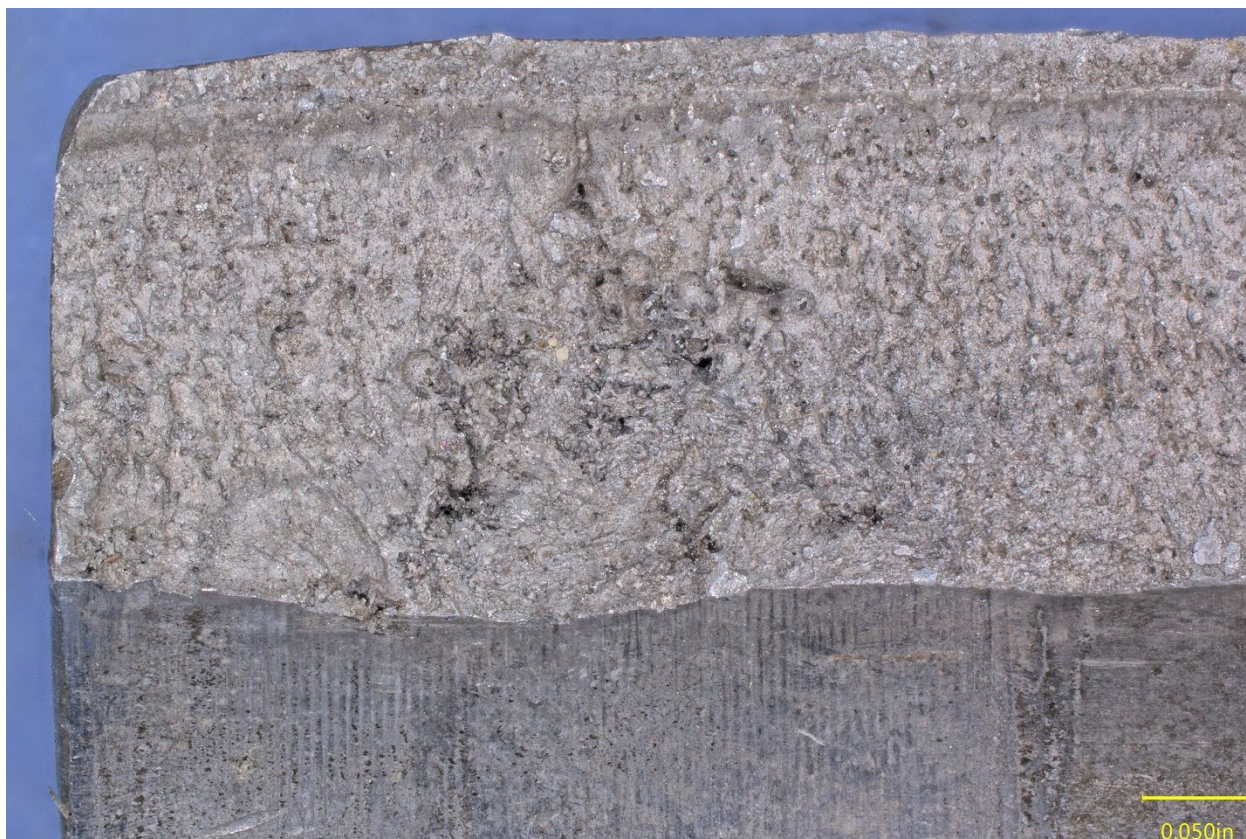
Figure 18. Left side of the center boss fragment fracture surface.
