# National Transportation Safety Board

ERA24LA239

## **MATERIALS LABORATORY**

Factual Report 24-083

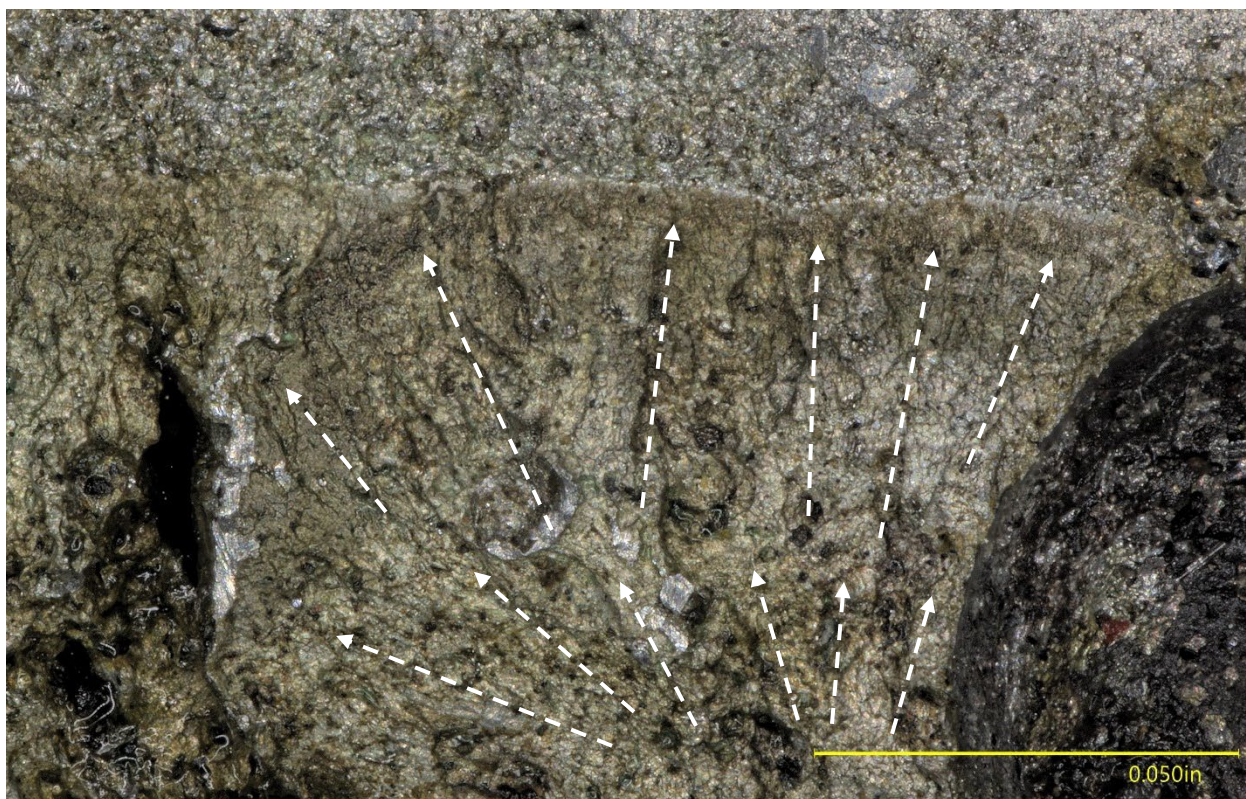
Figure 19 shows the end of a portion of the crack. This area exhibited crack arrest marks consistent with upward propagation, as annotated in the Figure. The fracture surface was examined using a field emission scanning electron microscope (SEM). Figure 20 shows a closer view of the end of the crack—this region exhibited fatigue striations, consistent with fatigue crack propagation.

Figure 19. Terminus of one of the thumbnail cracks on the central boss fracture surface.

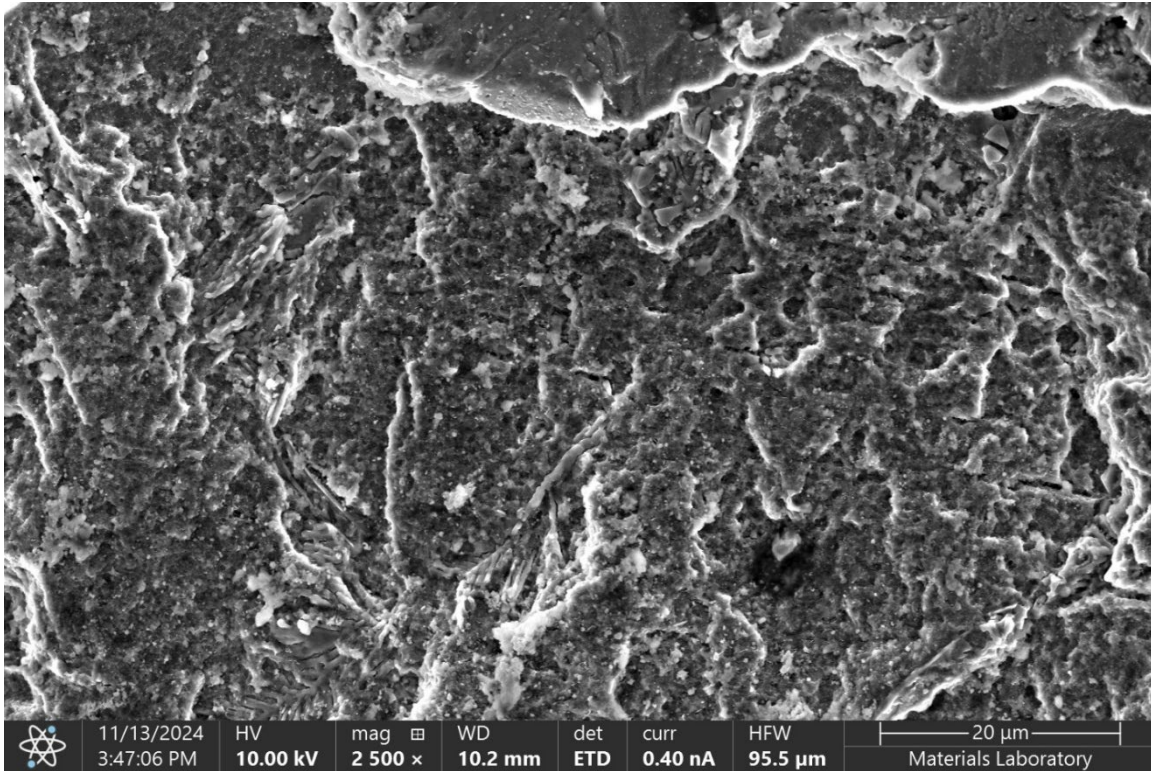
Figure 20. Secondary electron (SE) micrograph of the end of a fatigue crack on the center boss fragment.

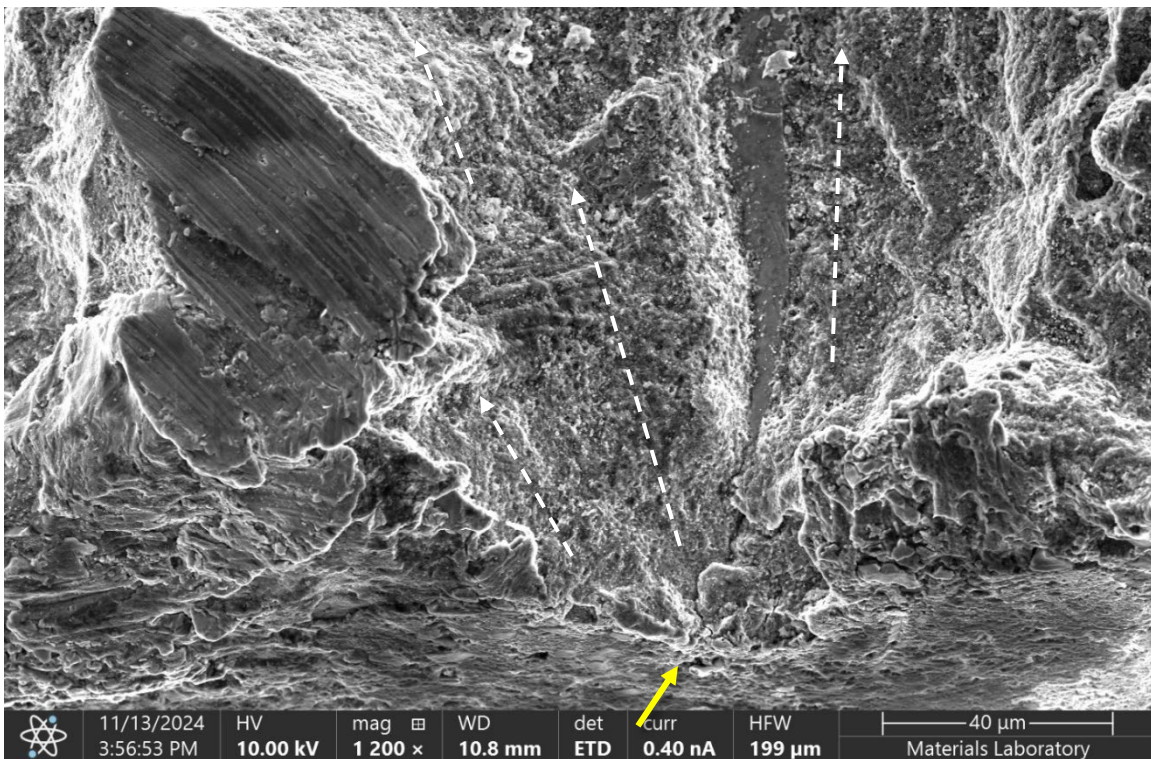
The fatigue cracking began at multiple initiation sites along the edge of the fracture surface with the shaft bore. One initiation site is shown in Figure 21 at an area of wear along the shaft bore. The crack then propagated inward, as evidenced by the striations in Figure 22. Other initiation sites, such as the one shown in Figure 23, were all present along the bore, which had created an edge with the fracture surface.

Figure 21. SE micrograph of an initiation site (yellow arrow) of the boss fragment. The dashed arrows represent the general crack growth direction.

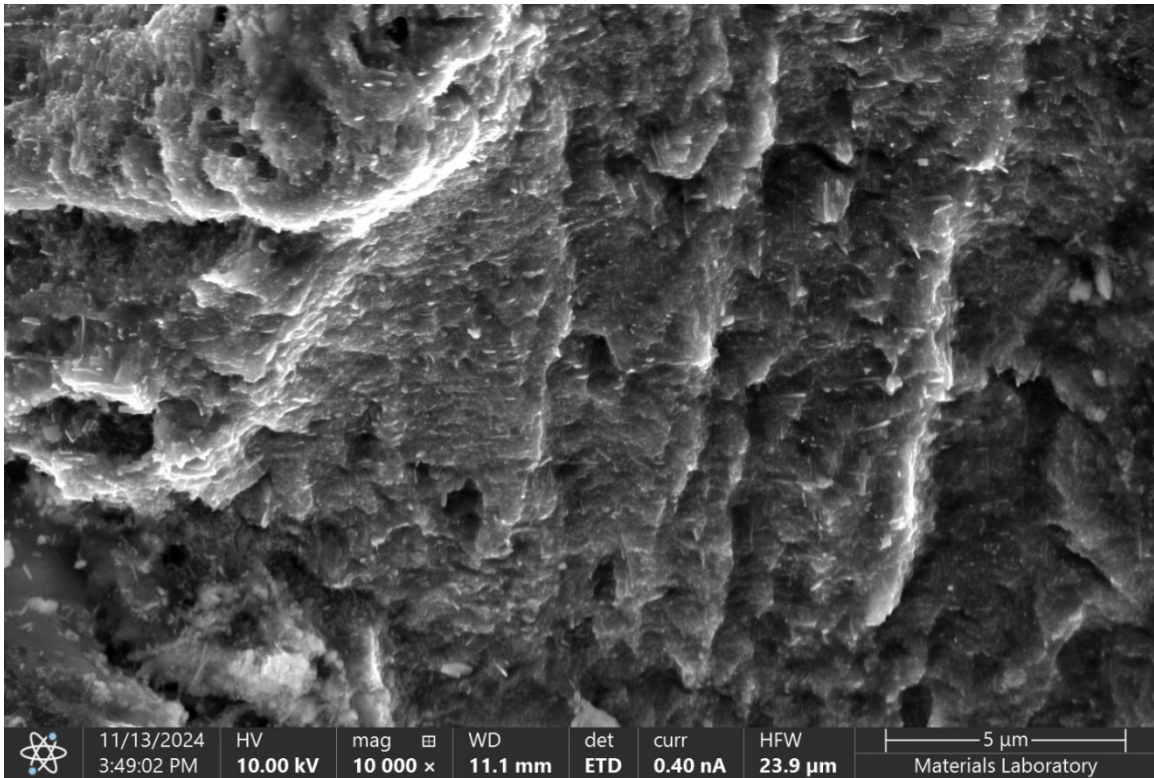
Figure 22. SE micrograph of striations near the initiation site in Figure 21.

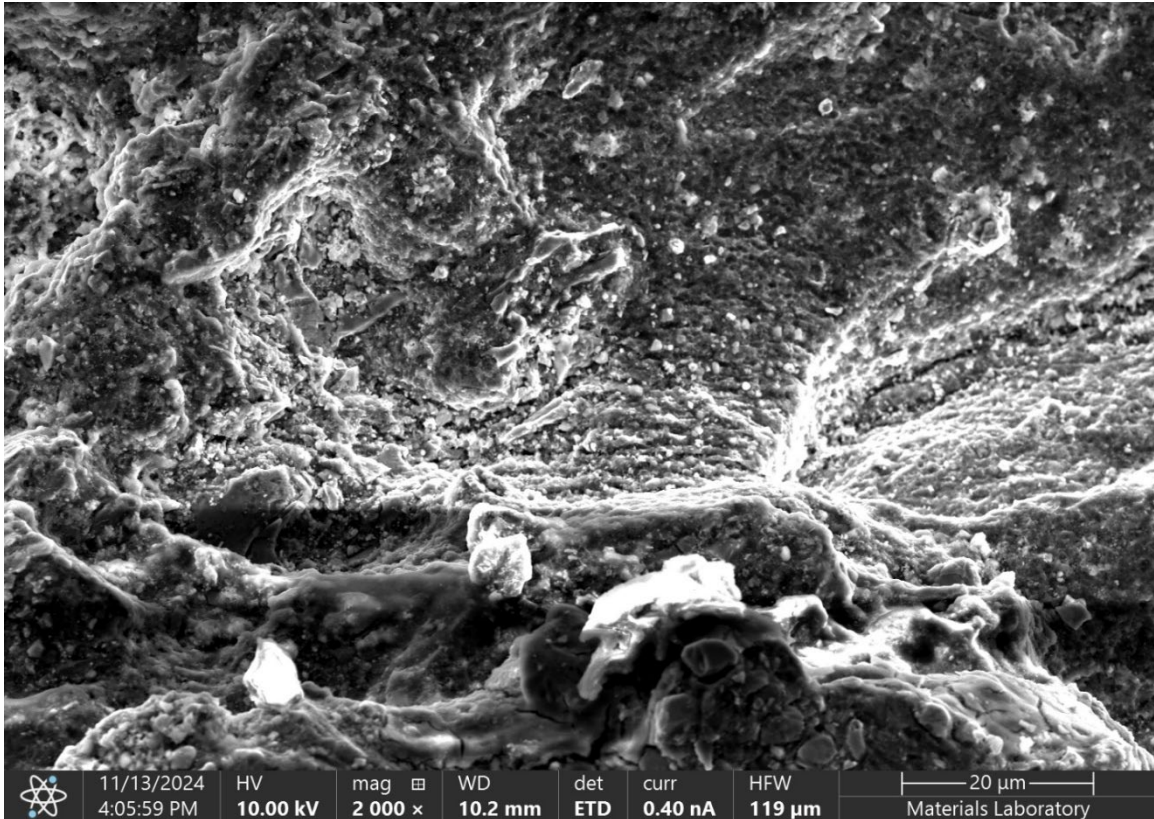
Figure 23. SE micrograph of another initiation site on the bore of the boss fragment.

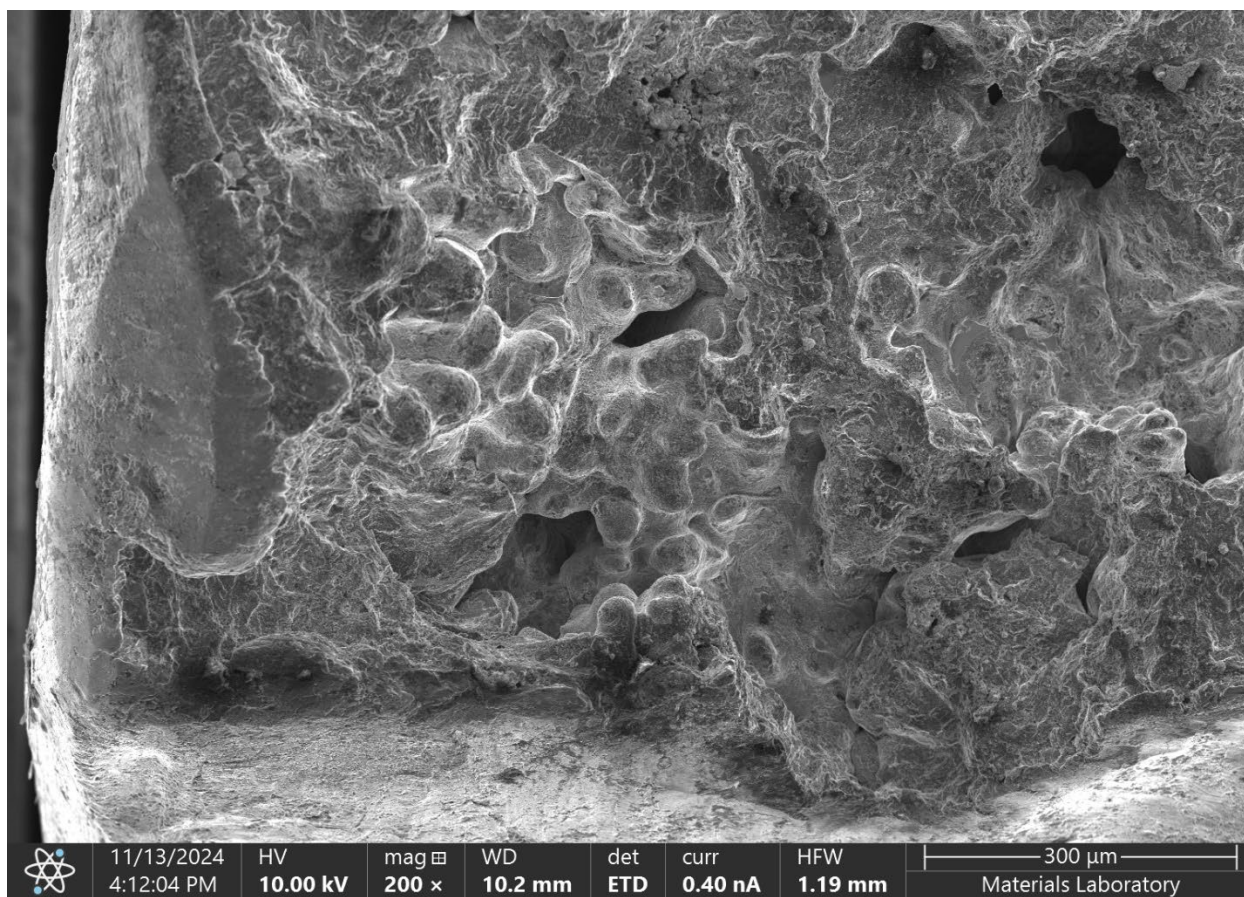
None of the cracks exhibit striation orientations consistent with propagation directly from an internal void. One such void is shown in Figure 24. The interior surface of this void exhibited a rounded texture with lobe or dendritic shapes. These features were consistent with solidification shrinkage that would develop during the casting of the cylinder housing. While the fatigue cracking propagated through the internal voids, no features were observed that were consistent with initiation along the void surfaces.

Figure 24. SE micrograph of solidification voids on the boss fragment fracture surface.
