ERA24LA239

## INVESTIGATION PHOTOGRAPHS

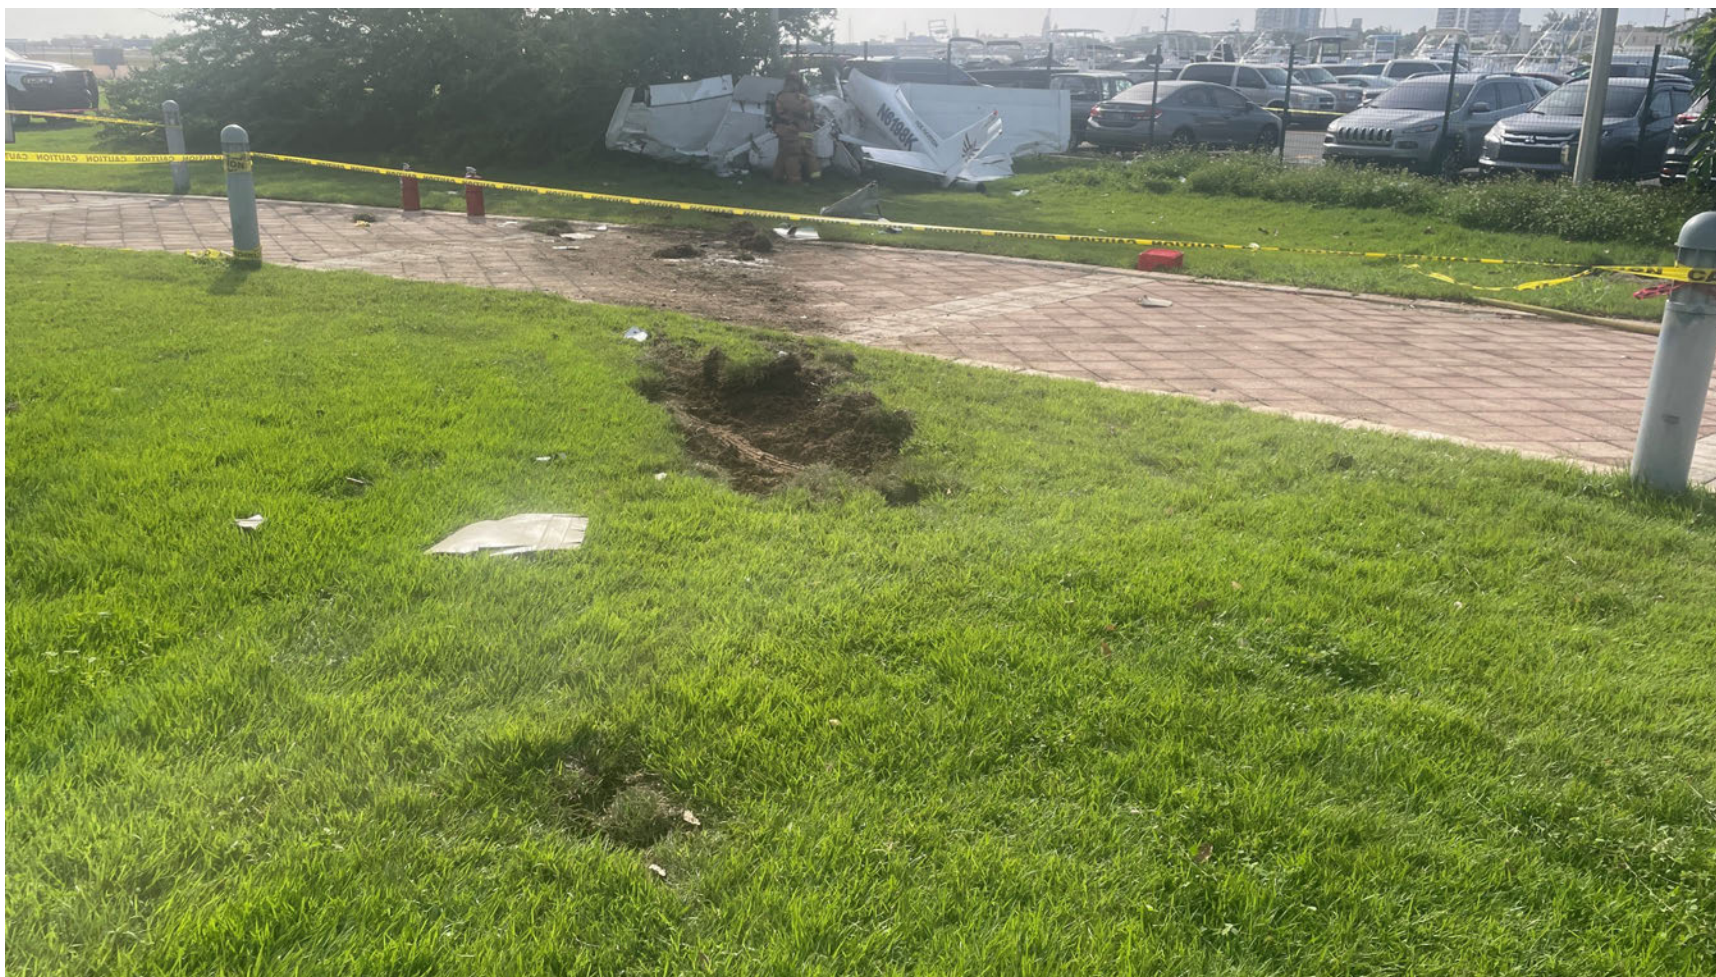
**Photograph 1 - Airplane at the accident site. (Courtesy of FAA)**

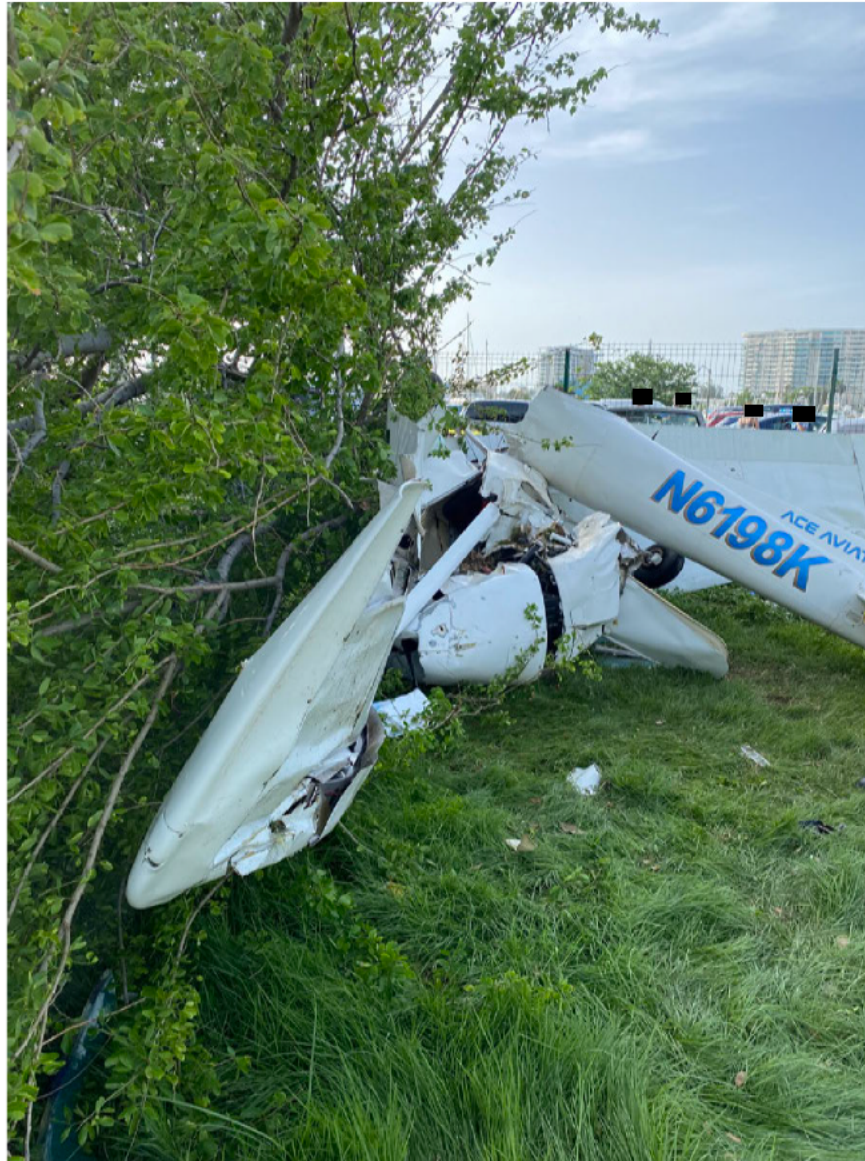
**Photograph 2 - View of the left side of the airplane. (Courtesy of FAA)**

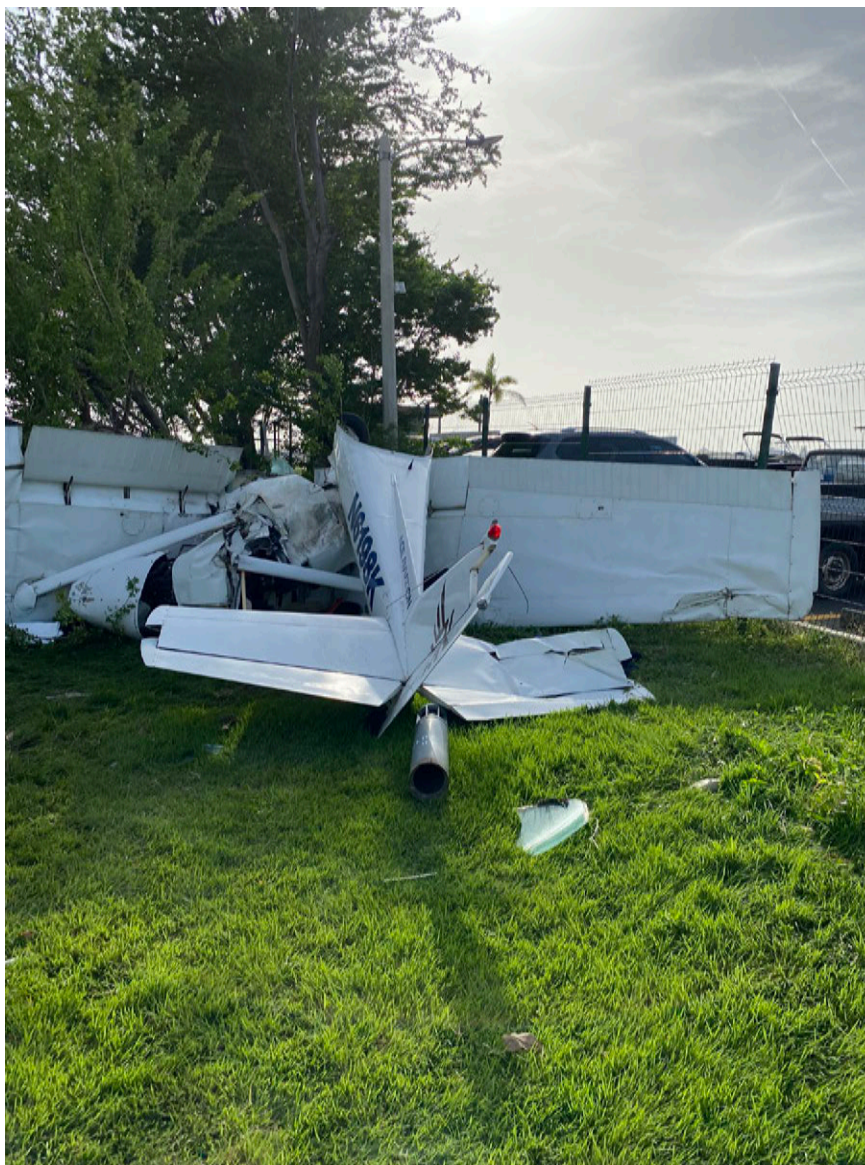
**Photograph 3 - View of the tail and right wing of the airplane. (Courtesy of FAA)**

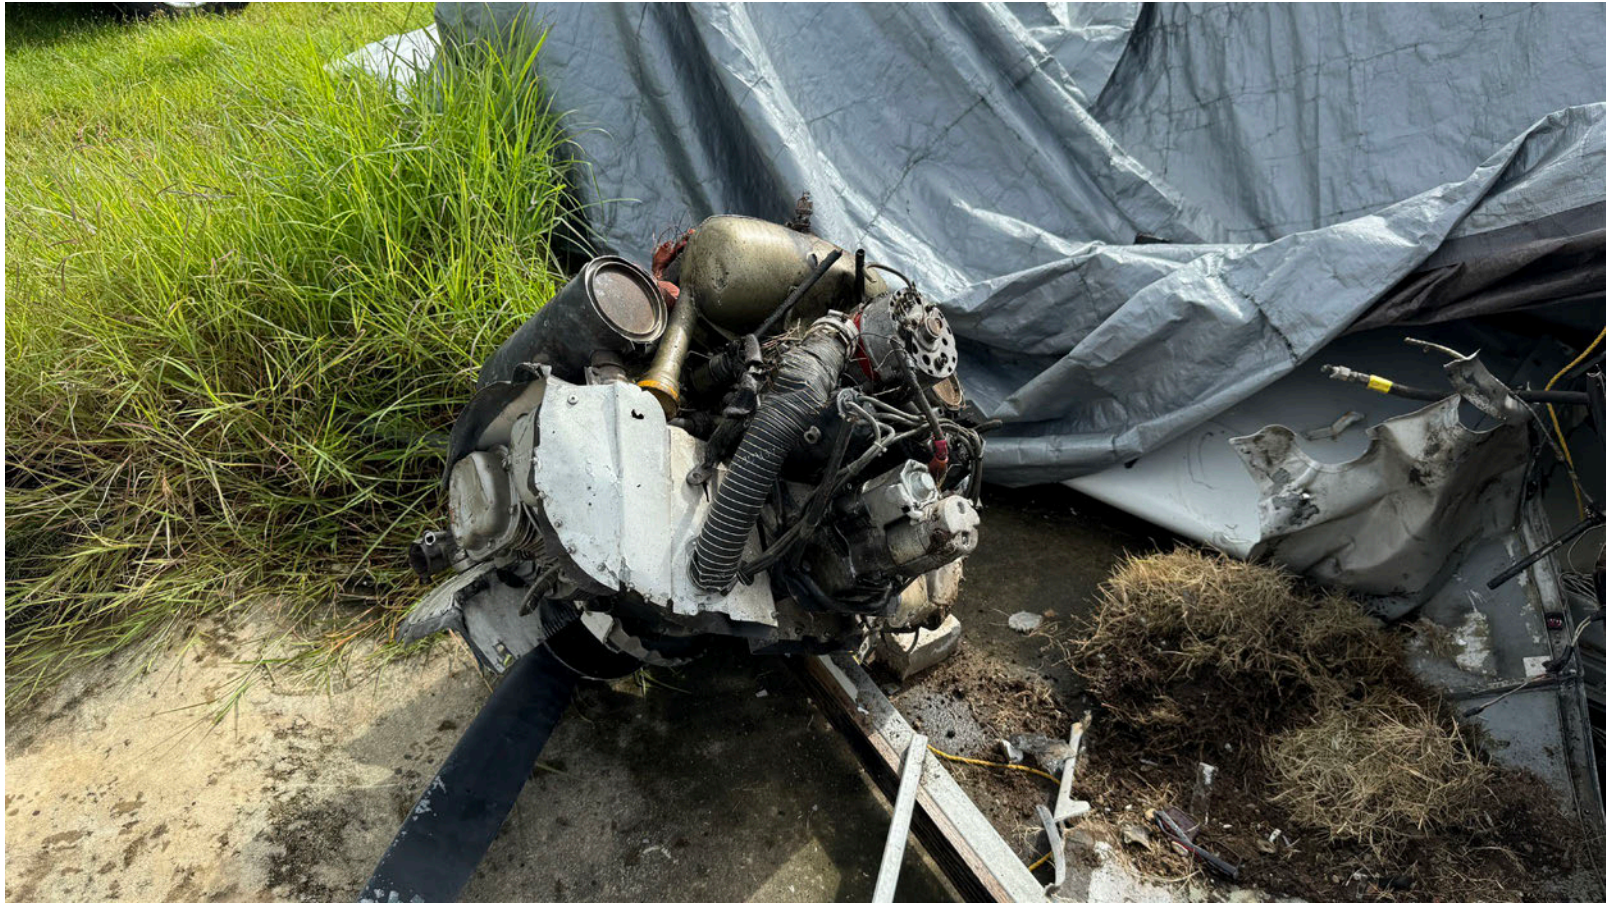
**Photograph 4 - View of the engine prior to teardown. (Courtesy of FAA)**

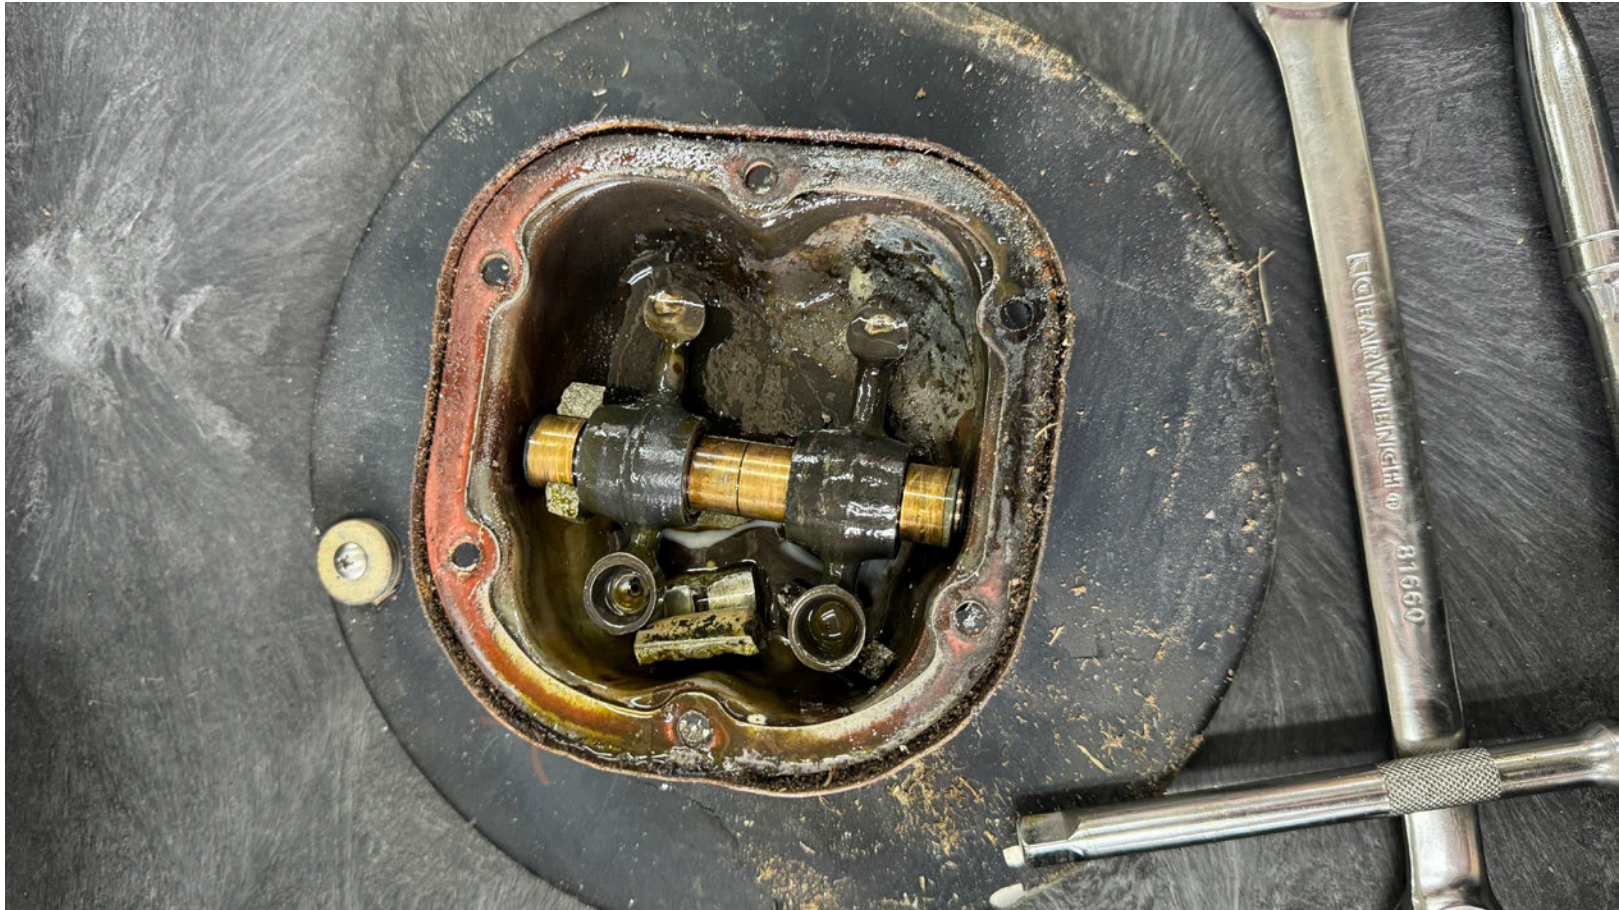
**Photograph 5 - View of the No. 2 cylinder rocker box cover with fractured parts. (Courtesy of FAA)**

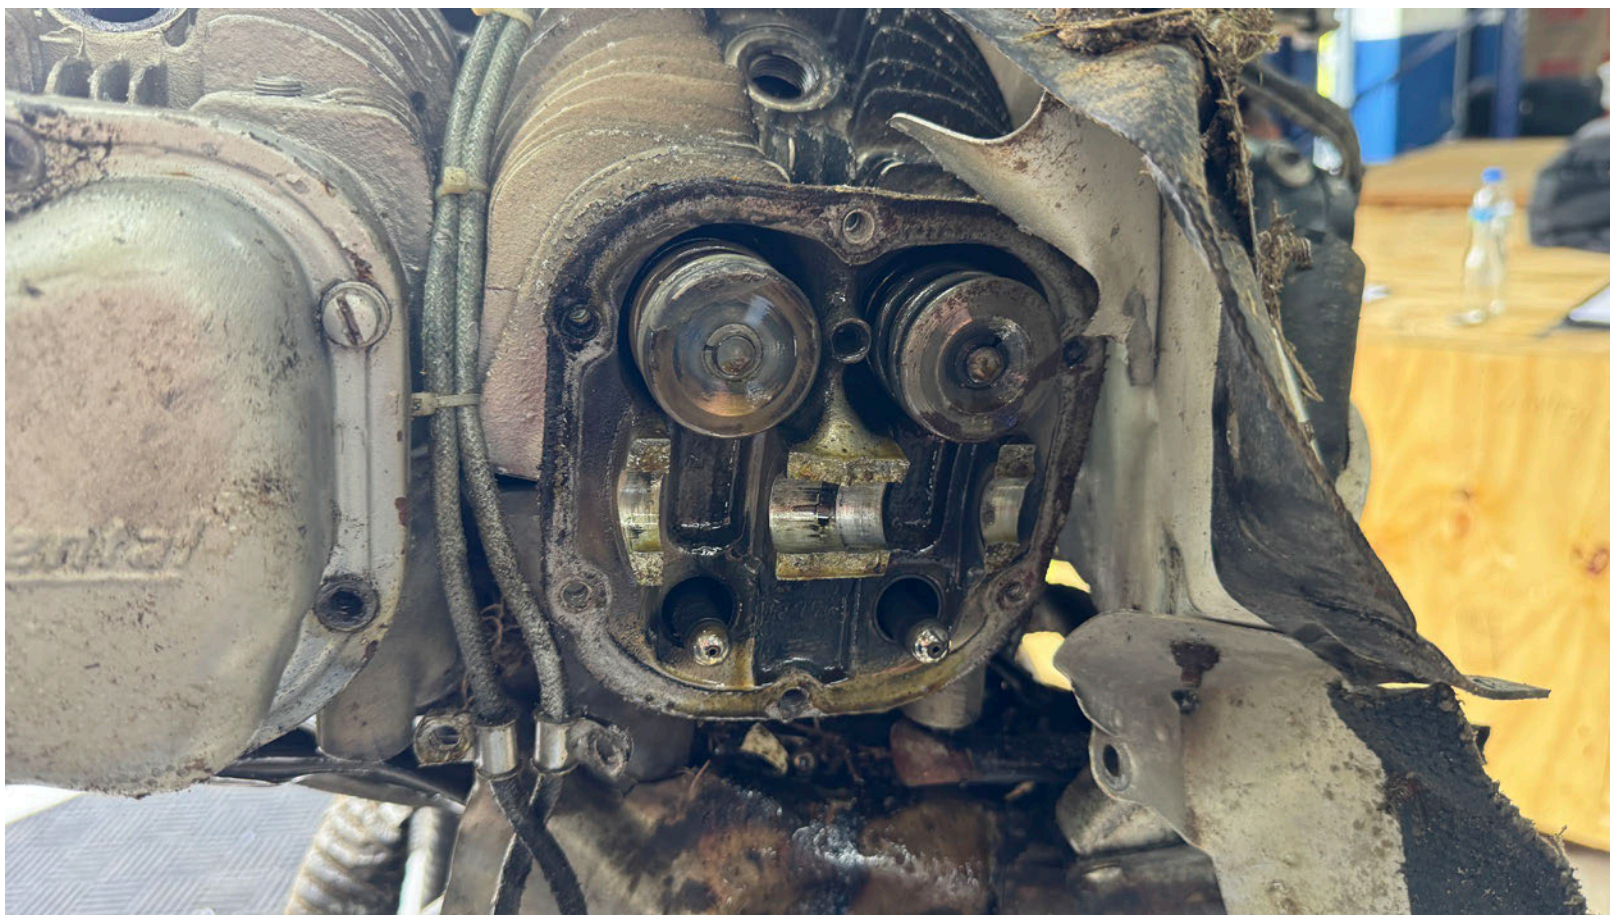
**Photograph 6 - View of the No. 2 Cylinder with rocker box cover removed. (Courtesy of FAA)**
