ERA22LA241

## INVESTIGATION PHOTOGRAPHS

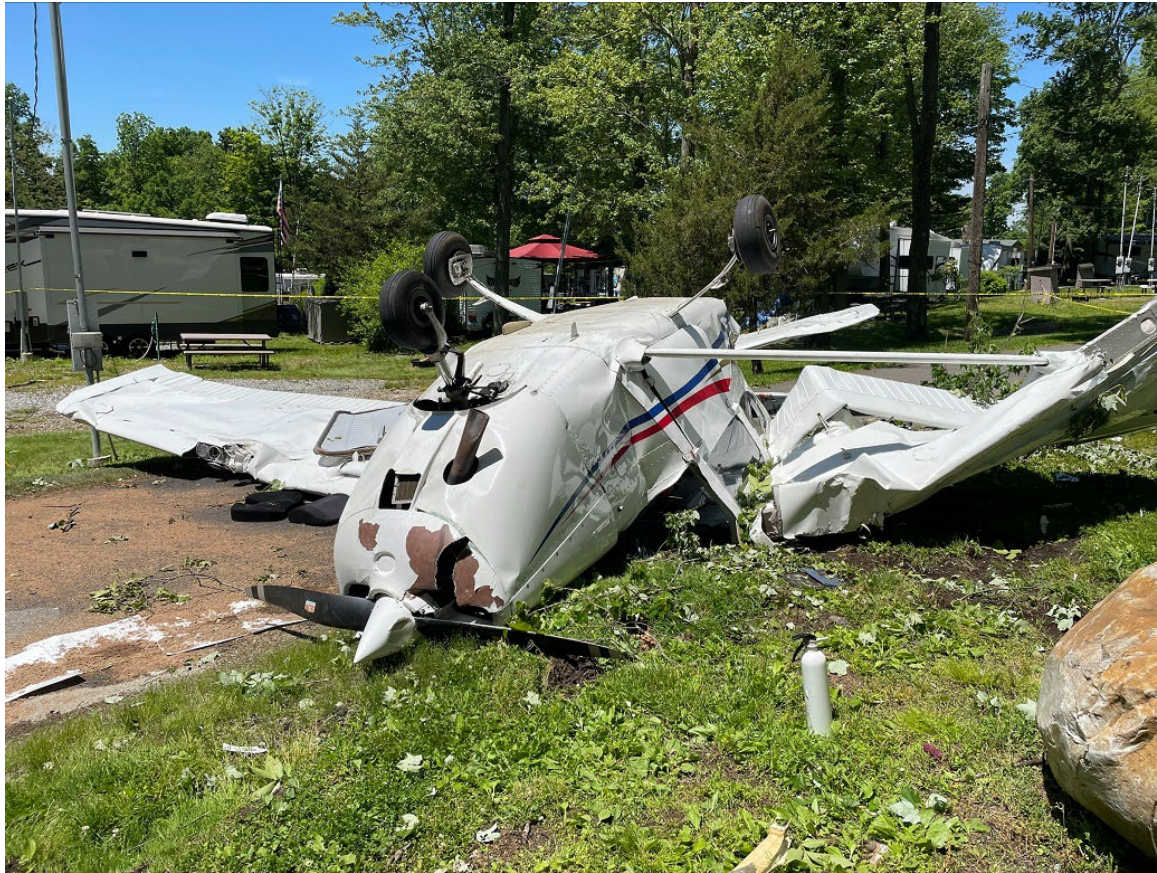
**Photograph 1 - Main Wreckage (Courtesy of FAA)**

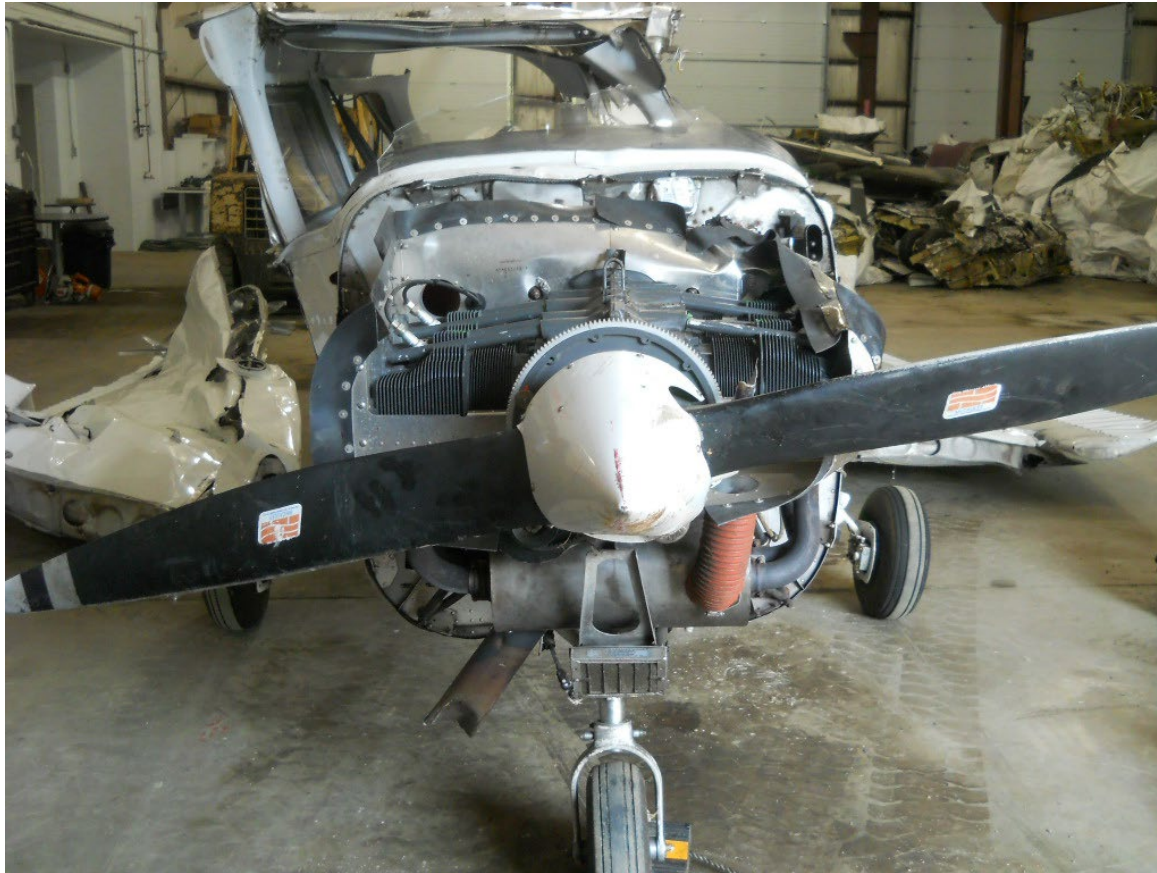
**Photograph 2 - Engine And Propeller (NTSB)**

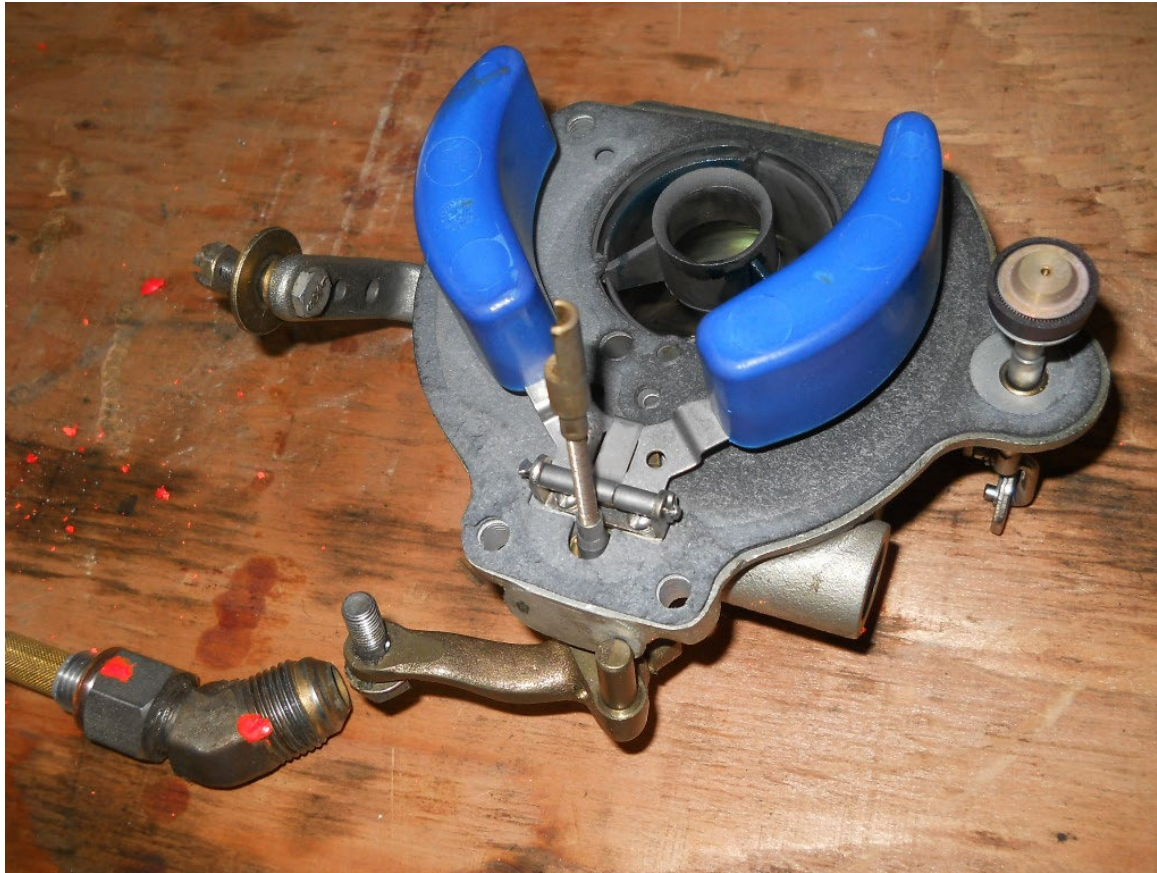
**Photograph 3 - Carburetor (NTSB)**

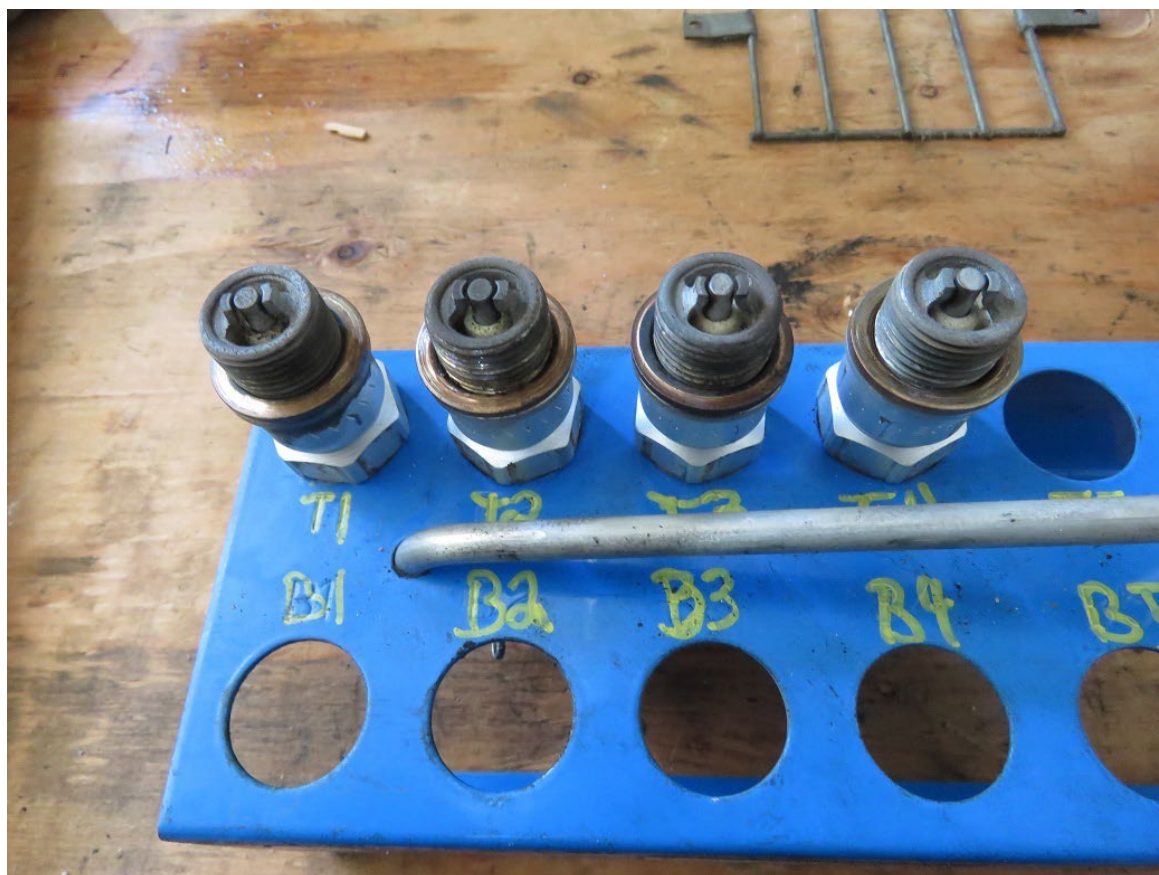
**Photograph 4 - Top Spark Plugs (Courtesy of Lycoming)**

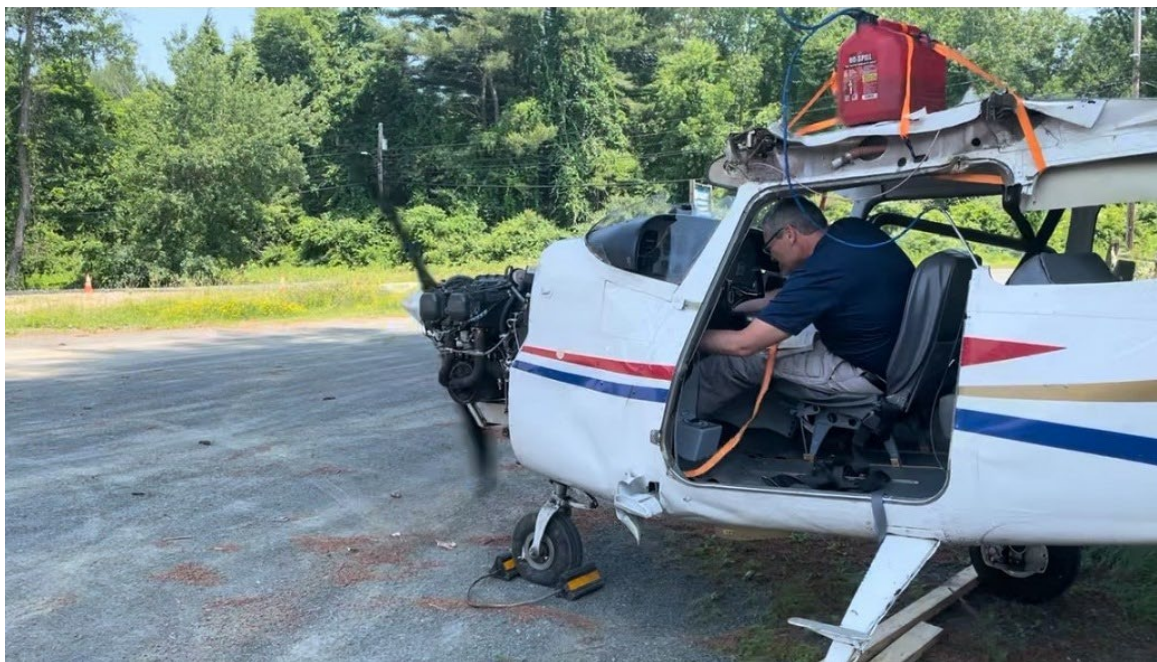
**Photograph 5 - Screenshot of Engine Run Video (Courtesy of FAA)**
