# National Transportation Safety Board

ERA24LA241

## **ENGINE EXAMINATION**

Location: Terryville, CT  
Date: June 3, 2024  
Registration: N906B  
Model: Cessna 172K

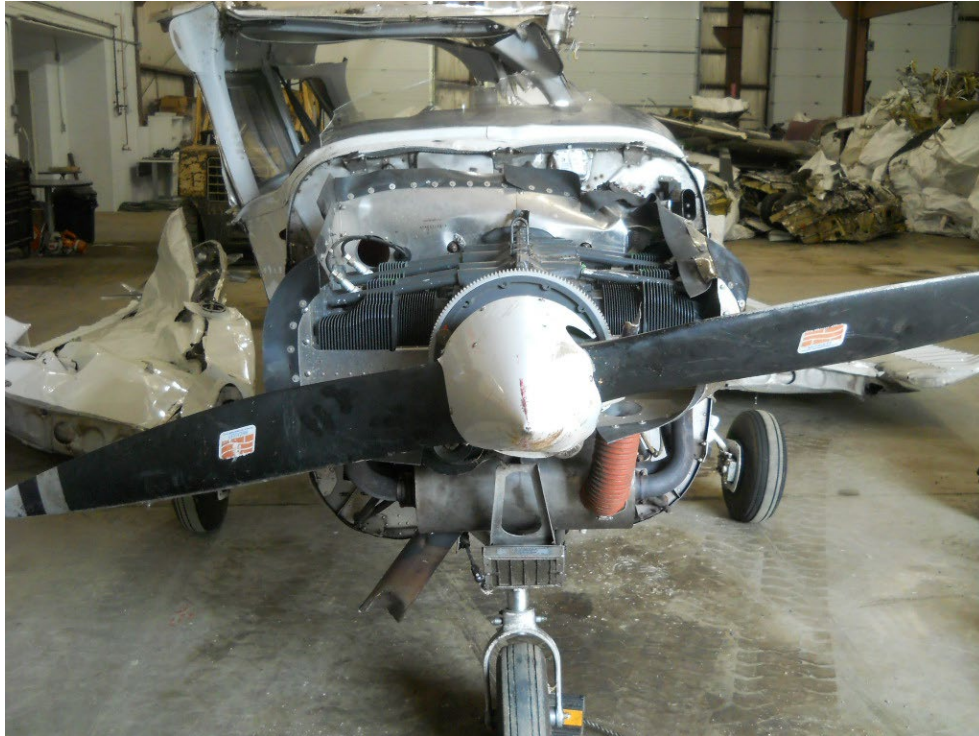
**Figure 1 - Main Wreckage (NTSB)**

- The engine remained attached to the airframe through all engine mounts.
- The two-bladed propeller remained attached to the crankshaft flange.
  - One blade appeared undamaged, and the other was bent forward near the blade tip.
- The cylinders remained attached to the crankcase.
  - The No. 2 cylinder exhaust pushrod exhibited impact damage but continued to operate when tested.
- Engine crankshaft rotation was accomplished when force was applied to the propeller.

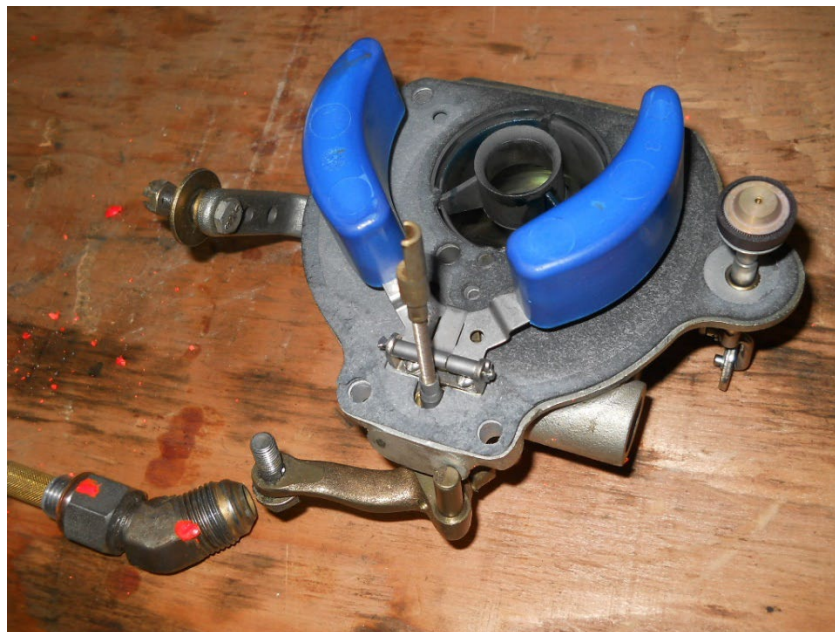
The carburetor remained intact, and fuel was observed in the carburetor bowl. The fuel was blue, clear, and absent of visible contamination. The carburetor fuel screen was also absent of debris. Similar fuel was also drained from the airplane's fuel sump. Continuity was confirmed from both wing fuel tank fuel lines to the carburetor.

**Figure 2 - Carburetor, Separated from Engine (NTSB)**

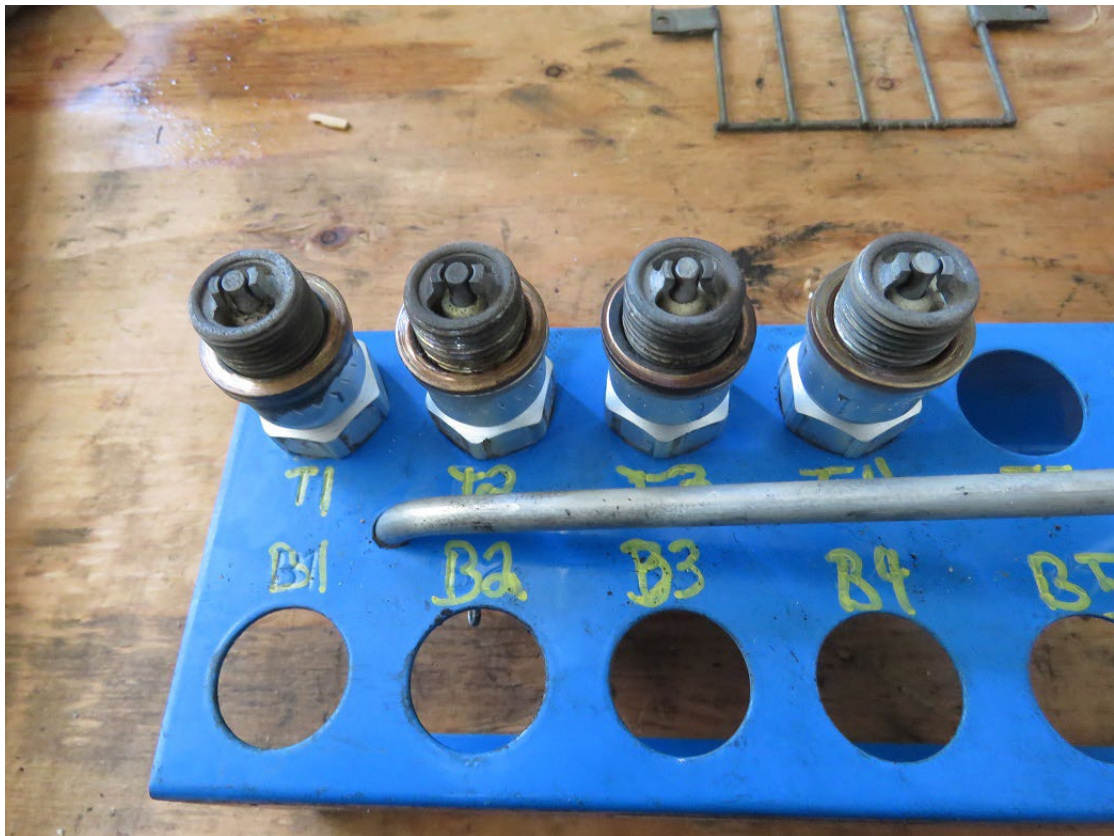
The top spark plugs were removed. Their electrodes were intact and light gray in color.

**Figure 3 - Top Spark Plugs, Removed from Cylinders (Courtesy of Lycoming)**

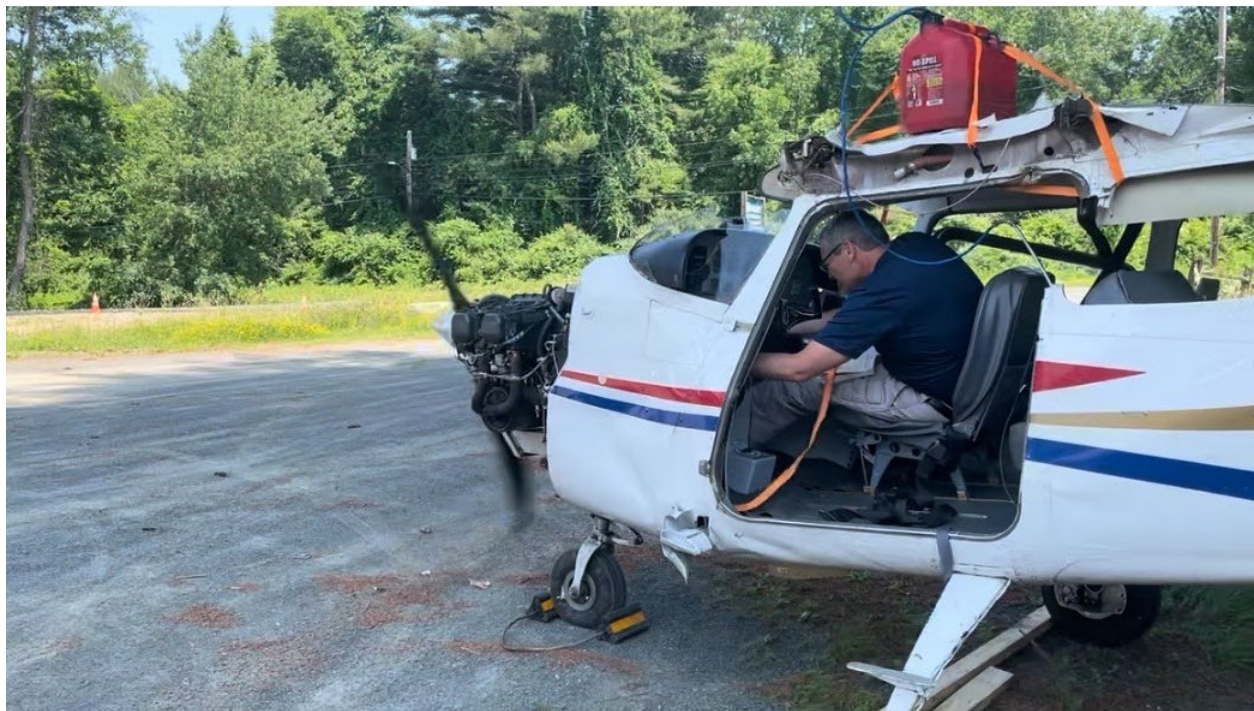
No anomalies were noted during the cursory examination. The removed components were subsequently reinstalled for a test run. Fuel was supplied to the left fuel tank fuel line via a portable container. The engine started without hesitation and ran continuously at idle power. Due to propeller damage and vibration, higher engine power settings were not attempted.

**Figure 4 - Screenshot From Engine Run Video (Courtesy of FAA)**
