ERA24LA242

## INVESTIGATION PHOTOGRAPHS

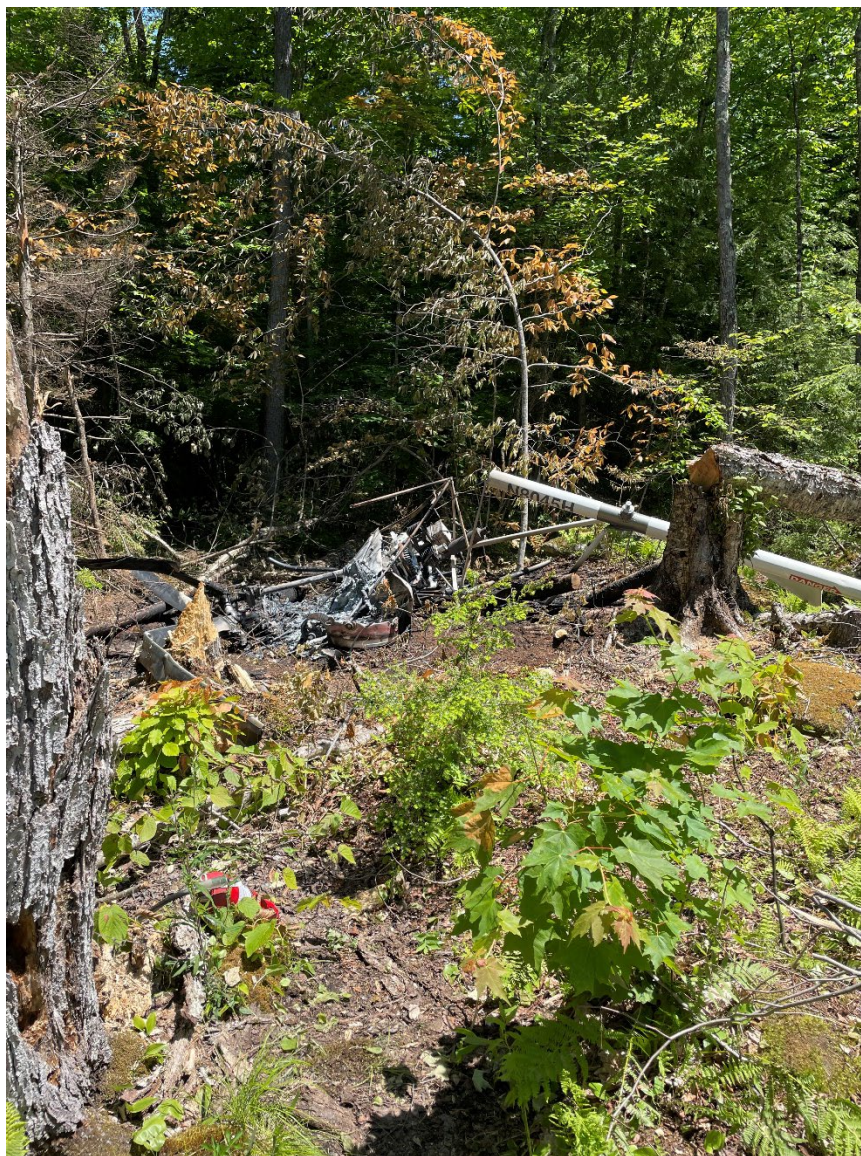
**Photograph 1 - Wreckage overview (Courtesy of FAA)**

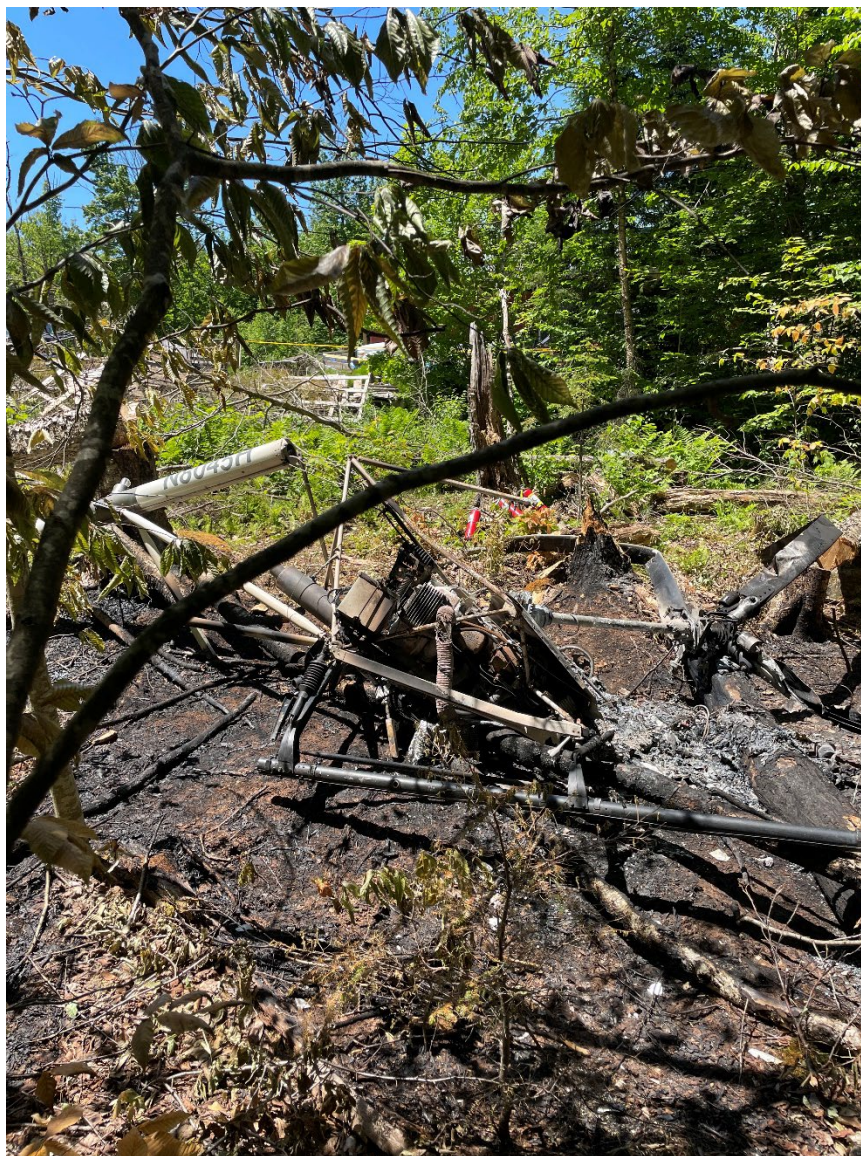
**Photograph 2 - Wreckage overview (Courtesy of FAA)**

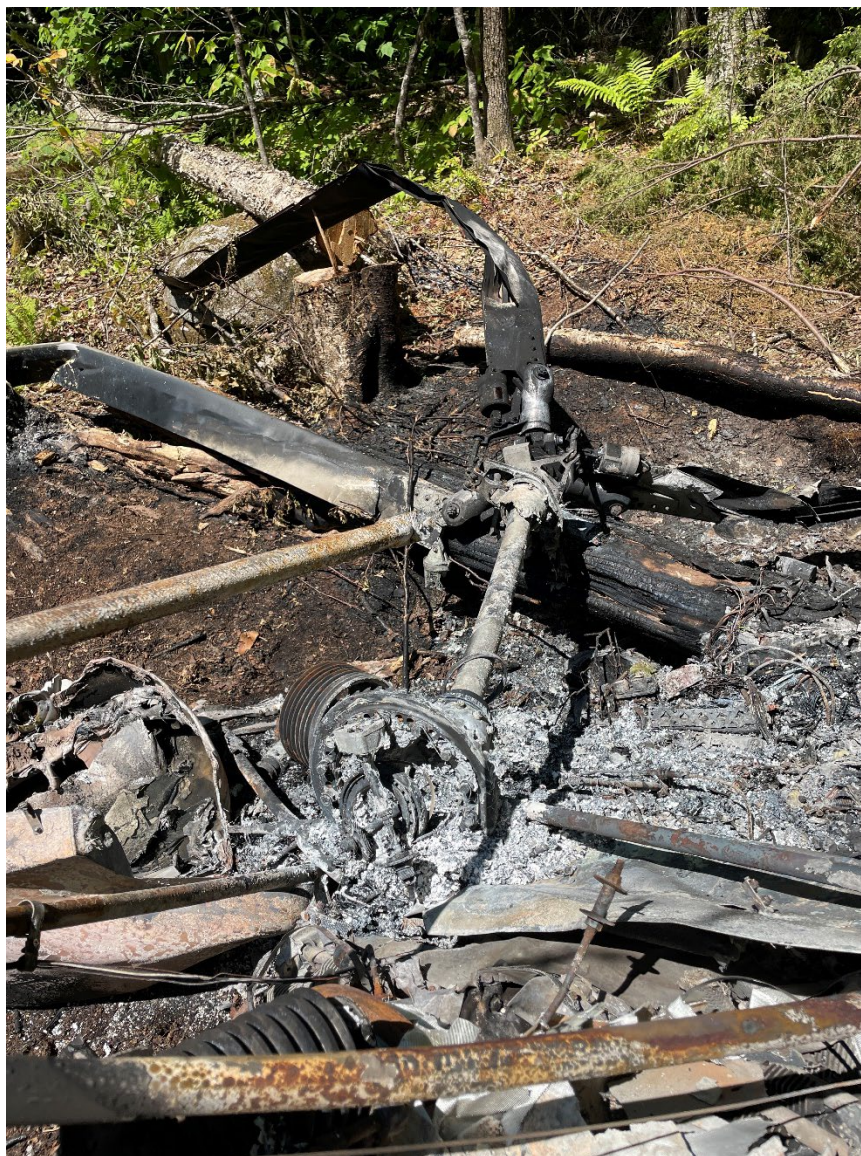
**Photograph 3 - Main rotor assembly and drive shaft (Courtesy of FAA)**

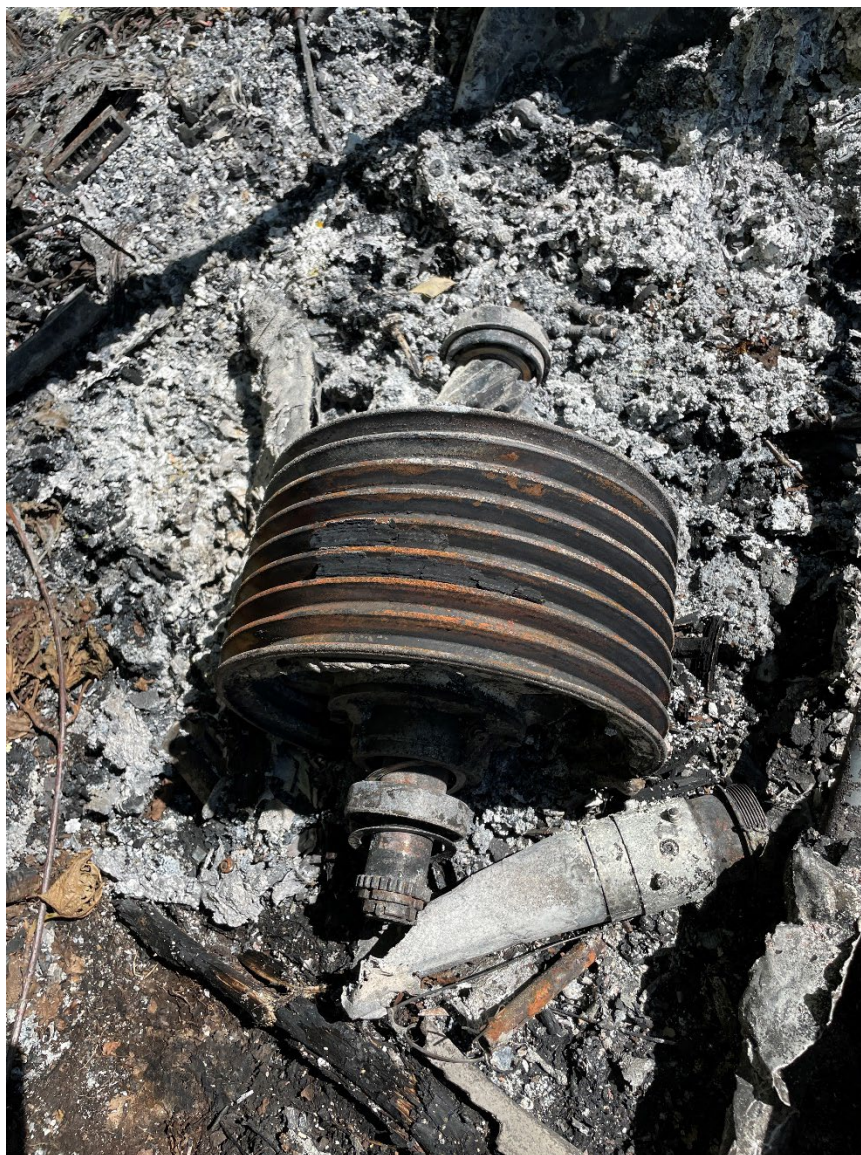
**Photograph 4 - Drive belt pulley (Courtesy of FAA)**

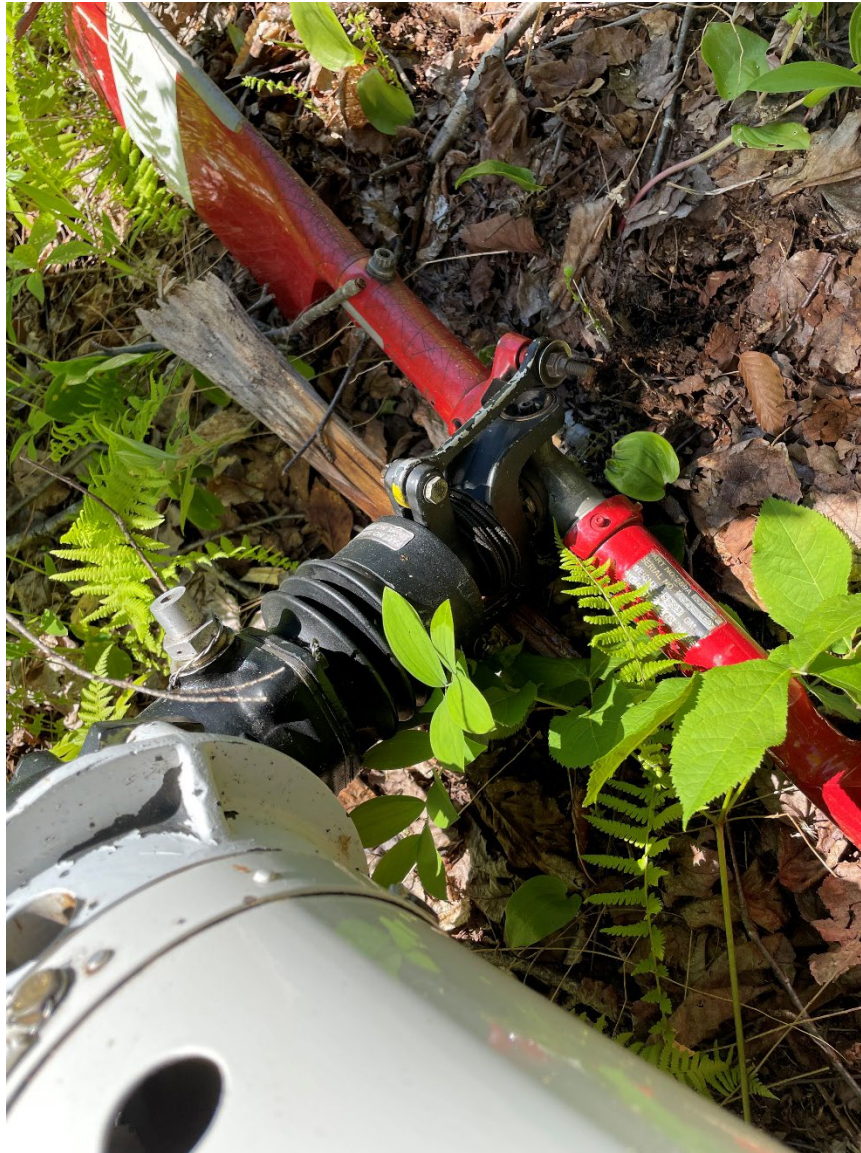
**Photograph 5 - Tail rotor assembly (Courtesy of FAA)**

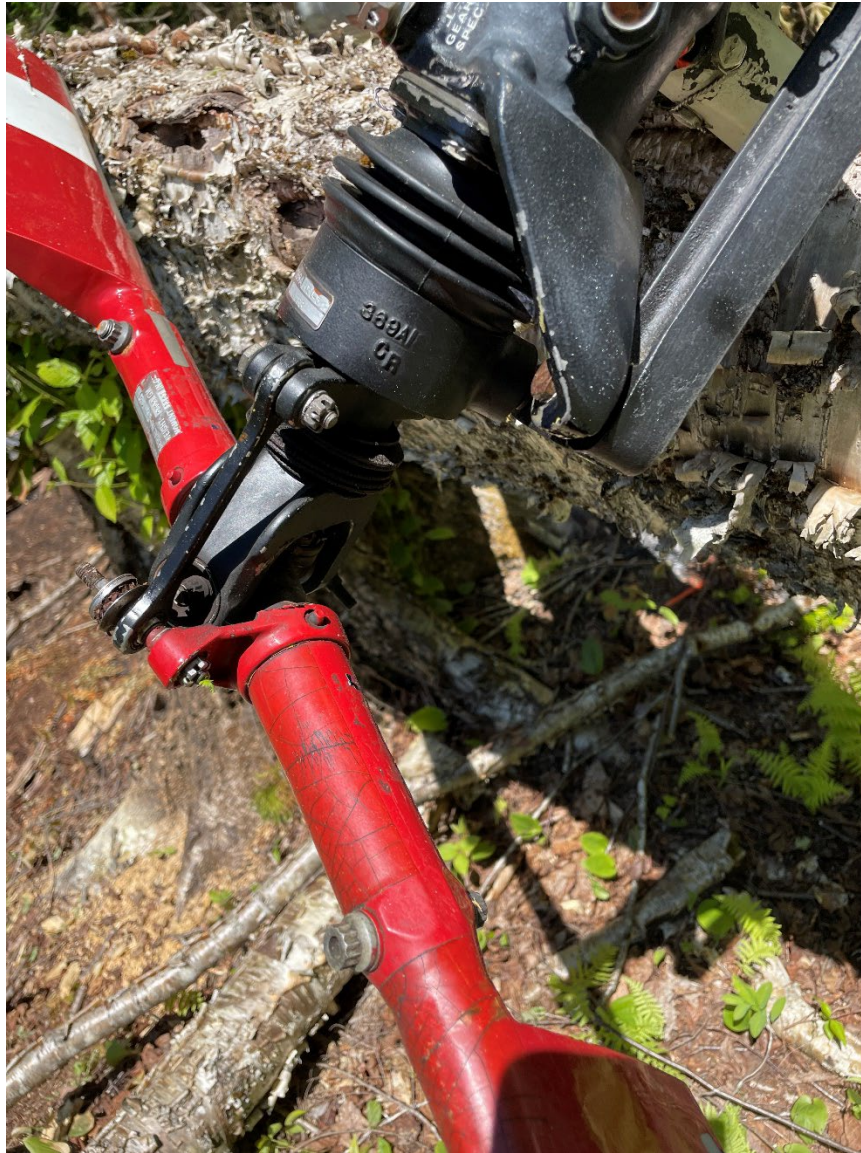
**Photograph 6 - Tail rotor assembly (Courtesy of FAA)**

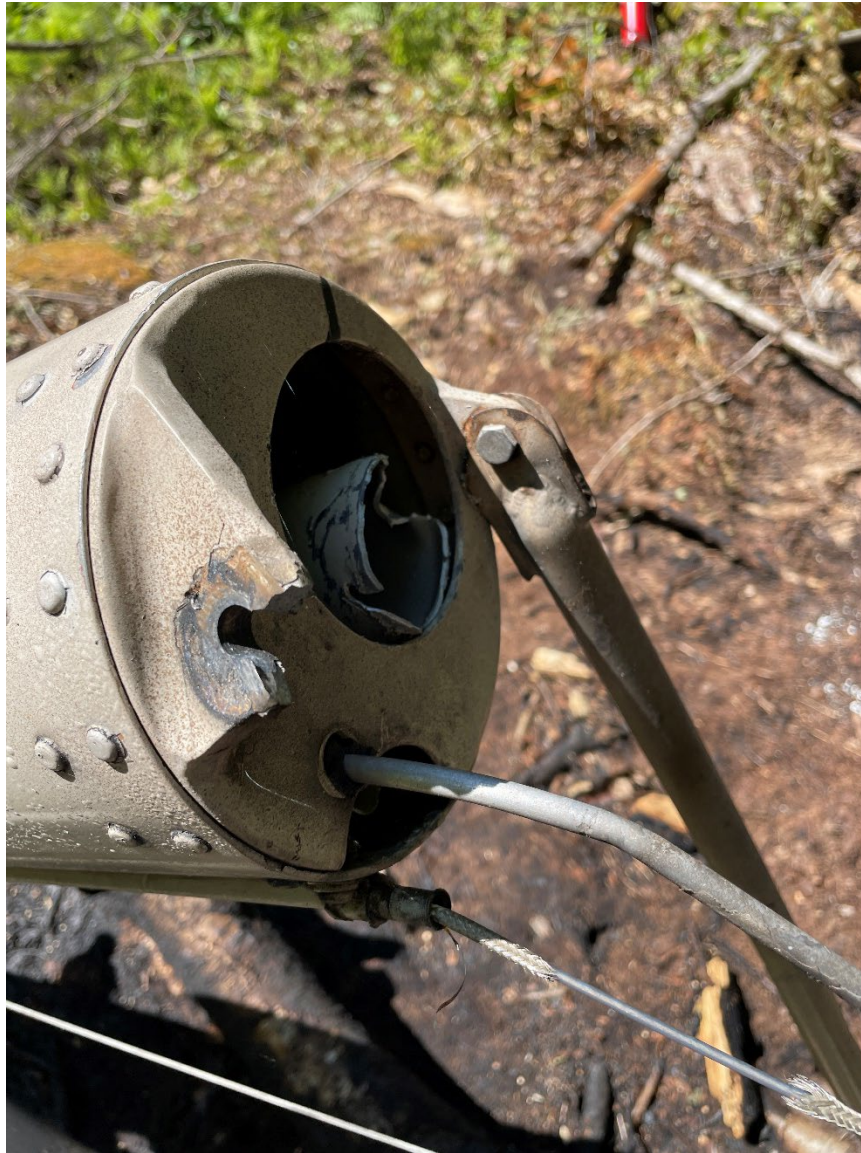
**Photograph 7 - Tail rotor drive shaft (Courtesy of FAA)**
