# National Transportation Safety Board

## **MATERIALS LABORATORY**

Factual Report 24-088

Location: Colquitt, Georgia  
Date: June 5, 2024  
Time: 06:30 eastern daylight time  
10:30 coordinated universal time  
Vehicle: Piper PA-25-235, N8715L  
Investigator: Ralph Hicks, AS-ERA

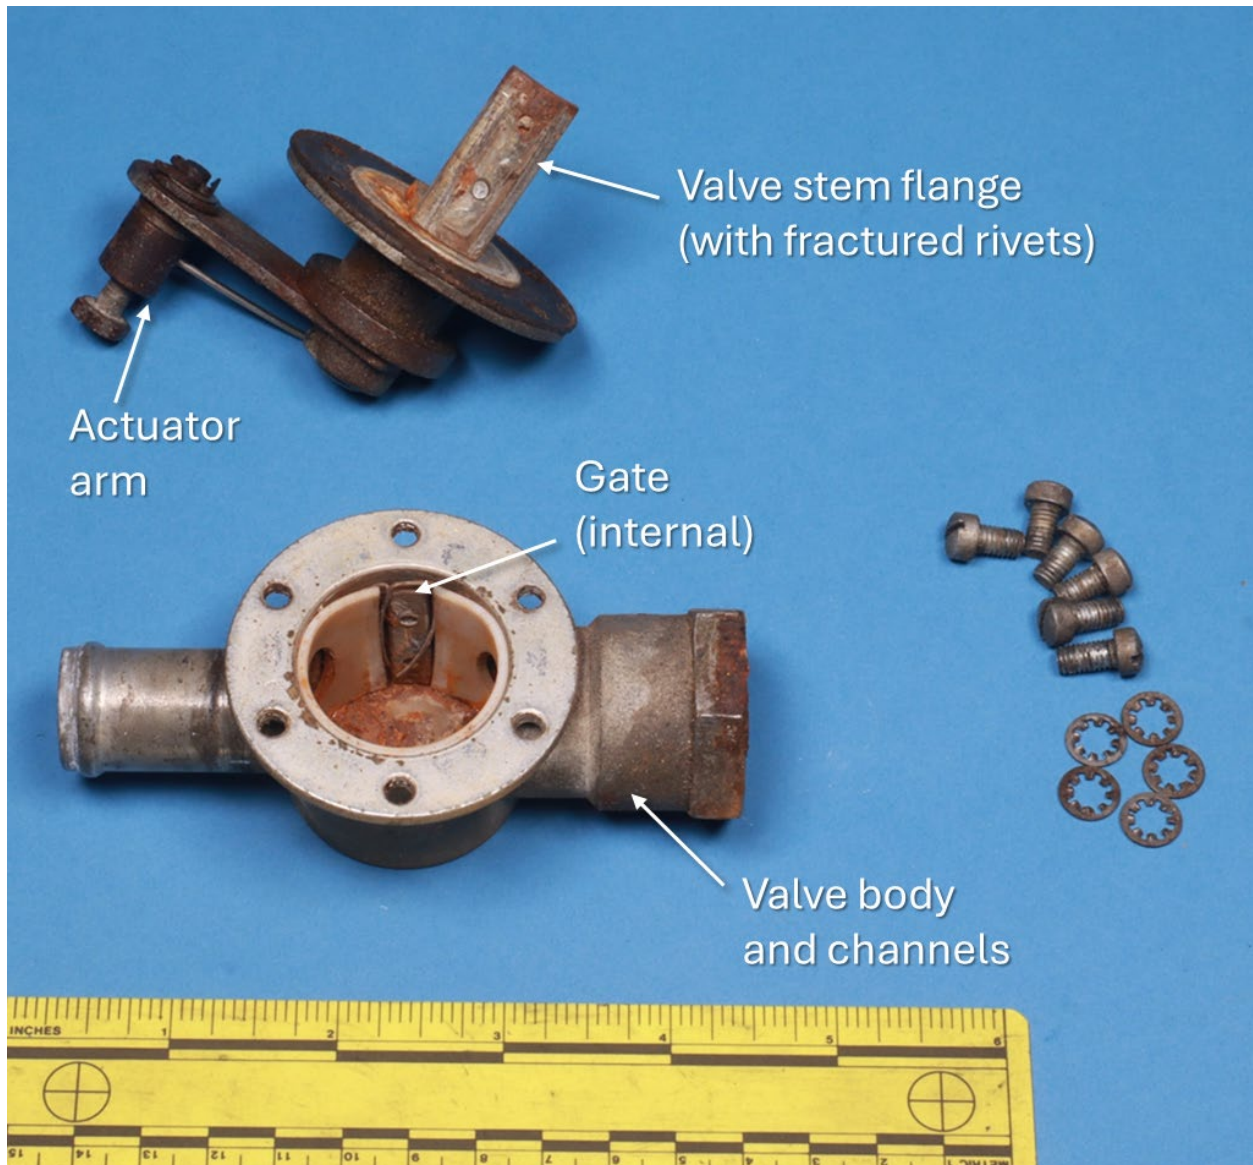
Figure 1 shows the components from the shut-off valve as received. The valve body housing had already been disassembled, with the six screws and washers packaged separately. Of note, the valve stem flange had separated from the gate.

Figure 1. View of the components from the fuel shutoff valve.

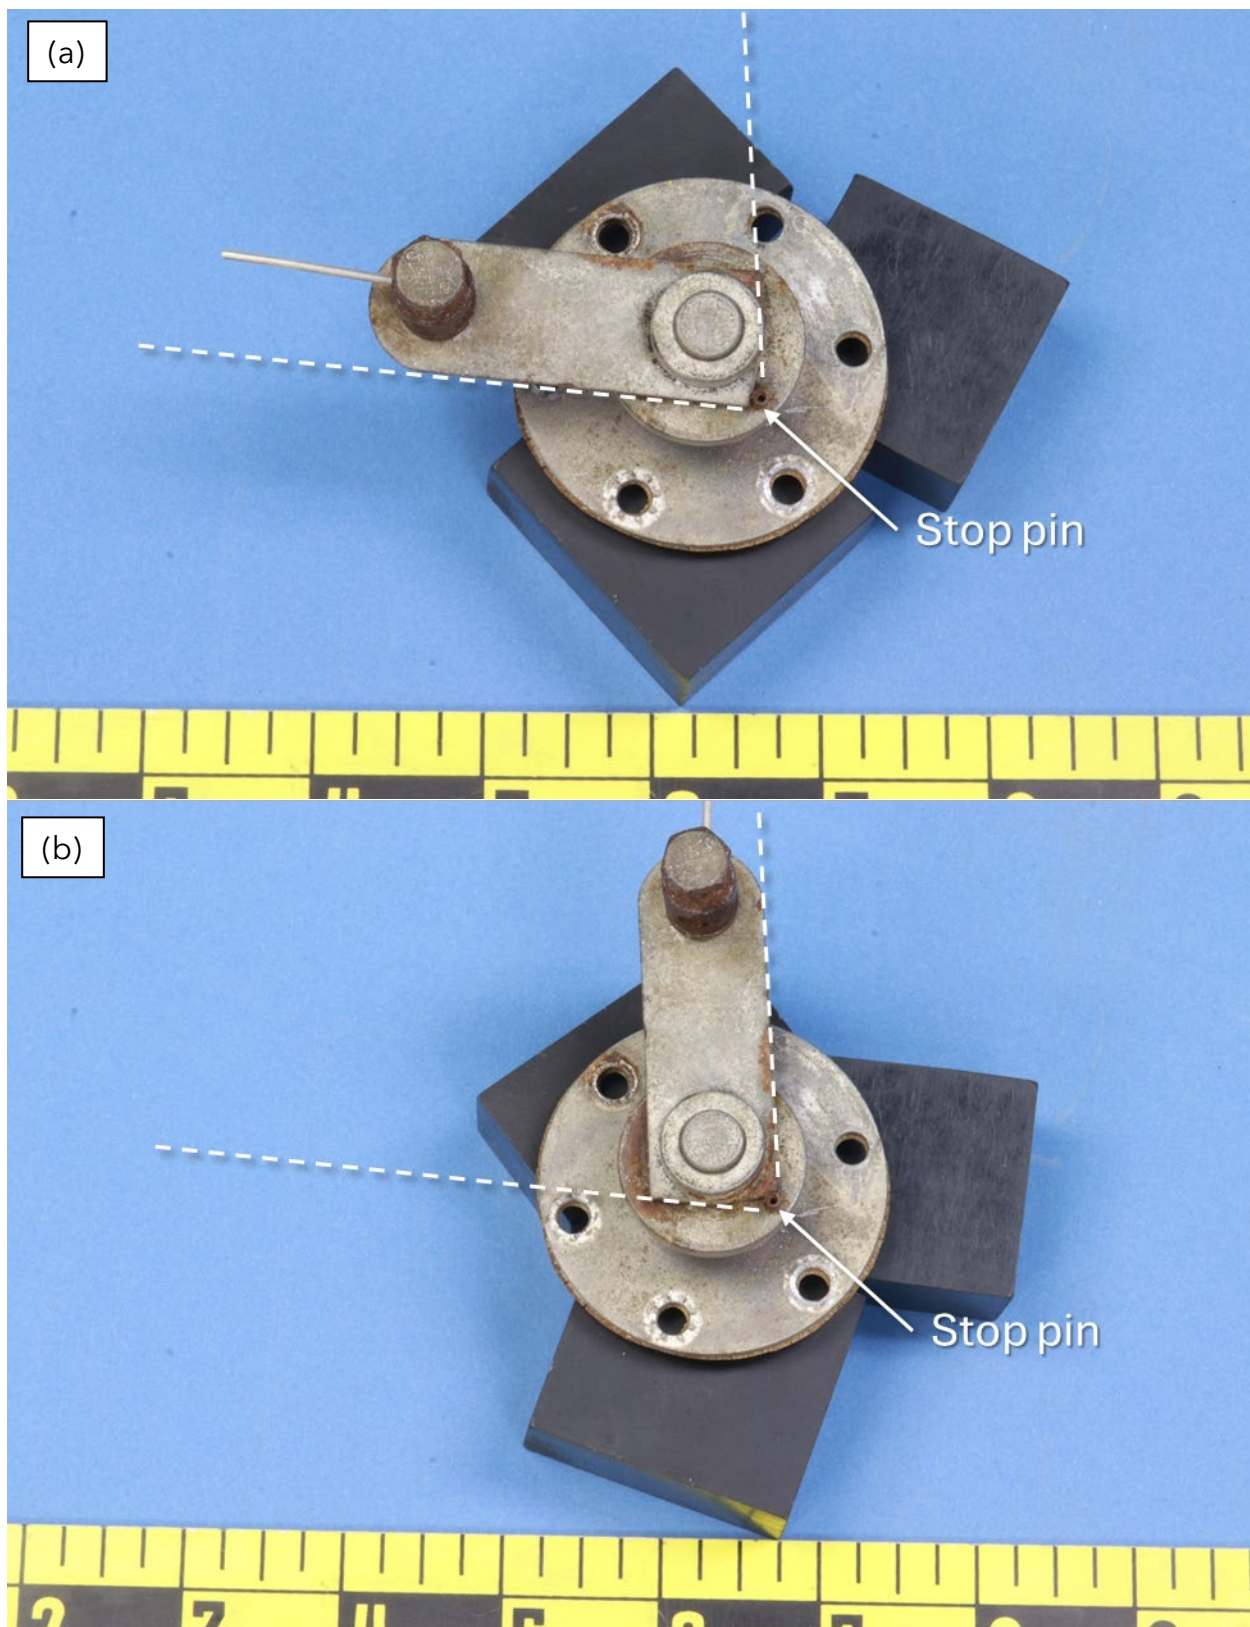
The actuator arm was attached to the stem and rotated between the stops within the valve body housing cover. Figure 2 shows the two maximum positions of the arm, showing (in these figures) the 270° and 0° positions. The stop pin was in place and

Figure 2. View of the lever and arm outside the fuel shutoff valve, showing the maximum travel in each direction (denoted by dashed white lines).

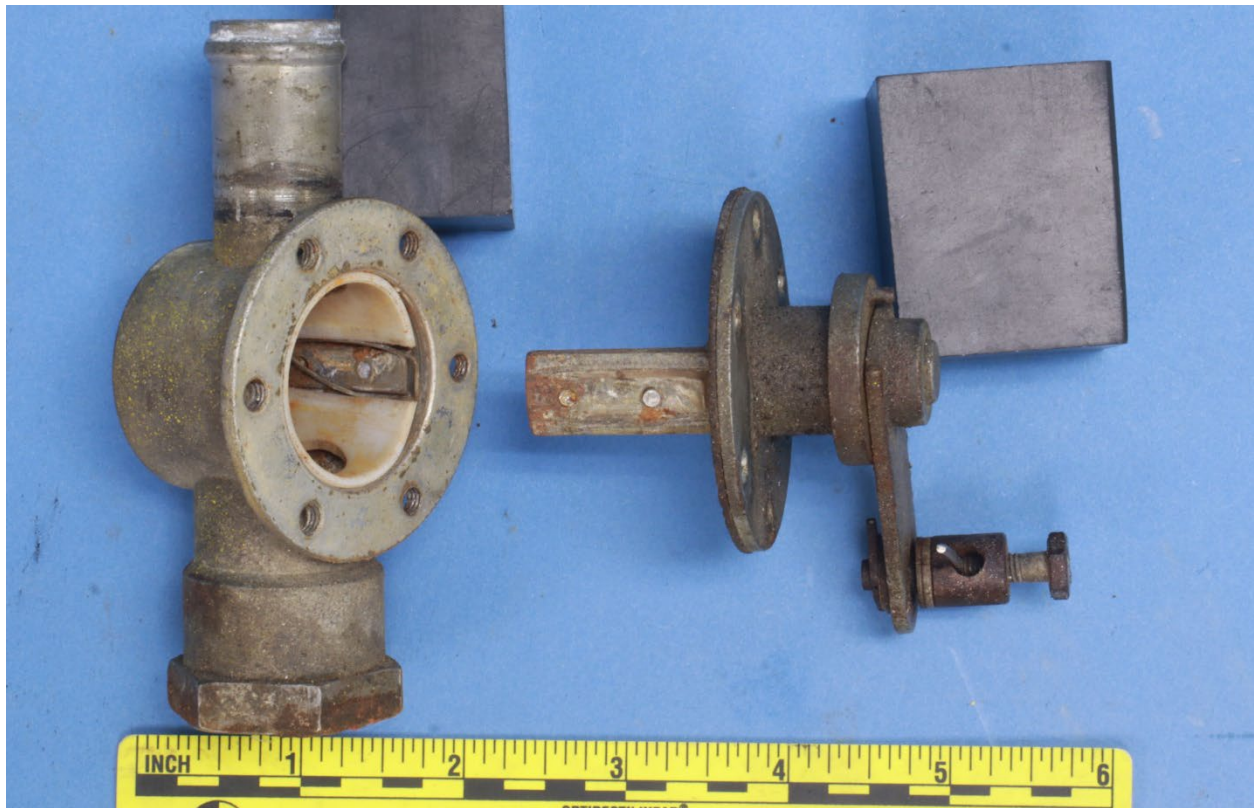
Figures 3 and 4 show the opposite faces of the valve stem assembly and the body's interior, showing the gate. The two key features were corrosion on the interior body of the valve, as indicated by the left side of the stem flange in Figure 4, and the two fractured rivets, which had joined the stem flange to the gate. Figure 5 shows two views of the stem-side interior surface, which exhibited white, gray, and rust-colored deposits.

Figure 3. View of the valve body and stem positioned showing the rivet fracture surfaces.

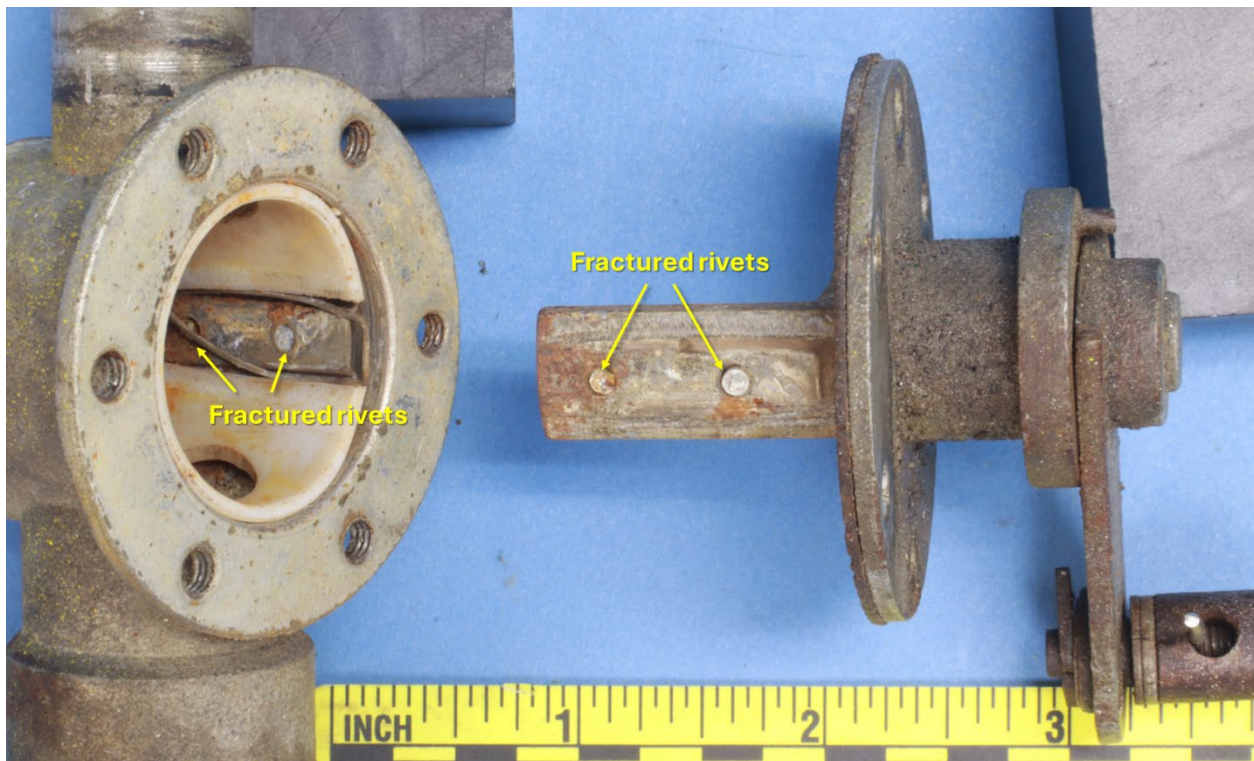
Figure 4. Closer view of the stem flange and interior of the valve body, with the fractured rivets annotated.

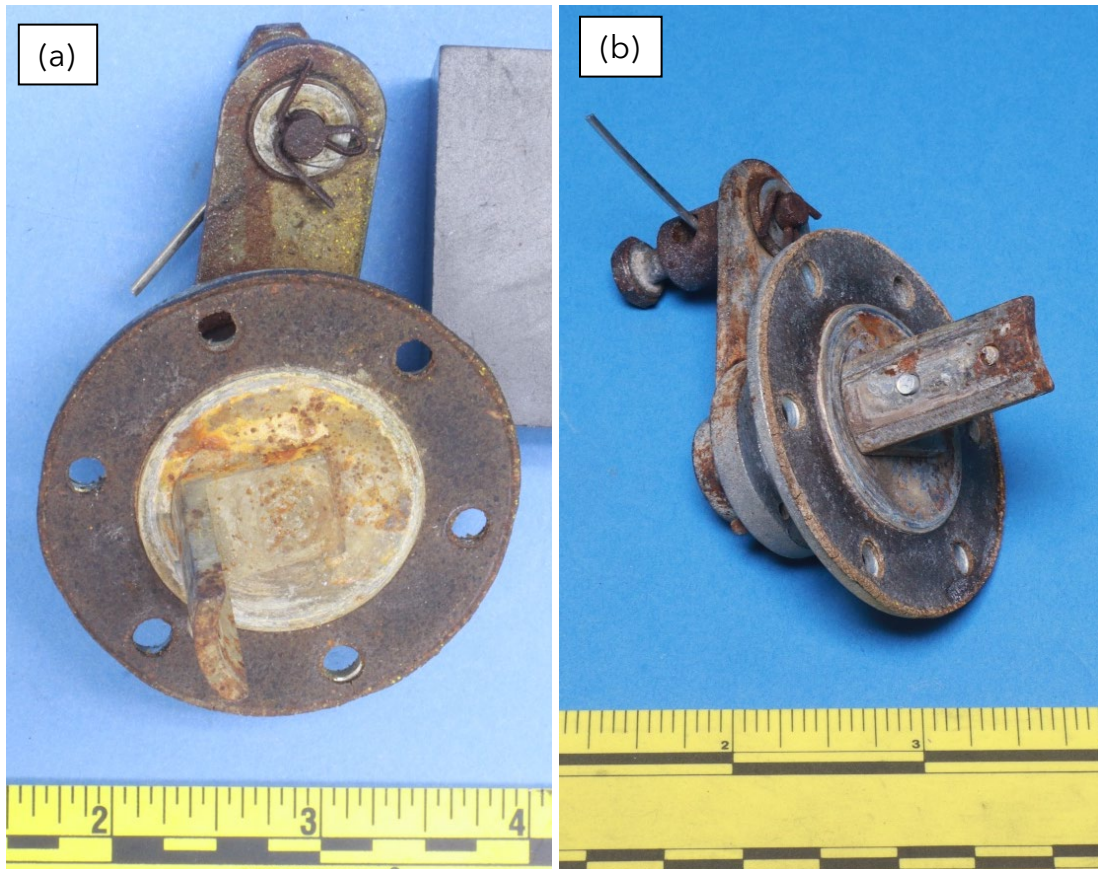
Figure 5. Views of the valve stem flange inside the valve body showing (a) the stem joint and (b) the fractured rivet side of the flange.

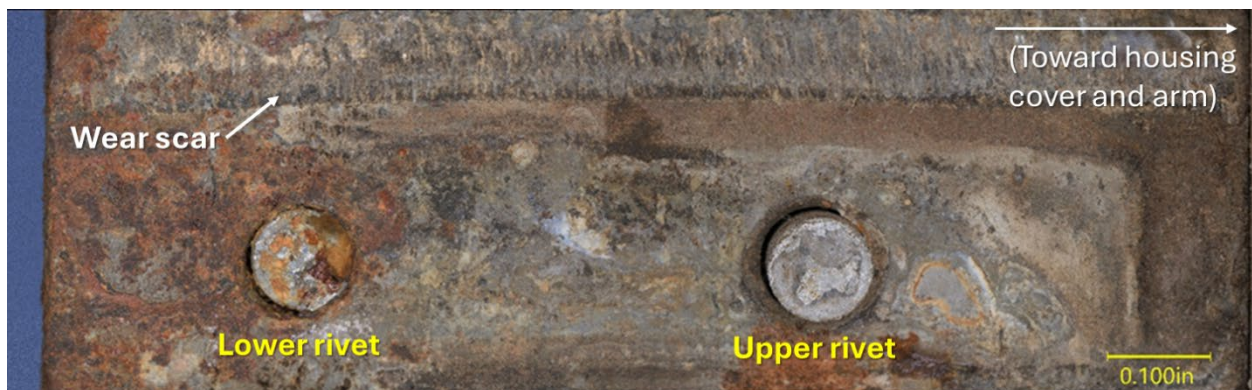
A closer view of the fractured rivets on the stem flange, illustrated in Figure 6, showed that one exhibited more of these deposits than the other. The left rivet is the one that sat deeper into the valve body than the other. For this report, the left rivet in Figure 6 is identified as the lower rivet, and the one on the right is the upper rivet.

The portion of the stem flange at the upper side of the image in Figure 6 exhibited a reflective horizontal band parallel to the flange direction (shown above the rivets in Figure 6). This band exhibited multiple parallel streaks, oriented vertically and towards the left in the figure. This band was consistent with grinding against an adjacent surface.

Figure 6. Closer view of the fractured rivets from the valve stem flange, showing a horizontal streak of sliding wear.

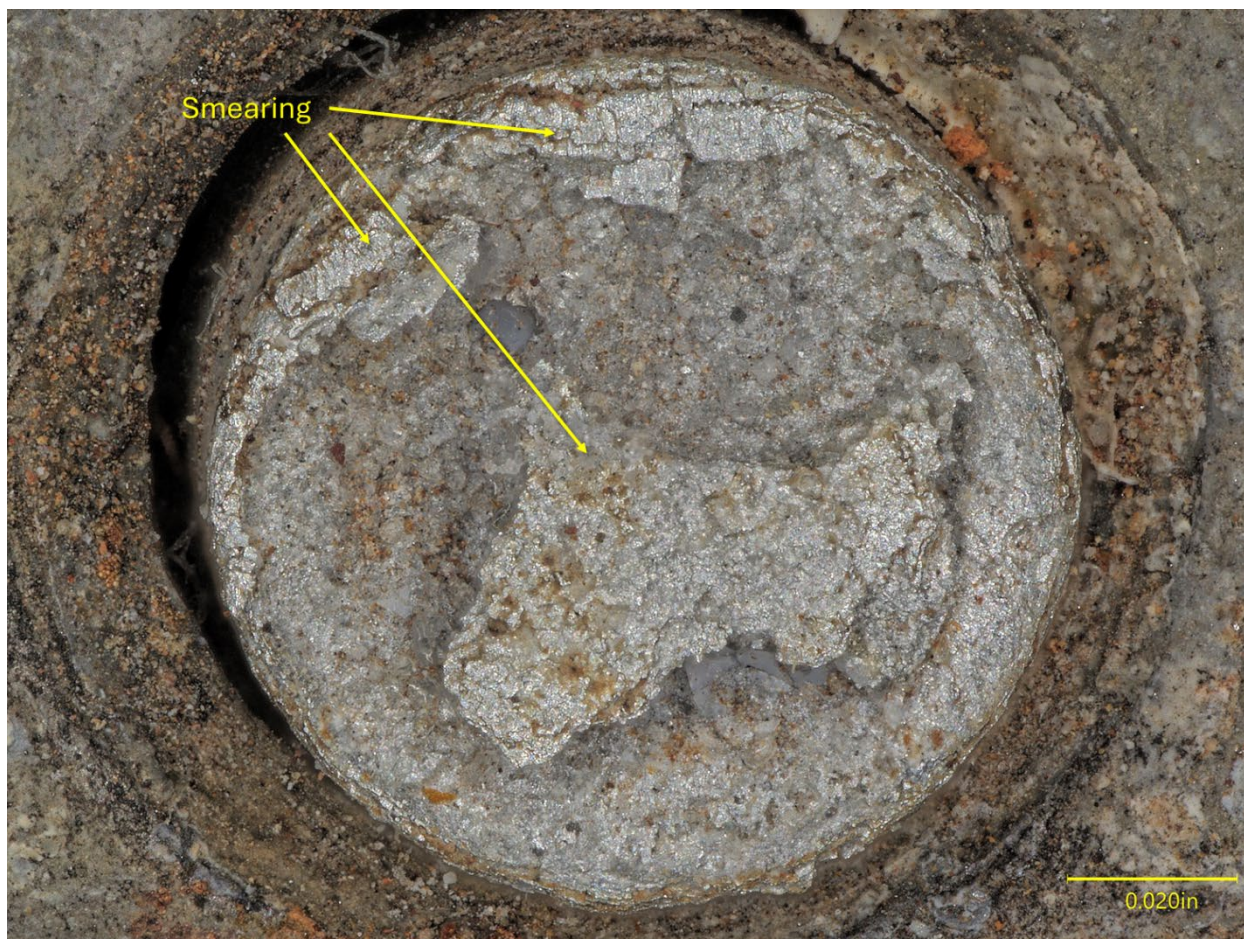
Figure 7 shows a closer view of the upper rivet on the stem flange as received. This rivet had been bent outward and upward toward the stem, depicted towards the right in the figure. While the fracture surface generally exhibited a rough, fibrous surface with a dull luster, three distinct regions, annotated in Figure 7, showed a reflective, streaky texture. These areas exhibited features with post-fracture smearing damage.

Figure 7. View of the upper fractured rivet, as received, with areas of smearing damage.

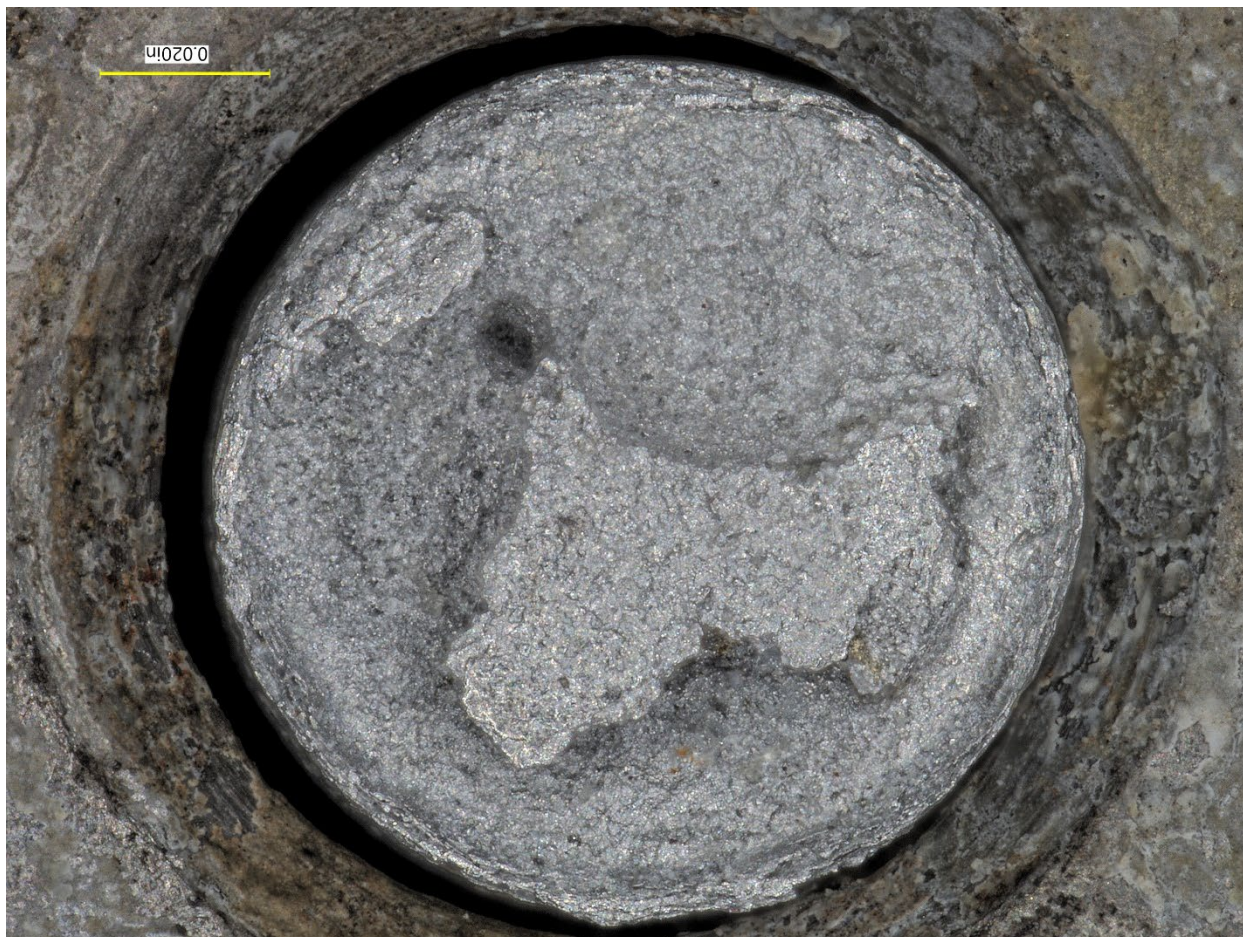
The valve stem flange was cleaned sequentially in an ultrasonic bath with acetone followed by Evapo-Rust.<sup>1</sup> In Figures 7 and 8, which show the upper rivet pre- and post-cleaning, little material was removed, indicating a lack of corrosion compounds and deposits on this rivet fracture surface. A side view, in Figure 9, shows localized necking near the fracture surface, as well as outward-oriented edge deformation, consistent with shear.

Figure 8. View of the upper rivet, after cleaning.

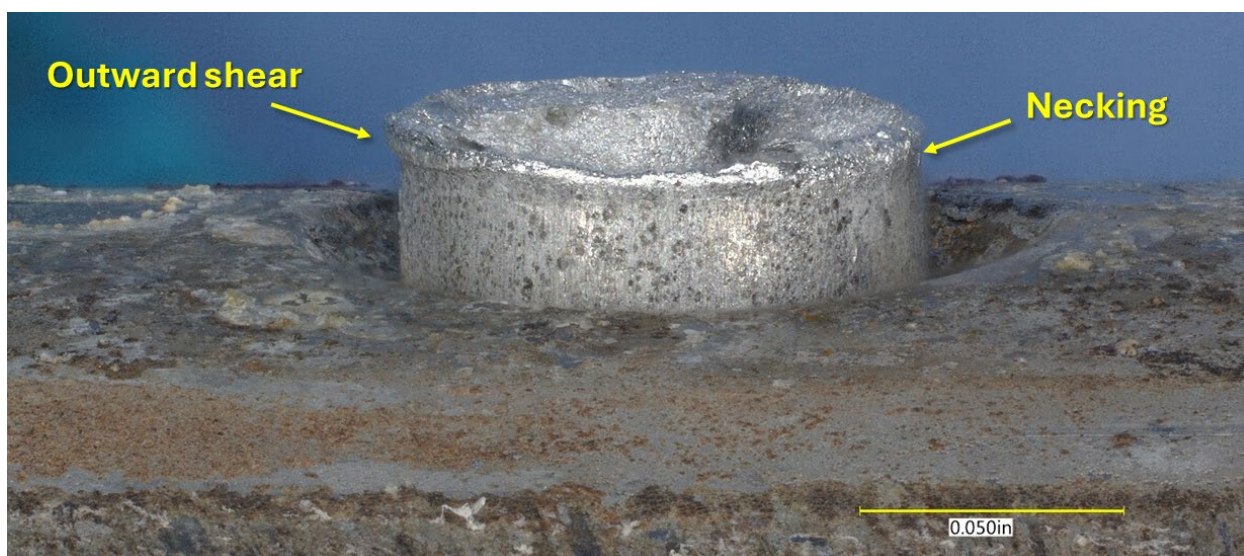
Figure 9. Side view of the upper rivet, after cleaning, with areas of plastic deformation annotated.

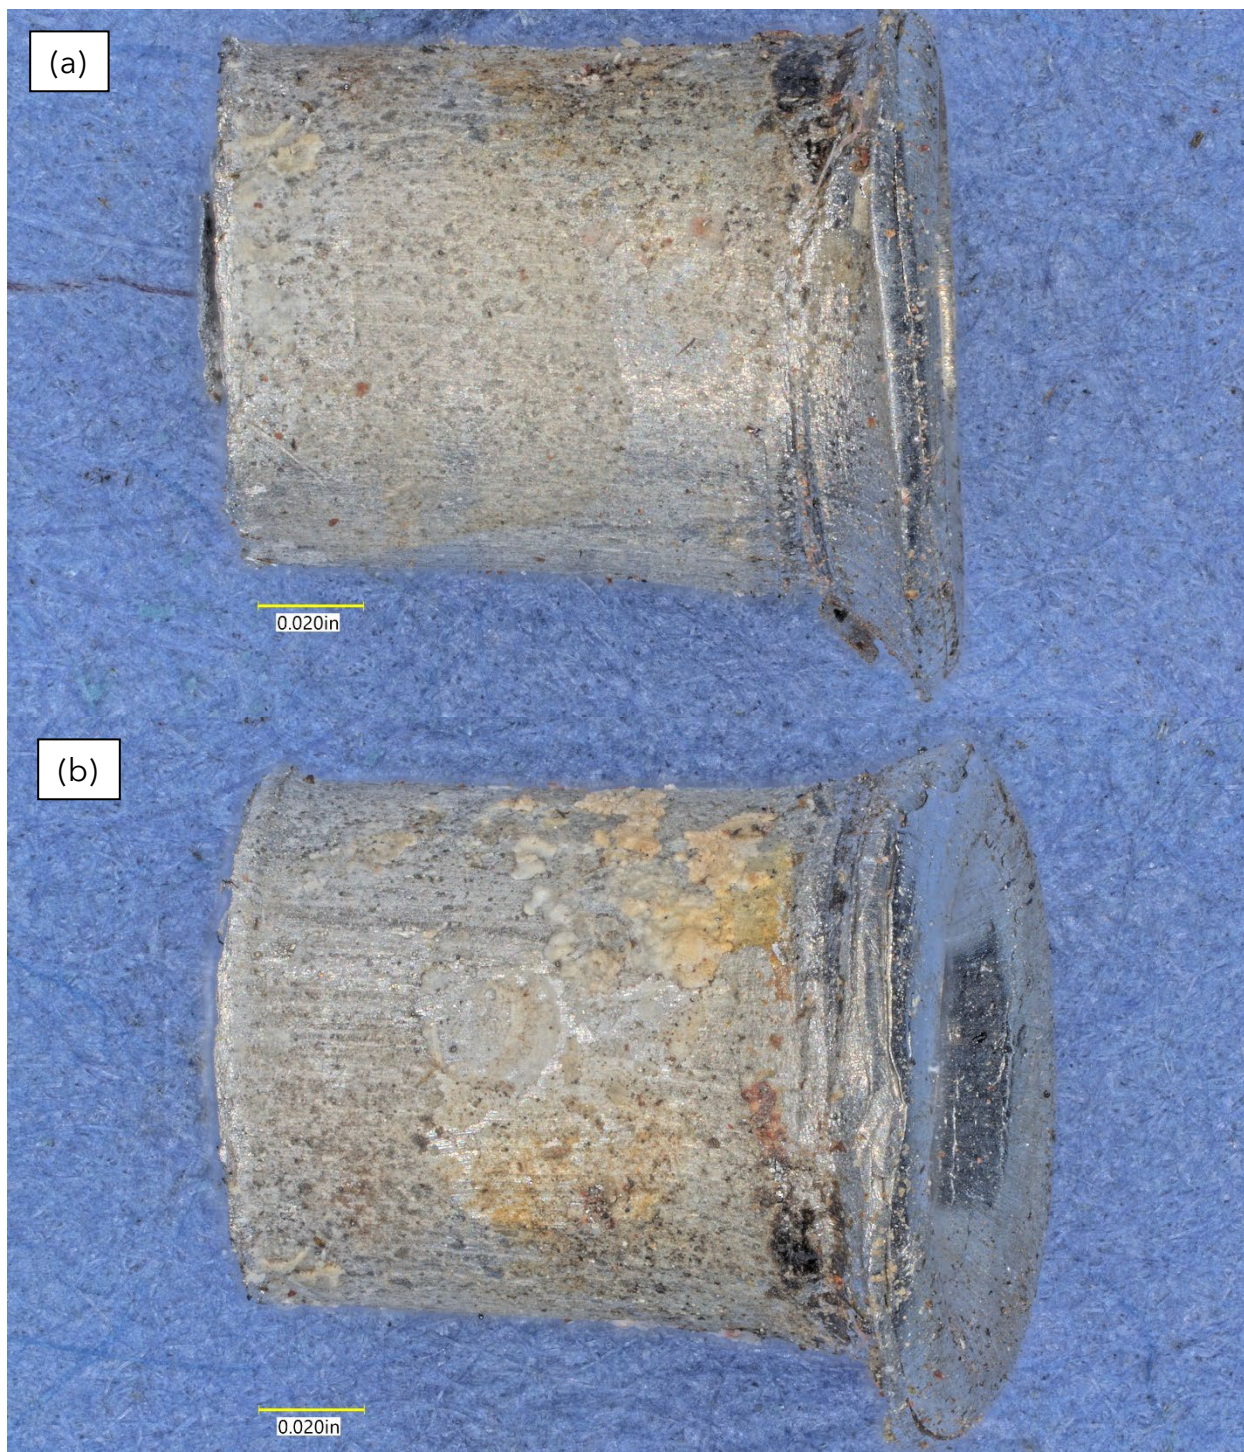
The upper rivet fragment is illustrated in Figure 10 from the side after it was removed from the stem flange. The body of the remnant was intact and cylindrical, with some white-colored deposits on the sides. The area near the fracture surface, on the left in the figures, exhibited necking and outward smearing deformation. The rivet was examined using a field emission scanning electron microscope (SEM). The fracture surface, shown in Figure 11, displayed dimpled rupture, as typified in Figure 12. The

Figure 10. Opposite 180° views of the upper rivet fragment, after removal from the valve stem flange.

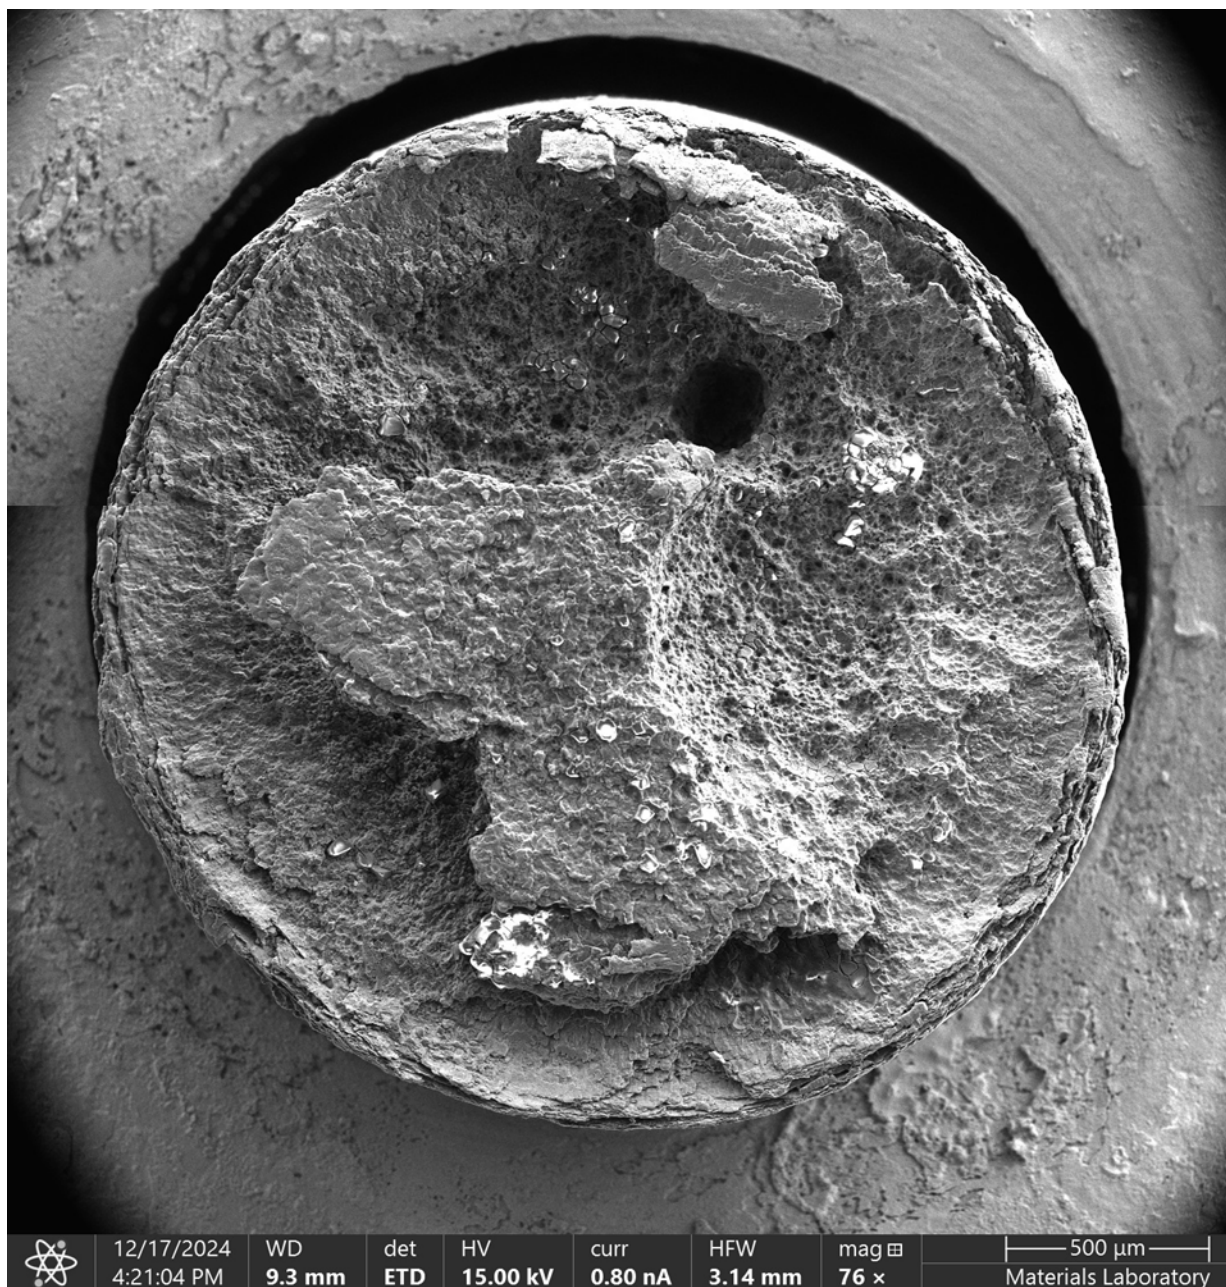
Figure 11. Secondary electron (SE) montage image of the upper rivet fracture surface.

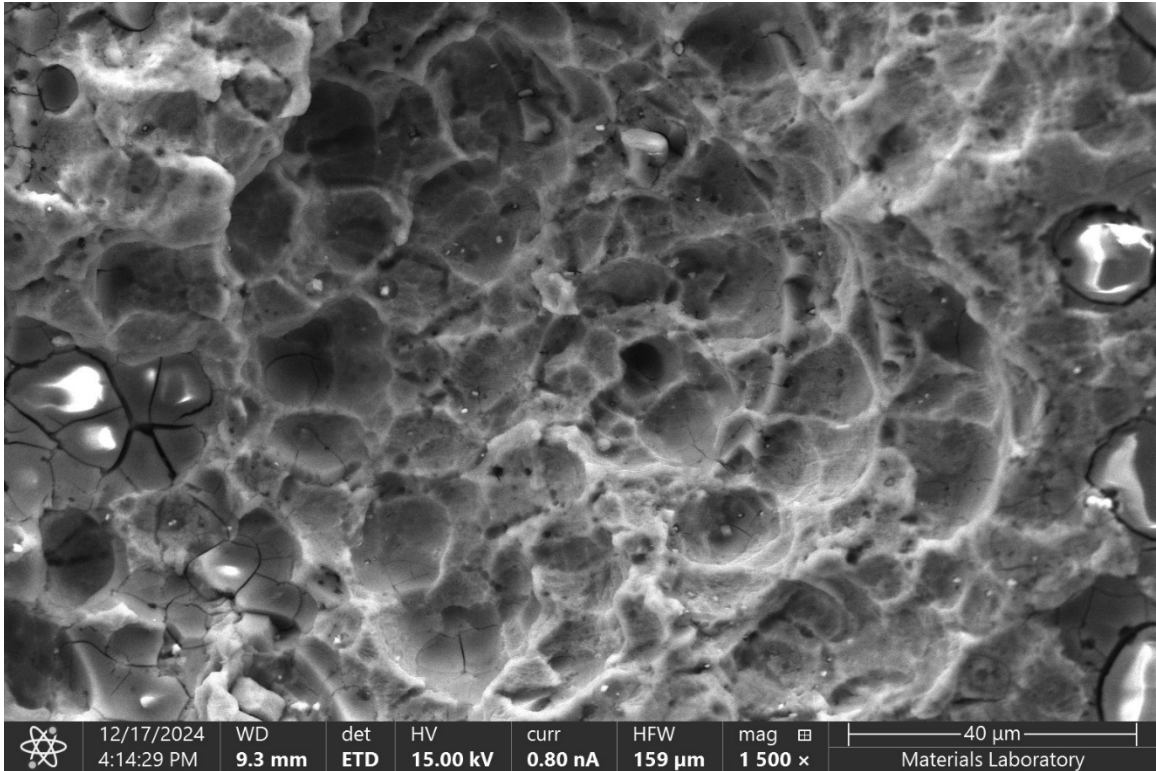
Figure 12. SE micrograph of dimpled rupture on the upper rivet fracture surface.

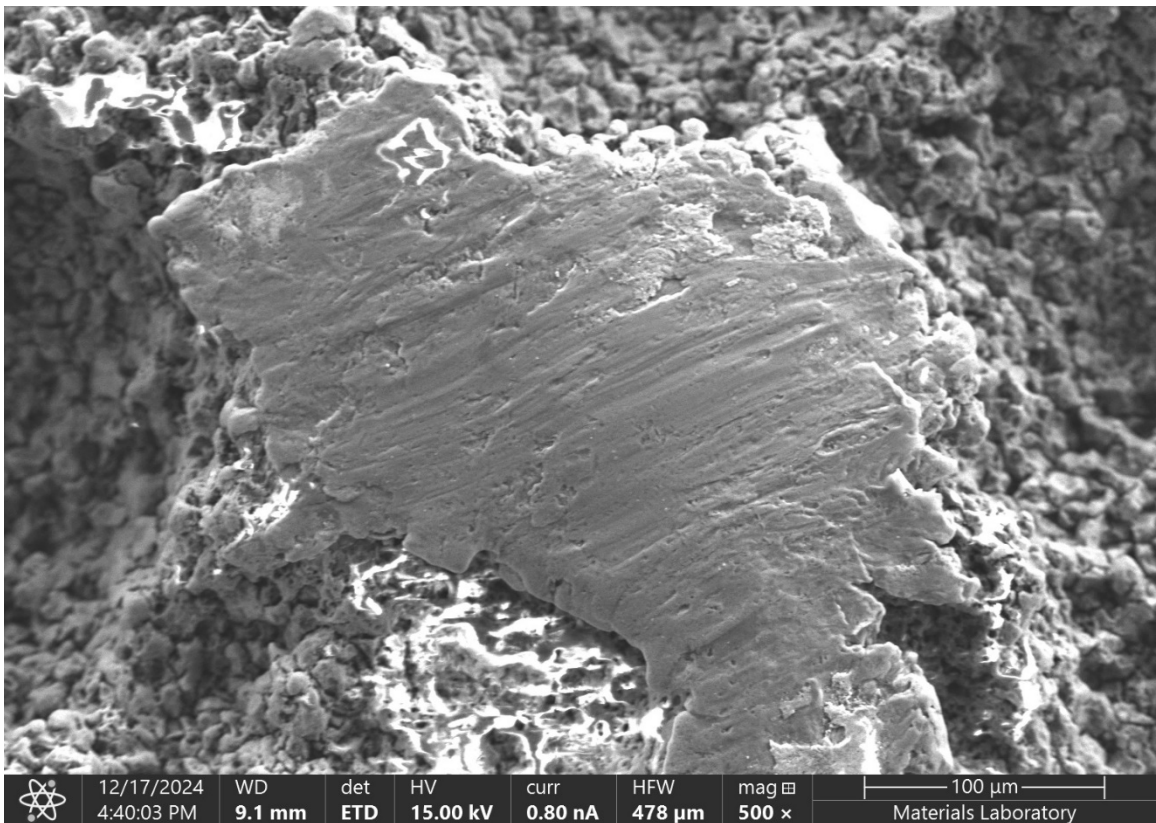
areas with smearing, shown in Figure 13, were present over the dimpled rupture features. These features were consistent with overstress fracture, followed by post-fracture smearing of the surface.

Figure 13. SE micrograph of smearing on the upper rivet fracture surface.

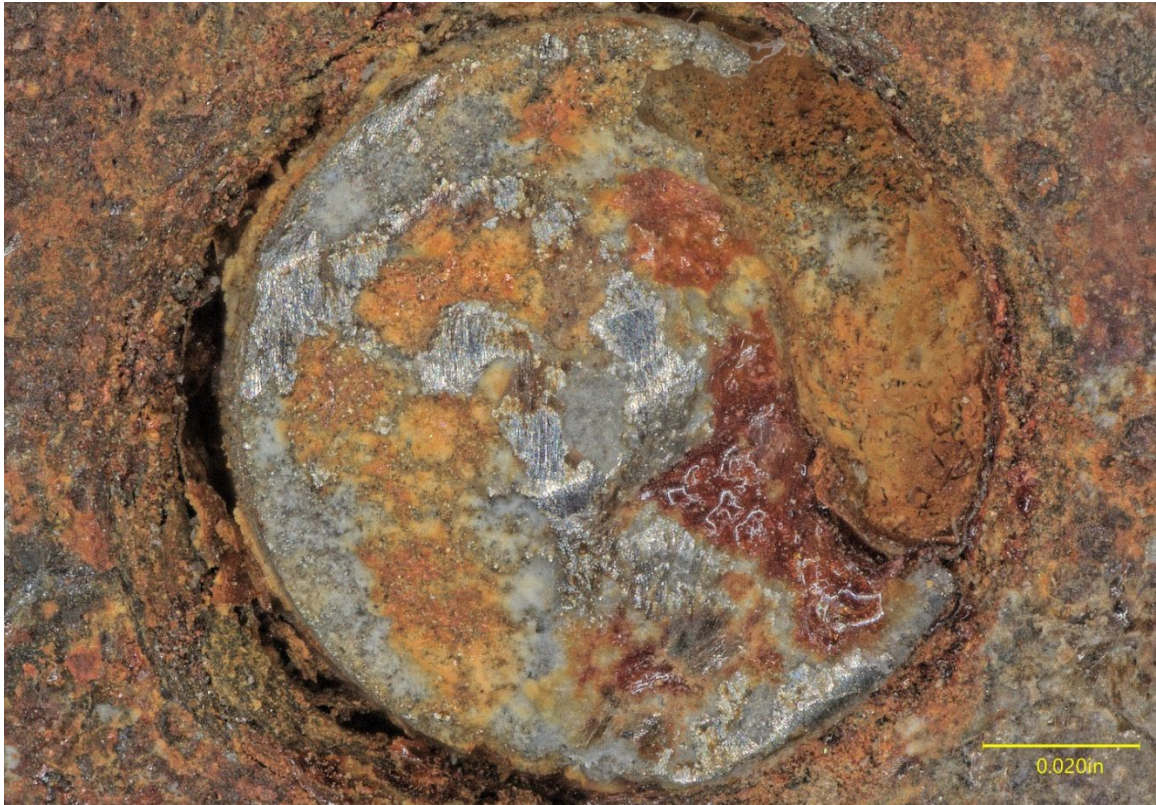
Figures 14 and 15 show the fractured lower rivet, both as received and after cleaning. This fractured subcomponent exhibited enough corrosion product to obscure the underlying fracture surface. Even after successive cleaning attempts, globules of surface corrosion were still present. Figure 15 shows several areas of reflective regions, consistent with post-fracture smearing. Fewer areas exhibited smearing features on this rivet fracture surface than on the upper rivet.

Figure 14. The lower rivet fracture surface, as received.

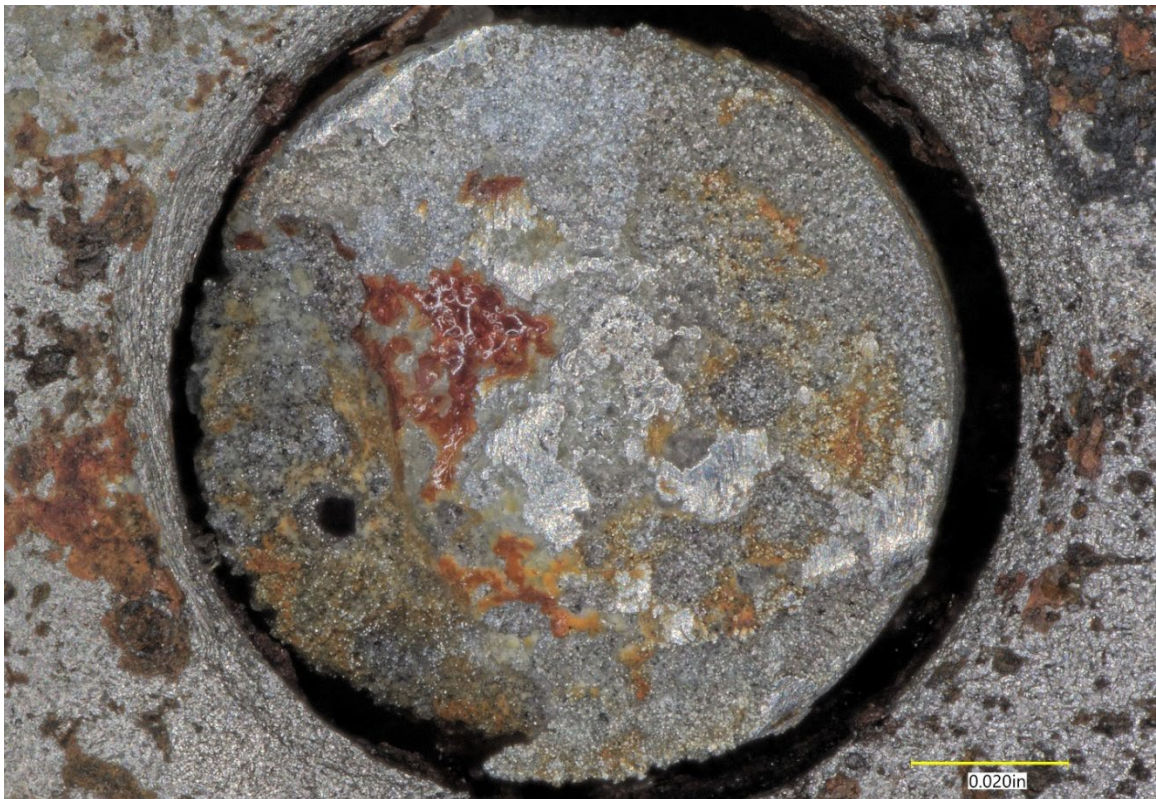
Figure 15. The lower rivet fracture surface, after multiple cleaning iterations.

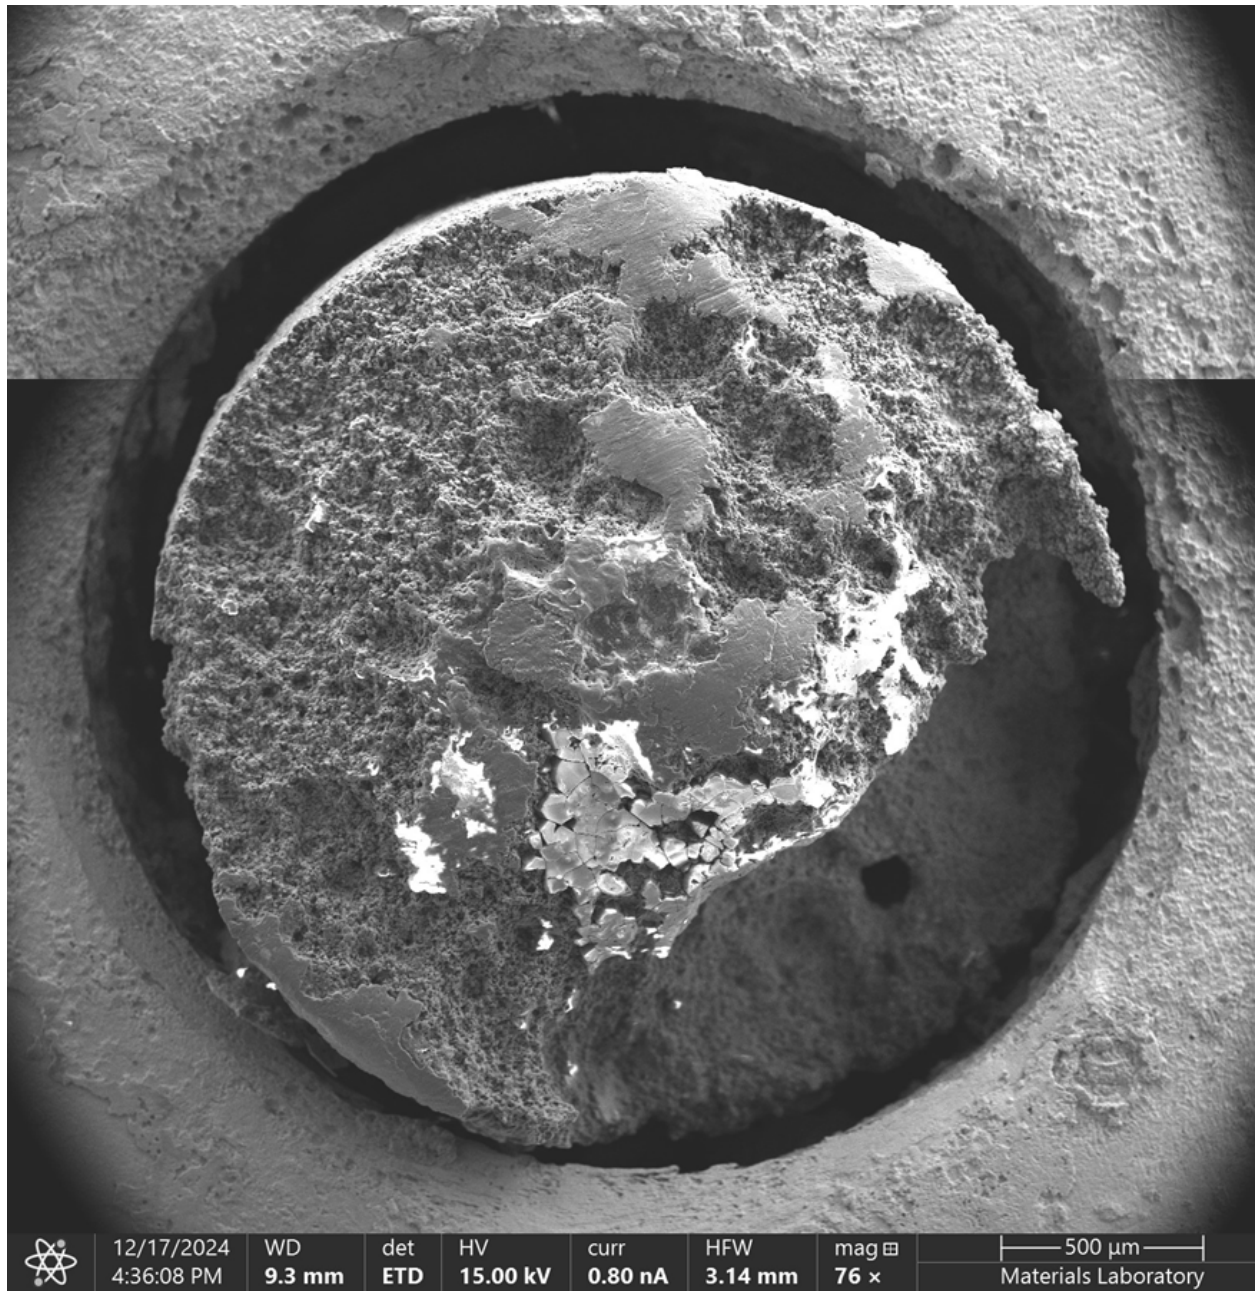
This rivet fracture surface was examined using an SEM, as demonstrated in Figure 16. While part of the surface protruded from the rivet hole, a small crescent region was present below and within the hole. A backscattered view, shown in Figure 17, revealed areas of disparate material compositions.<sup>3</sup>

Figure 16. SE montage image of the lower rivet fracture surface.

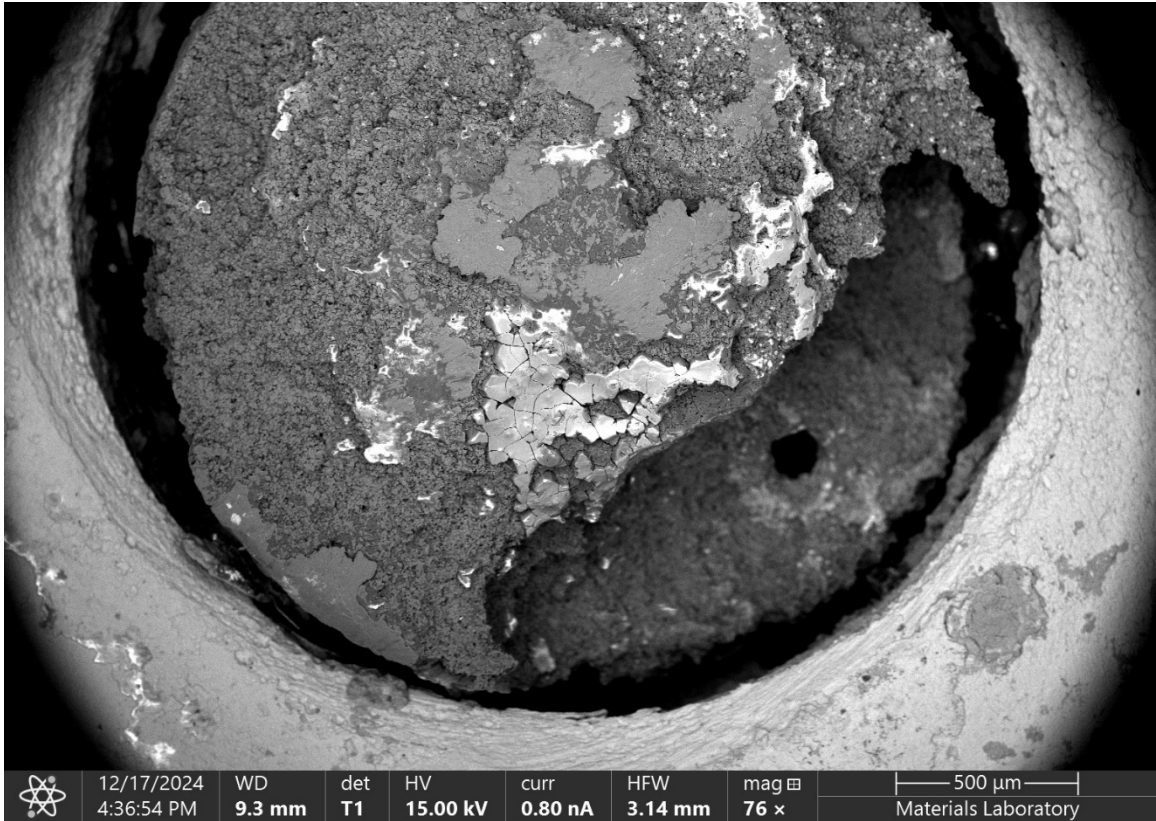
These regions were probed using EDS. The medium gray areas, consistent with smeared areas, were exhibited spectra of an aluminum alloy consistent with that of the rivet material. The darker gray regions were consistent with aluminum oxide, containing minor amounts of sodium, phosphorus, magnesium, sulfur, and cadmium. The light areas were consistent with iron oxide and aluminum oxide, with the same minor amounts as the other surface oxides.

Figure 17. Backscattered electron (BE) micrograph of a part of the lower rivet fracture surface.

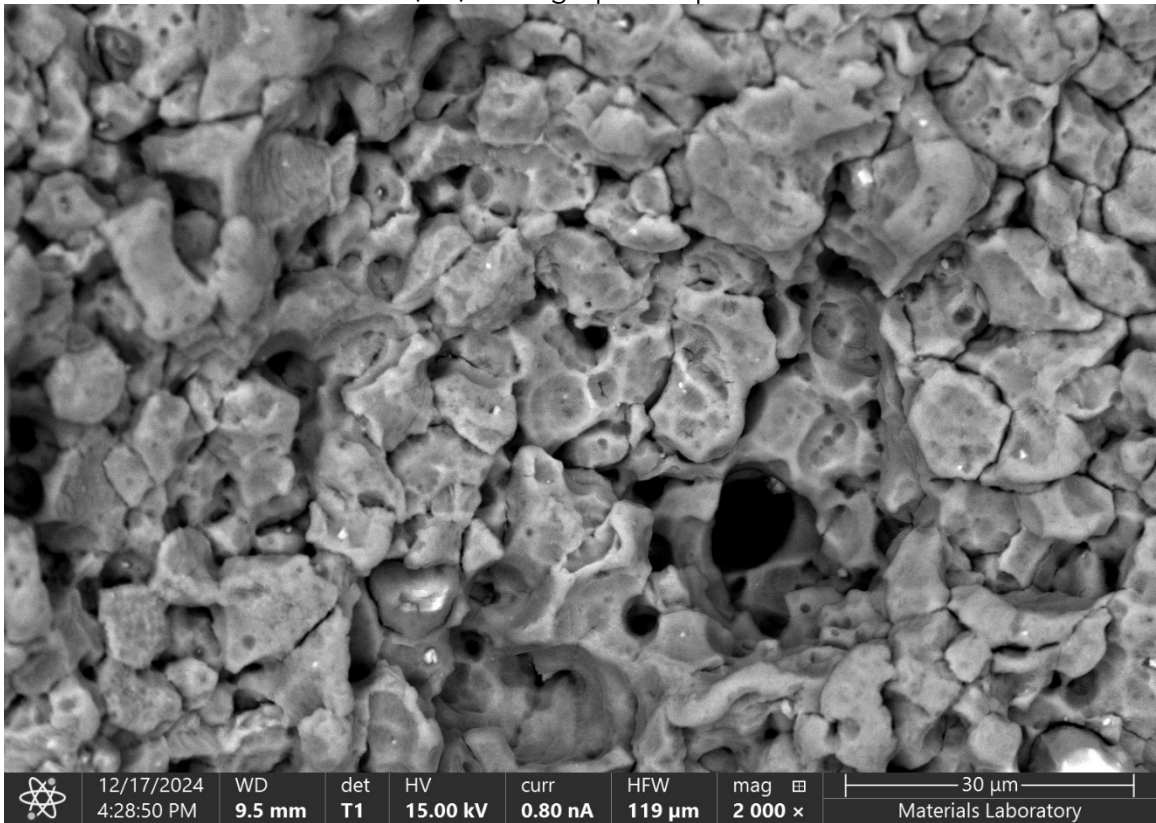
A closer view of the un-smeared regions of the fracture surface showed mixed dimple rupture and intergranular attack, as illustrated in Figure 18. This attack was exemplified by the darker lack of material between grains and the general blocky morphology of the surface. Examining the parts of the fracture surface near the smearing damage revealed wear streaks over the intergranular and dimpled rupture features, consistent with post-fracture contact (Figure 19).

Figure 18. BE micrograph of intergranular fracture features on the lower rivet fracture surface.
