# National Transportation Safety Board

## **MATERIALS LABORATORY**

Factual Report 24-088

Location: Colquitt, Georgia  
Date: June 5, 2024  
Time: 06:30 eastern daylight time  
10:30 coordinated universal time  
Vehicle: Piper PA-25-235, N8715L  
Investigator: Ralph Hicks, AS-ERA

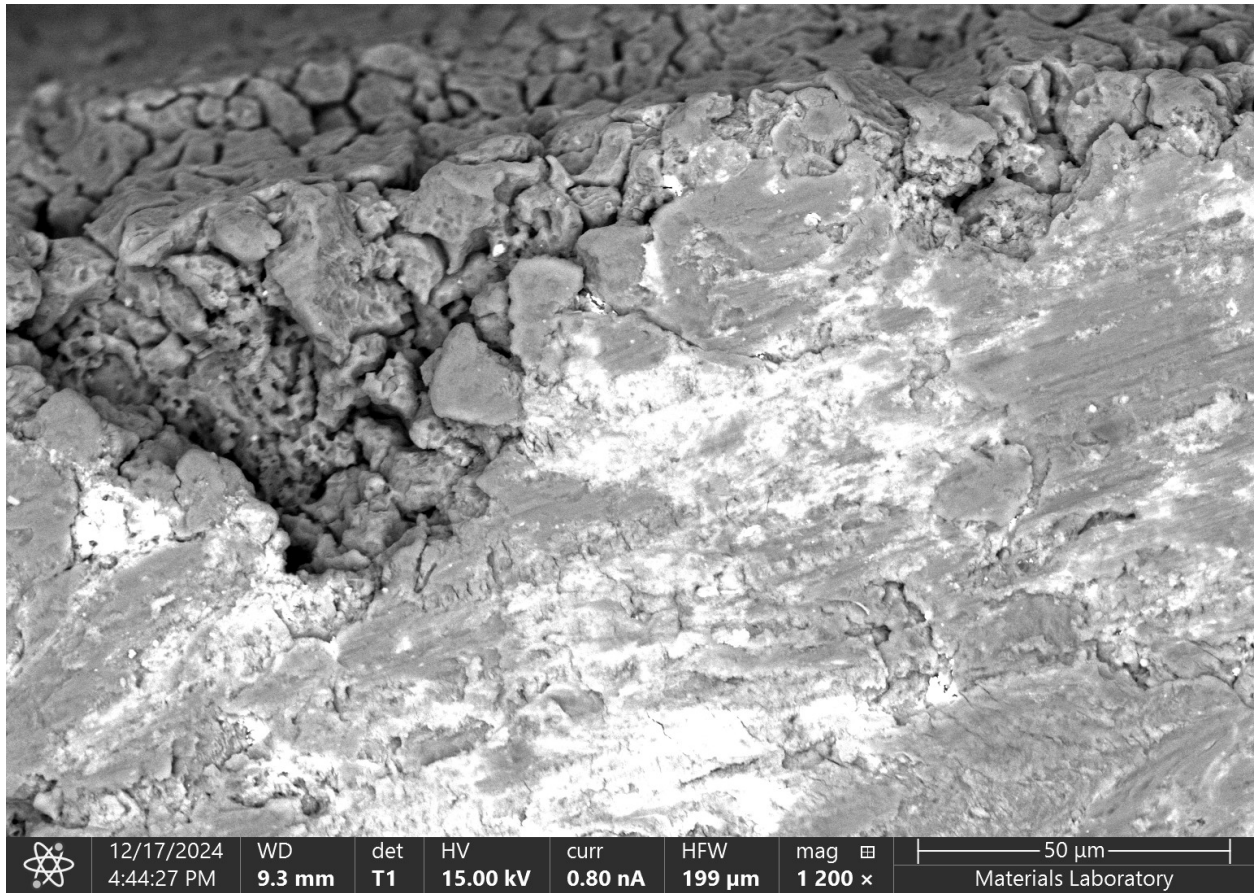
A closer view of the un-smeared regions of the fracture surface showed mixed dimple rupture and intergranular attack, as illustrated in Figure 18. This attack was exemplified by the darker lack of material between grains and the general blocky morphology of the surface. Examining the parts of the fracture surface near the smearing damage revealed wear streaks over the intergranular and dimpled rupture features, consistent with post-fracture contact (Figure 19).

Figure 19. BE micrograph of smearing damage and wear streaks on the intergranular fracture features of the lower rivet.

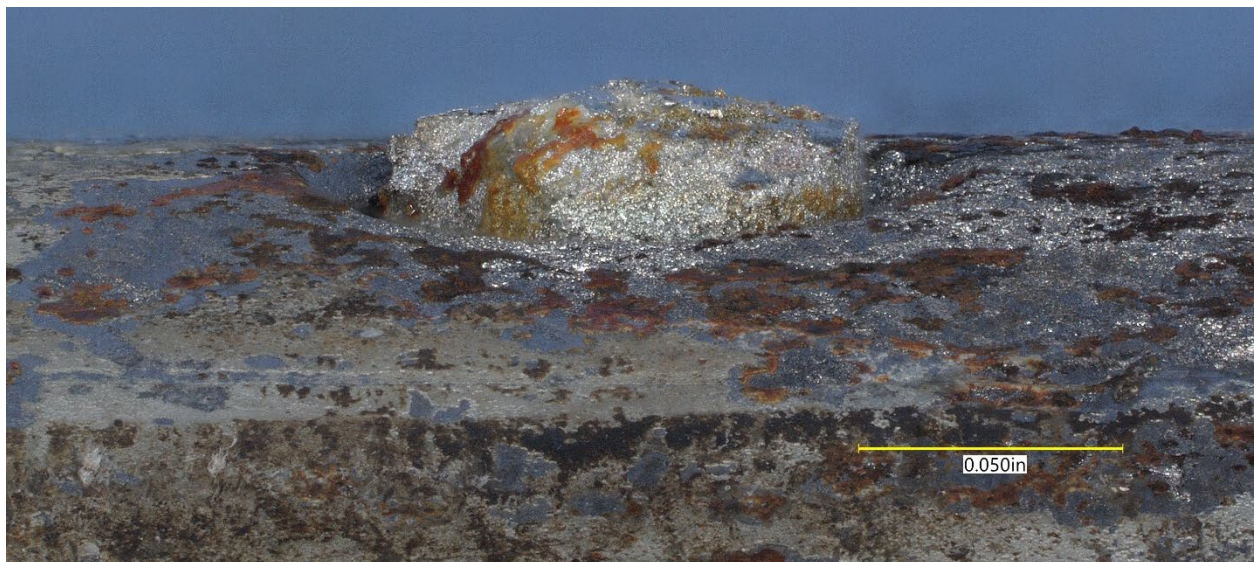
Figure 20 shows a side view of the lower rivet in the stem flange after cleaning. The surfaces of the rivet were jagged and erratic. After sectioning the stem flange to remove the rivets, the lower rivet exhibited areas of corrosion deposits. In addition, the sides of the rivet exhibited areas of missing material (Figure 21). The amount of

Figure 20. Side view of the lower rivet fracture in the valve stem flange, after repeated cleaning iterations.

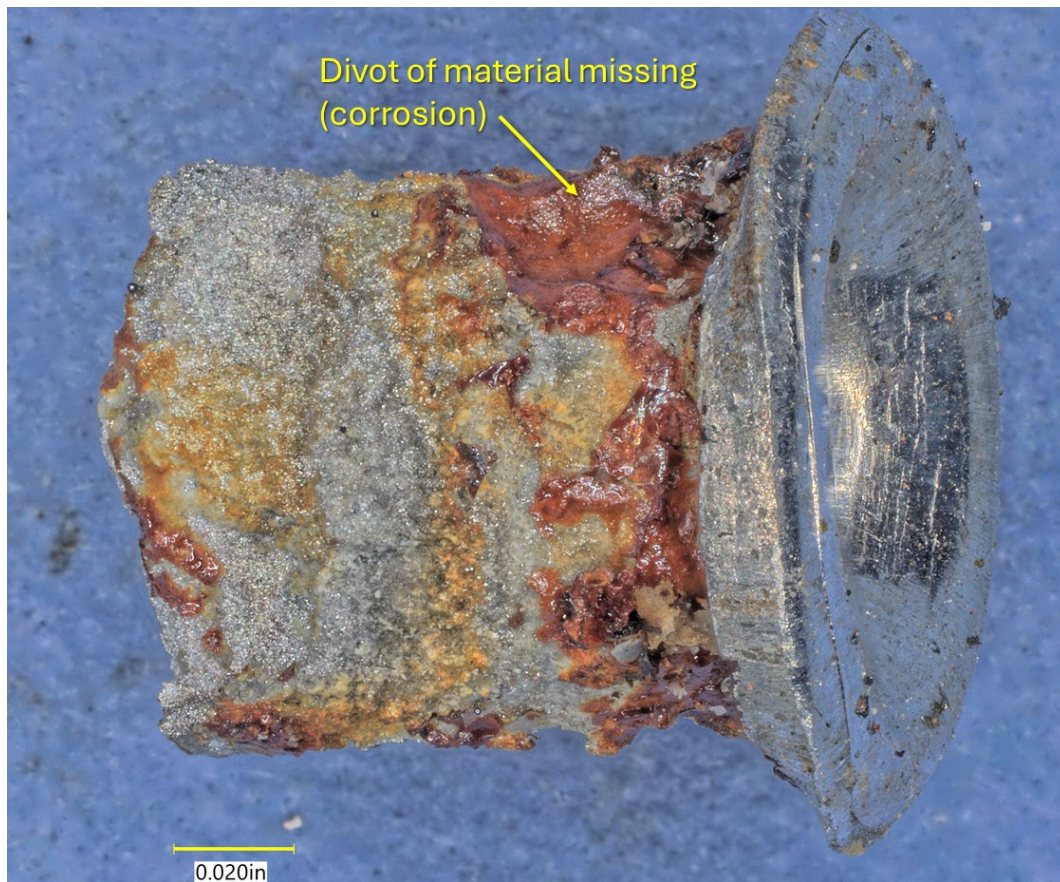
Figure 21. Side view of the lower rivet, after cleaning and removal from the flange.

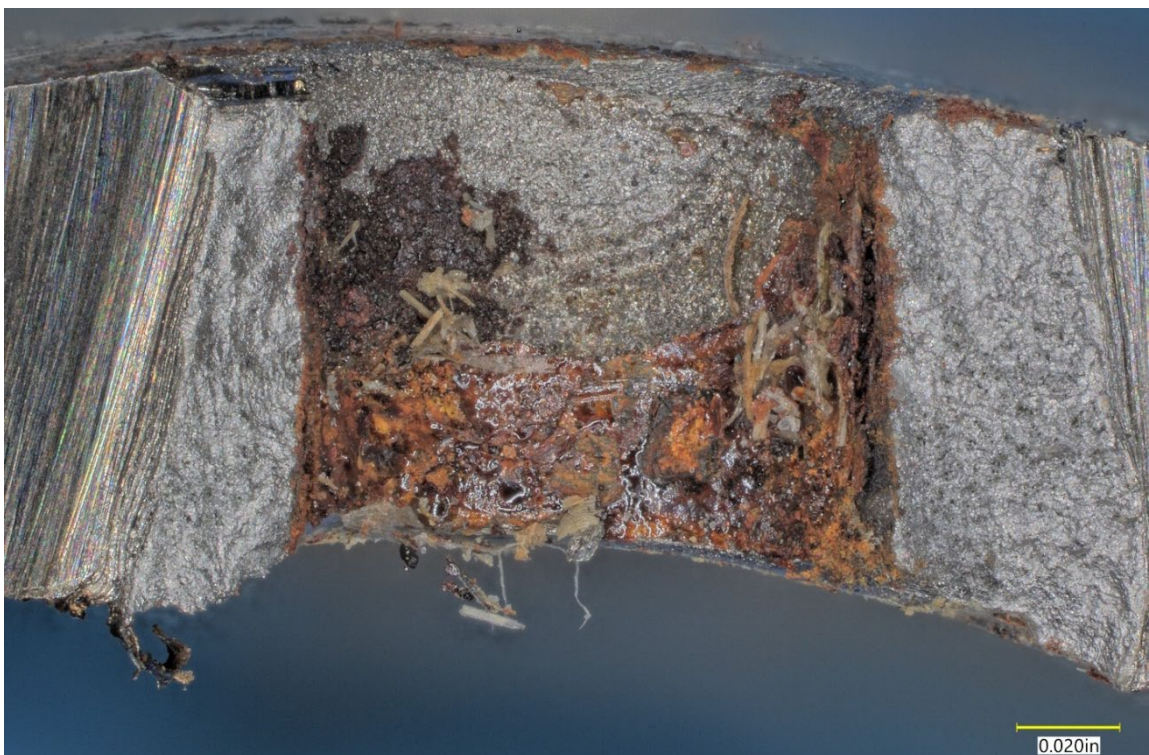
corrosion and missing material corresponded with the corrosion and material deposits on the bore of the mating rivet hole, shown in Figure 23. These features were consistent with corrosive attack and overstress fracture of the lower rivet.

Figure 22. Sectioned and opened rivet hole at the location of the lower rivet.
