ERA24LA251

## INVESTIGATION PHOTOGRAPHS

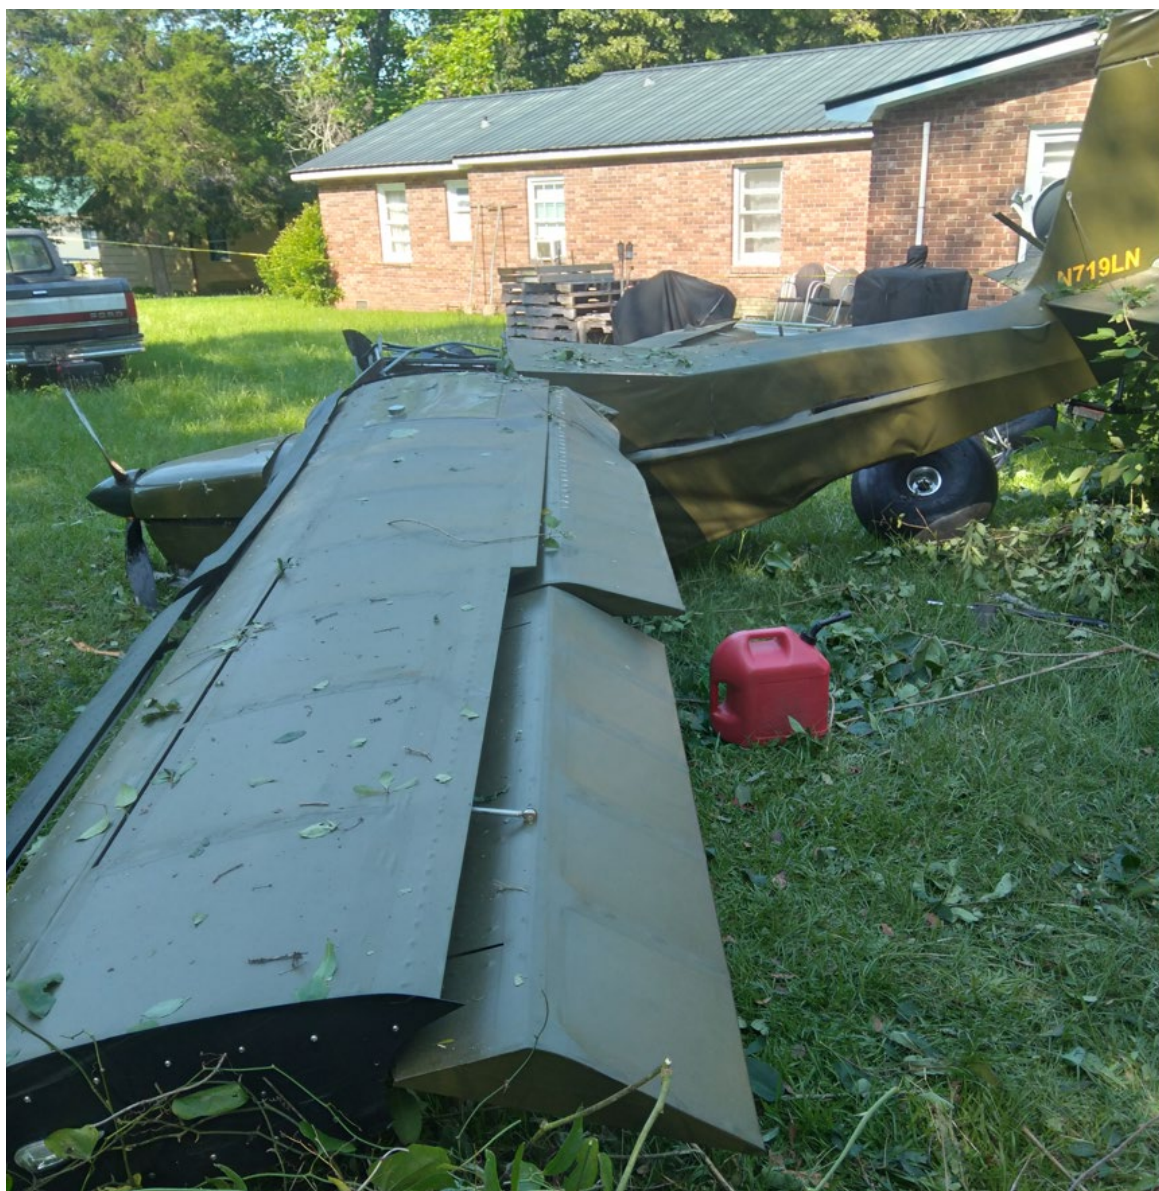
**Photo 1: View of the accident airplane at the accident site (Photo Courtesy of FAA)**

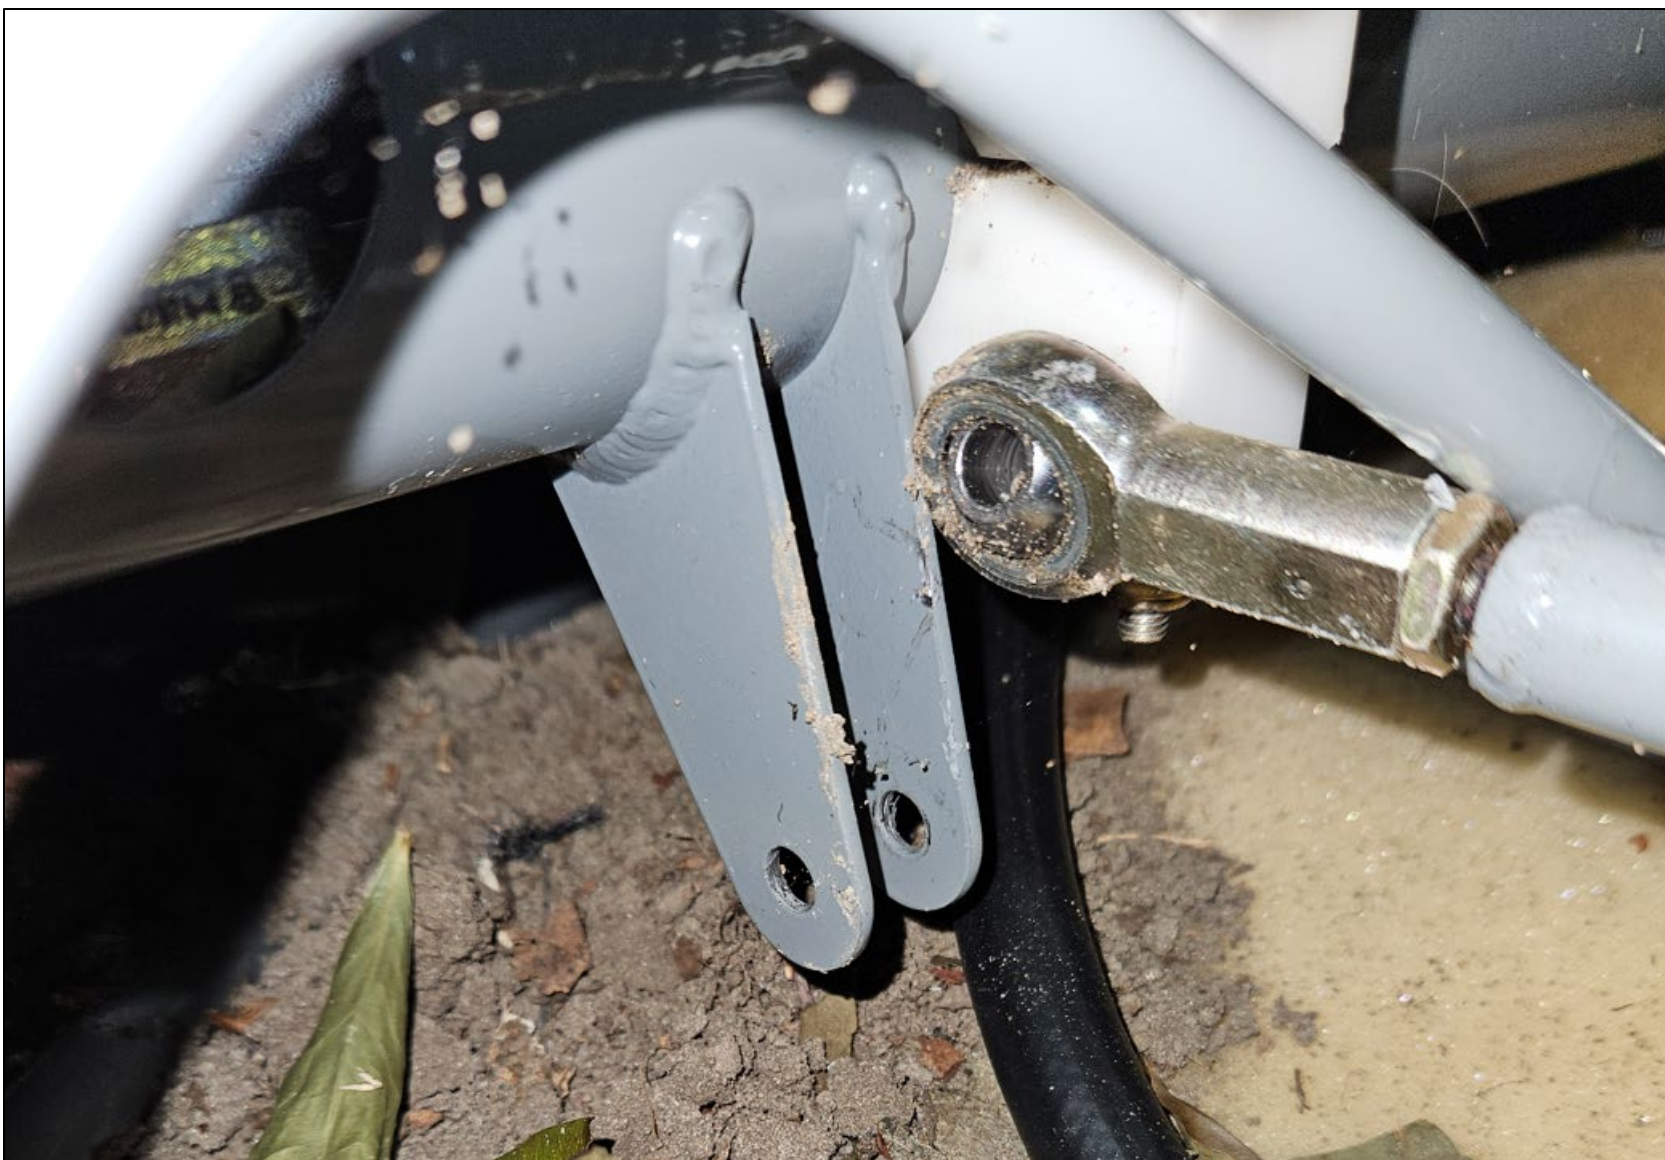
**Photo 2: View of the elevator connecting rod attachment area missing its hardware (Photo Courtesy of FAA)**

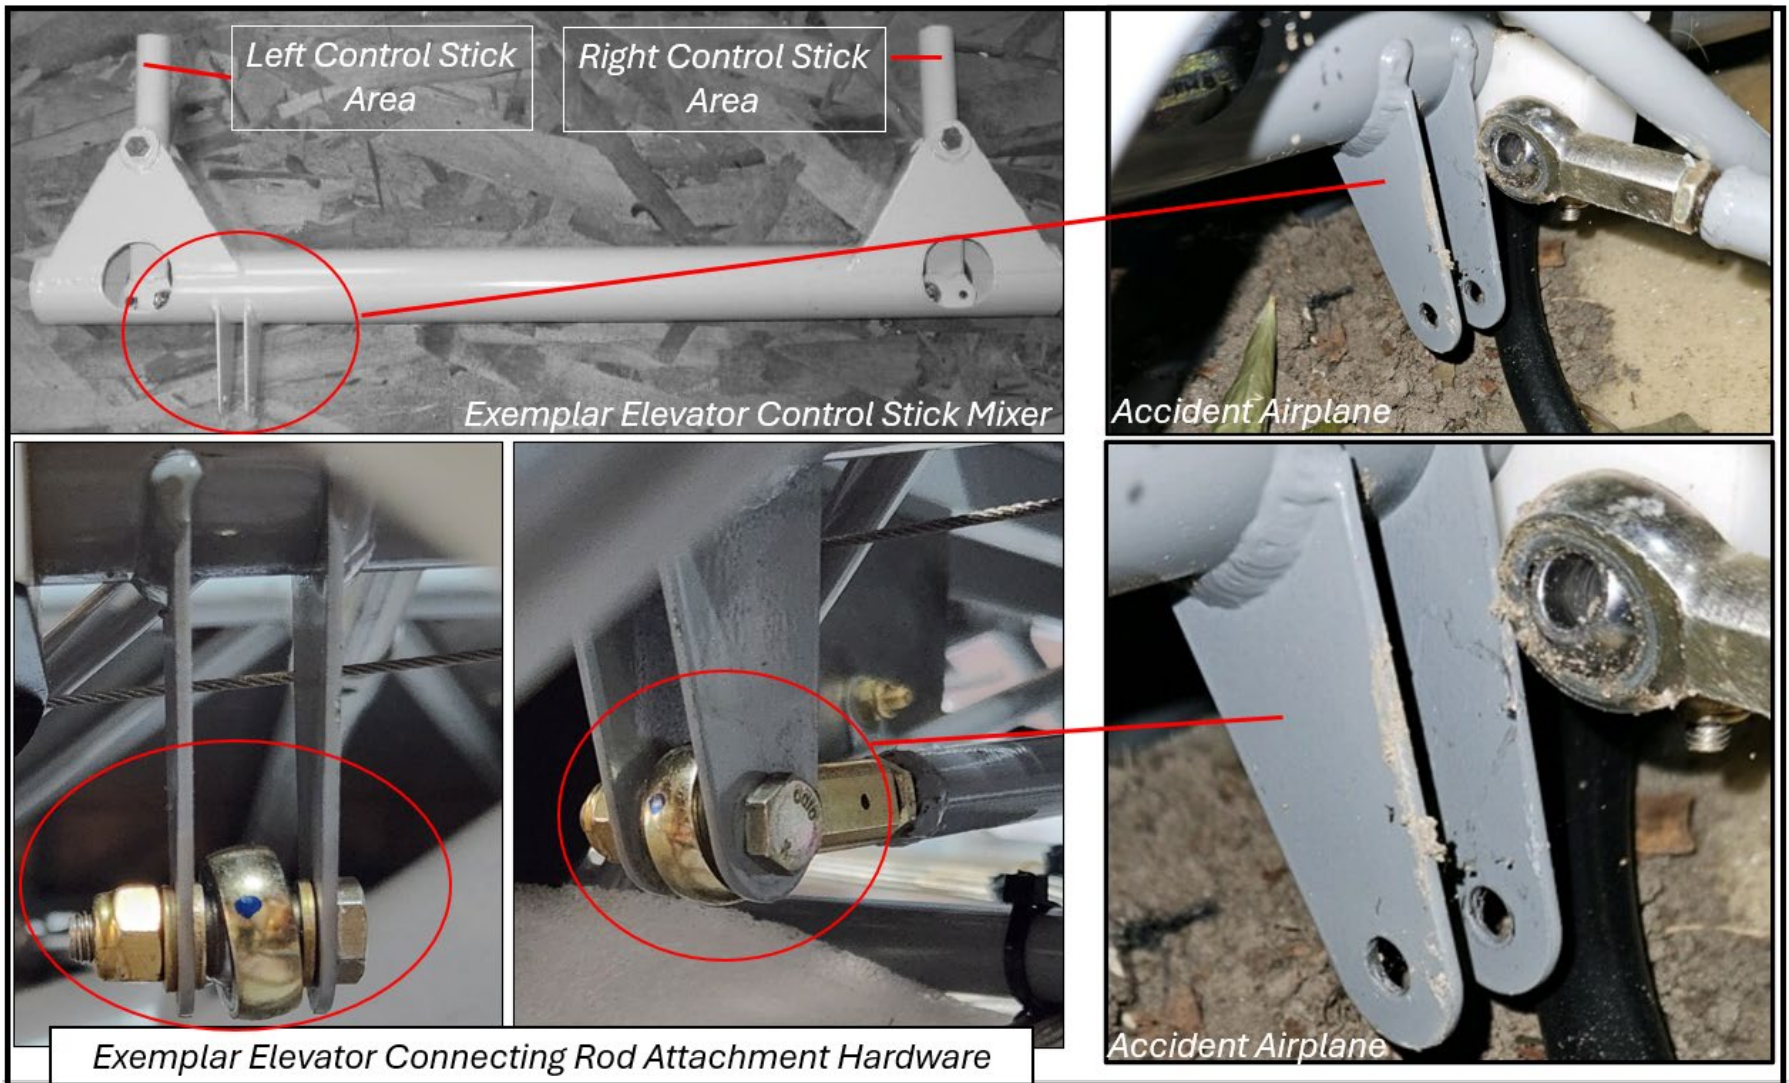
**Photo 3: View of the elevator connecting rod attachment areas, exemplar and accident airplane (Photo Courtesy of FAA & Just Aircraft)**

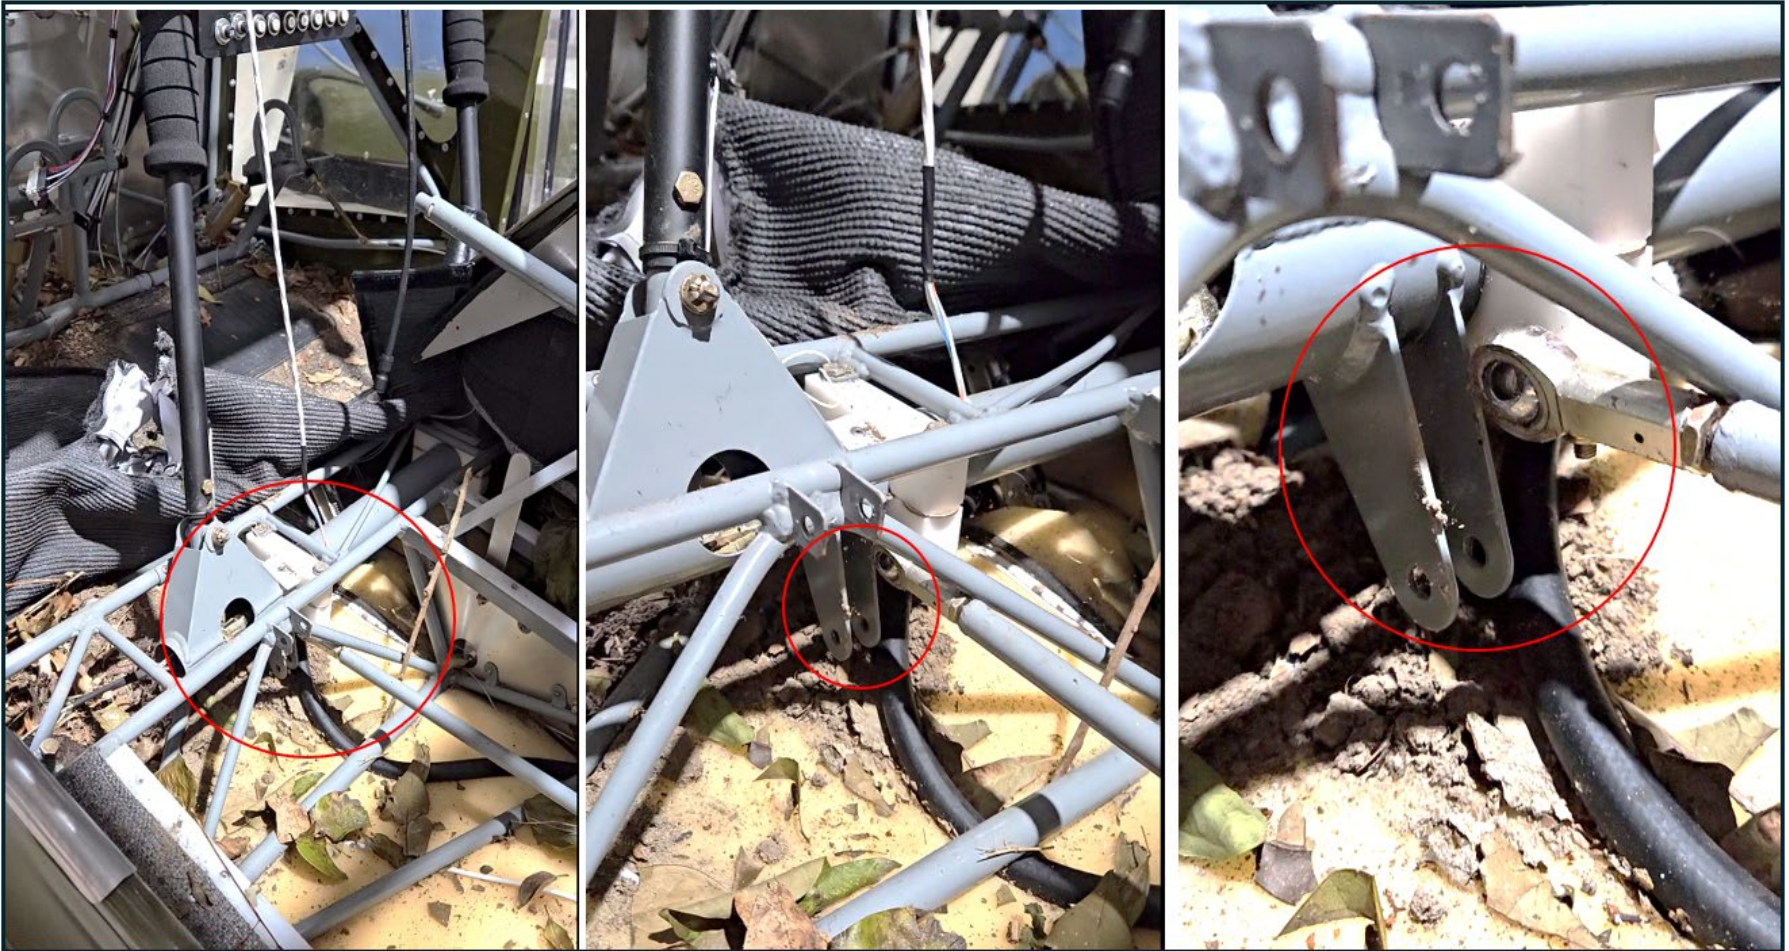
**Photo 4: Additional views of the accident airplane missing its elevator connecting rod hardware (screw and locknut) (Photo Courtesy of FAA)**
