## Inspector Statement for N3304R Accident in Telford, TN

On June 8<sup>th</sup>, 2024, at approximately 1058 local time, N3304R, a Cessna 182 serial number 18258604, while attempting to land at 97TN airport, attempted to perform a missed approach that eventually stalled the aircraft and crashed into a wooded area approximately ¼ mile from the airstrip. Two persons on board were severely injured. The pilot was transported via air evacuation services and the passenger was transported via ambulance.

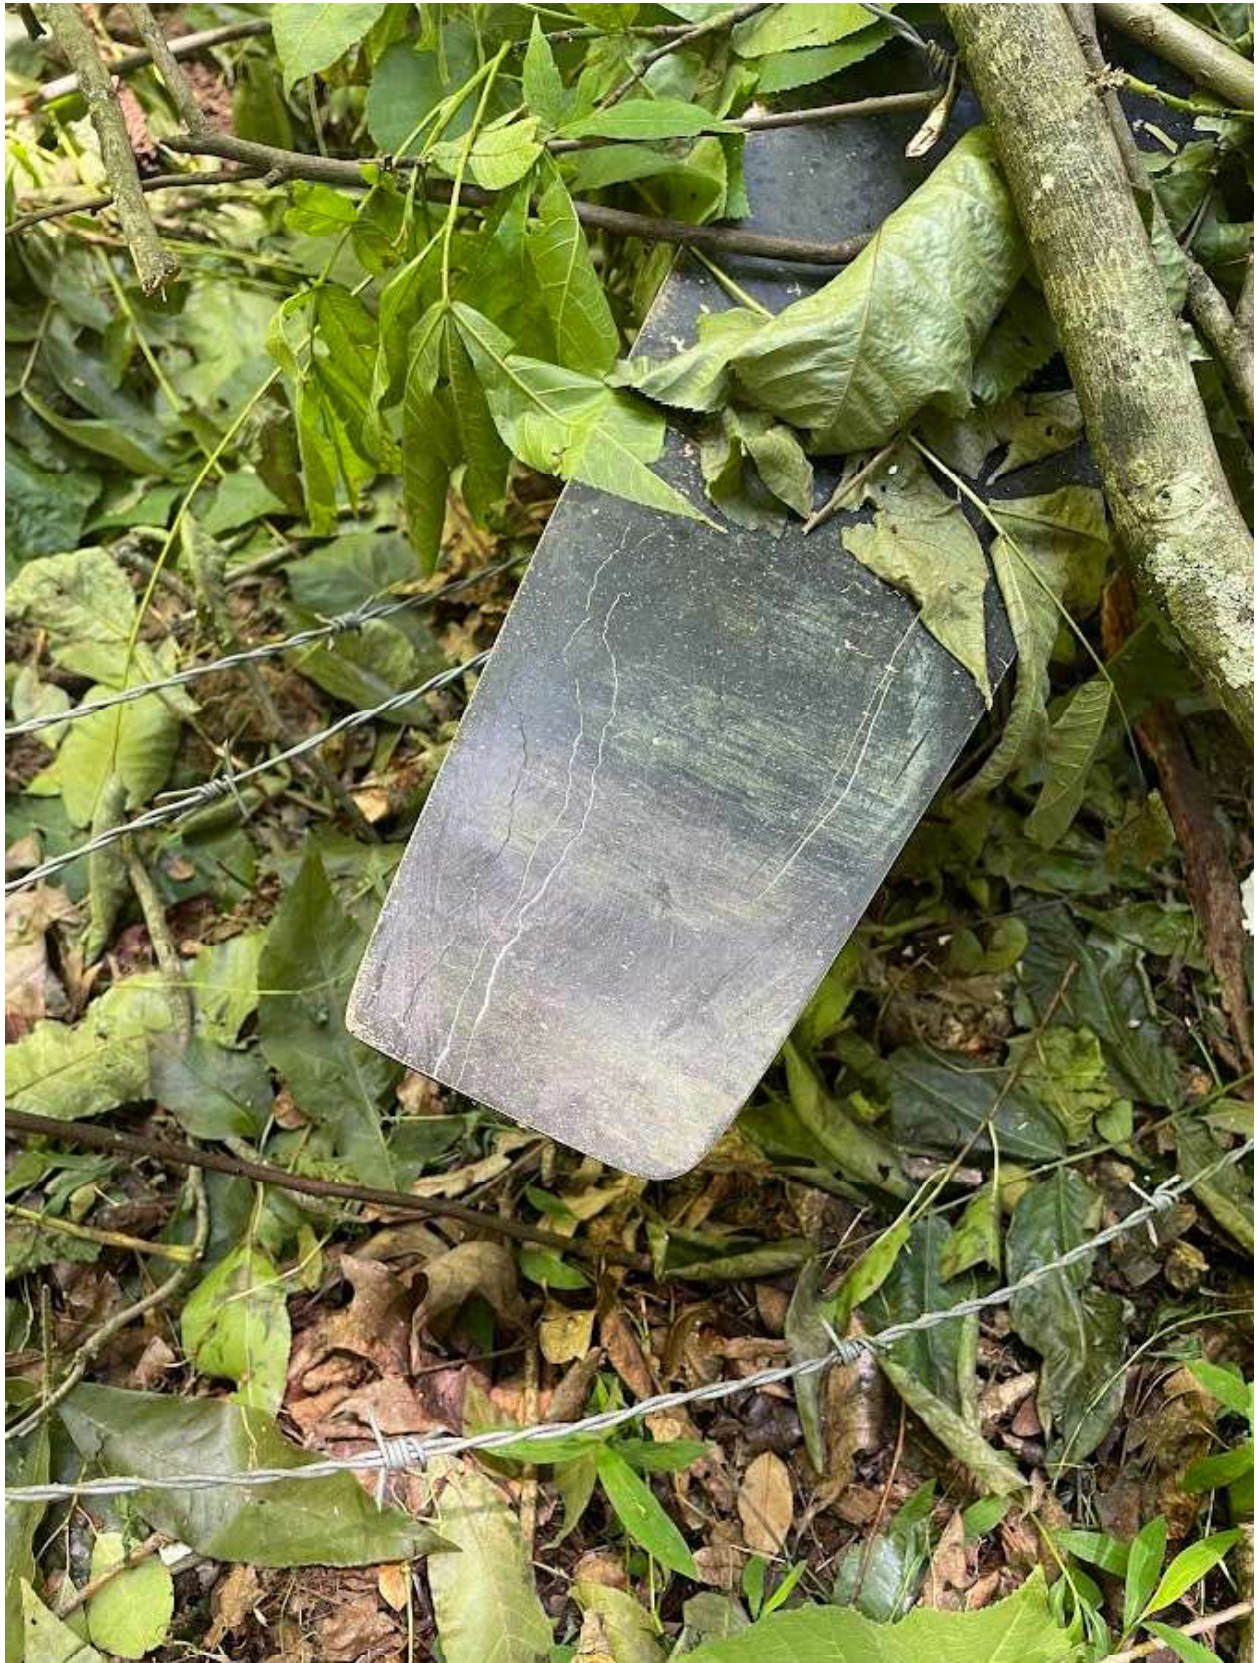
RH side Prop in dirt prior to recovery
