ERA24LA253

## INVESTIGATION PHOTOGRAPHS

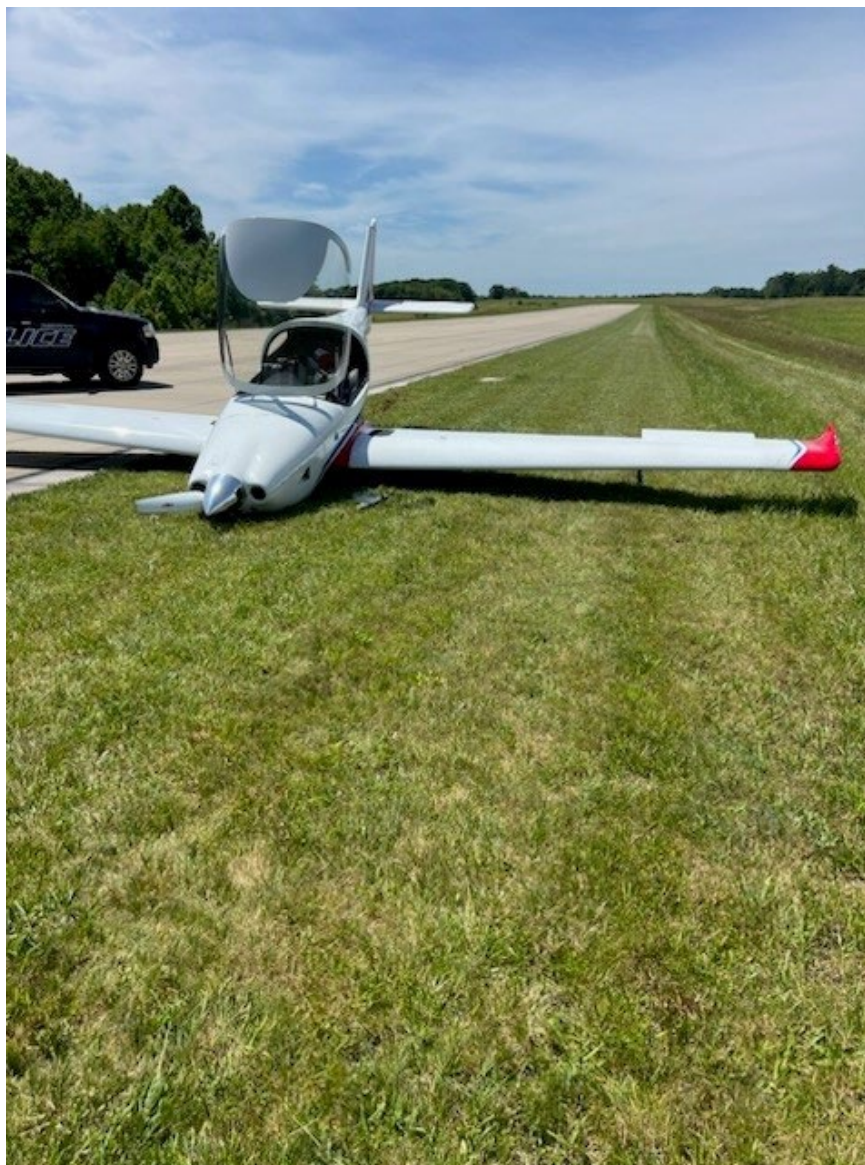
**Photograph 1 - FAA Digital Photograph. Left Forward Quartering View of the Airplane Where it Came to Rest**

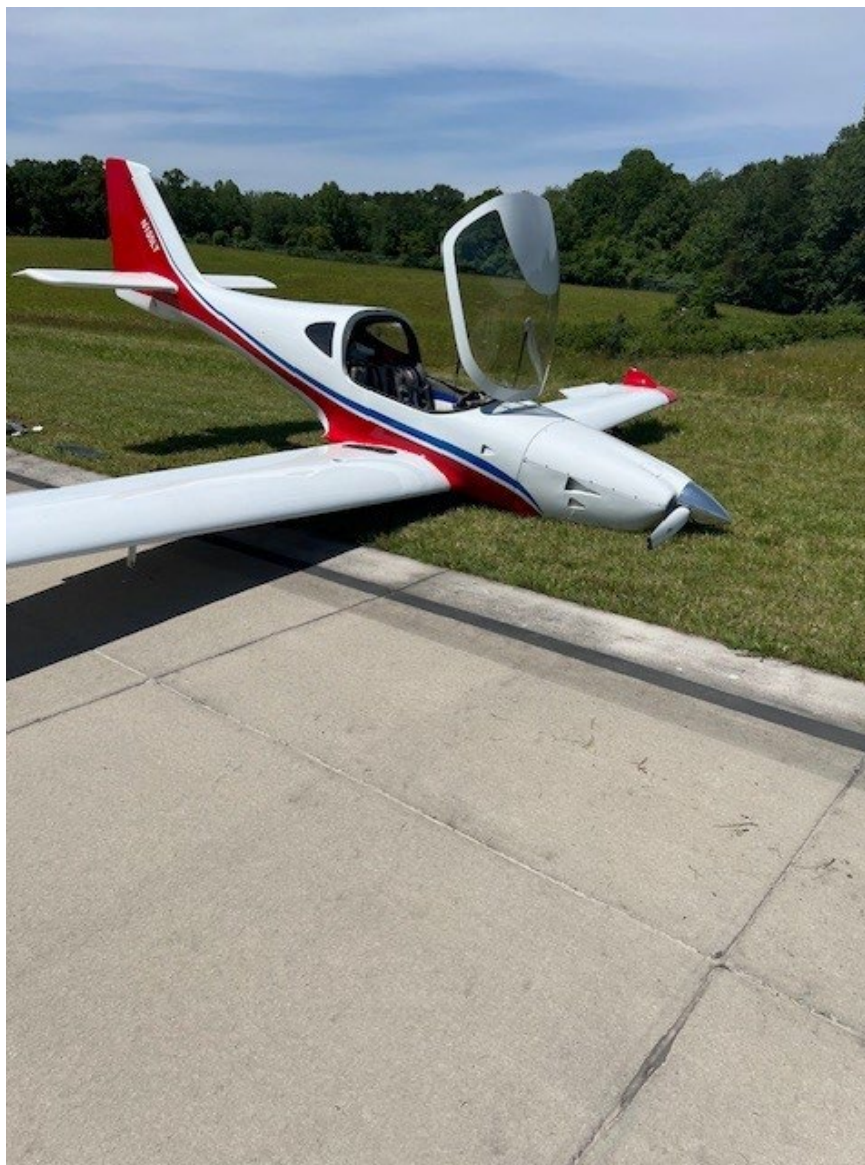
**Photograph 2 - FAA Digital Photograph. Right Forward Quartering View of the Airplane at the Accident Site.**

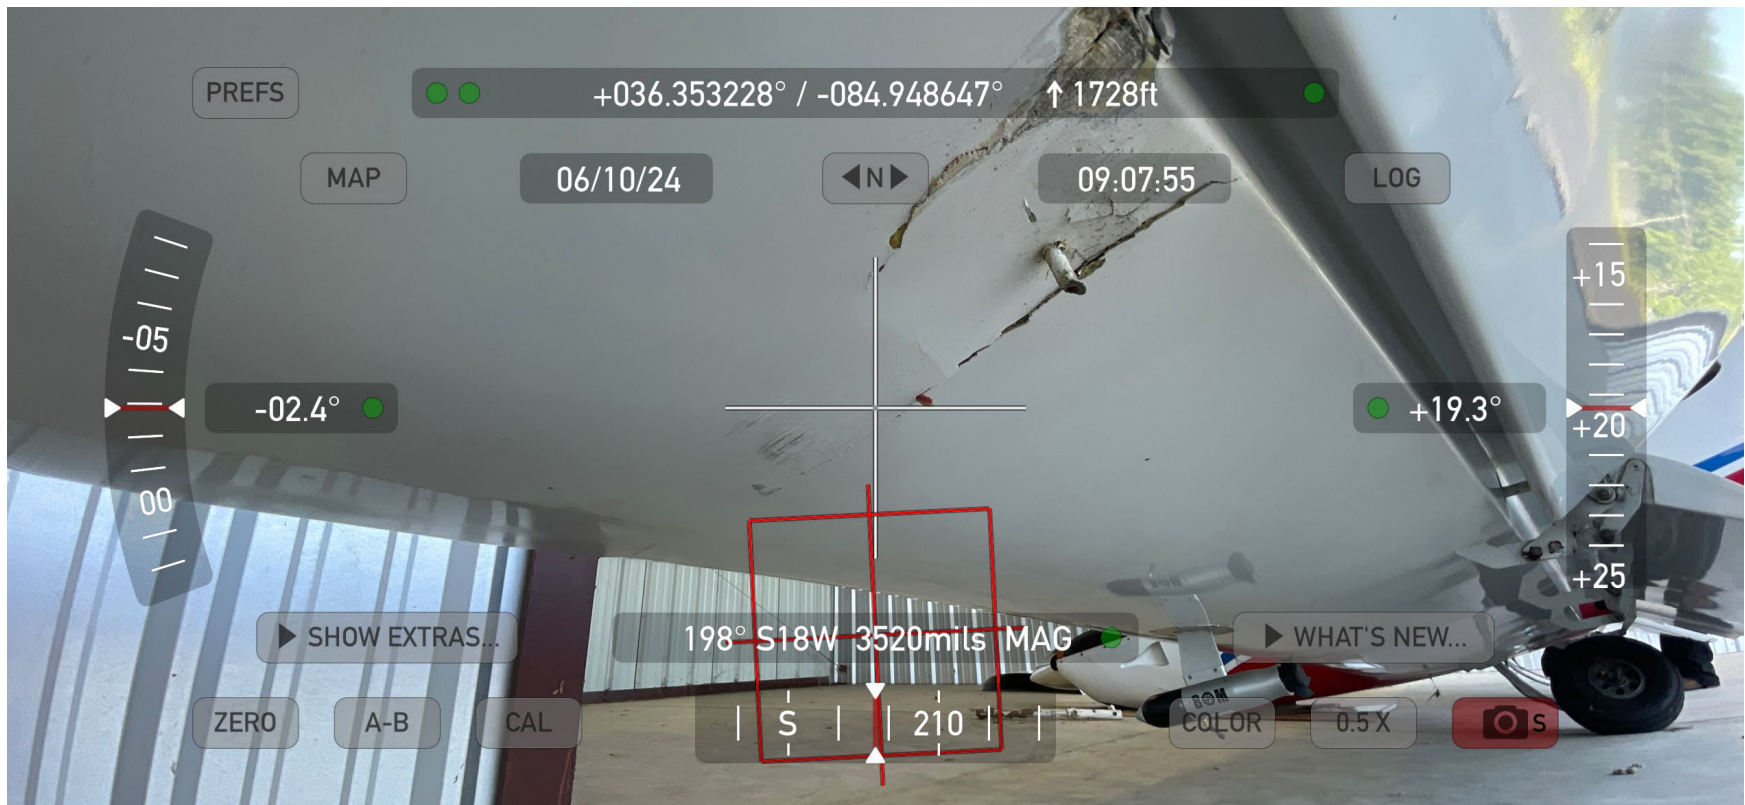
**Photograph 3 - FAA Digital Photograph. View of the Bottom of the Left Wing. Note the Chordwise Cracks in the Lower Wing**

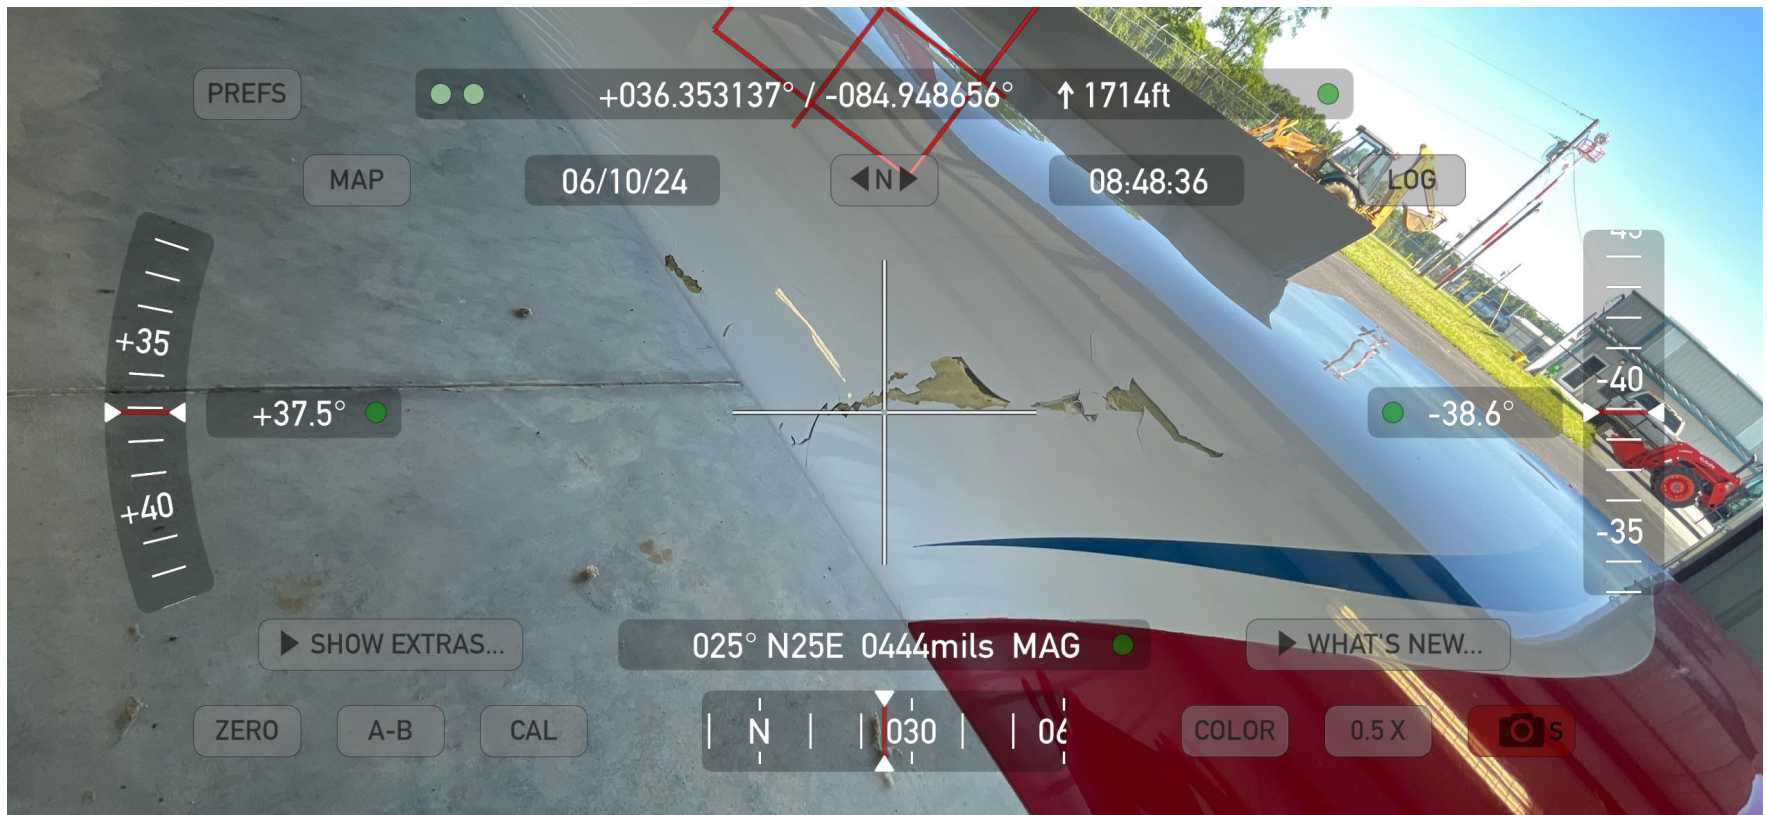
**Photograph 4 - FAA Digital Photograph. View of the Outboard Upper Surface of the Left Wing. Note the Cracks**

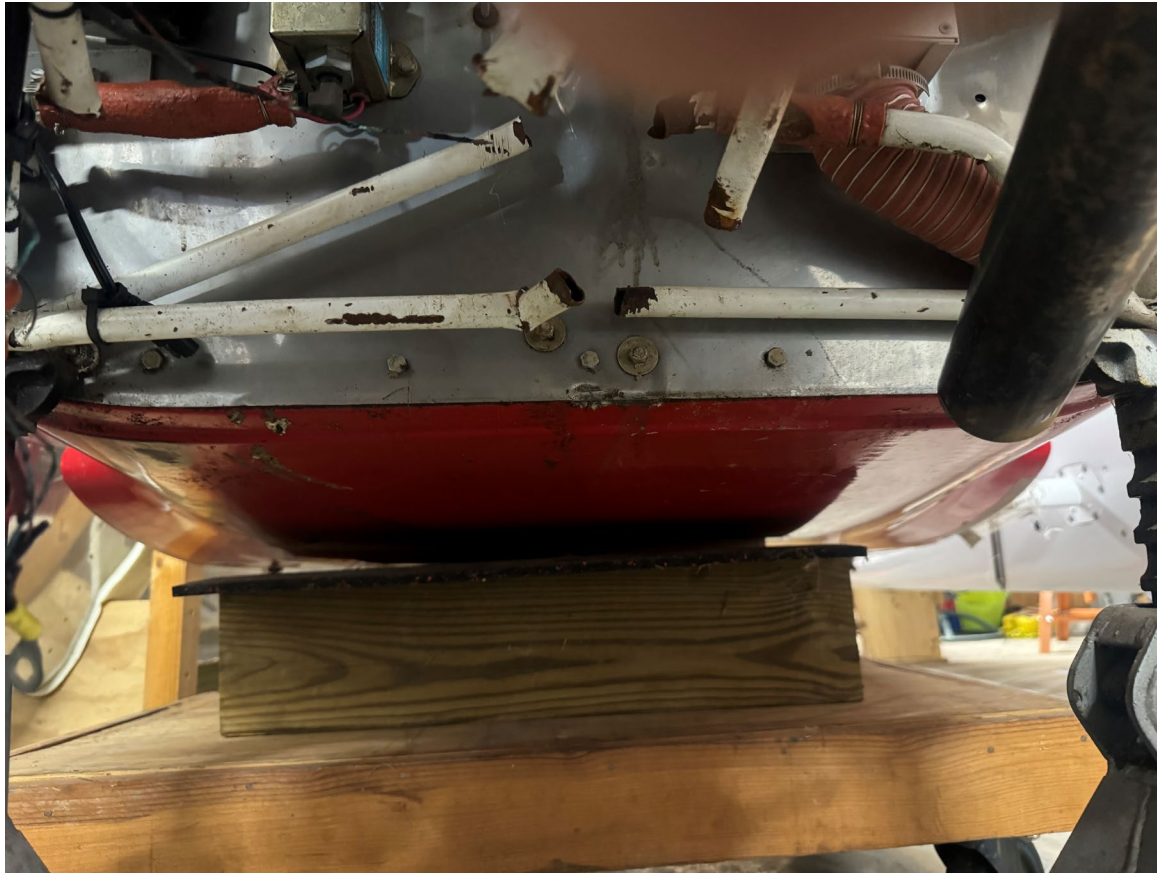
**Photograph 5 - Digital Photograph From New Owner. View Showing the Broken Engine Mount Tubes**
