# National Transportation Safety Board

ERA24LA255

## **MATERIALS LABORATORY**

Factual Report 25-002

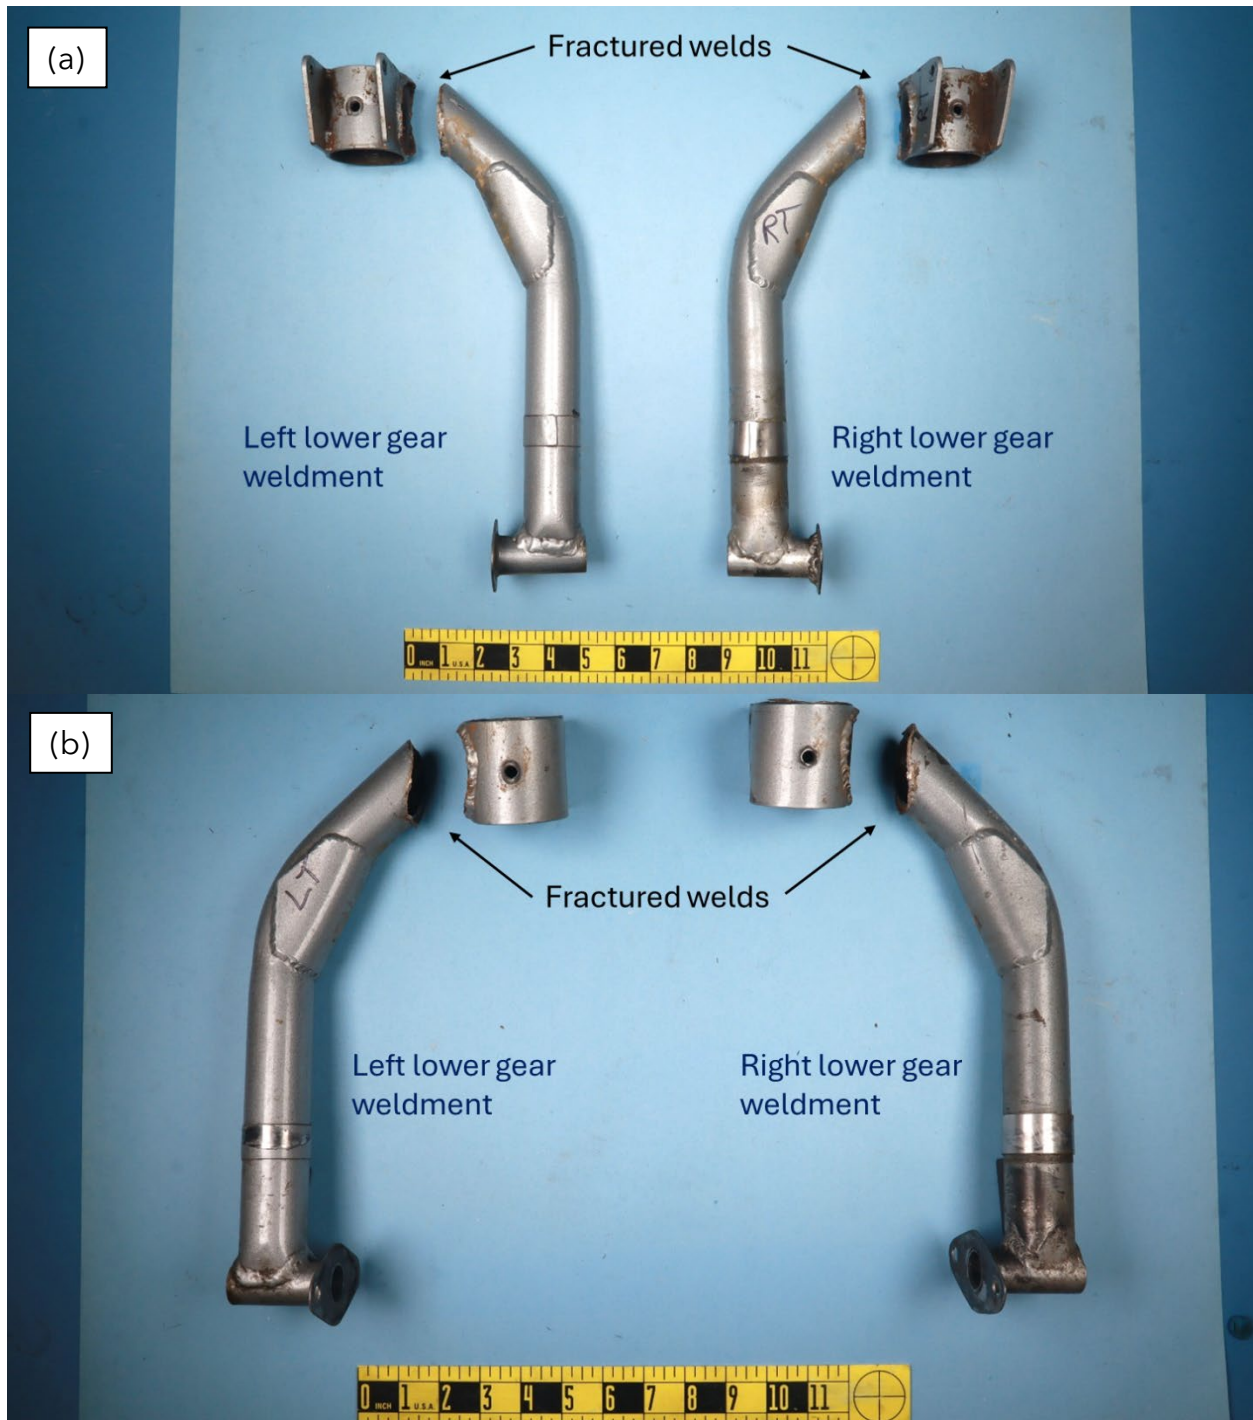
Figure 1 shows the remnants of the lower gear weldments, one from each side of the airplane (right and left). Both had fractured at the upper welds, connecting the legs to the upper sleeves. As shown in Figure 2, the oval fractures at the welds were consistent with the shape of the legs at this location. One area on the right landing gear leg exhibited features consistent with fatigue crack propagation, as detailed below.

Figure 1. The (a) forward and (b) aft views of the landing gear remnants, as received.

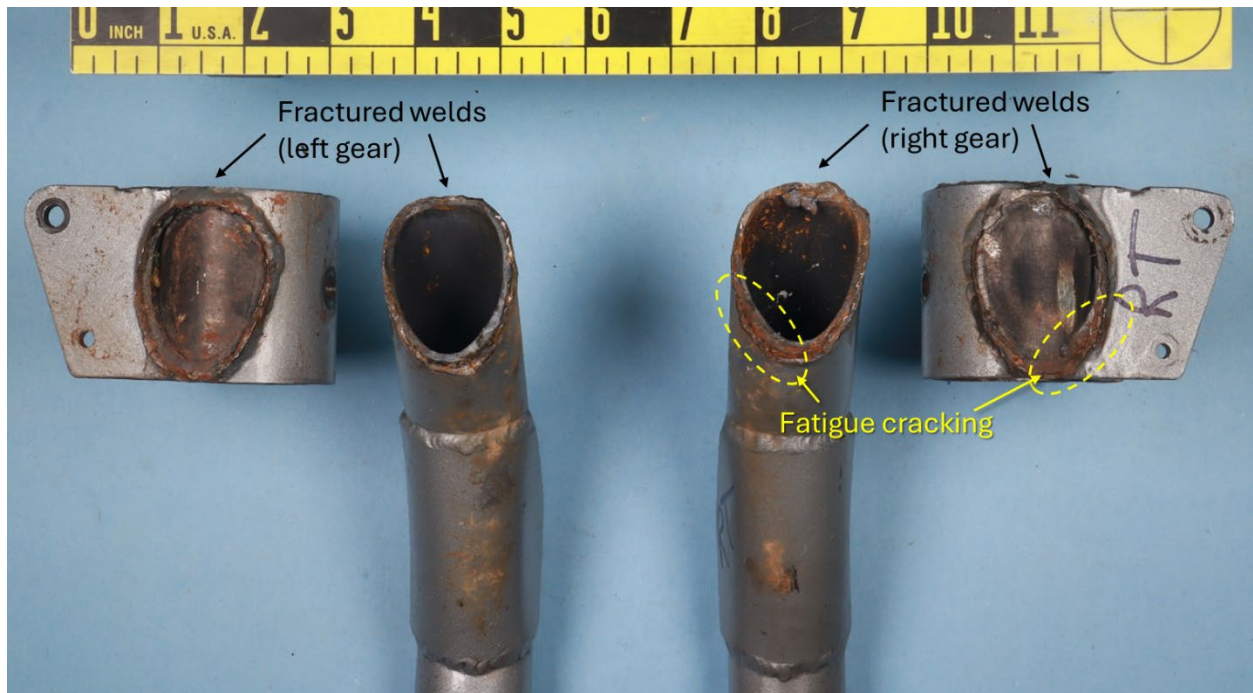
Figure 2. Views of the fracture surfaces of the legs at the weld with the strut sleeves.

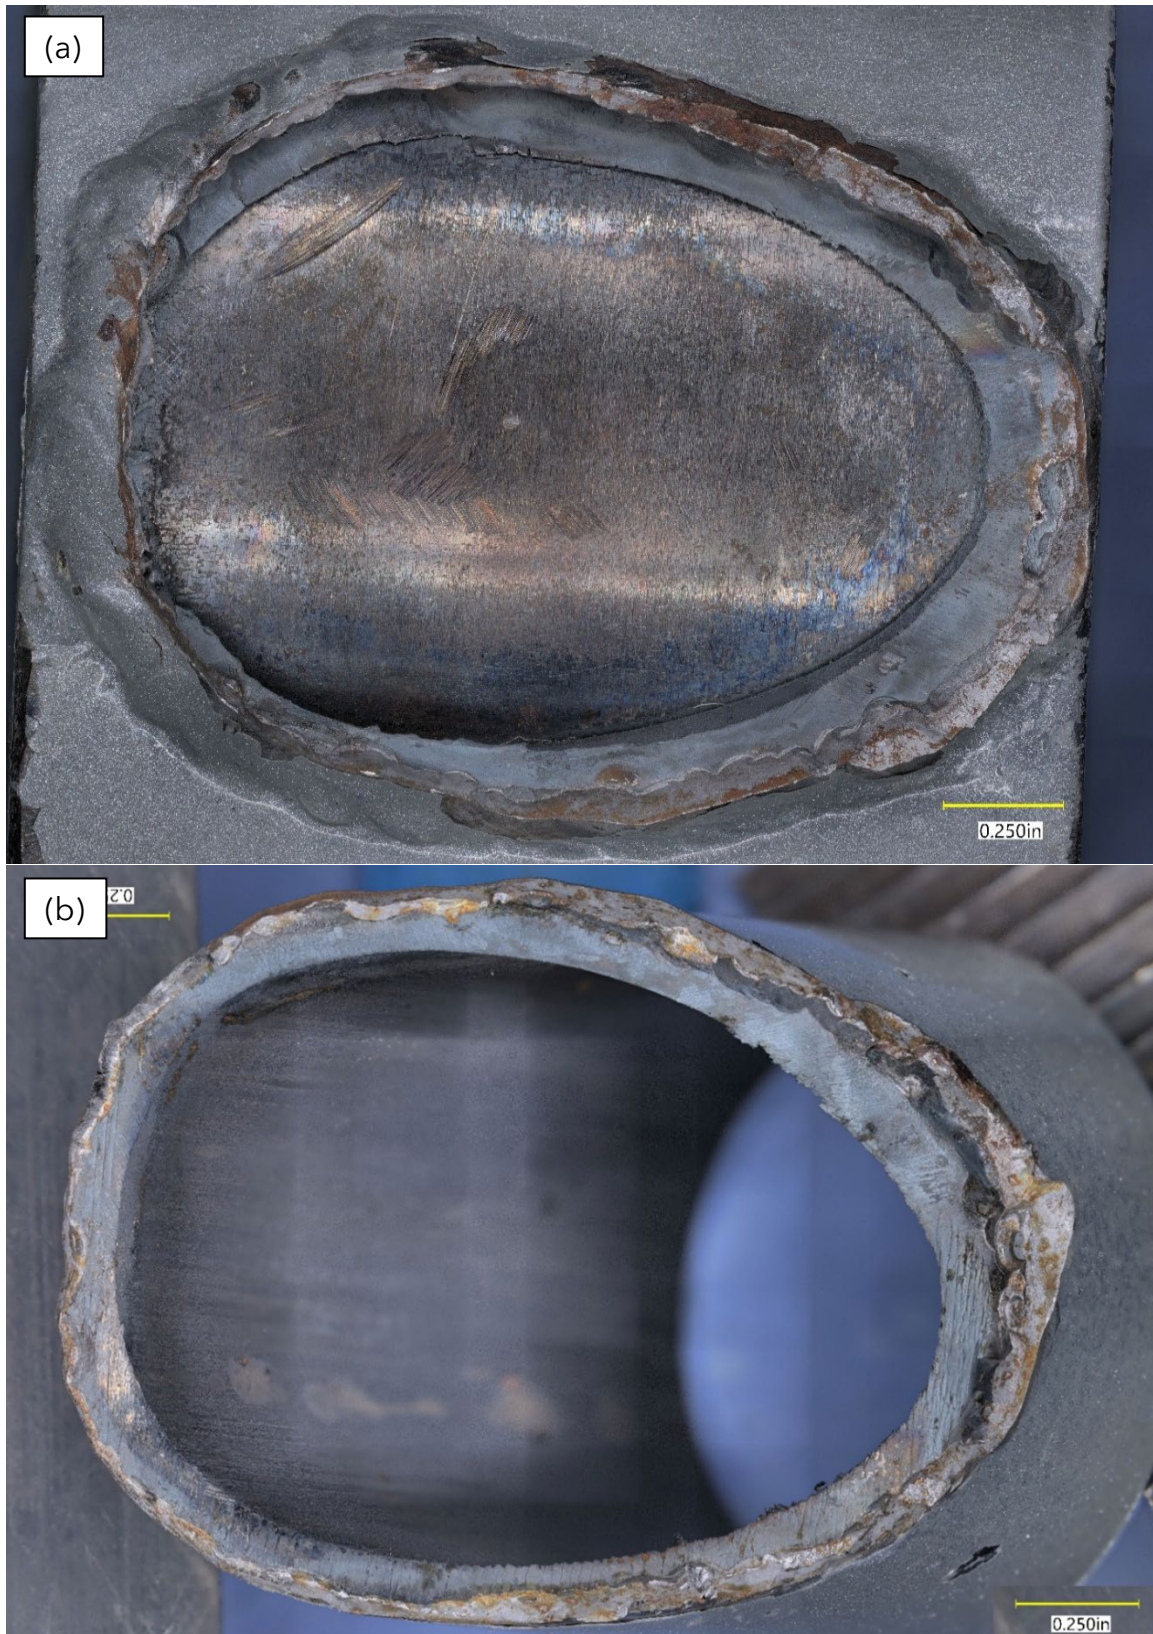
Figure 3 shows the mating sides of the left gear fracture surfaces from the left gear weldment after cleaning in an ultrasonic bath with acetone. The leg side was sectioned about 2 inches from the fracture surface. There was some visible porosity in part of the weld, particularly on the right side of Figure 3. The fracture surfaces were within the weld filler and did not exhibit features consistent with fractures in either the sleeve or leg tube.

Figure 3. The fractured weld of the left gear, from (a) the sleeve and (b) the leg sides.

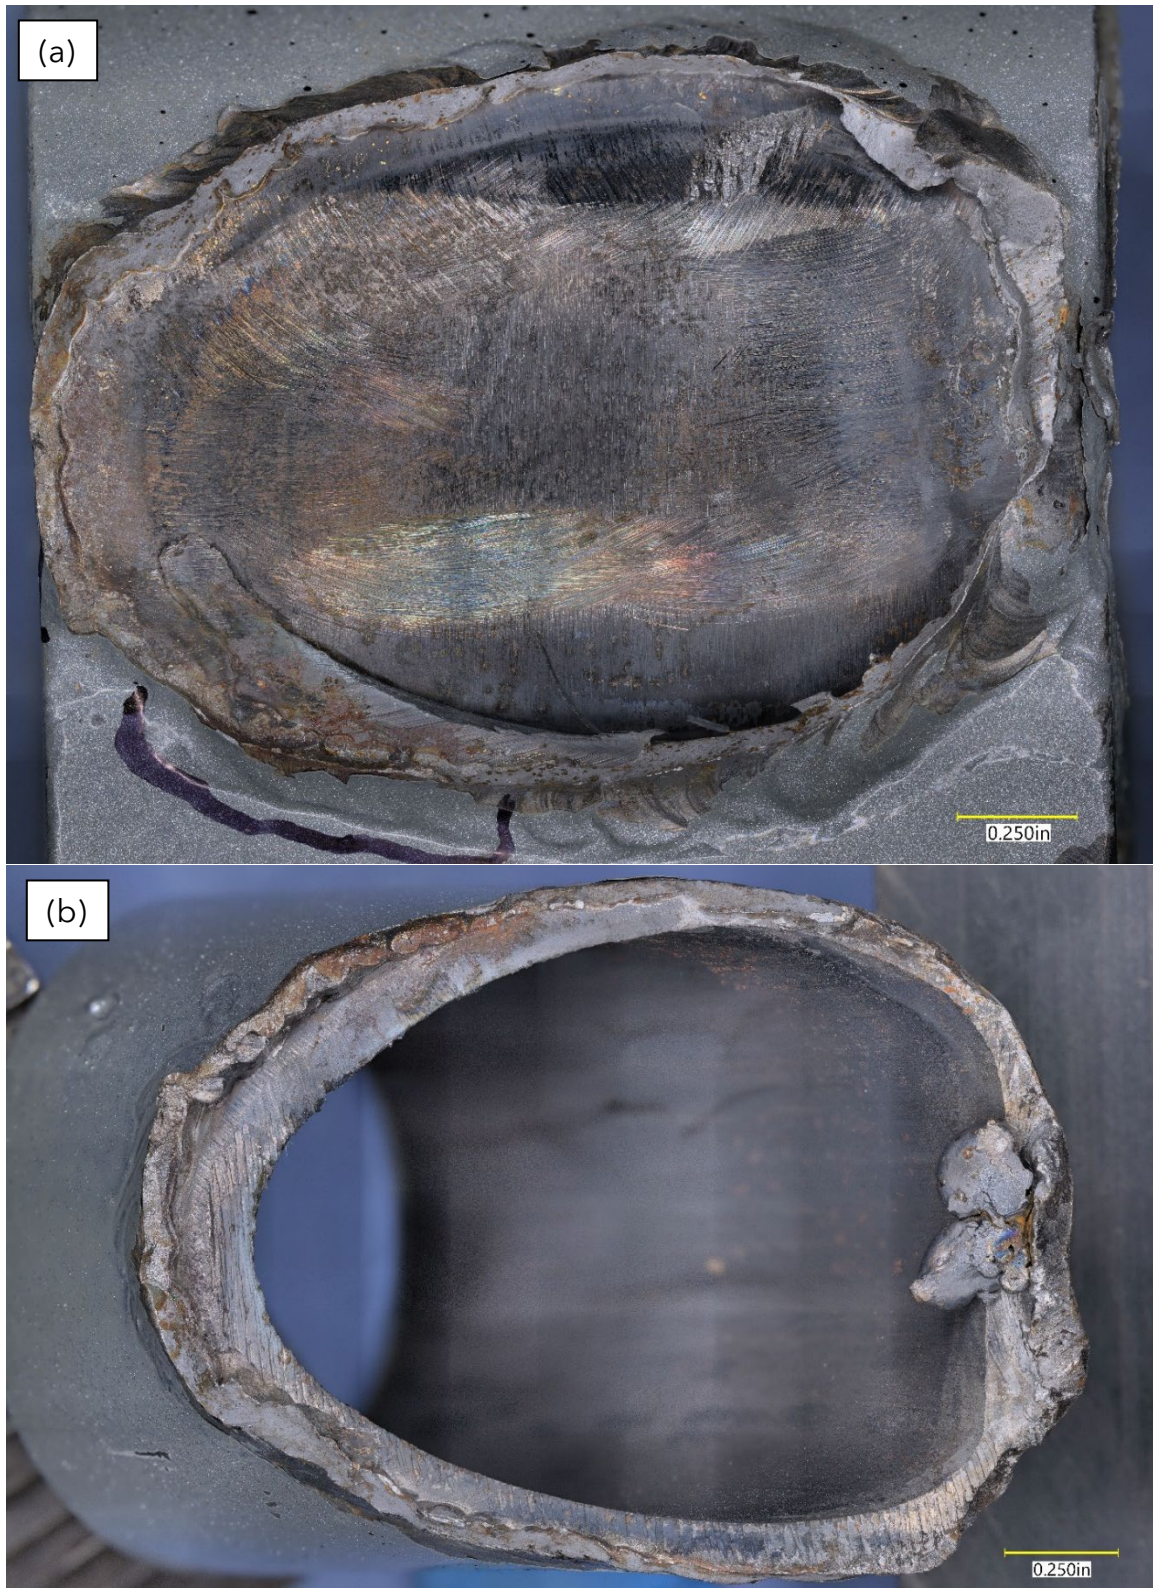
Similarly, the right landing gear leg weldment fractures, shown in Figure 4 after cleaning, also exhibited features consistent with the fracture located in the weld filler. The faces of the leg tube and sleeve exhibited parallel and erratic marks consistent with pre-weld grinding operations. On both mating surfaces of each fractured leg, there were areas of fractured weld material on top of the bare machined tube or sleeve surfaces.

Almost all of the fracture surfaces of the left gear weldment exhibited features consistent with overstress fracture. However, much of the right side of the fracture surface of this weldment (as positioned in Figure 4) had been obliterated by smearing. There were three small areas of thumbnail cracks, as illustrated in Figure 12. These areas exhibited fatigue striations when examined using an SEM. However, they were no longer than 0.05 inches in length.

Figure 4. The fractured weld of the right gear, from (a) the sleeve and (b) the leg sides.

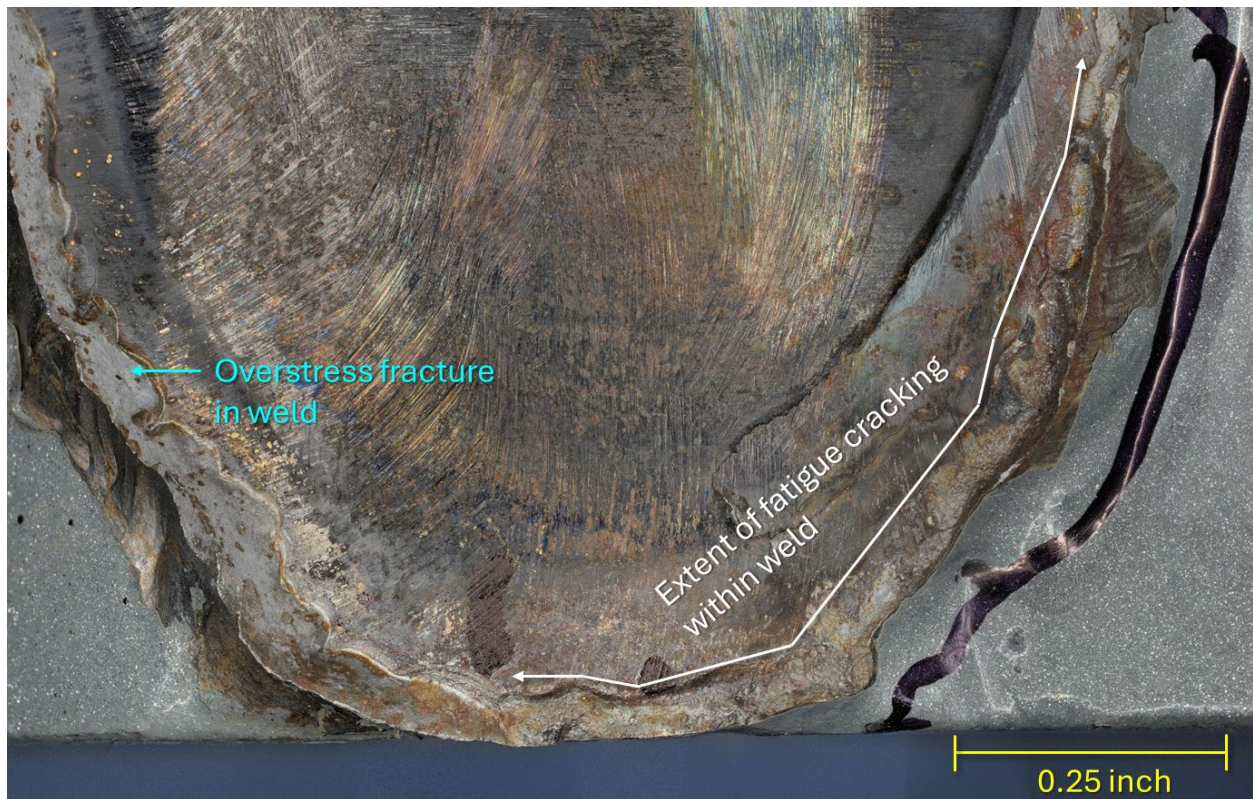
The right lower gear weldment fractured during landing from fatigue cracking that had initiated at multiple locations on the outer surface of the weld. The fatigue cracking propagated through the weld filler up to approximately 1.6 inches in circumference. The remainder of the fracture surface exhibited features consistent with overstress. The tailwheel link, which was also broken, fractured from tensile overstress.

Figure 5 shows a closer view of the portion of the weld that was positioned on the right side of Figure 3a. A part of the fracture surface exhibited a flatter morphology with a darker but more reflective luster. This area exhibited crack arrest marks, consistent with progressive cracking, later determined to be fatigue crack propagation. The circumferential length of this region, annotated in Figure 5, was 1.63 inches (41.5 mm) as measured using digital calipers.

Figure 5. Closer view of the fatigue cracking (demarcated by the white line) from the fractured weld on the right landing gear sleeve.

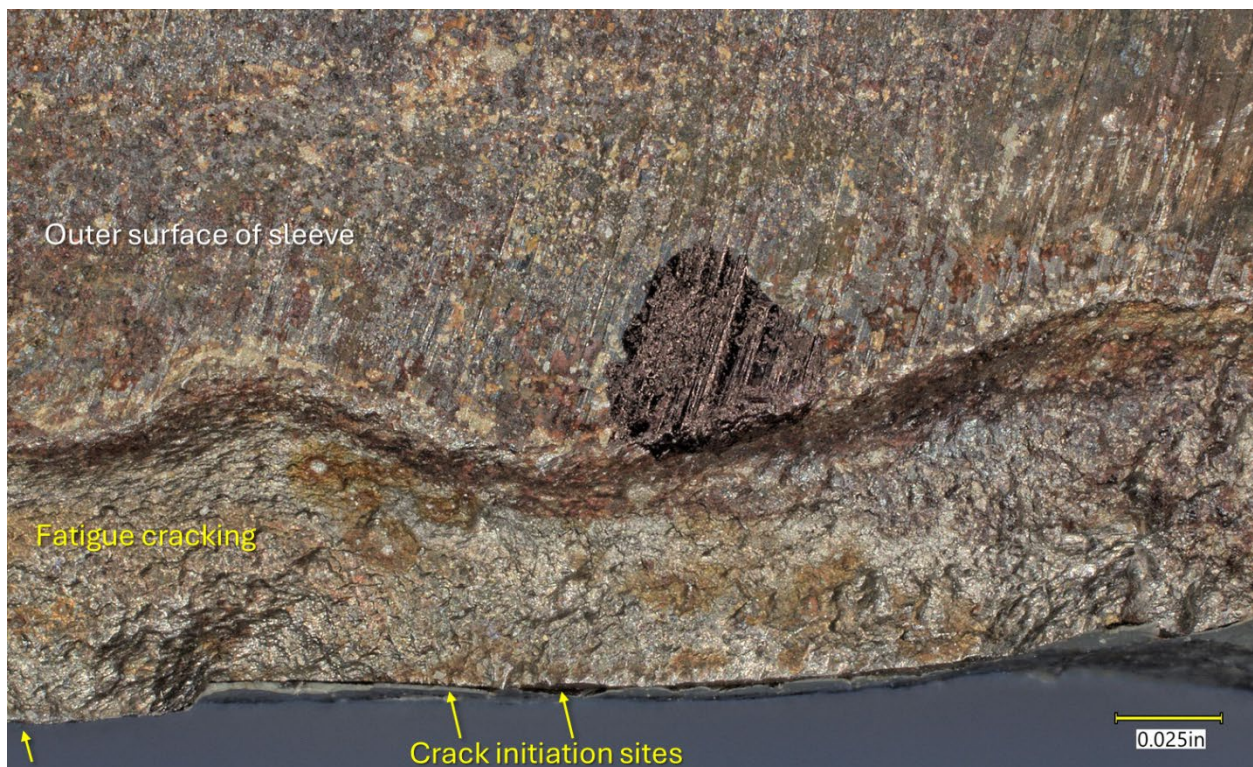
The fatigue cracking exhibited ratchet marks indicative of multiple crack initiation sites, as demonstrated in Figure 6. In all cases, the crack initiation sites were located on the outer surface of the weld.

Figure 6. Crack initiation sites of the fatigue crack from the lower portion of Figure 5.

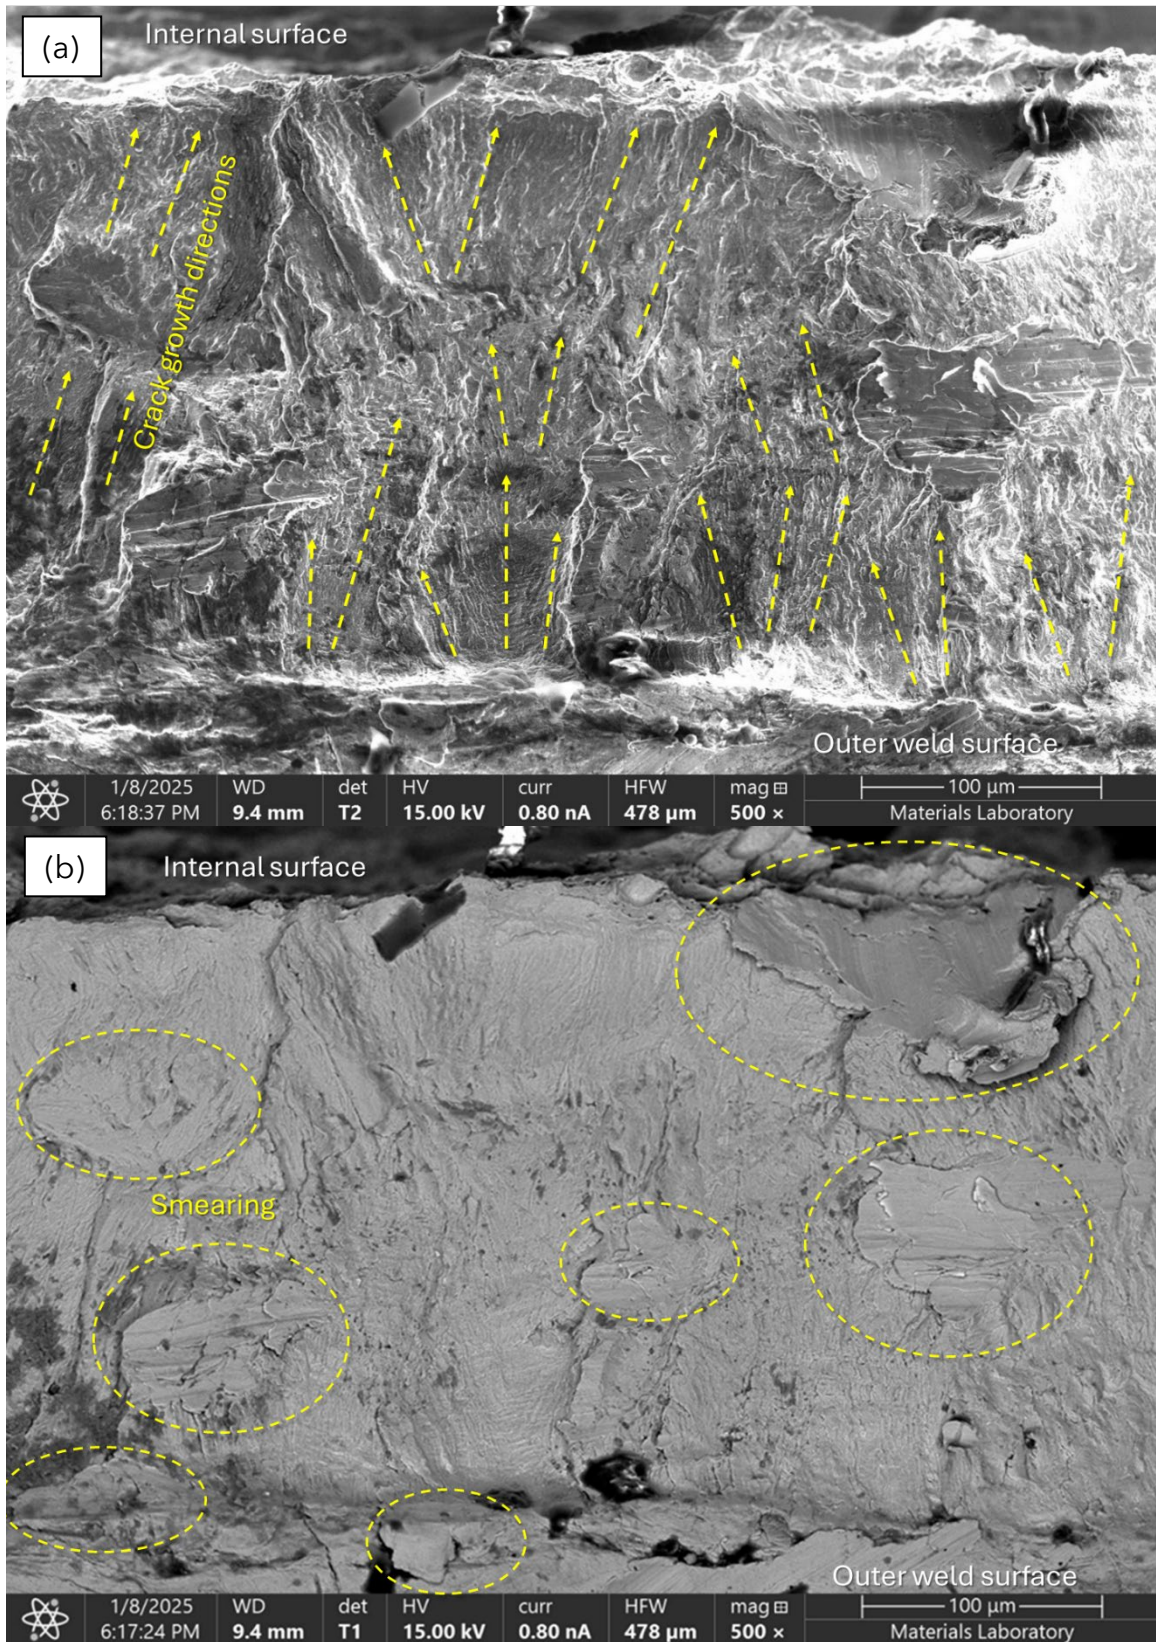
The mating fracture surfaces of the right weldment were examined using a field emission scanning electron microscope (SEM). A typical area of the fatigue cracking is shown in Figure 7. This part of the fracture surface exhibited striations, consistent with fatigue crack propagation. The direction of the striations was from the outer surface towards the inner surface. There were multiple regions with post-fracture damage, as indicated by areas of smearing annotated in Figure 7b. Figure 8 shows a closer view of the striations and the larger-spaced crack arrest marks.

Figure 7. Secondary electron (SE) and backscattered (BE) micrographs of an area of the right leg weld fracture with fatigue cracking.

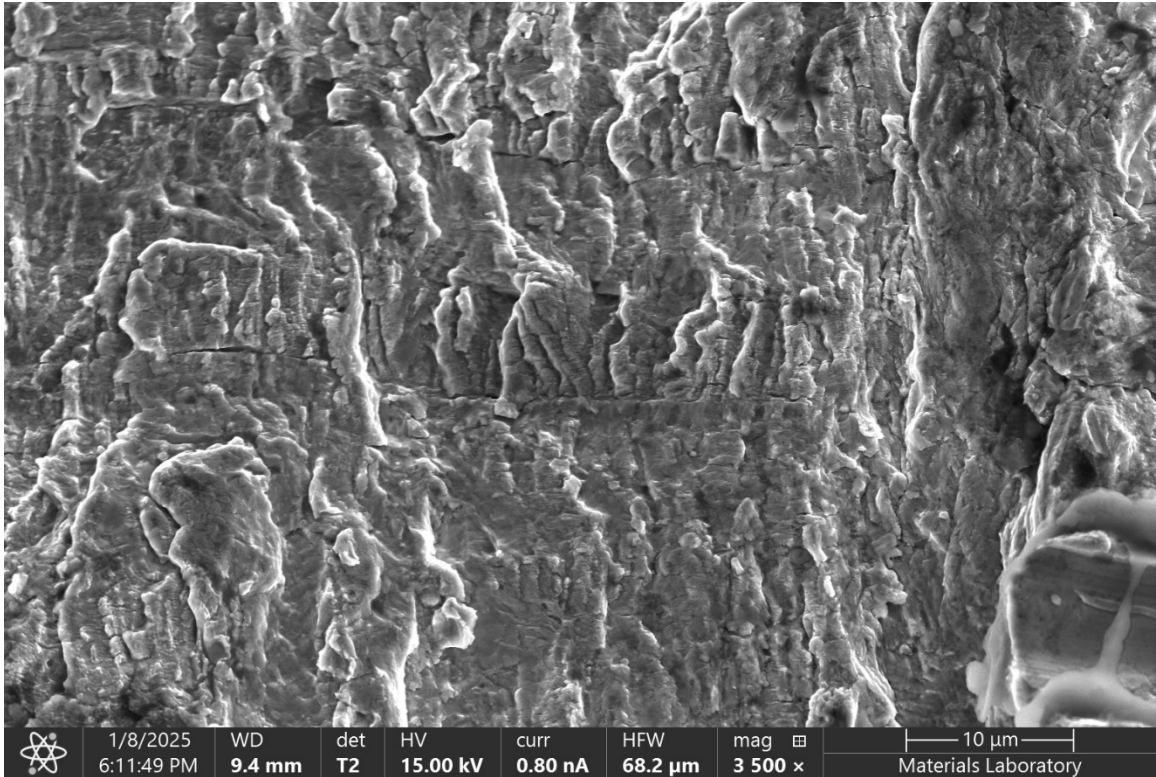
Figure 8. SE micrograph of fatigue striations on the right leg weld fracture surface.

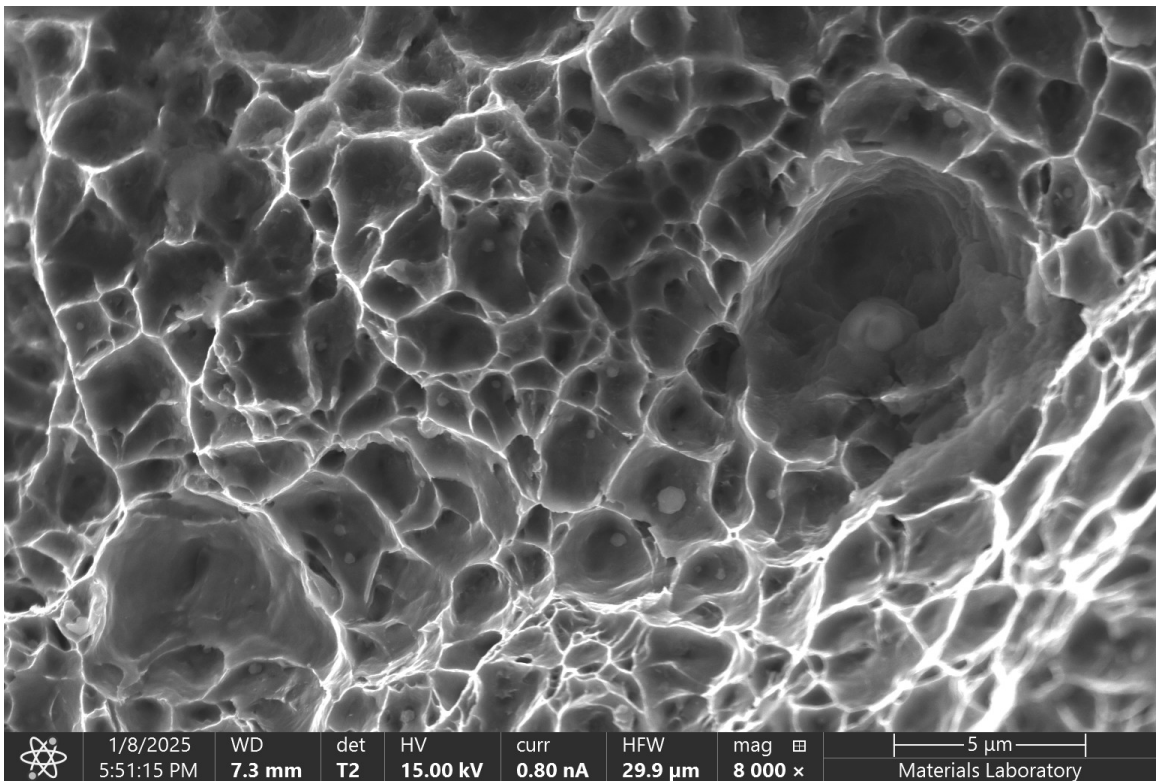
As typified in Figure 9, dimpled rupture was observed outside the fatigue region. The dimpled rupture features were located along the dull, lighter areas in Figure 5. These regions also exhibited localized thinning near the fracture surfaces, along with cup-shaped or slanted fracture orientations. These features were consistent with subsequent overstress fracture during landing.

Figure 9. SE micrograph of dimpled rupture on the right leg weld fracture surface, outside the fatigue cracking.

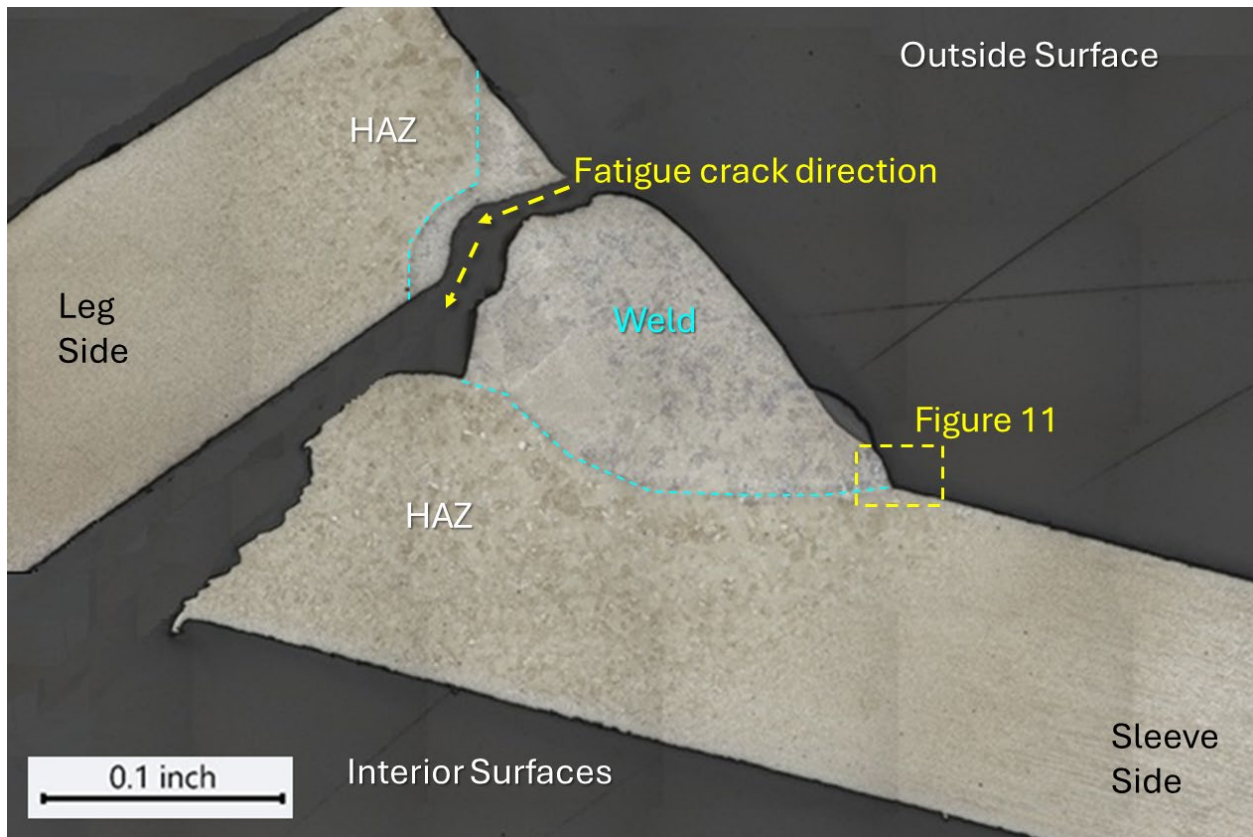
Two areas of the mating left gear weldment fractures were sectioned, vacuum cold-mounted in epoxy, polished, and etched with a 2% Nital solution. Figure 10 shows a montage of a cross-section through the mating fractures on the left weldment. The border of the weld is outlined on the leg and sleeve sides of the fracture, along with the heat-affected zones (which exhibited larger, more equiaxed grains). The fracture was located through the weld in this location, with the general crack propagation direction annotated from outside the weld surface inward. The weld exhibited satisfactory fusion and partial penetration in this location.

Figure 10. Montage of bright-field (BF) optical micrographs of a cross section of the reconstructed fractured weld through the mating sides of the left landing gear weld, showing areas of the weld, heat affected zones (HAZ) and the mating fracture surfaces which exhibited fatigue cracking features (~25X, etched 2% Nital).

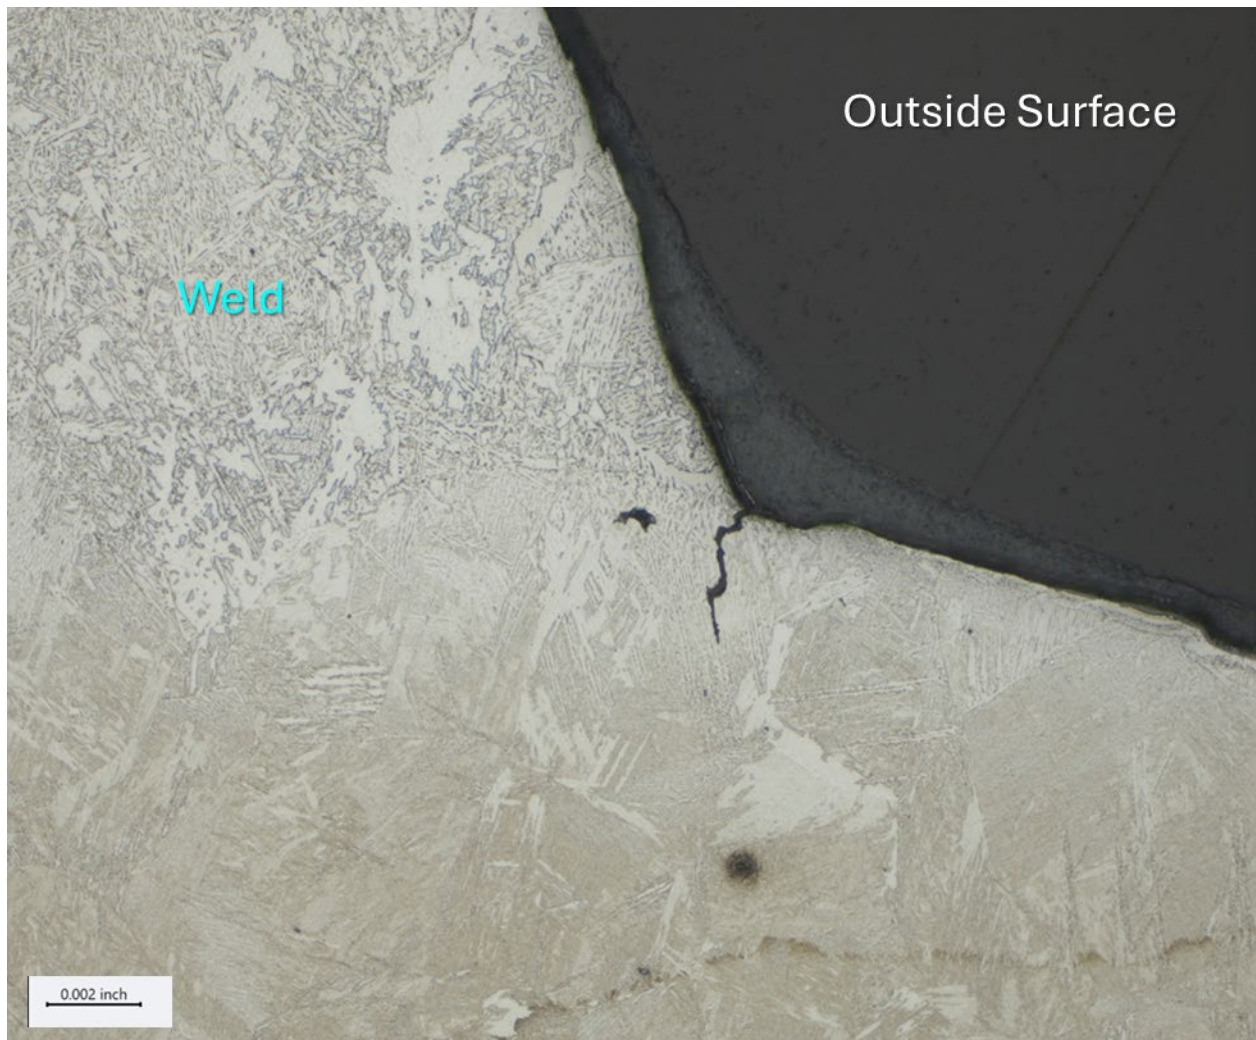
An area on the right toe of the weld in Figure 10 is highlighted in Figure 11. This location exhibited a small crack (~0.002 inches) at the interface between the weld and the heat affect zone (HAZ). This crack had initiated on the surface of the weld. No cracks were observed in the heat-affected zones or other features underneath the exterior surface.

Figure 11. BF optical micrograph of a crack at the toe of the weld from Figure 10 opposite that fracture surface (located off image towards left) (~200X, etched 2% Nital).

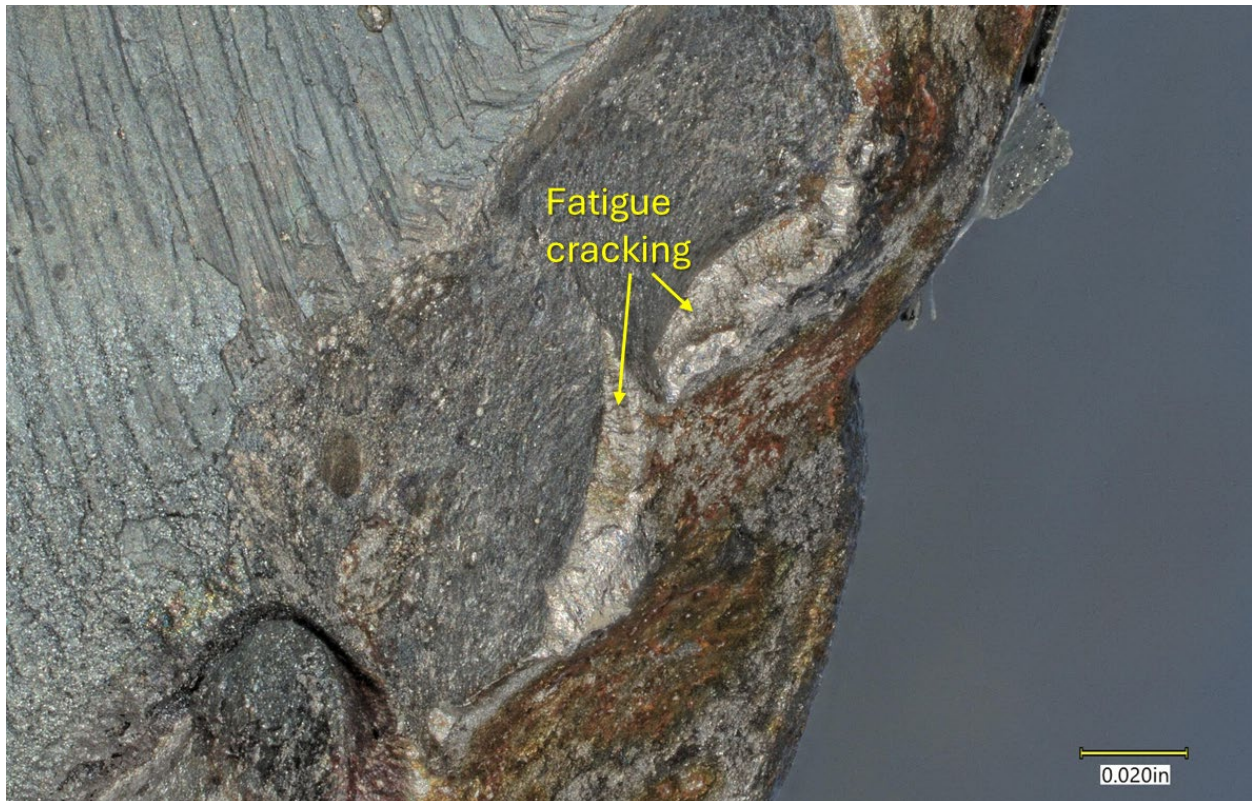
Figure 12. Isolated fatigue cracks on the left landing gear weld fracture (leg side).

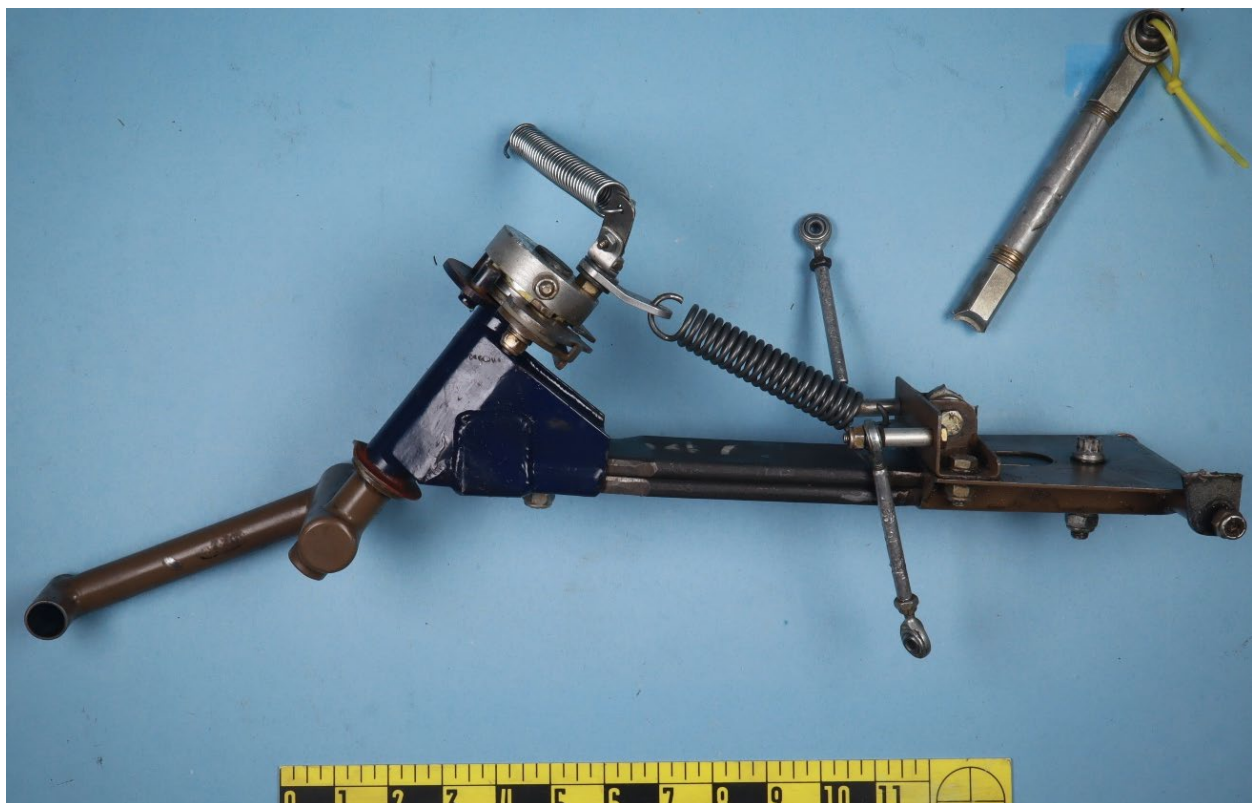
The components from the tailwheel assembly are depicted in Figure 13. Of note was the tailwheel link had fractured. As shown in Figure 14, the fracture had occurred near the ball joint at the neck. The bearing inside the ball joint had jammed, and the face exhibited severe gouging on the side facing the reader in Figure 14b. The fracture surface of the link is shown in Figure 15.

Figure 13. View of the components submitted from the tailwheel assembly.

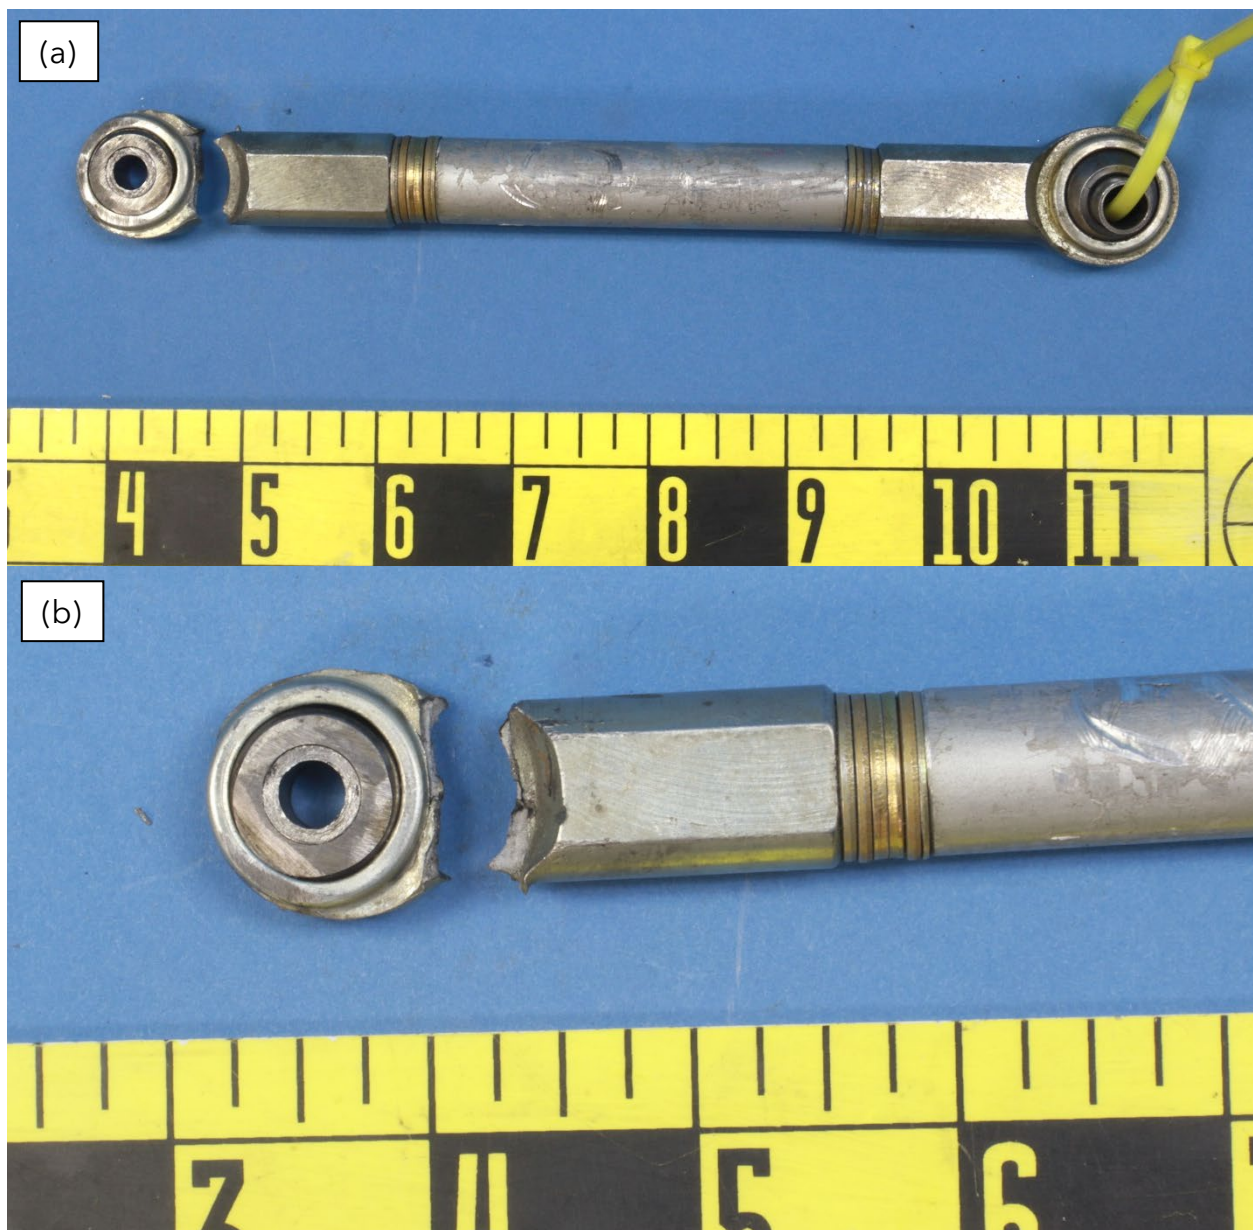
Figure 14. View of (a) the tailwheel link body and (b) a closer view of the fractured neck near the ball joint.

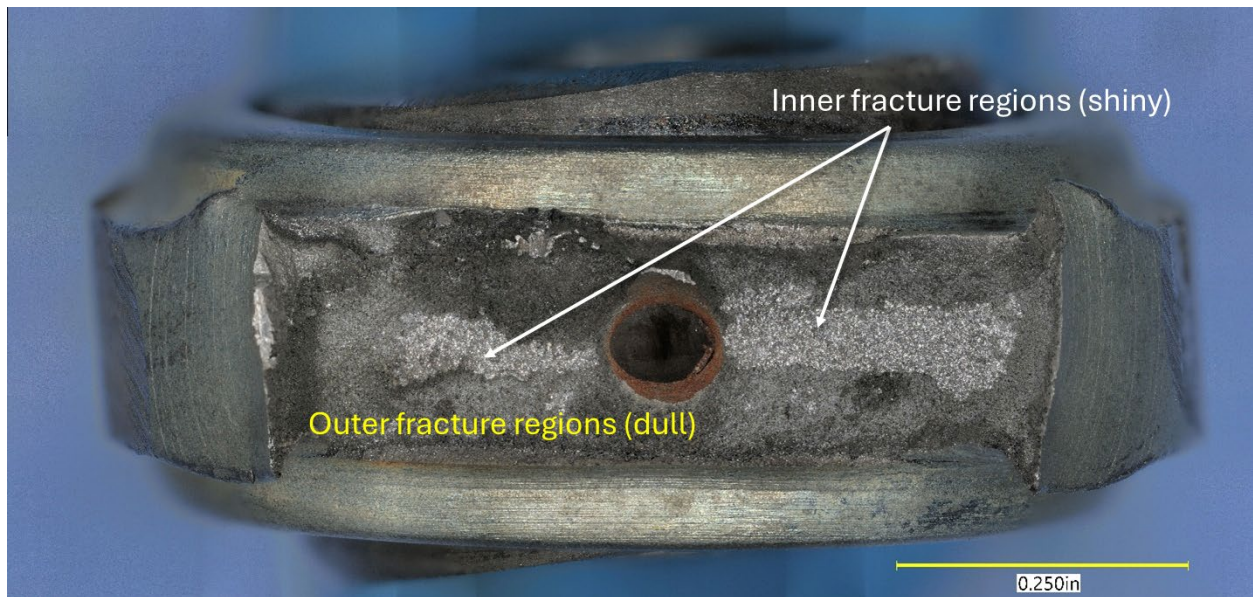
Some plastic deformation in the form of thinning or necking was observed along the sides adjacent to the fracture surface. The edges of the fracture exhibited 45° slanted orientations and were generally cup-shaped. The fracture surface exhibited a rough texture, with two areas: a dull gray outer region and a reflective metallic inner region.

Figure 15. The fracture surface of the tailwheel link, viewed from the ball joint side.

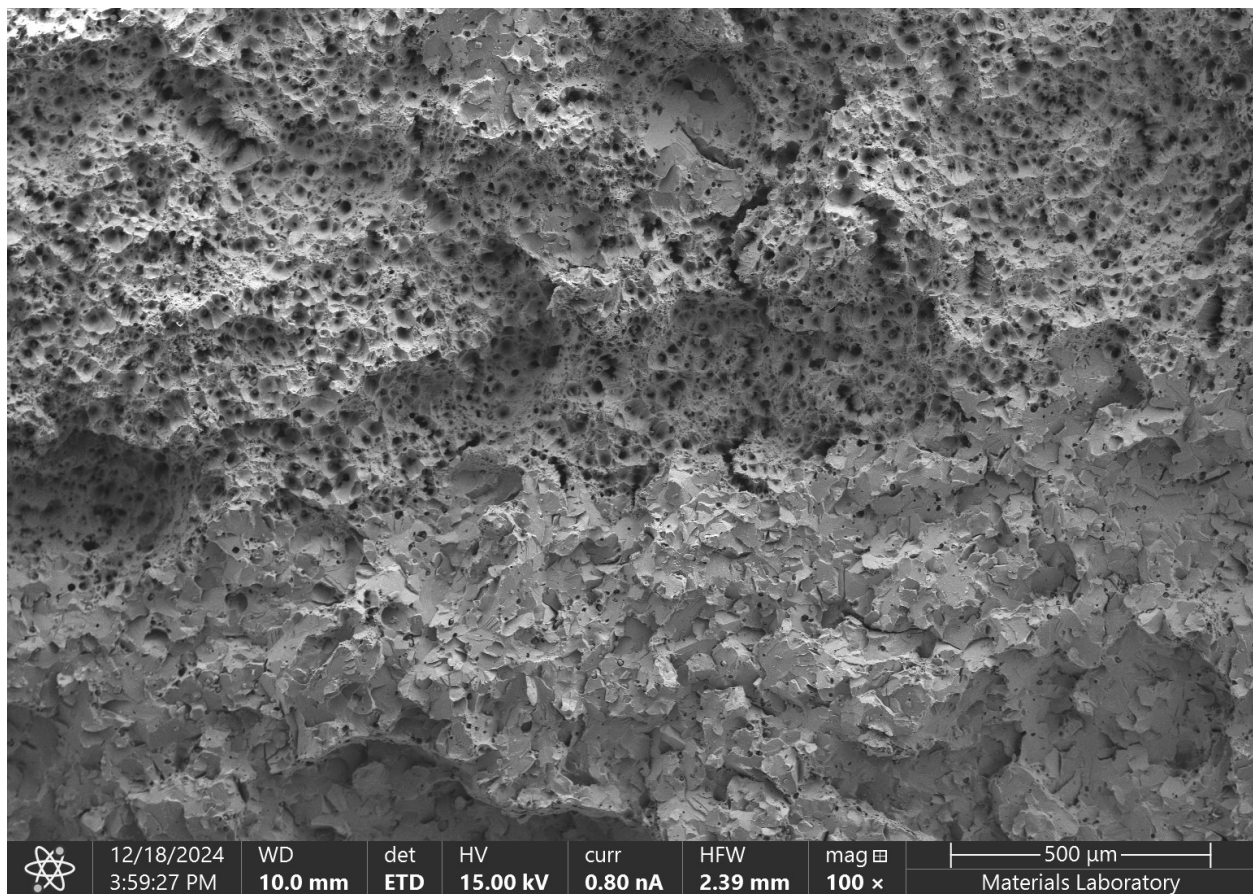
The fracture surface of the link was examined using a SEM. The boundary between the two fracture regions is highlighted in Figure 16, with the inner reflective region positioned in the lower half of the figure. The outer region of the link fracture surface exhibited dimpled rupture, as typified in Figure 17. The inner region exhibited

Figure 16. SE micrograph of the transition area of the tailwheel link fracture surface.

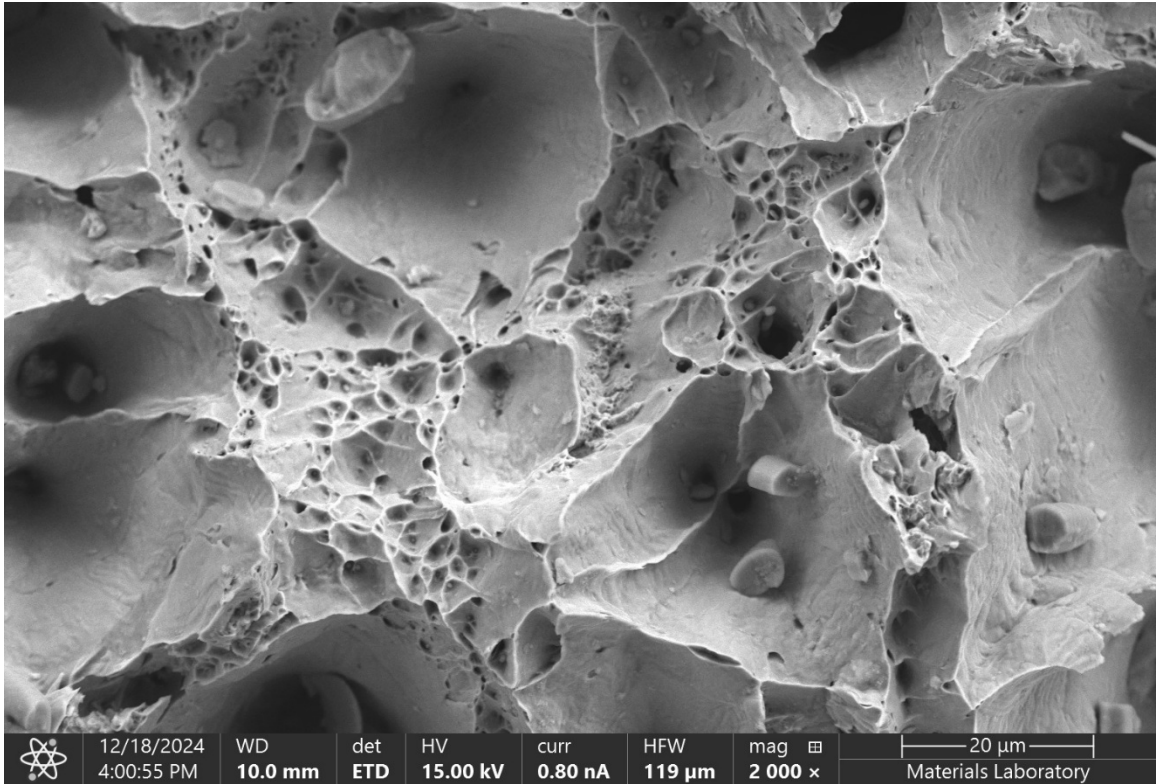
Figure 17. SE micrograph of dimpled rupture in the outer areas of the tailwheel link fracture surface.
