# National Transportation Safety Board

ERA24LA255

## **MATERIALS LABORATORY**

Factual Report 25-002

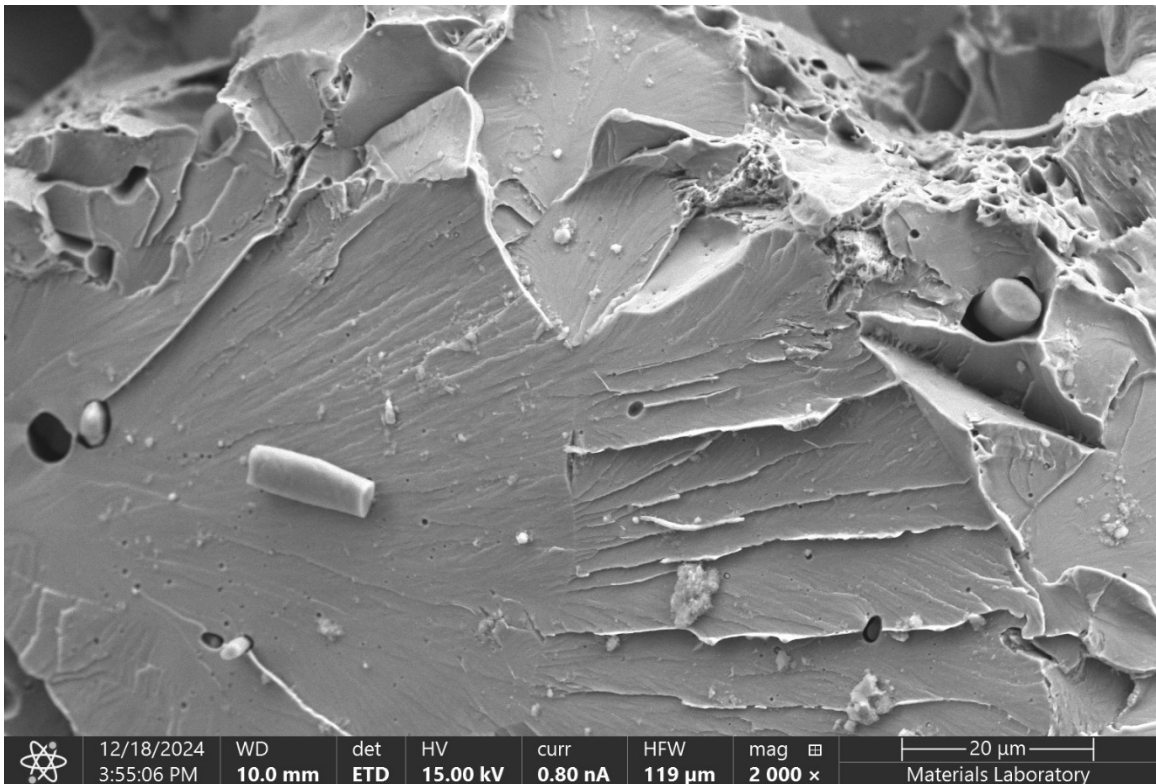
cleavage fracture, with isolated areas of dimpled rupture (see Figure 18). These features were consistent with tensile overstress fracture of the tailwheel link.

Figure 18. SE micrograph of cleavage in the inner areas of the tailwheel link fracture surface.
