ERA24LA257

## INVESTIGATION PHOTOGRAPHS

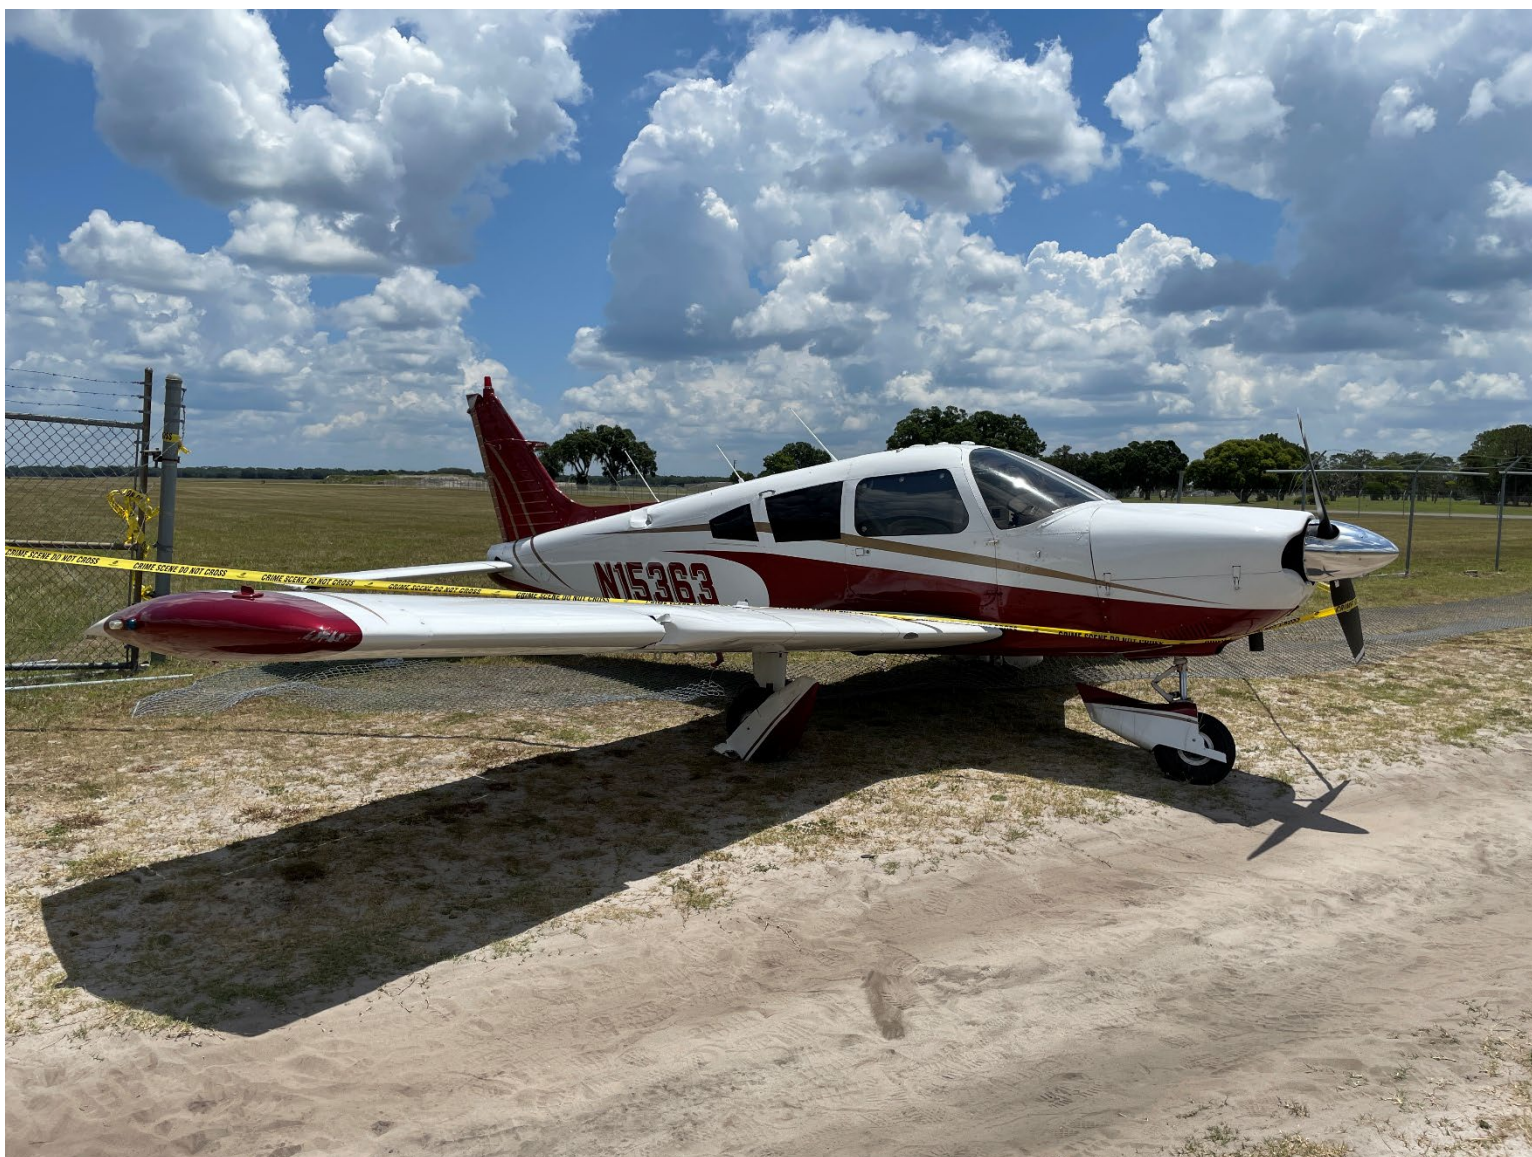
**Photograph 1 - Airplane at the accident site (Source: FAA)**

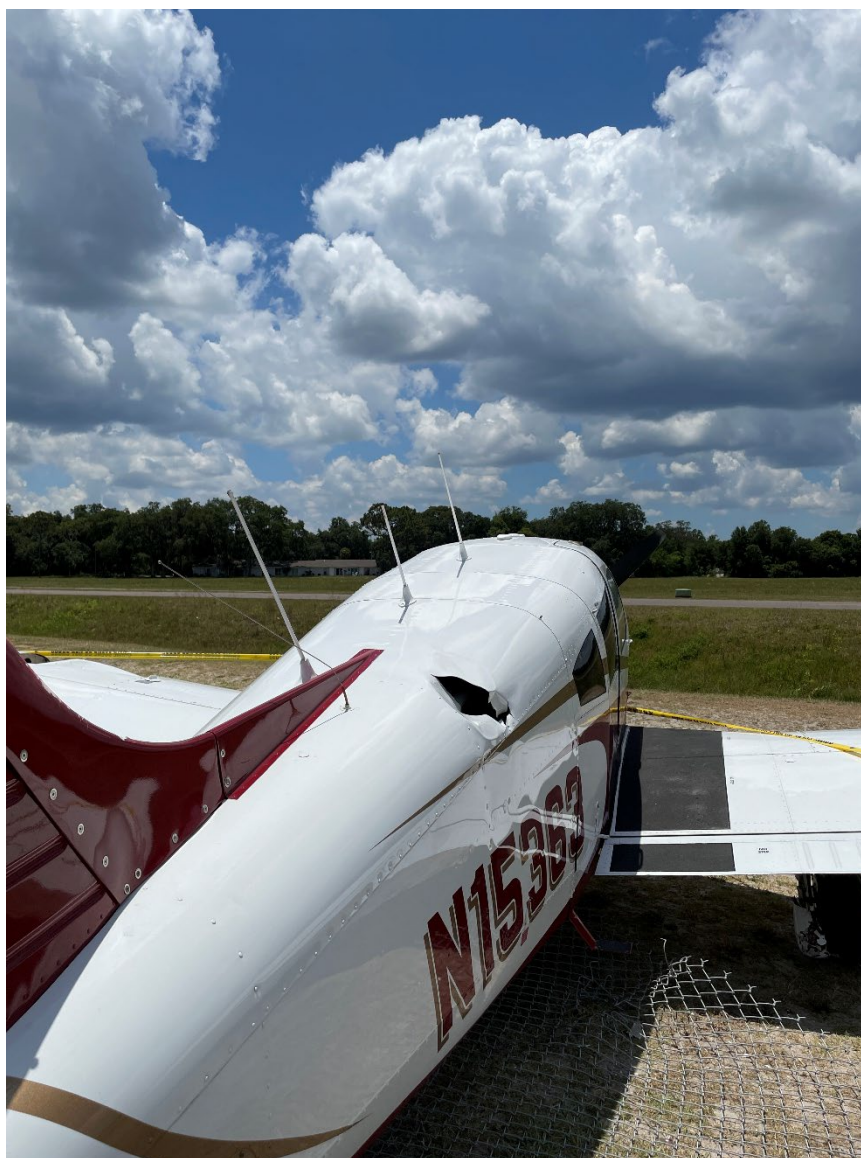
**Photograph 2 - Airplane at accident site (Source: FAA)**

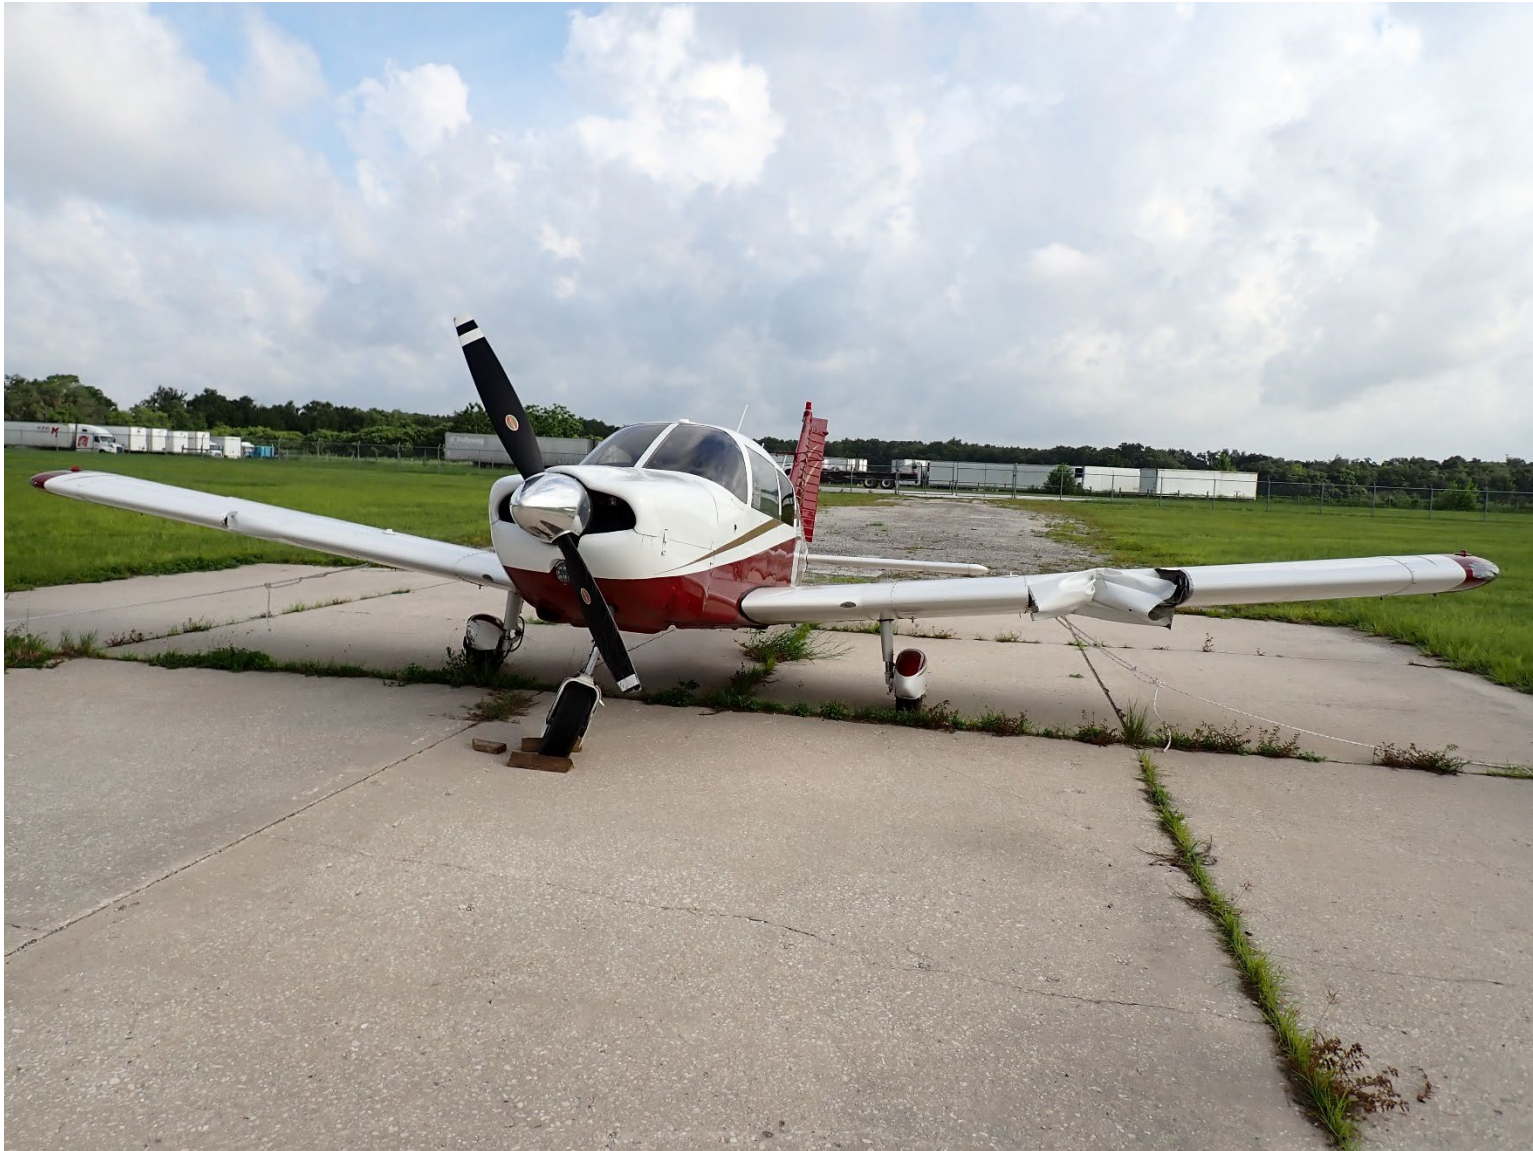
**Photograph 3 - Airplane after recovery**

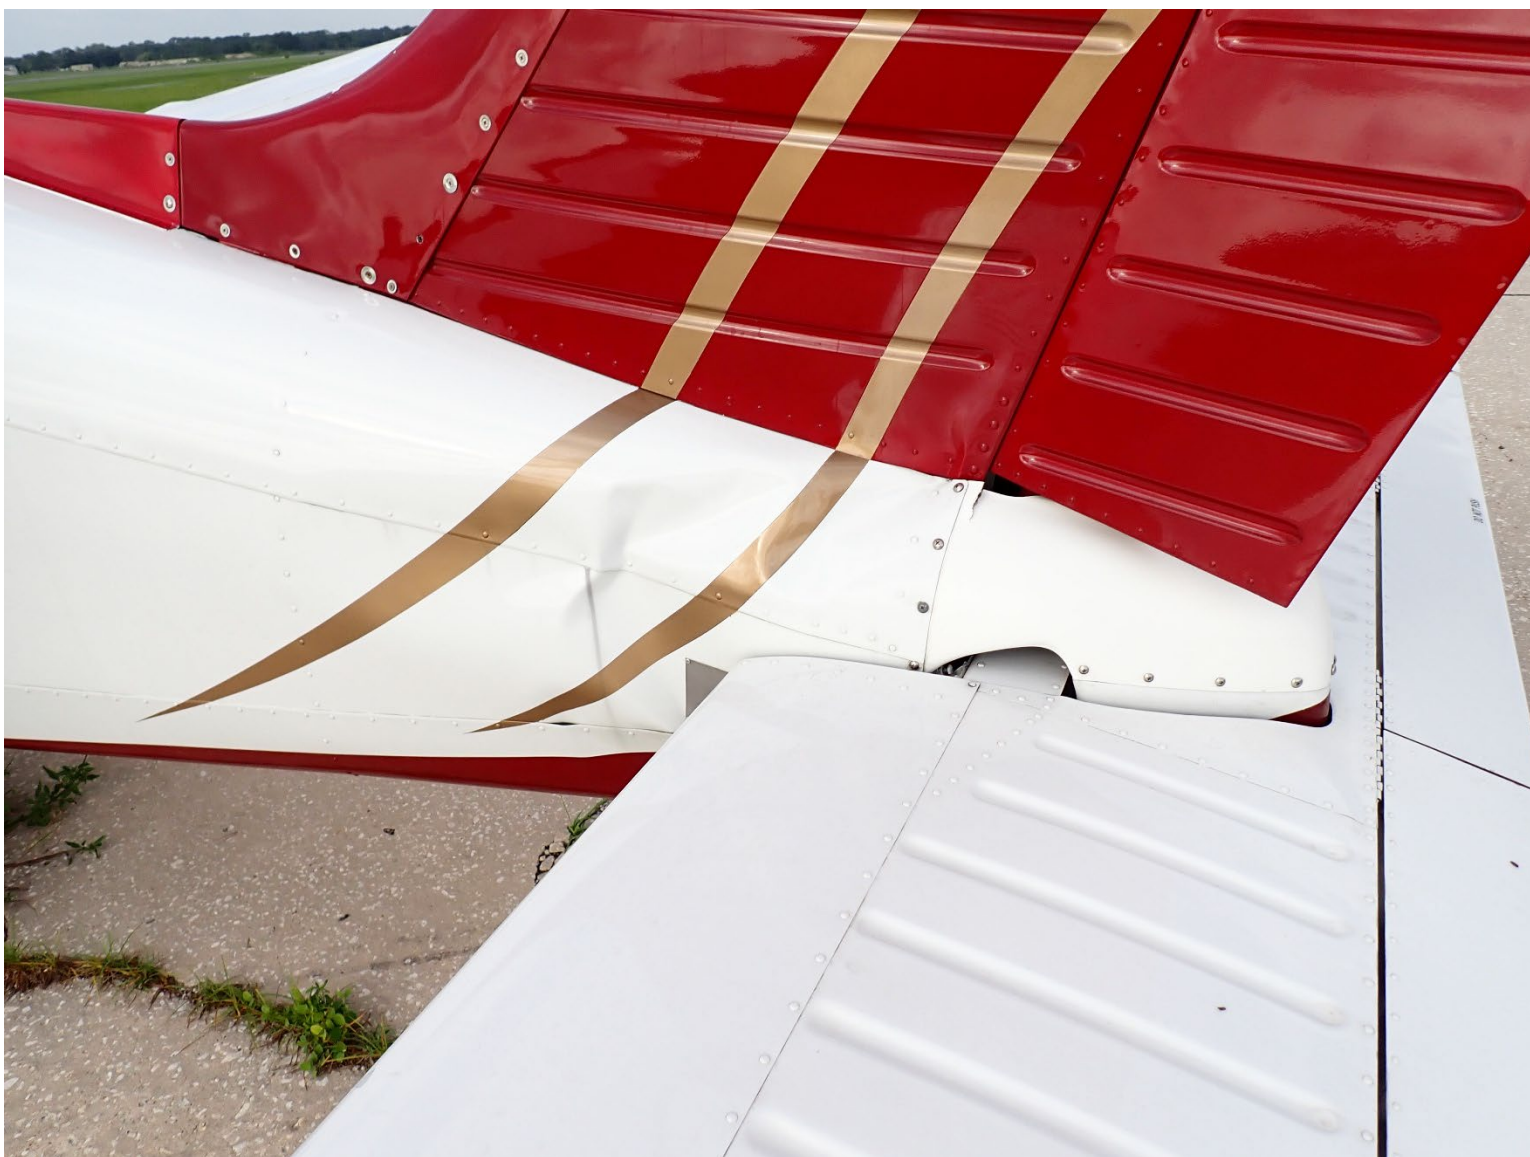
**Photograph 4 - Damage to empennage**

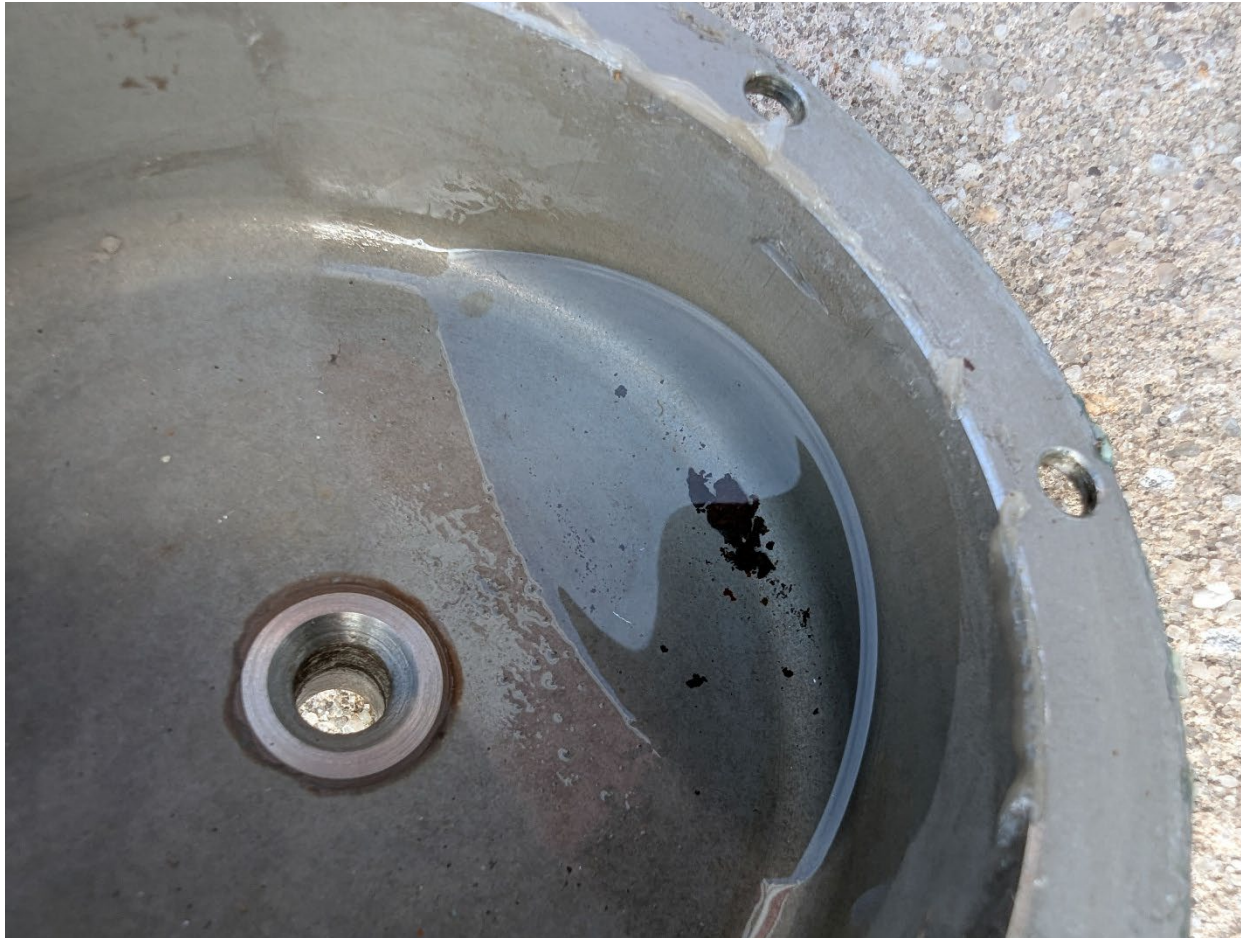
**Photograph 5 - Debris found in strainer bowl**

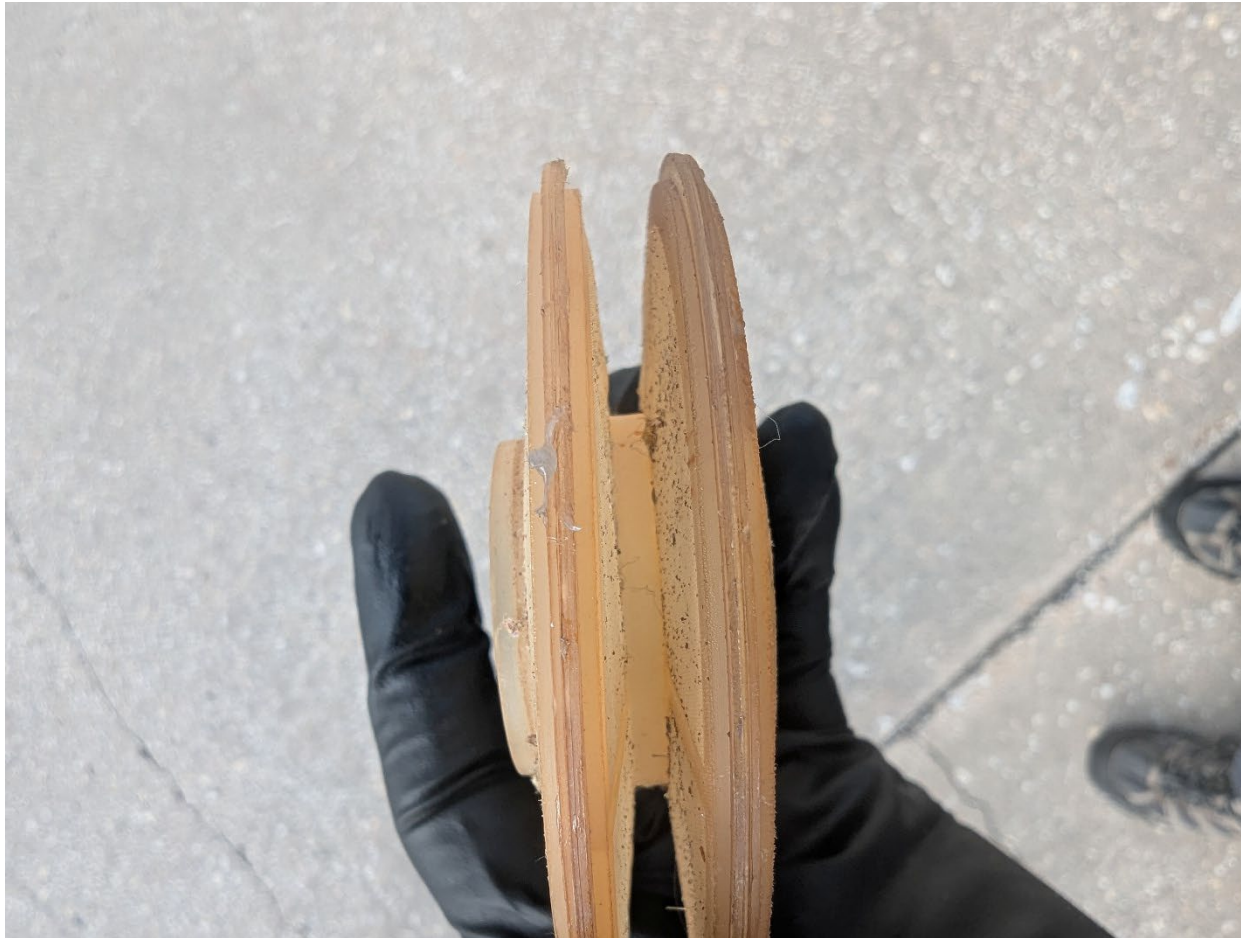
**Photograph 6 - Debris found in strainer screen**

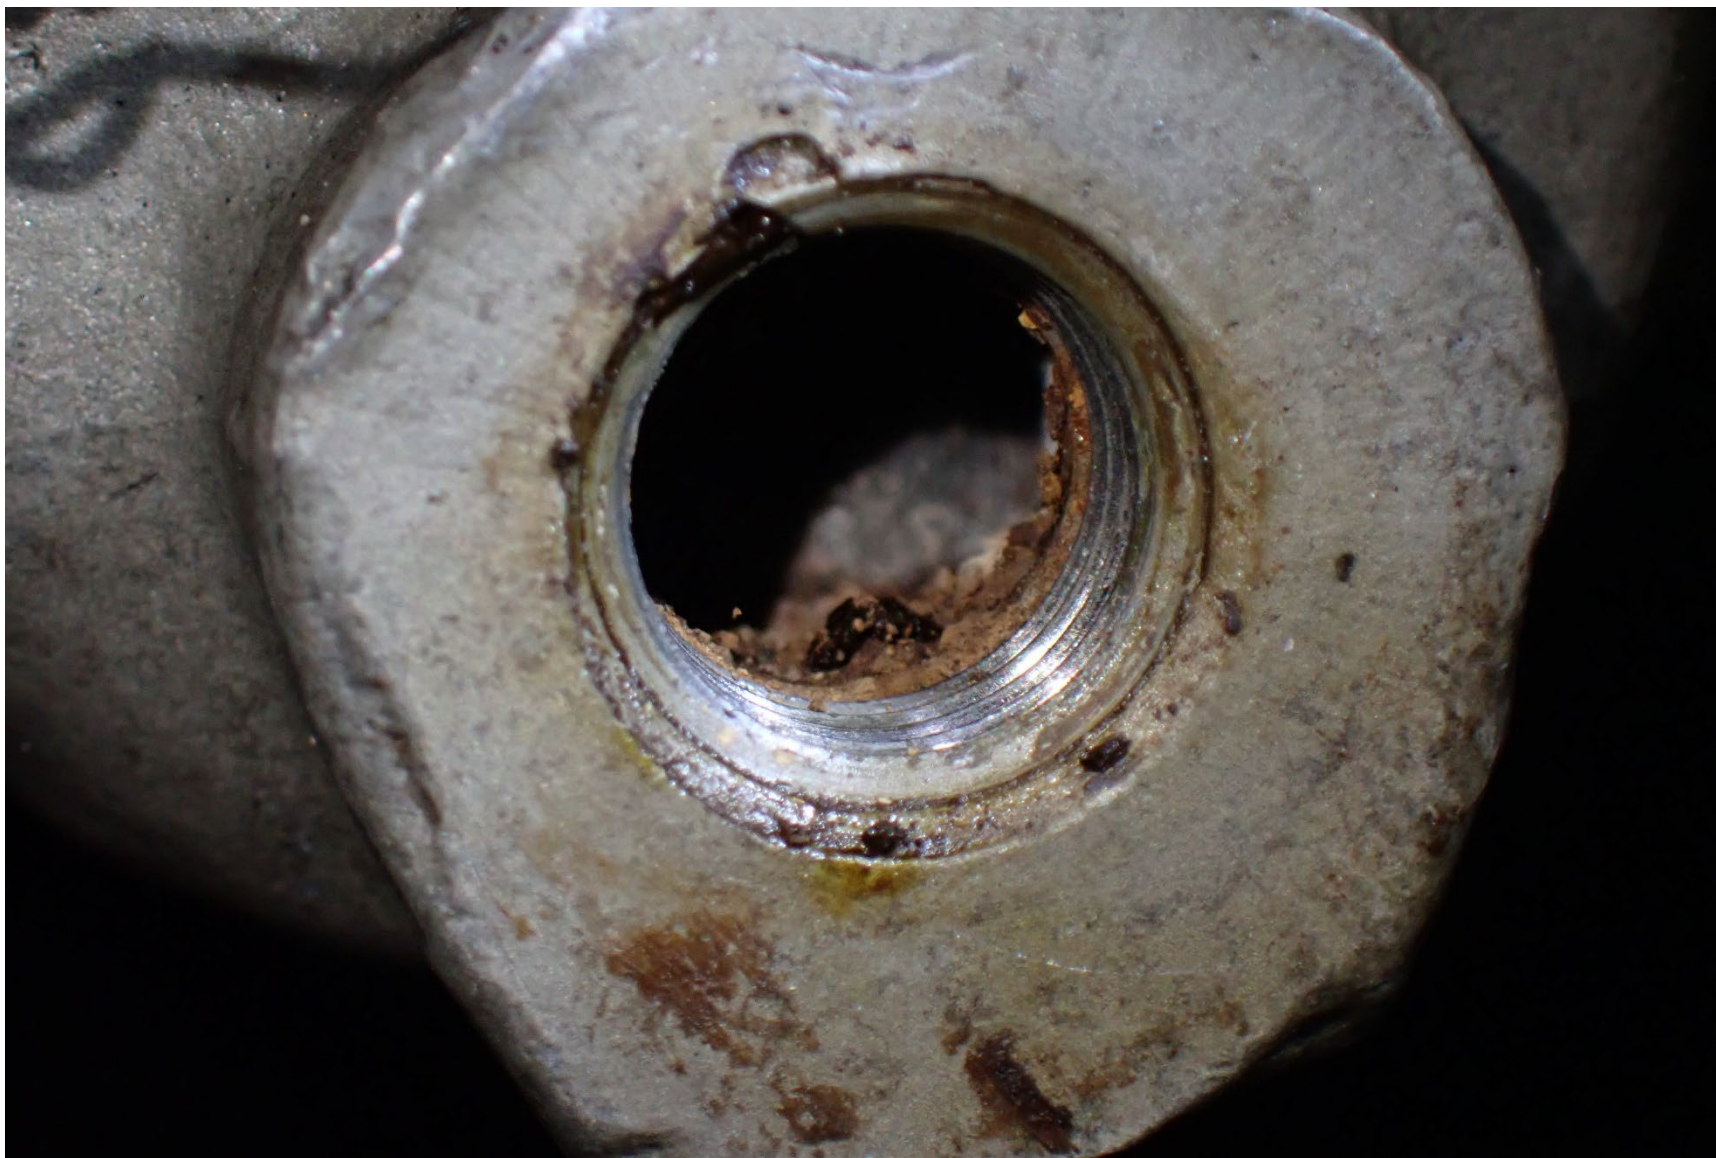
**Photograph 7 - Debris found in carburetor through drain plug**

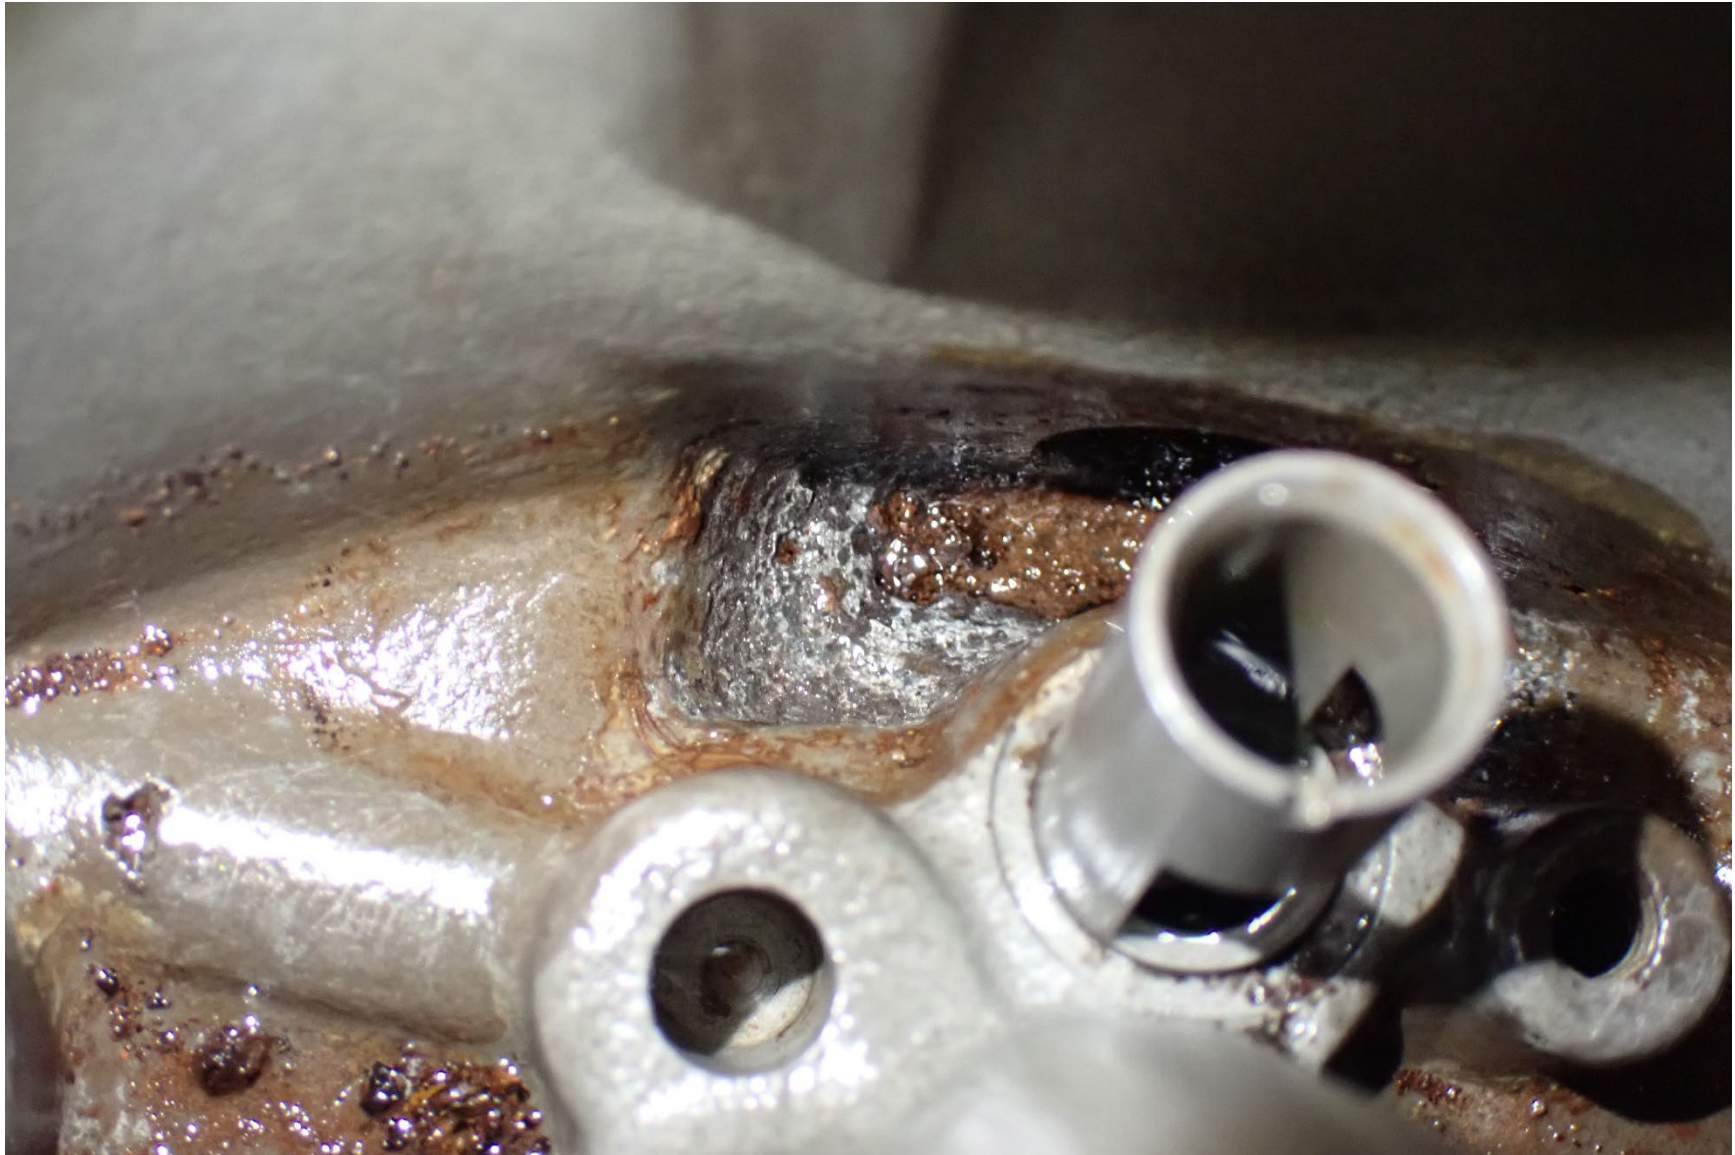
**Photograph 8 - Corrosion and debris found in the carburetor bowl**

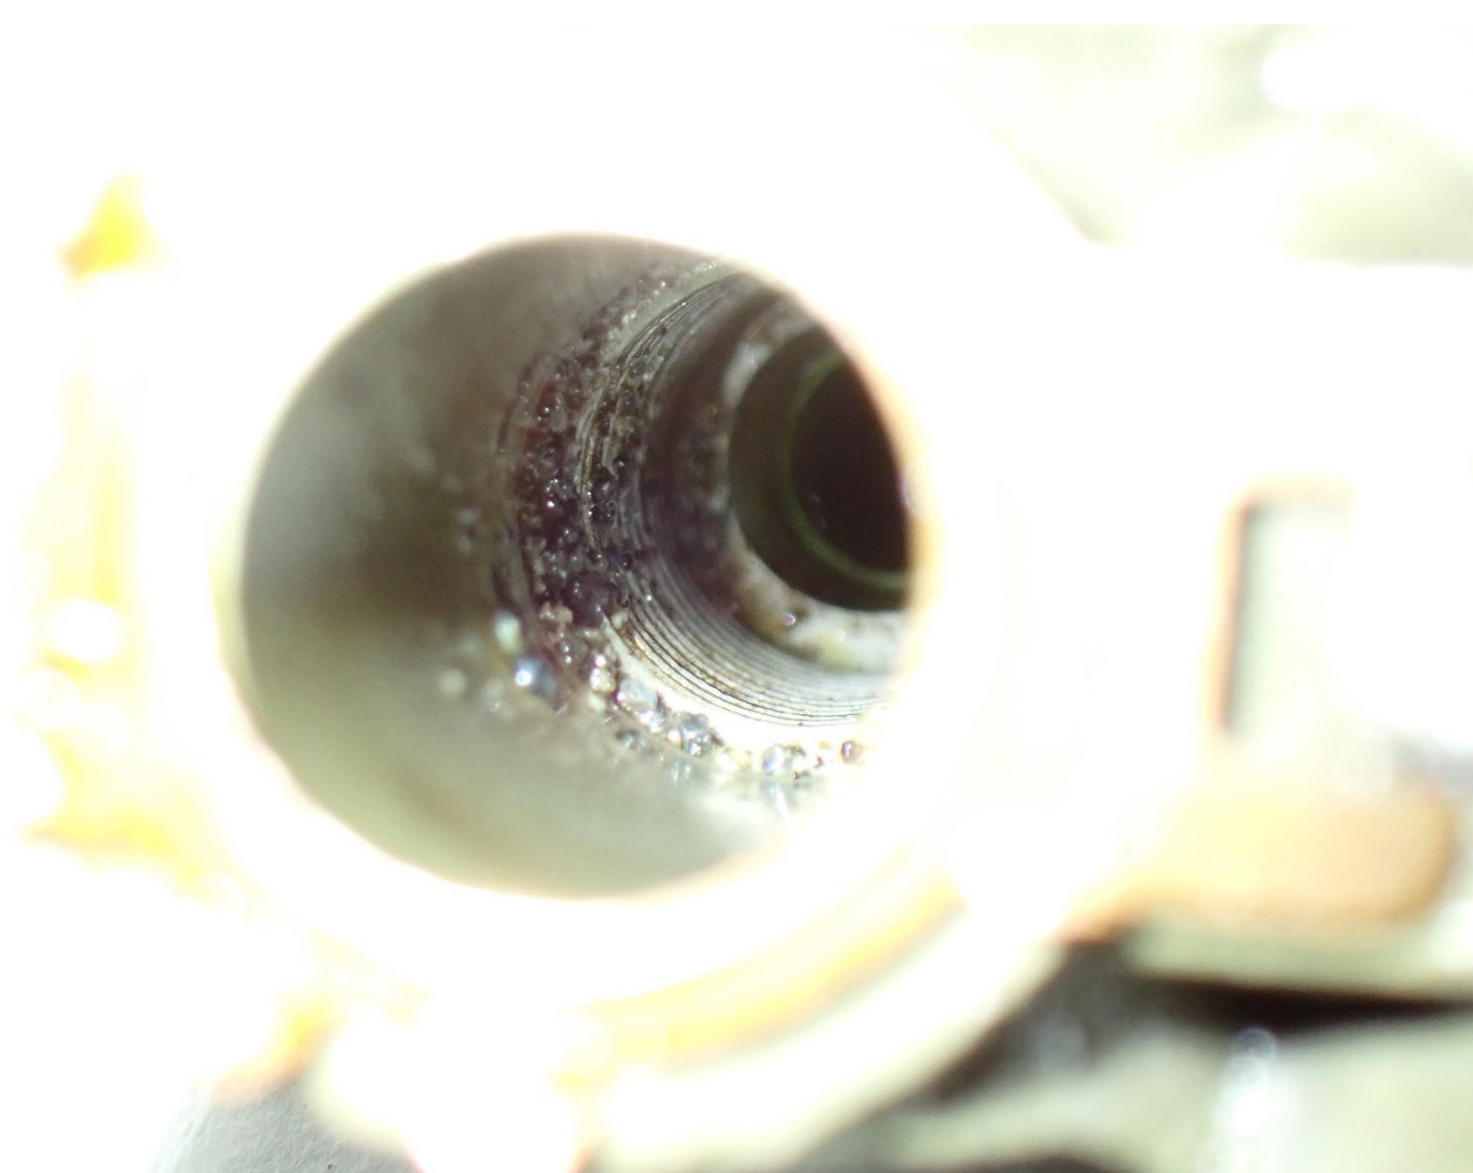
**Photograph 9 - Debris found in the carburetor main metering jet well**

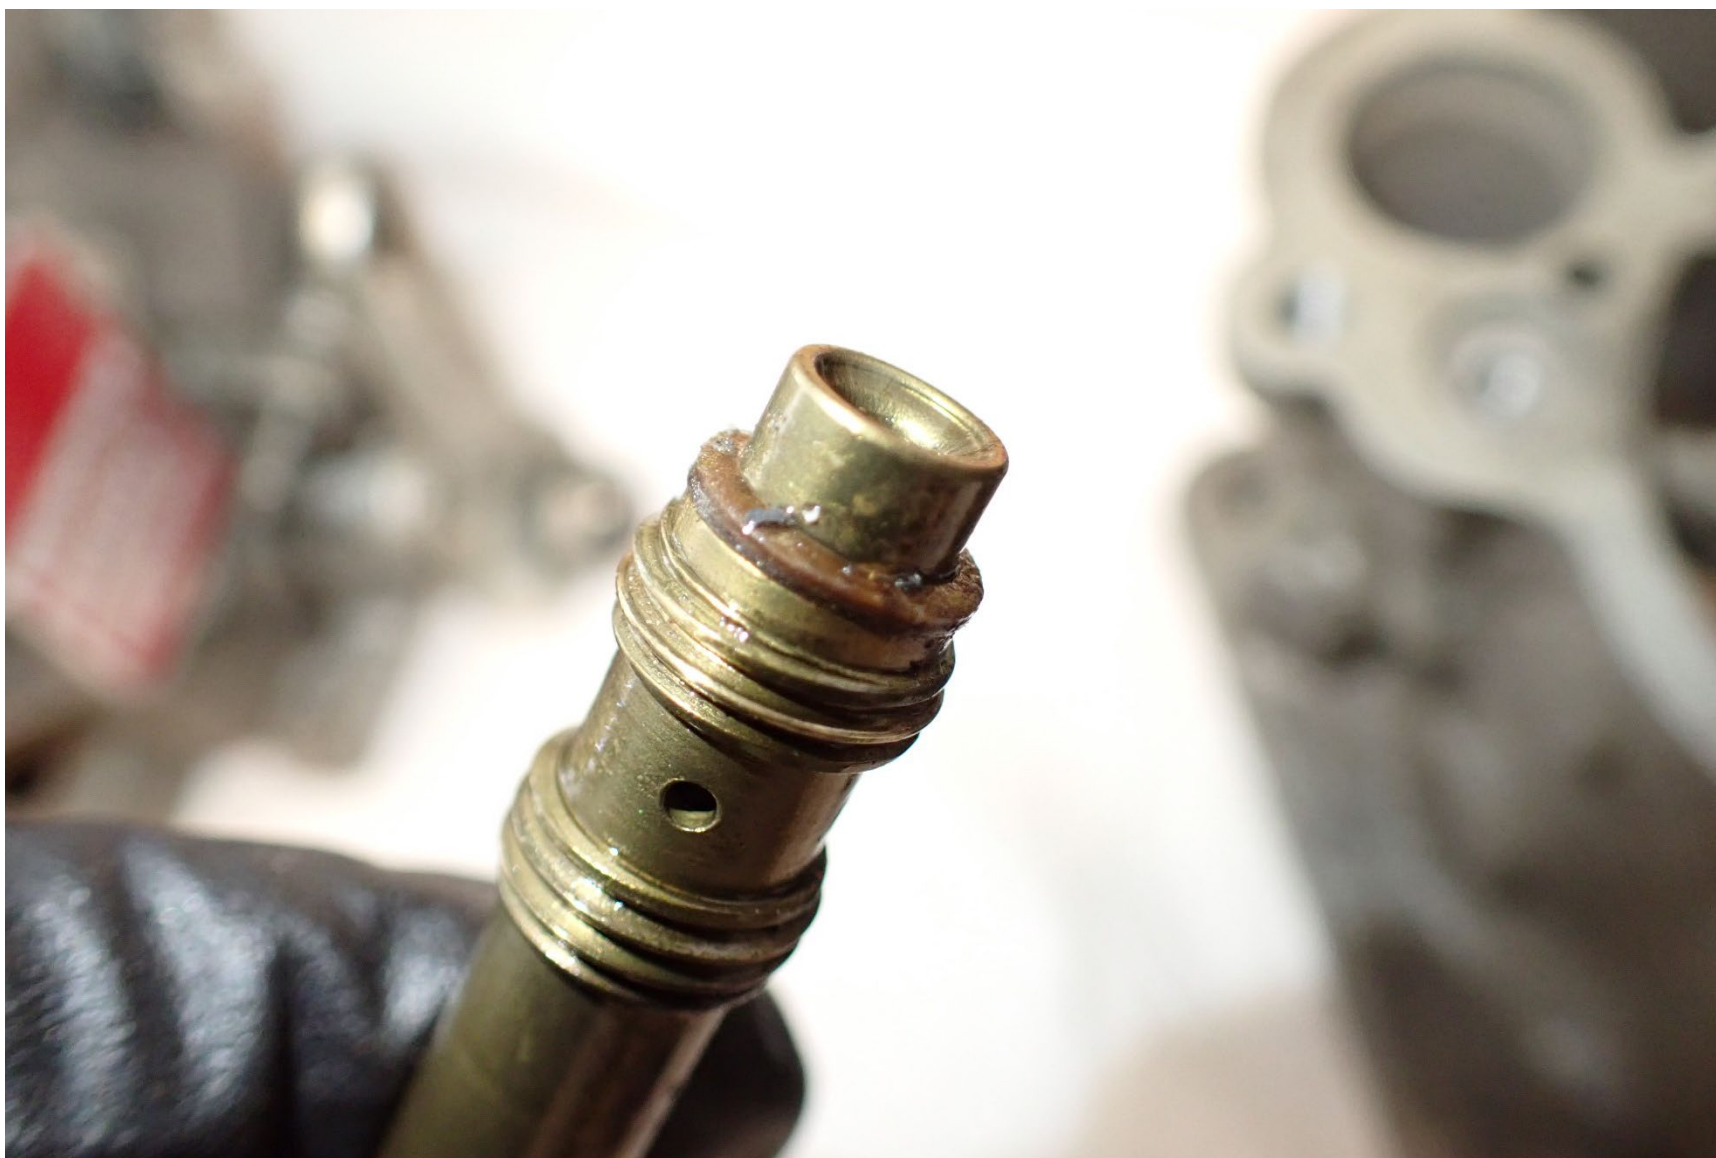
**Photograph 10 - Debris found on the main metering jet**

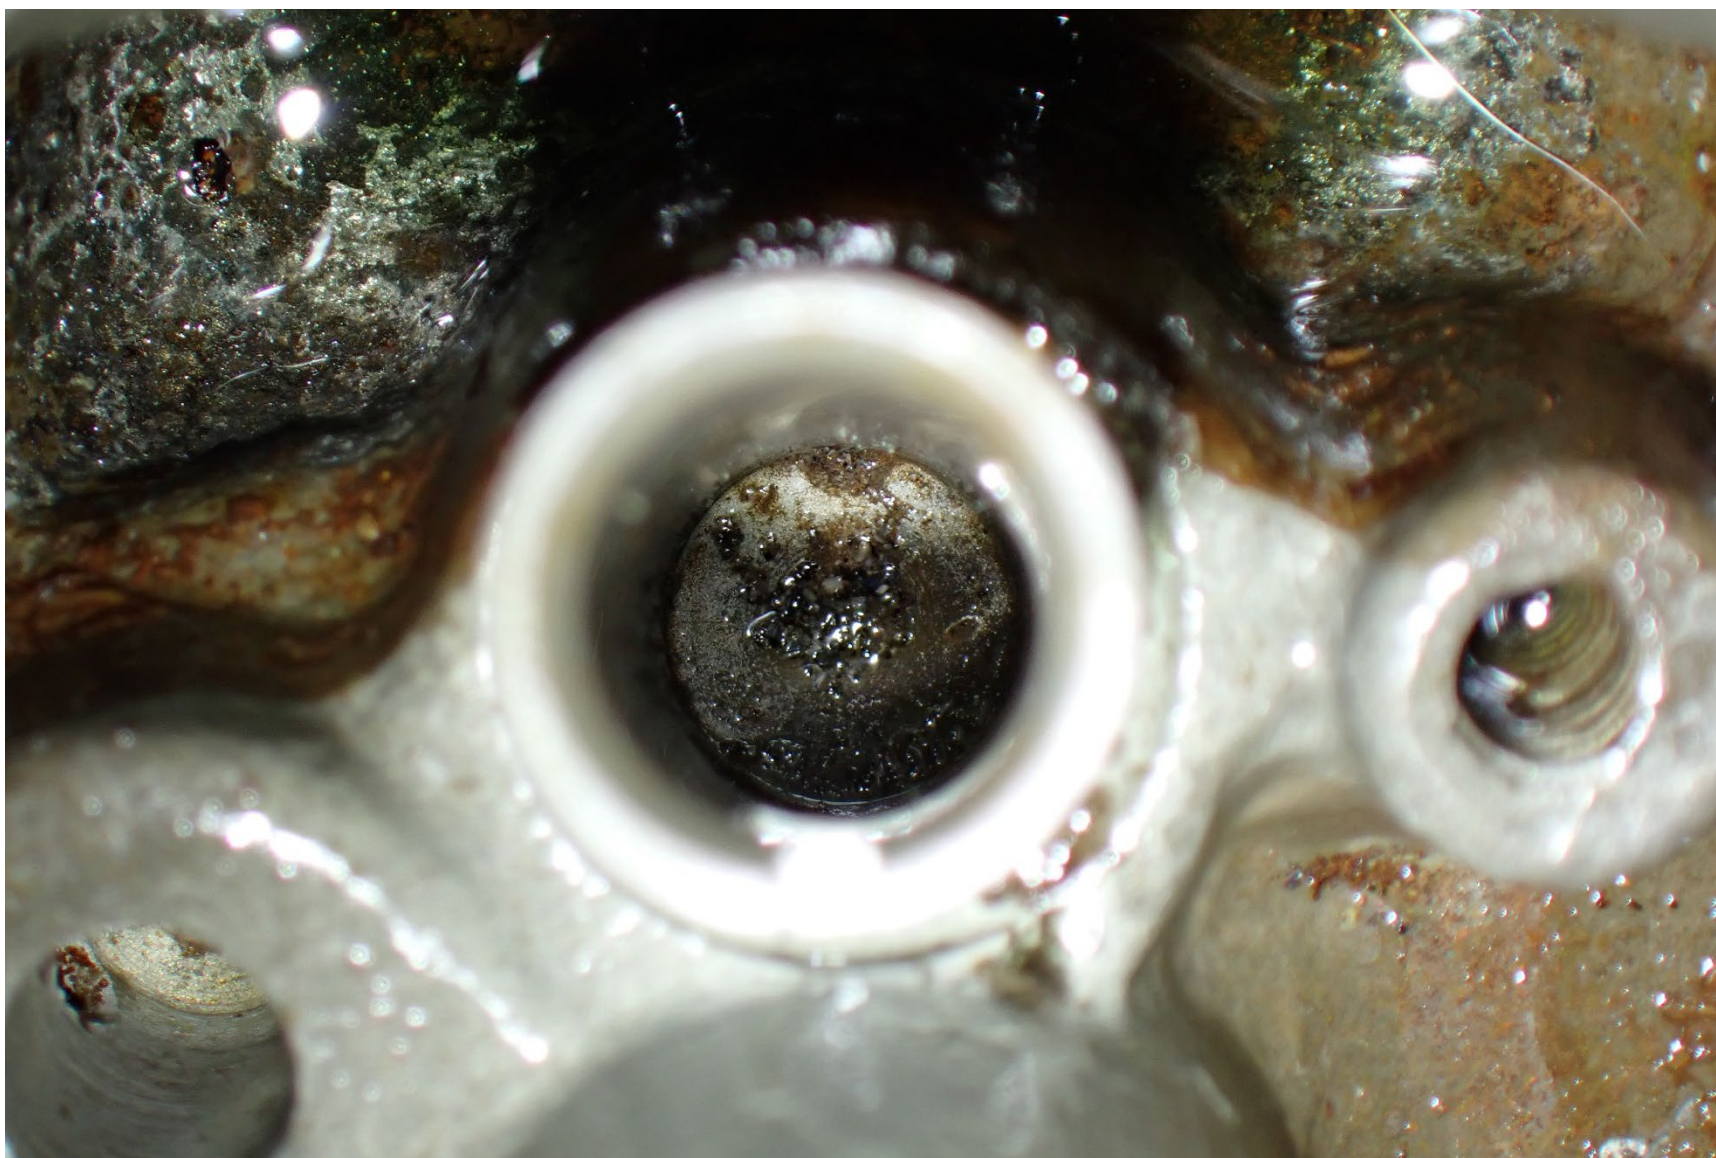
**Photograph 11 - Debris found in carburetor mixture control sleeve**

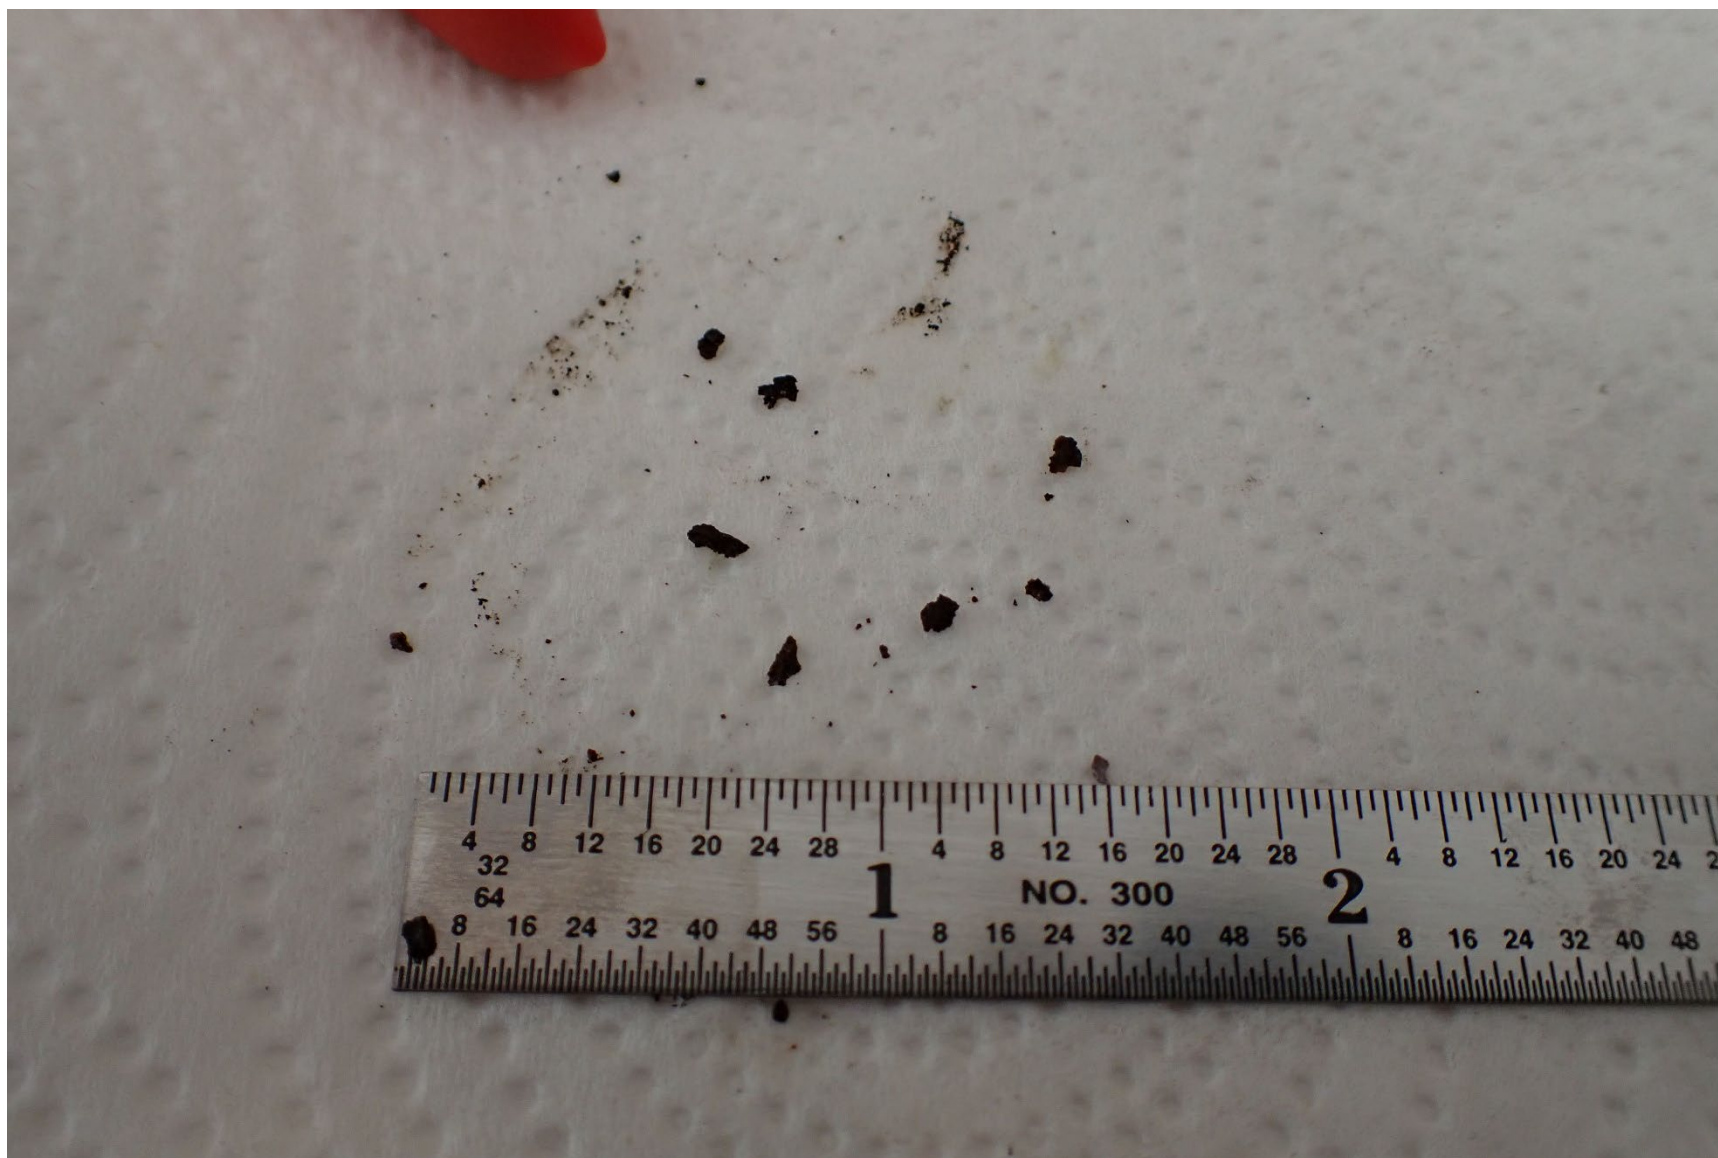
**Photograph 12 - Sample of corroded debris found in the carburetor with scale**

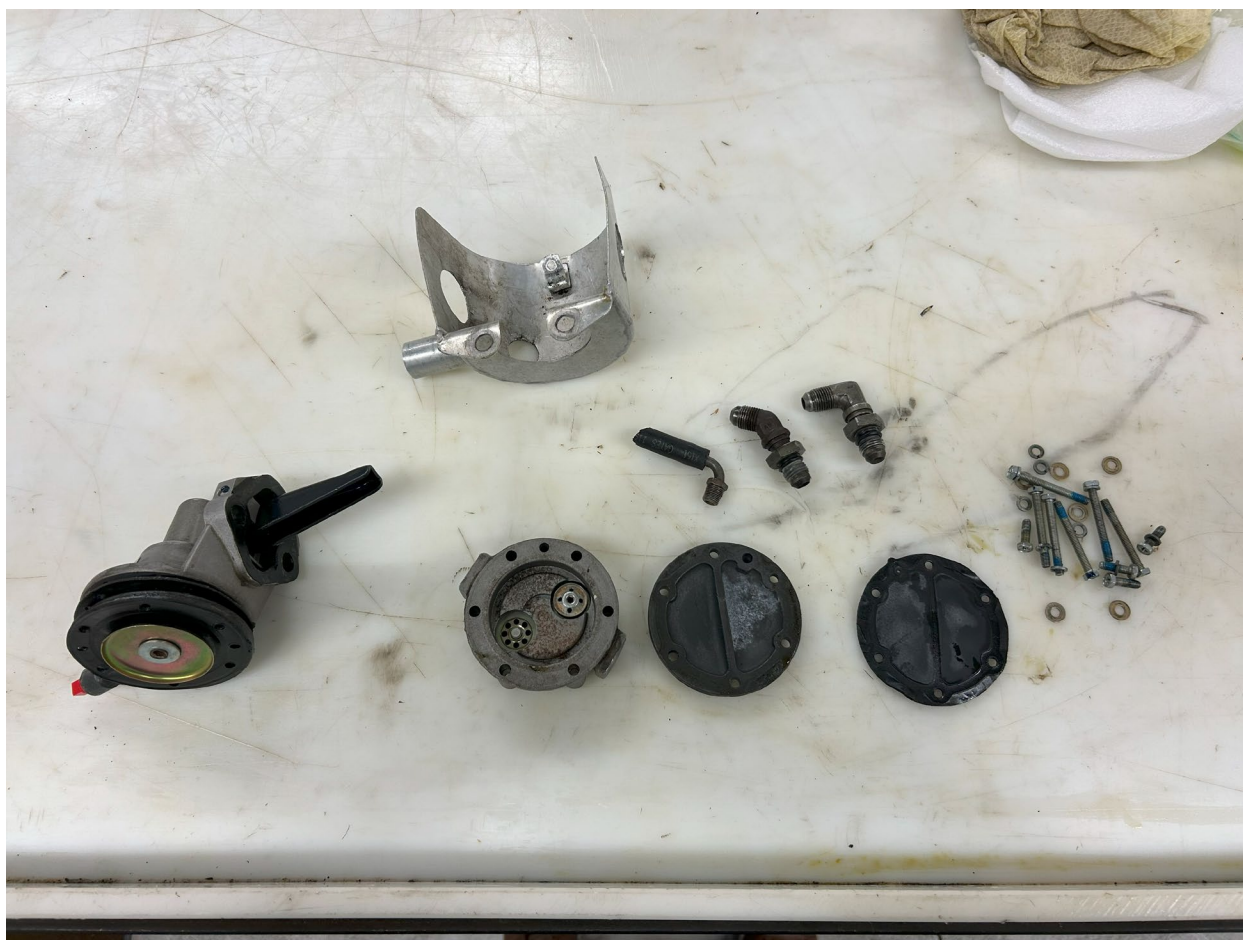
**Photograph 13 - Fuel pump after disassembly**

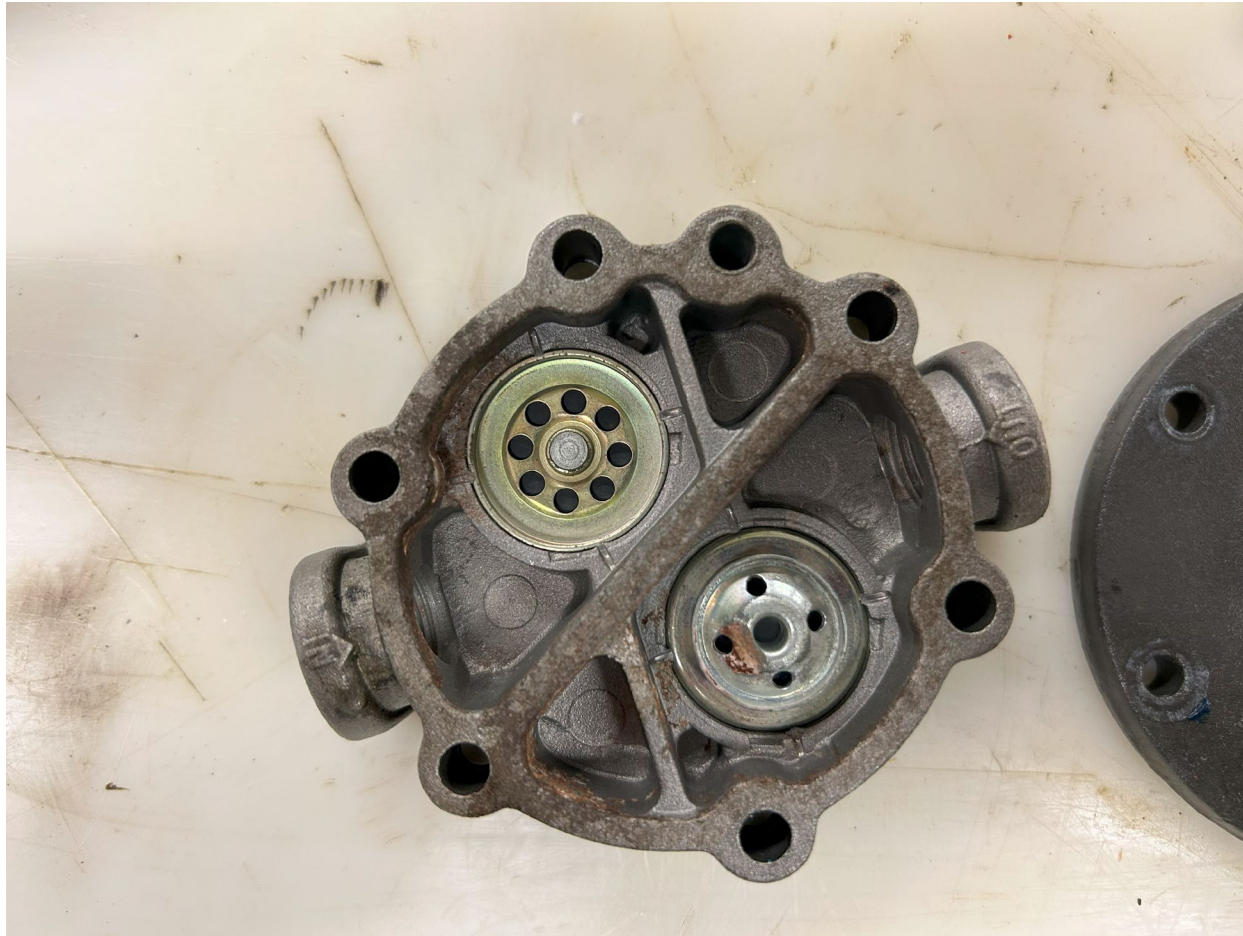
**Photograph 14 - Fuel pump with corroded internal components (Source: Lycoming)**
