ERA24LA257

## INVESTIGATION PHOTOGRAPHS

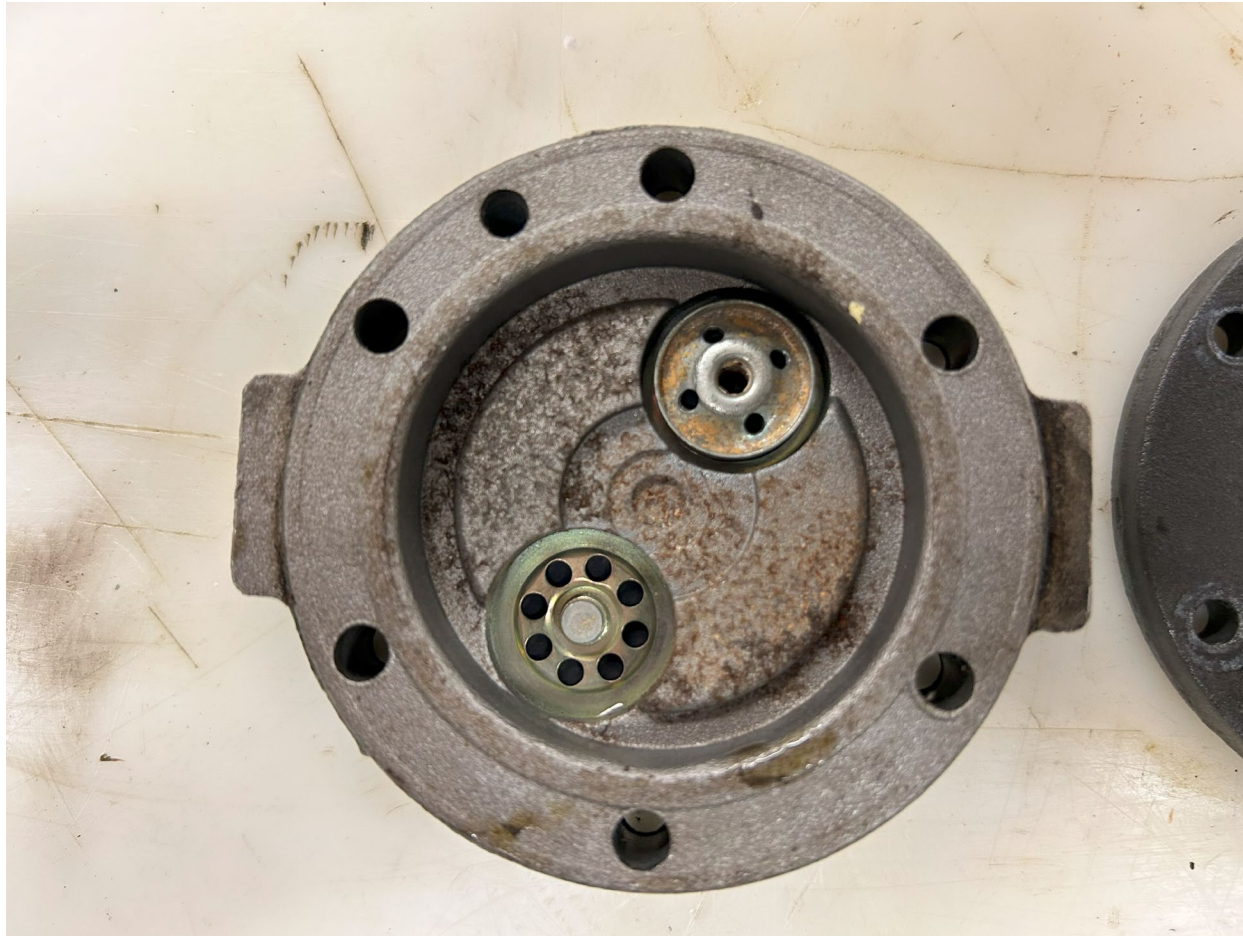
**Photograph 15 - Fuel pump with corroded internal components (Source: Lycoming)**
