# National Transportation Safety Board

ERA24LA257

## **CARBURETOR TESTING AND EXAMINATION**

Airplane: Piper PA28-235 Registration: N15363

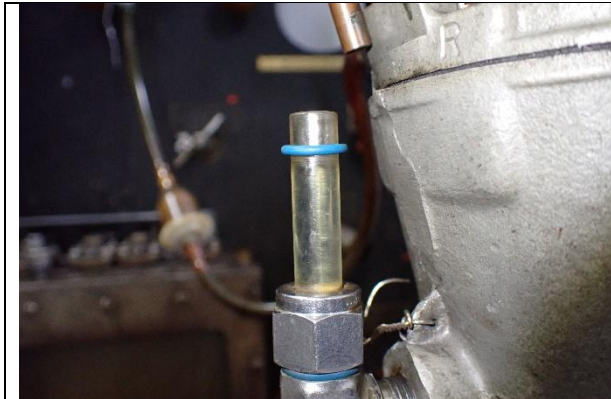
The carburetor was placed on a test bench, and a static pressure test was performed. The carburetor static pressure test indicated the bowl, floats, and float valve were operating normally. During the carburetor static test, the accelerator pump was tested; the test revealed that the accelerator pump was capable of discharging fluid; however, it was very weak, and the amount of fluid expelled during pump actuation was low.

Photograph 1: Carburetor Static Testing

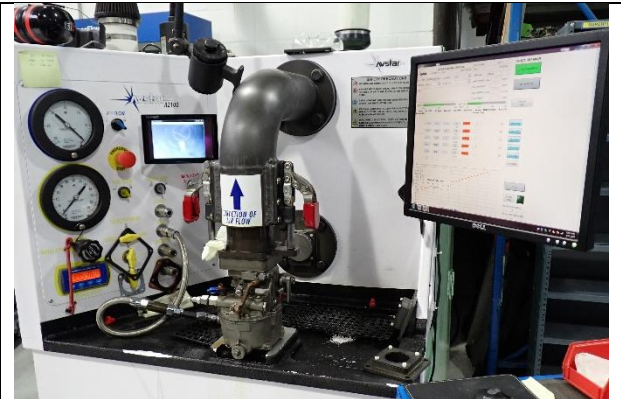
The carburetor was then placed on a carburetor flow test bench. The carburetor performed normally with a slightly leaner fuel flow when tested at the 1400 PPH air flow test point; however, it would not have prevented normal operation of the engine.

Photograph 2: Carburetor Fuel Flow Testing

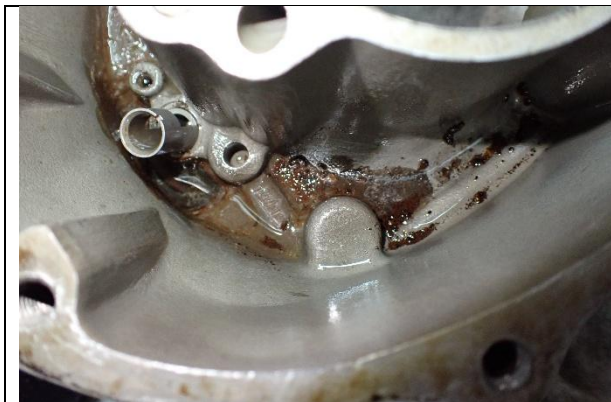
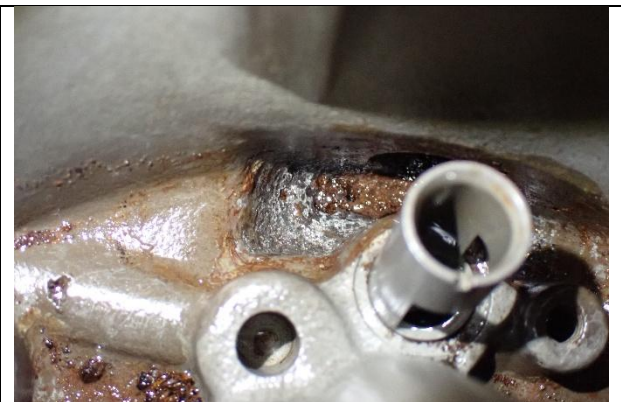
The carburetor was disassembled, and the internal components were examined. The disassembly revealed that the carburetor bowl contained a significant amount of debris and corrosion, and there were several large, loose particulates within the carburetor bowl. The main fuel nozzle was removed, and it was found that particulates were within the main fuel nozzle and the fuel nozzle well. Debris was also found in the mixture metering sleeve. The accelerator pump displayed normal wear signatures; however, the metal check valve ball was missing within the accelerator pump housing. There were no signs of the metal check valve ball anywhere within the carburetor.

Photograph 3: Carburetor bowl with corrosion and contamination

Photograph 4: Carburetor bowl with corrosion and contamination

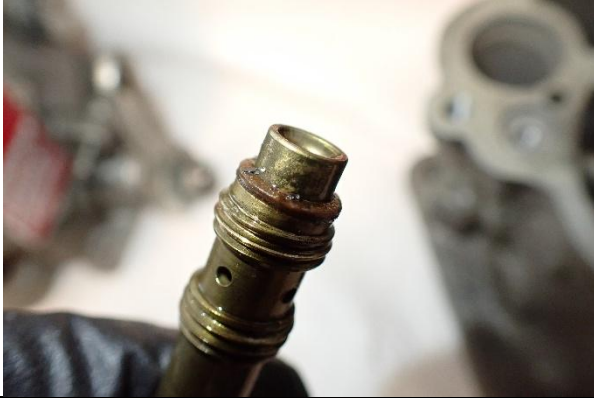
Photograph 5: Main metering jet with debris

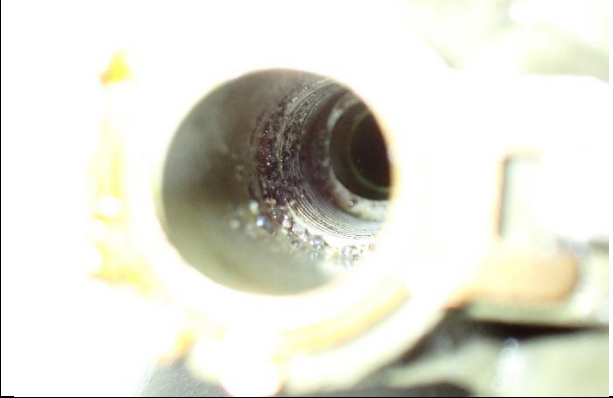
Photograph 6: Main metering jet housing with debris

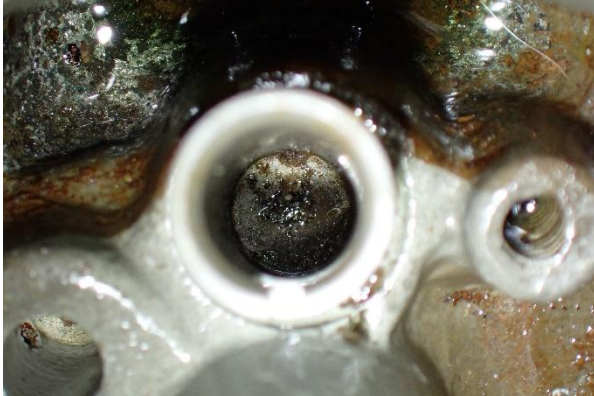
Photograph 7: Mixture control housing with debris

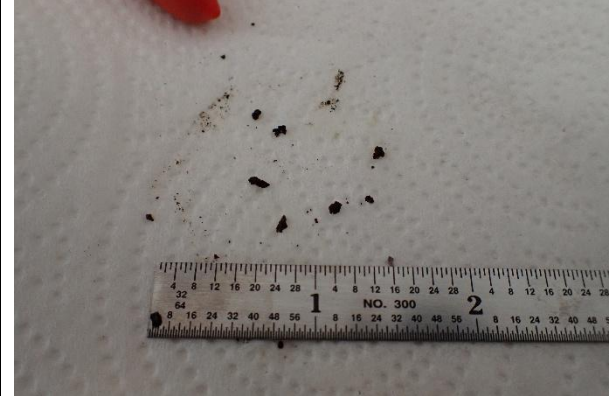
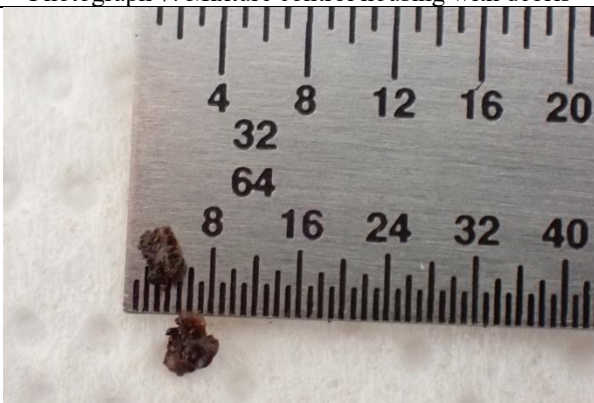
Photograph 8: Debris sample with scale

Photograph 9: Debris sample with scale

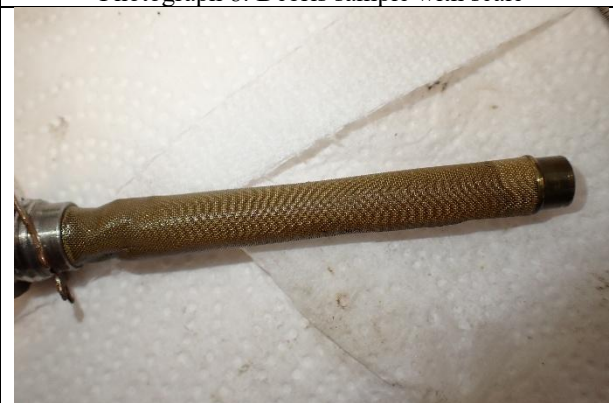
The carburetor floats, and the carburetor float valve displayed normal operating and wear signatures. The fuel inlet screen was removed, and it was observed to be slightly crushed on one end; however, the screen was unobstructed, and there was no debris within the screen.

Photograph 10: Fuel inlet screen
