# National Transportation Safety Board

ERA24LA257

## **WRECKAGE EXAMINATION AND ENGINE RUN REPORT**

Location: Zephyrhills, FL  
Date: June 8, 2024  
Time: 1016 EDT  
1416 UTC  
Airplane: Piper PA28-235 Registration: N15363

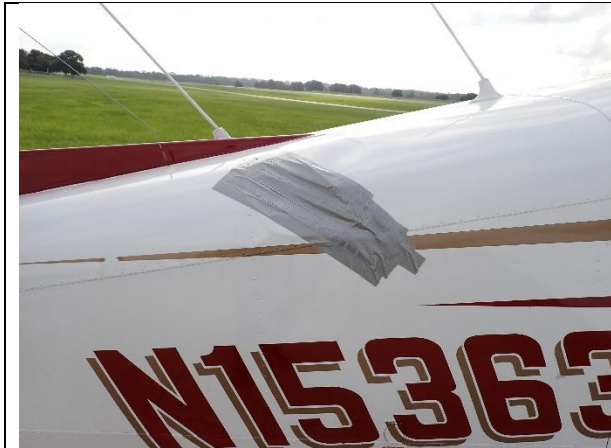
The fuselage displayed impact damage toward the empennage; the fuselage displayed buckling and there was a large-sized hole on the right side of the top fuselage.

Photograph 5: Damage to fuselage (covered by tape)

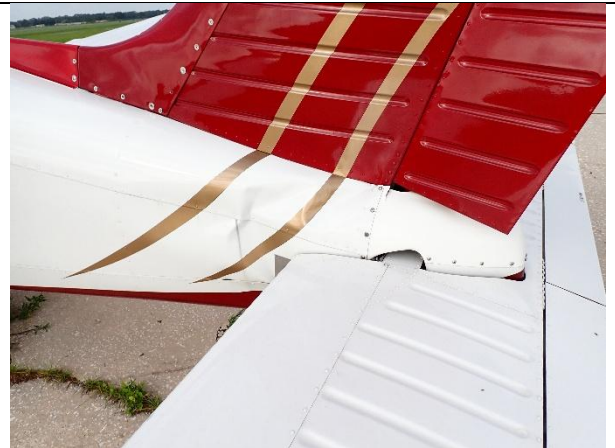
The empennage remained attached to the fuselage and displayed impact damage signatures. There was buckling just forward of the tail cone installation point, and the right stabilator tip had partially fractured. Flight control continuity for the stabilator, rudder, and stabilator trim was verified by moving the cockpit controls and observing flight control movement.

Photograph 6: Damage to empennage

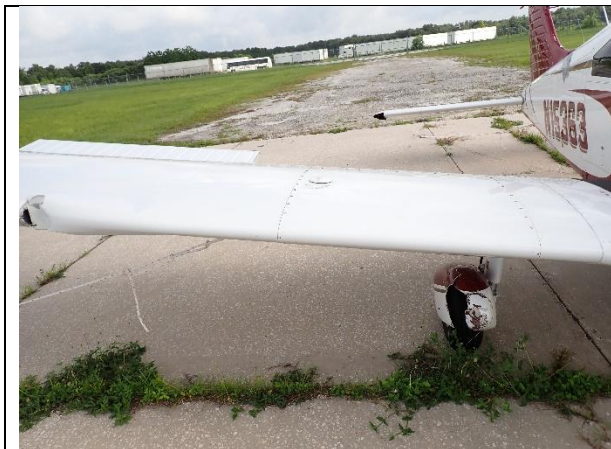
Photograph 7: Right wing with damage

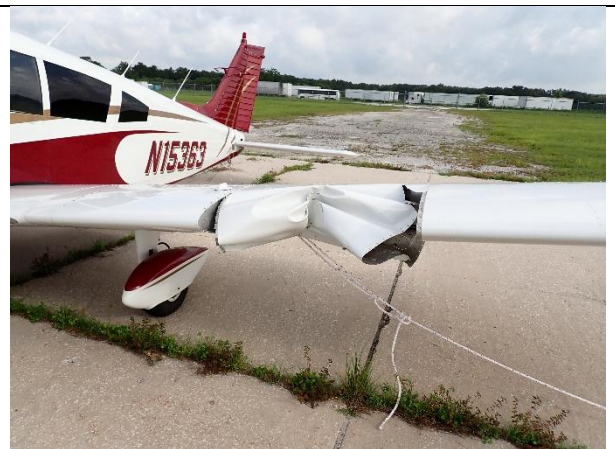
Both wings remained attached to the fuselage and displayed impact damage signatures. The left-wing displayed the most damage, there was a large dent consistent with an impact with a fence post midspan of the wing. The left-wing tip, where the left aux fuel tank is located, displayed impact damage. According to the FAA, the fuel tank was noted to be leaking fuel after the accident. The right-wing displayed a medium-sized dent about midspan of the wing, the impact area also displayed buckling of the wing skin aft of the impact point. The right aileron displayed impact damage to the bottom forward portion of the aileron. Flight control continuity for the ailerons was verified by moving the cockpit controls and observing aileron movement.

Photograph 8: Left wing with damage

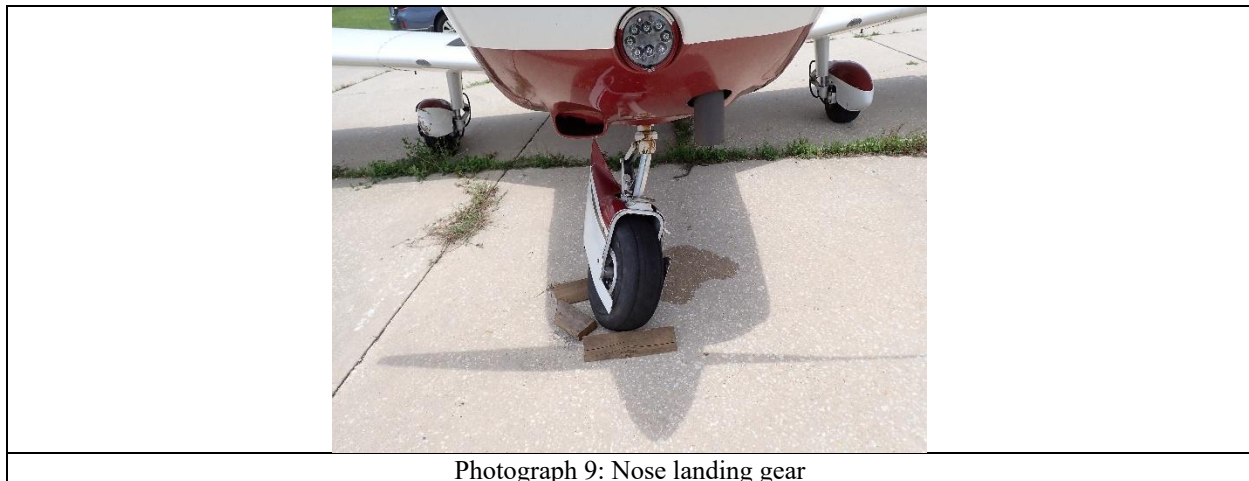
The main landing gear remained secured to their installation points and appeared to be undamaged. The nose landing gear remained attached to its installation point; however, the landing gear displayed impact damage and was bent to the left.

Photograph 9: Nose landing gear

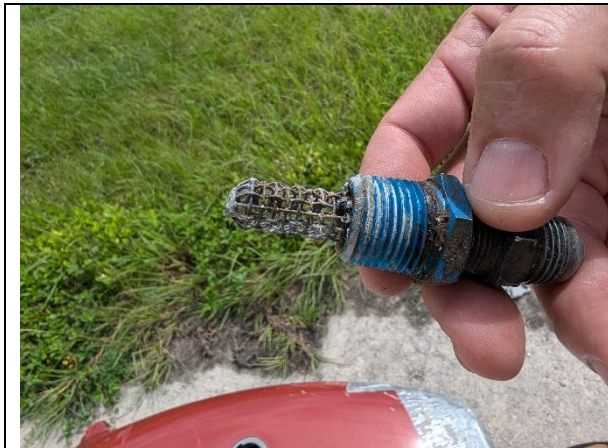
According to the pilot, he had selected the left auxiliary fuel tank during the accident takeoff. The left auxiliary fuel tank was breached and was devoid of fuel. The left auxiliary fuel tank was removed, and the fuel pickup screen was removed from the fuel tank. The fuel pickup screen was clear of any contamination and was unobstructed. The left main fuel tank was undamaged, and there were no visible signs of fuel leaks around the fuel tank. The fuel cap was secured to the fuel tank, the

Photograph 10: Left aux tank pickup screen

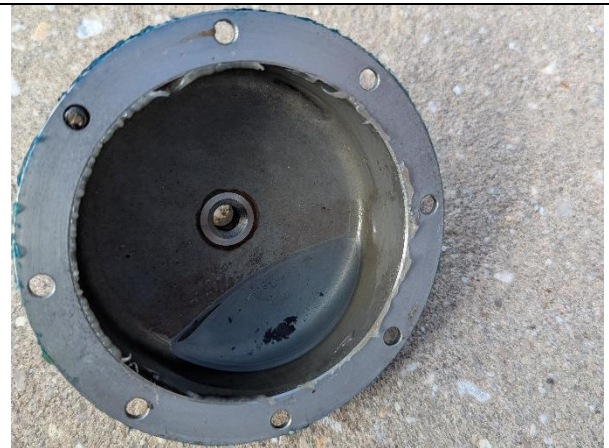
fuel cap was removed and the fuel tank was noted to be close to full with fuel that had the color and odor consistent with 100LL Avgas. The right main fuel tank was undamaged and there were no signs of fuel leaks around the fuel tank and the fuel cap was secured to the fuel tank. The fuel cap was removed, and the fuel tank was noted to be close to full with fuel that had the color and odor consistent with 100LL Avgas. The right auxiliary fuel tank displayed minor impact damage to the fuel tank quick drain, and the fuel cap was secured to the fuel tank. The fuel cap was removed, and the fuel tank was devoid of fuel. The fuel selector in the cockpit was rotated to each position and was noted to have a normal detent for each position. The fuel selector was positioned to the left tip tank position, and low-pressure air was blown through the fuel strainer outlet; the left tip tank fuel lines were unobstructed, and there were no signs of breaks in the lines. During the engine test run, the left main fuel tank and right main fuel tank were selected, and the engine ran on either of the main fuel tanks normally. After the engine test run, the fuel strainer bowl was removed, and the screen was examined. The fuel strainer bowl had a large piece of debris inside the fuel bowl, and the fuel screen had debris contamination in the screen; however, the screen was not obstructed.

Photograph 11: Fuel strainer bowl with debris in fuel

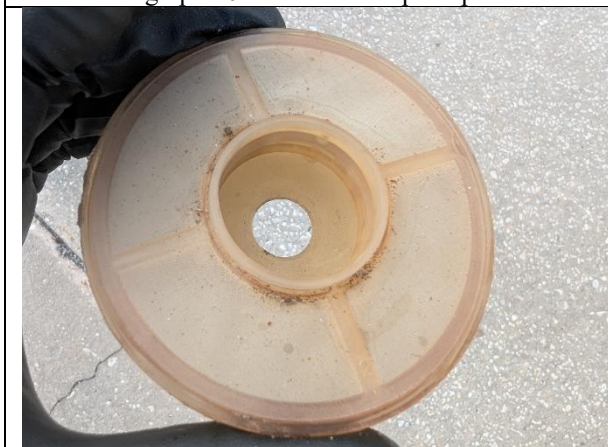
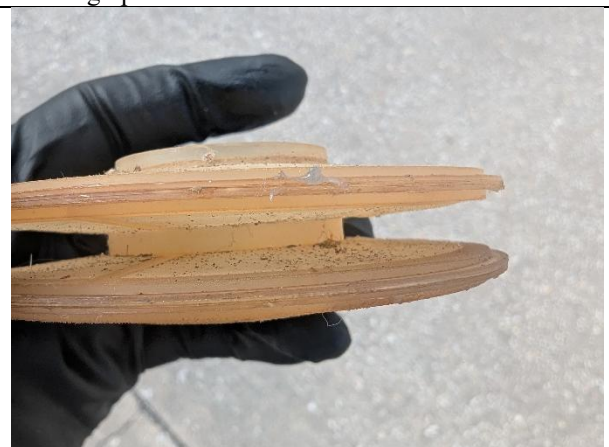
Photograph 12: Fuel strainer screen with debris in screen

Photograph 13: Fuel strainer screen with debris in screen

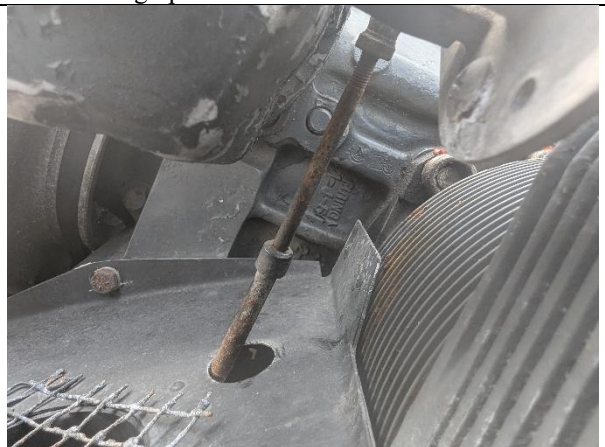
The cockpit was undamaged and all flight controls, switches, and the throttle and mixture controls operated normally. The propeller control was seized and could not be moved more than ½" from the full RPM position.

Photograph 19: Propeller governor control cable end (corroded)

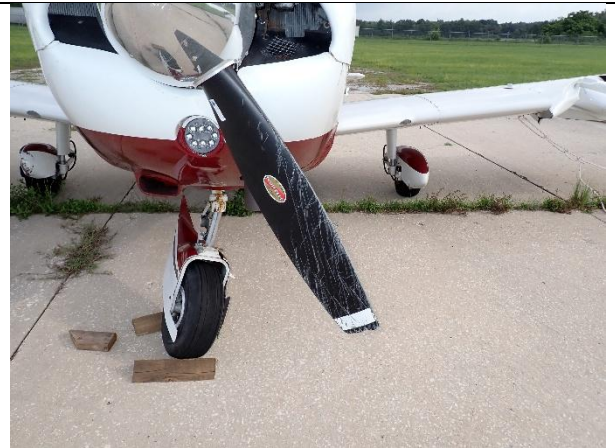
The two-bladed, constant-speed propeller remained attached to the crankshaft and displayed impact damage to one of the propeller blades. Approximately 2" of one of the propeller blades had separated from the rest of the propeller, the damage was consistent with impact damage. The other propeller blade was undamaged. To ensure the propeller was balanced during the engine run, approximately 2" of the undamaged propeller blade was cut off.

Photograph 21: Impact damaged propeller blade
