ERA24LA258

## INVESTIGATION PHOTOGRAPHS

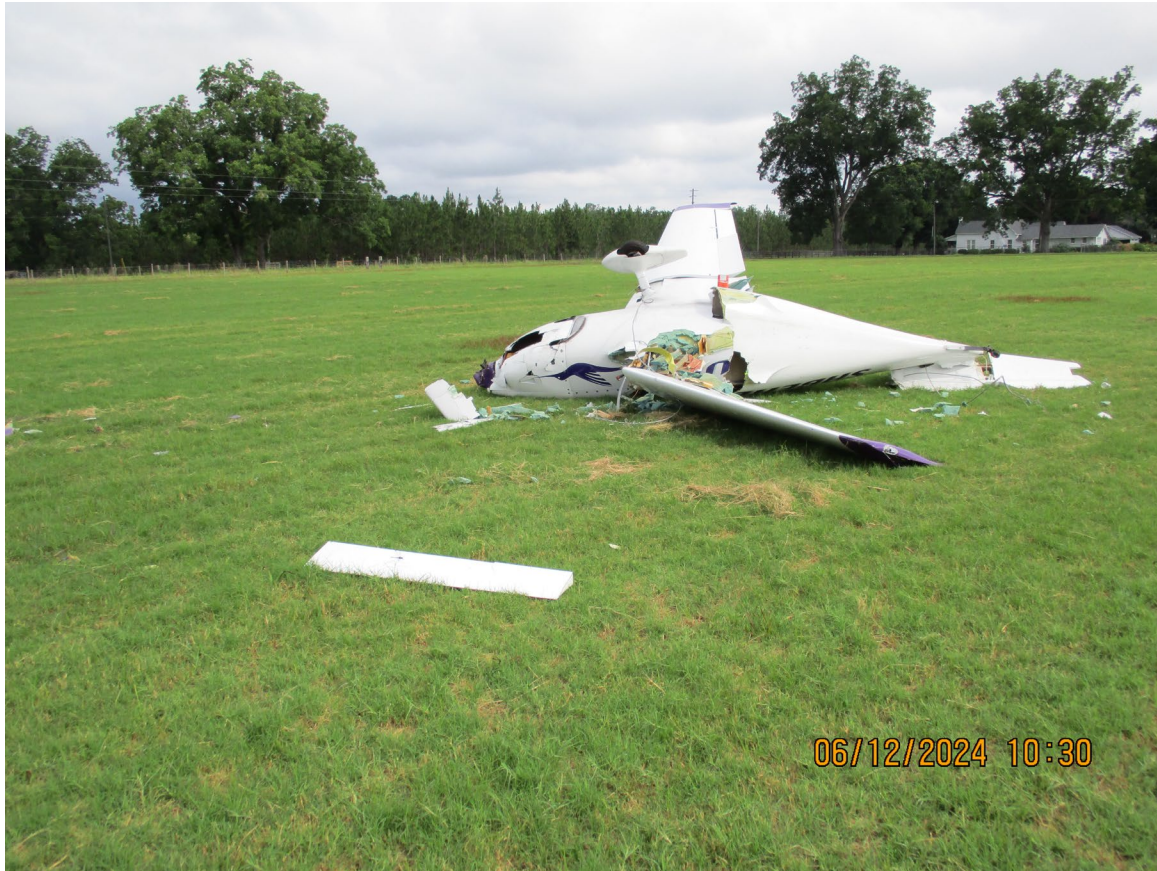
**Photograph 1 - Fractures noted to fuselage and right wing (Courtesy of FAA)**

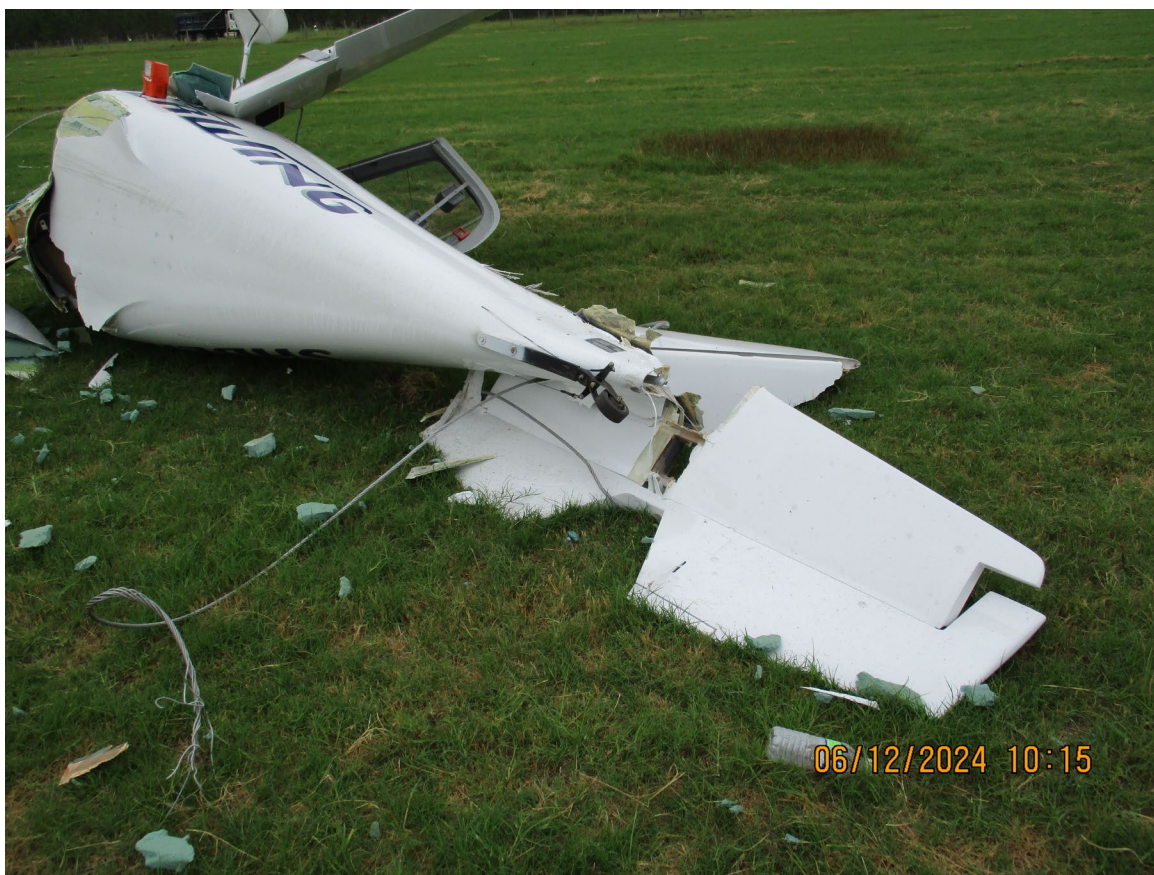
**Photograph 2 - Fractures and partial separation noted to empennage (Courtesy of FAA)**
