Damian Galbraith  
Aviation Accident Investigator  
OAS

**Subject:** ERA24LA258, Pilot's Statement and Engine Examination

Incident date 6/10/2024 Aircraft N120SW Saberwing Prototype - Valdosta, Lowndes Co. Georgia

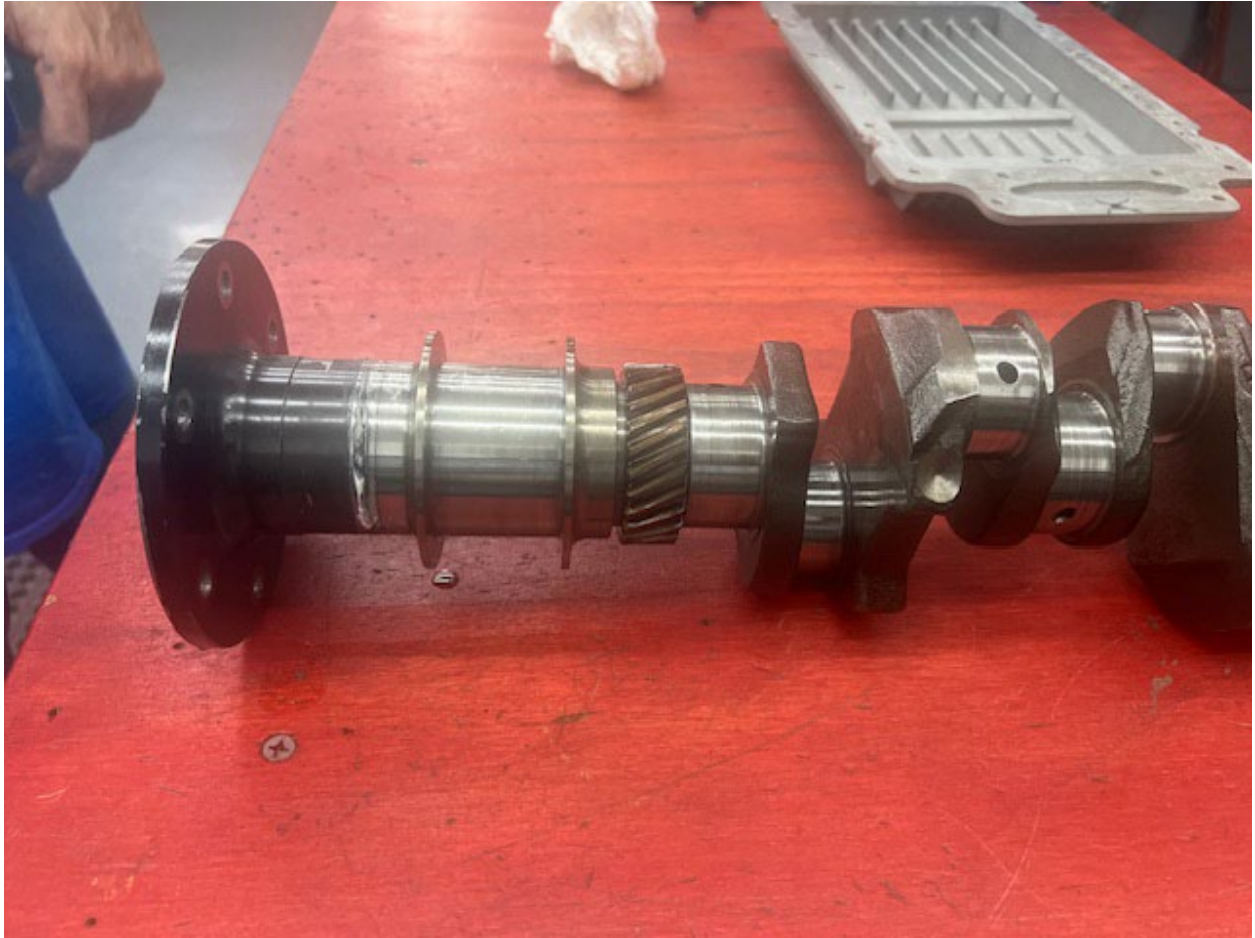
Conclusion: Engine failure occurred when crankshaft to cam gear slipped due to sheared woodruff key. This engine (built in 2007 era as test engine) had several ground run hours but only 20 or so flight hours. I had removed our turbo engine from the airframe for testing on our dynamometer and installed this engine in the interim. Flew off 5 hours and then to Sun n Fun 2024 for Air Show. Flew it back. All systems nominal. It was when I was testing the ignition that the failure occurred. When switching from points to electronic there is a small interval when electronics power up so there is a jolt across the engine once power is restored. This jolt at a high power setting was enough to rotate the gear and shear the key.

Crankshaft as removed from Engine prior to hub removal – timing marks on gear do not match crank position – about 30 degrees off

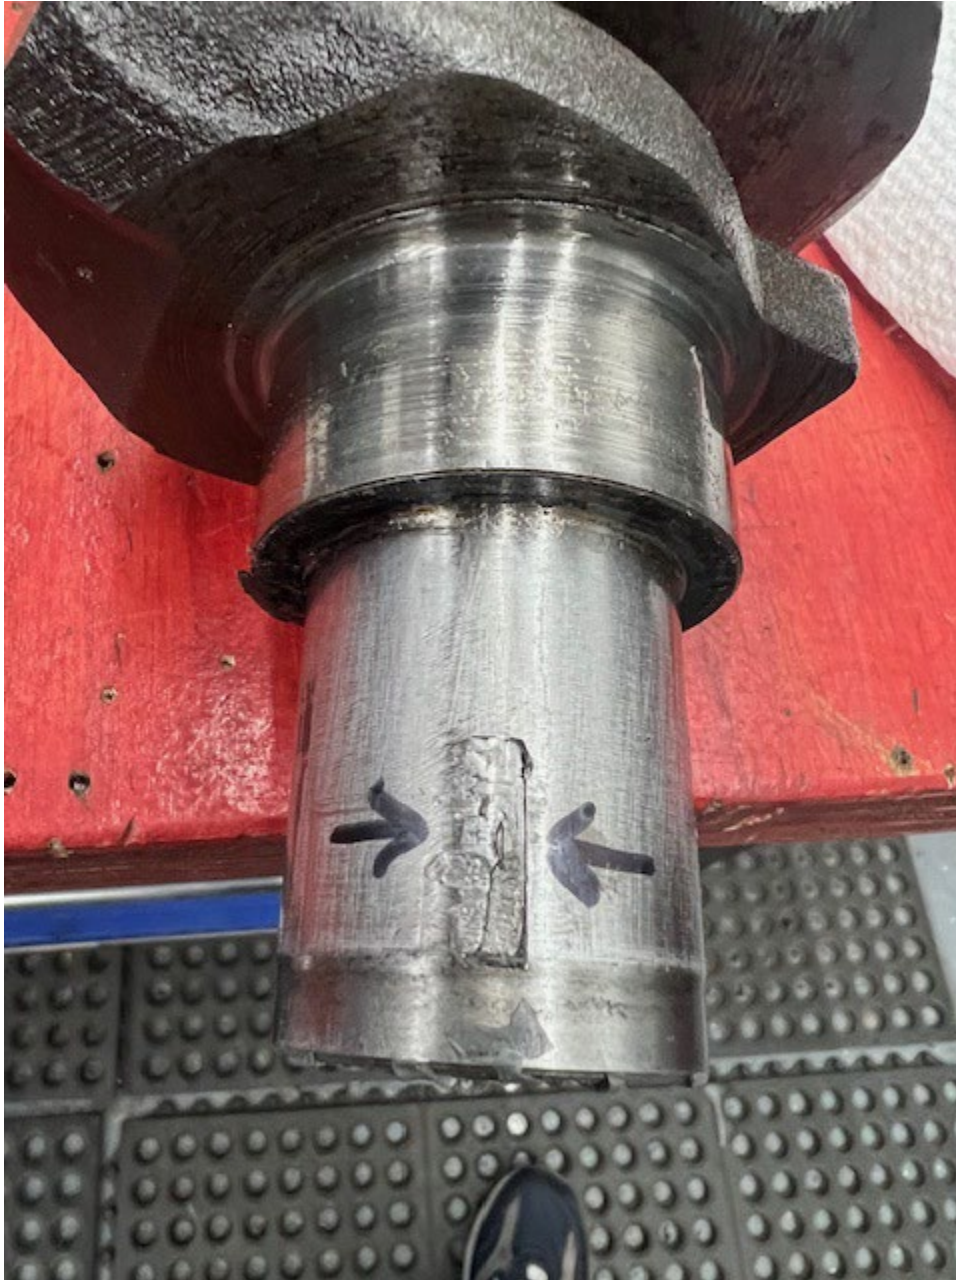
Notice sheared key

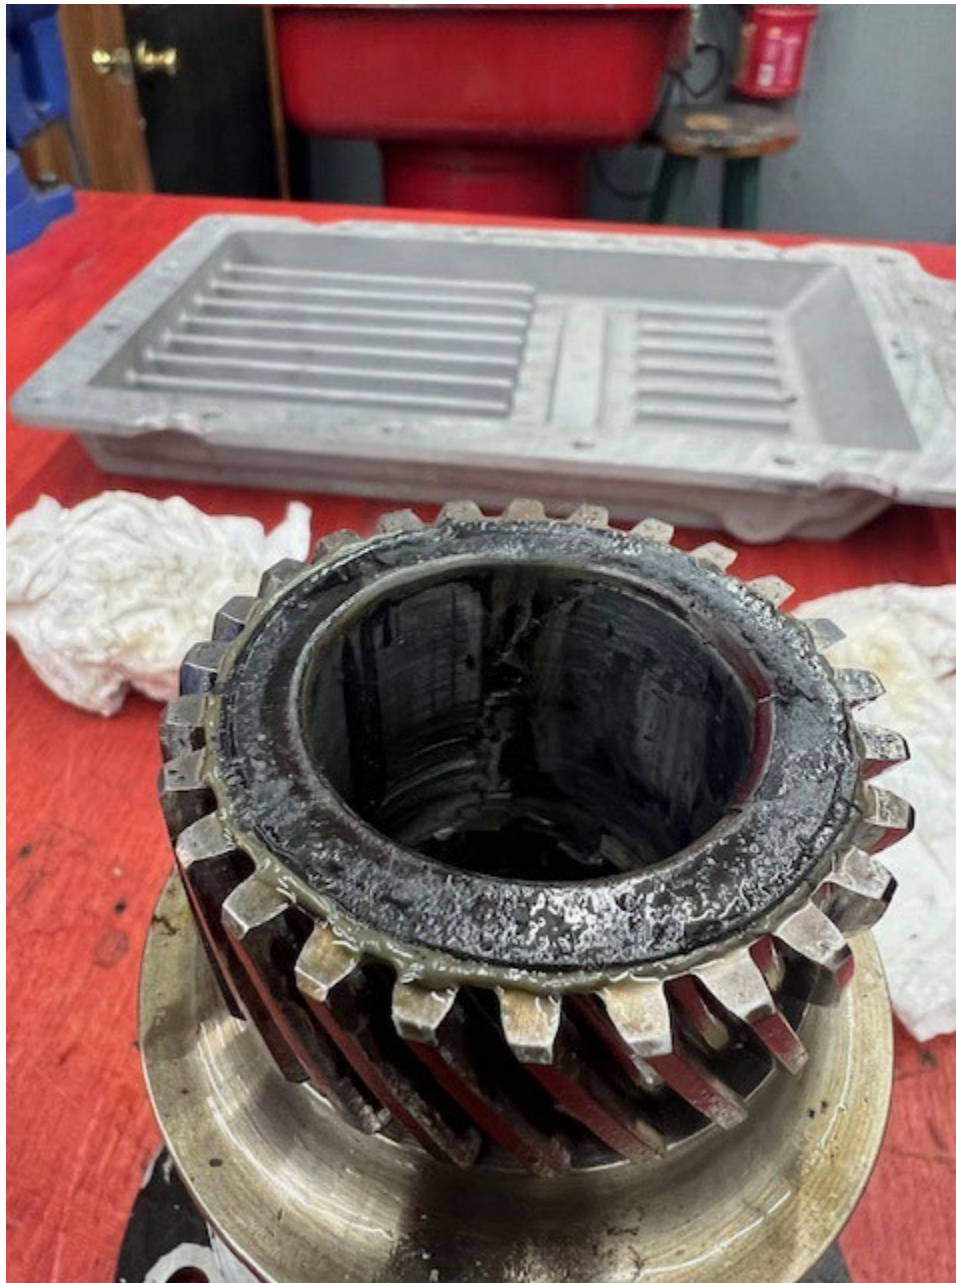
This gear is installed with a .004" interference fit and hardened key requiring @ 40 tons+ pressure to remove it. Early (2006-2007) test gears only had .002" interference and normal keys. We never had a failure in testing but noticed that removal of a test gear only took 5 tons of pressure so we changed our process to higher interference fit. There have not been any gear or keyway failures to date with new tolerances.

Inside of hub/gear showing sheared key. Striations on inside of hub show some non-contact areas. Hub came off with only 3 tons pressure – early hub design.
