ERALA24259

## INVESTIGATION PHOTOGRAPHS

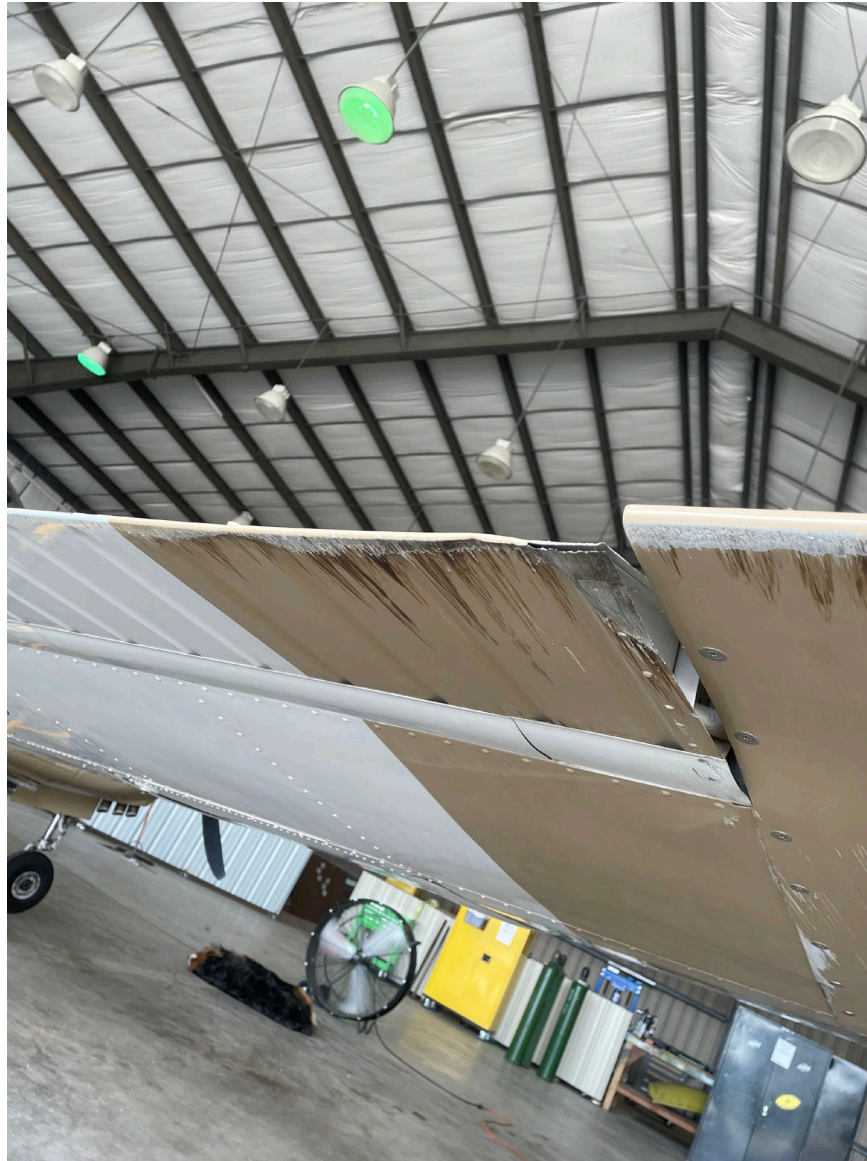
**Photograph 1 - Right aileron damage (Courtesy of FAA)**

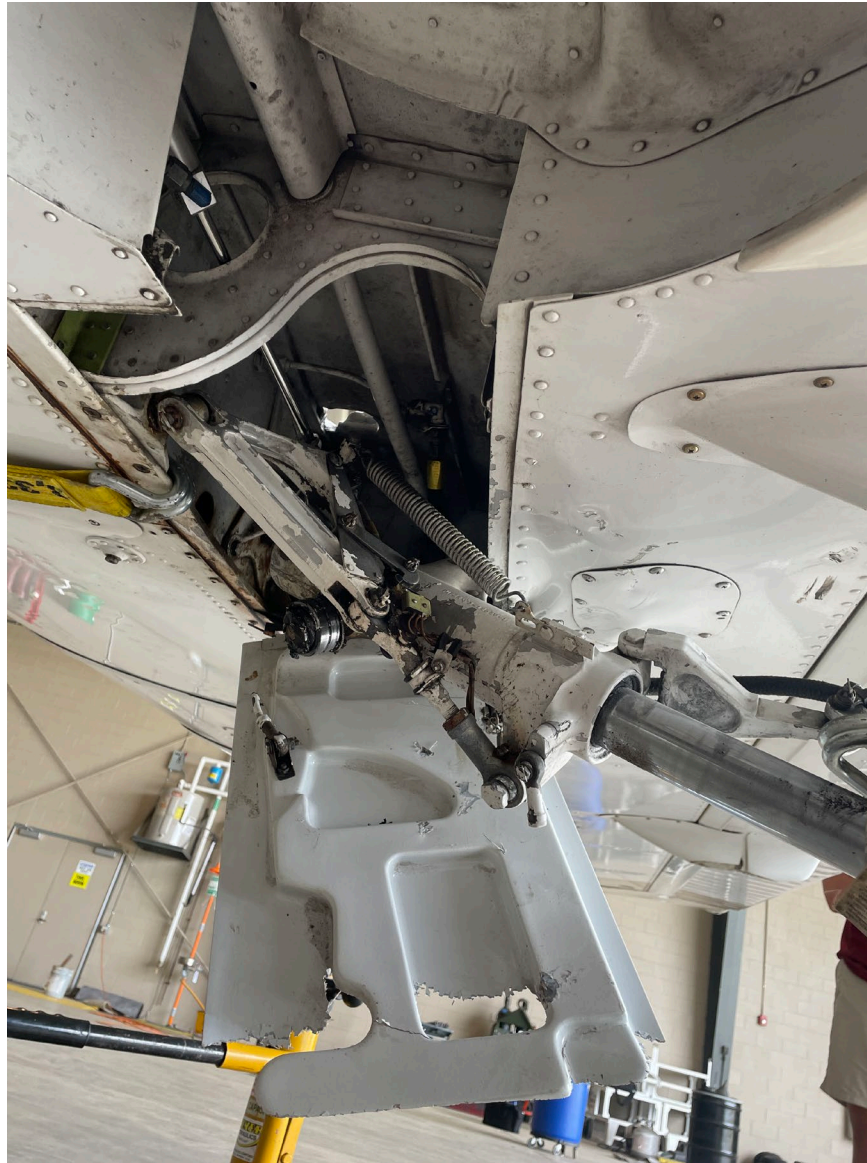
**Photograph 2 - Right main landing gear collapse (Courtesy of FAA)**
