Timothy W. Monville  
Sr. Air Safety Investigator  
Office of Aviation Safety - Eastern Region

**Subject:** ERA24LA263, Record of Conversation/Interview

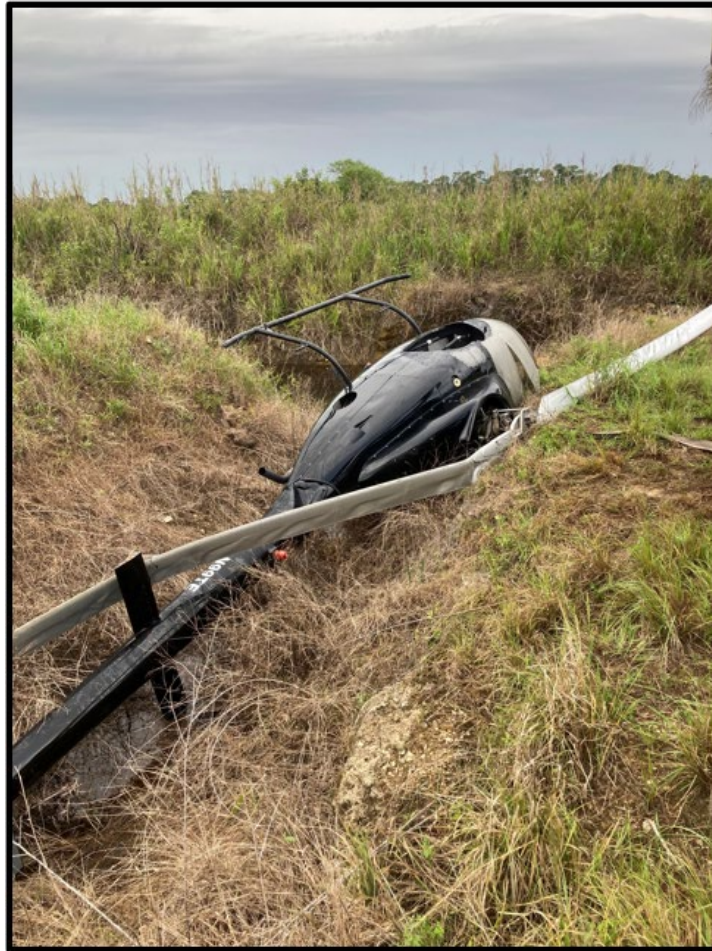
**Figure 1: Helicopter at Accident Site.**

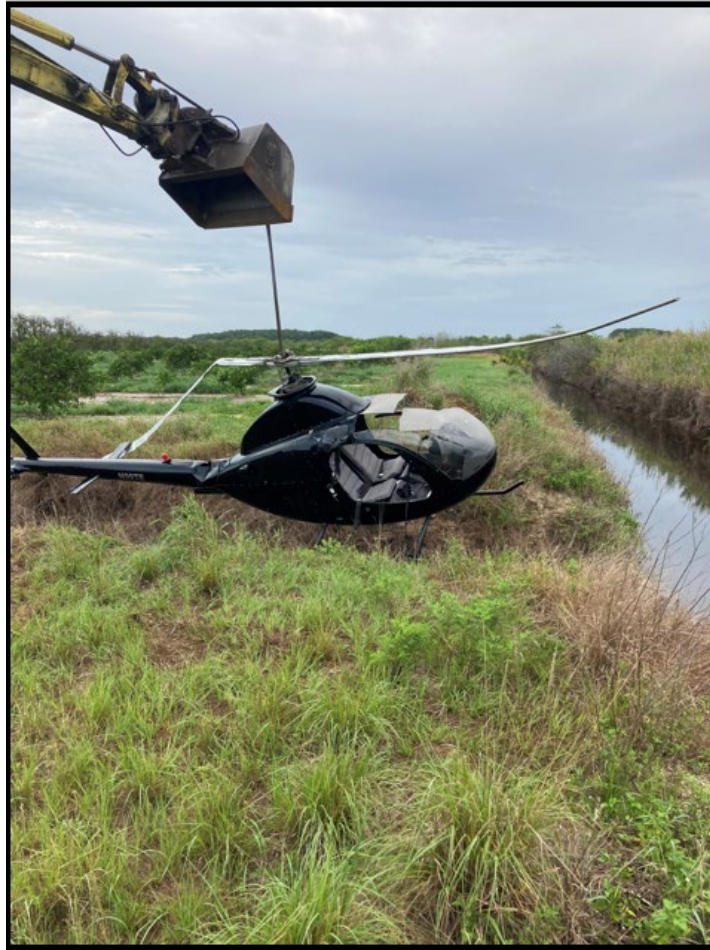
He (Robert Roper) performed the takeoff from their home and turned on course towards 87FL, then offered the controls to his son at about 200-300 ft. His son flew a “high recon” over 87FL and then flew in an easterly direction to the east/west oriented runway. During the approach his son he noted the main rotor rpm decreasing and applied corrections. Mr. Roper attributed this to be from the helicopter that was not equipped with a governor. While flying between 100 and 150 ft above ground level and between 20 and 30 mph, or just below effective translational lift (ETL), the flight encountered loss of tail rotor effectiveness (LTE). He took the controls from his son and applied forward cyclic and right anti-torque pedal to correct the left complete yaw, reporting that the helicopter was making a sweeping left descending turn with right anti-torque pedal input. The flight ran out of altitude and one skid impacted in a ditch and the other impacted the ground. The helicopter rolled and came to rest on its right side (Figure 1) in a north/south oriented ditch that fed a larger east/west oriented ditch. After coming to rest in an attempt to get out of the helicopter he damaged a section of the side window post and windshield. After coming to rest and getting out of the helicopter he and his son discussed the wind and observed it to be from the east at about 5 mph, adding that the type of helicopter they were in did not like a tailwind. Mr. Roper estimated that the entire flight time was 5 to 8 minutes total. The main rotor blades were damaged and there was crease in the tailboom (Figure 2).

**Figure 2: View of the Helicopter During Recovery. Note the Damage to the Tailboom.**

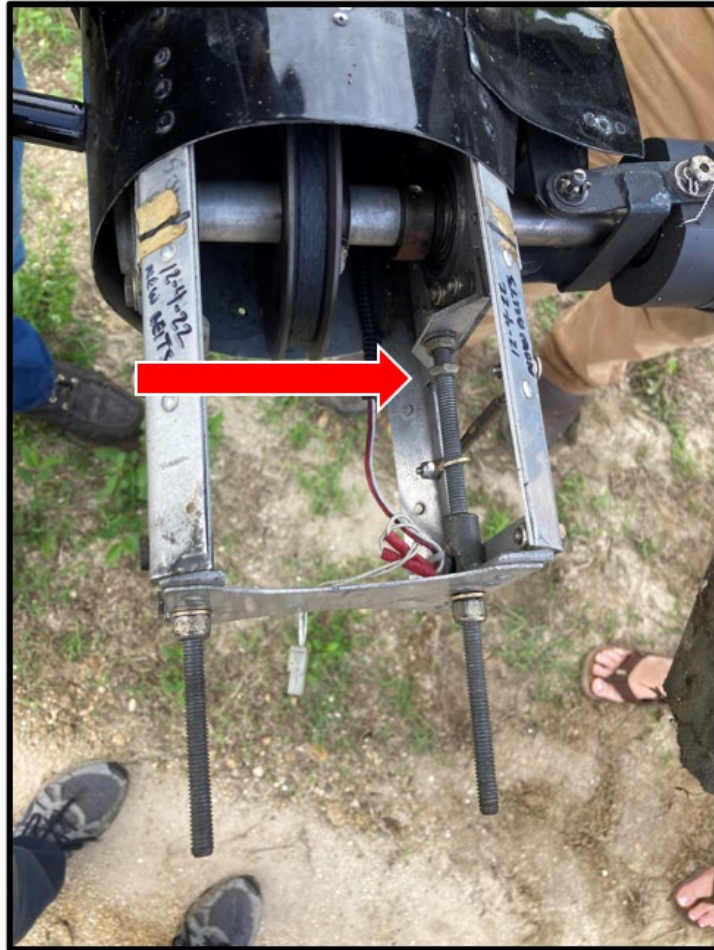
Although there was no fuel leakage noted at the site, because the helicopter was resting on its side and the fact that the ditch fed into a larger ditch with water, he moved the helicopter on June 15, 2024 without permission. He recovered it to his home address<sup>2</sup>. During the recovery he noted one jam nut of the tail rotor drive belt tensioner was about 3 inches away from the plate it was designed to be against (Figure 3). During recovery of the helicopter he confirmed anti-torque pedal control cable continuity for both seats from the anti-torque pedals to the tail rotor pitch change mechanism. Prior to recovery he did not check the tail rotor drive belt tension but added that due to damage to the tailboom any check would not have been accurate. He also reported that all tail rotor drive belts were in-place.

He indicated that immediately following the accident if there was an issue, he did not see it. The “engine and airframe performed as advertised.” He also indicated that based on observations immediately after the accident in, “high likelihood it was pilot induced and not part of the aircraft.” During the recovery of the helicopter he noted the jam nut out of position for the tail rotor drive and questioned if that would have prevented the tail rotor from operating at full rpm resulting in lack of full right anti-torque pedal authority.

Figure 3: Arrow Points to Tail Rotor Drive Belt Jam Nut Out of Position.
