Timothy W. Monville  
Sr. Air Safety Investigator  
Office of Aviation Safety - Eastern Region

**Subject:** ERA24LA269, Record of Conversation/Interview

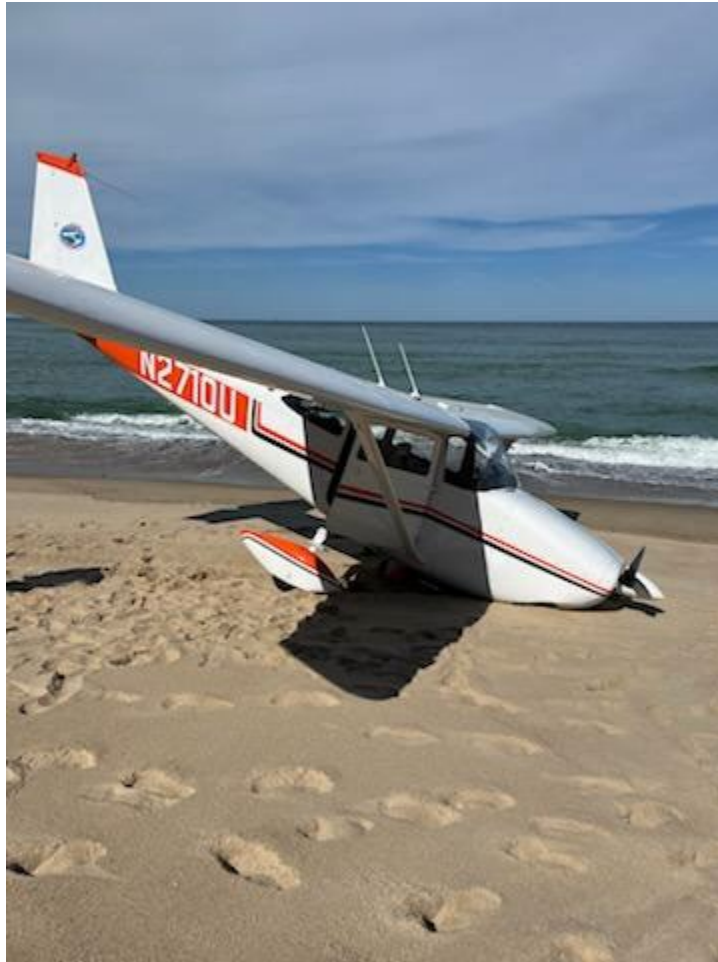
Mr. Howard indicated that he is an airframe and powerplant mechanic with inspection authorization as well as a commercial pilot. With respect to the accident flight, it was a planned 30 minutes long sight-seeing flight operated under Part 91. He estimated that the total flight duration was about 20 minutes. During the flight, the engine experienced loss of power and the pilot performed a forced landing to a beach resulting in collapse of the nose landing gear (Figure 1). There were no injuries to the pilot or two passengers.

**Figure 1: Right Side View of the Airplane at the Accident Site.**

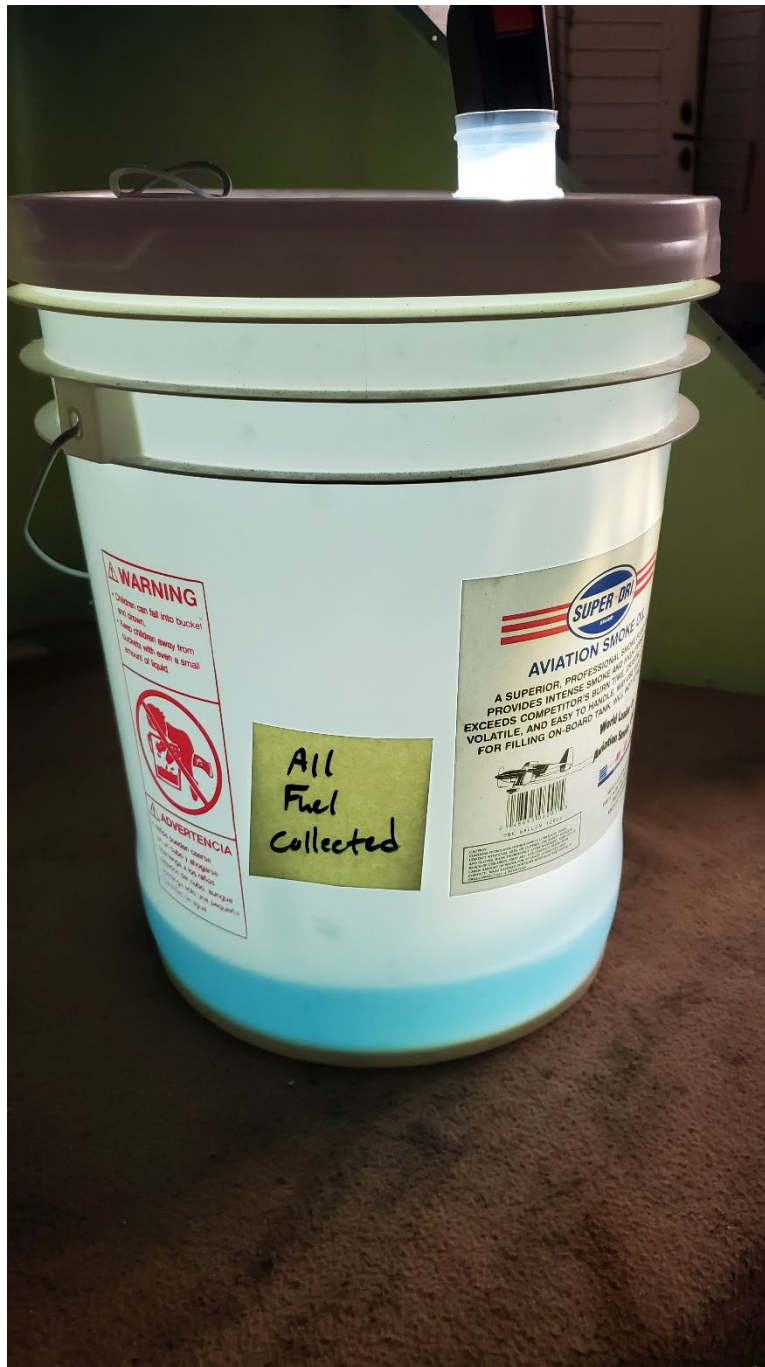
team met them and assisted them the last 1/4 mile to the nearest beach access road/trail. Once the aircraft was derigged from the tow harness it was once again resting in the same nose low position as it had landed. At this point Mr. Howard was able to fully inspect and photograph the aircraft. Prior to removing the wings, fuel was drained from each wing tank via the sump drains with about a 1/4 gallon of fuel drained from one tank and about 1/2 gallon of fuel drained from the other. Following the recovery of the aircraft, each wing was elevated at the wingtip and an additional approximately 1/8 gallon of fuel was drained from each wing tank. An additional approximately 1/4 gallon was drained from the fuselage plumbing resulting in a total amount drained from the airplane between 1.25 and 1.5 gallons (figure 2).

During the conversation Mr. Howard indicated that the unusable fuel capacity in each fuel tank was 1.5 gallons, or 3.0 gallons total for both wings. Thus, the total amount of fuel drained from both fuel tanks and the airplane was about the unusable fuel amount for each fuel tank.

**Figure 2: Photograph Showing Total Amount of Fuel Drained From the Airplane.**

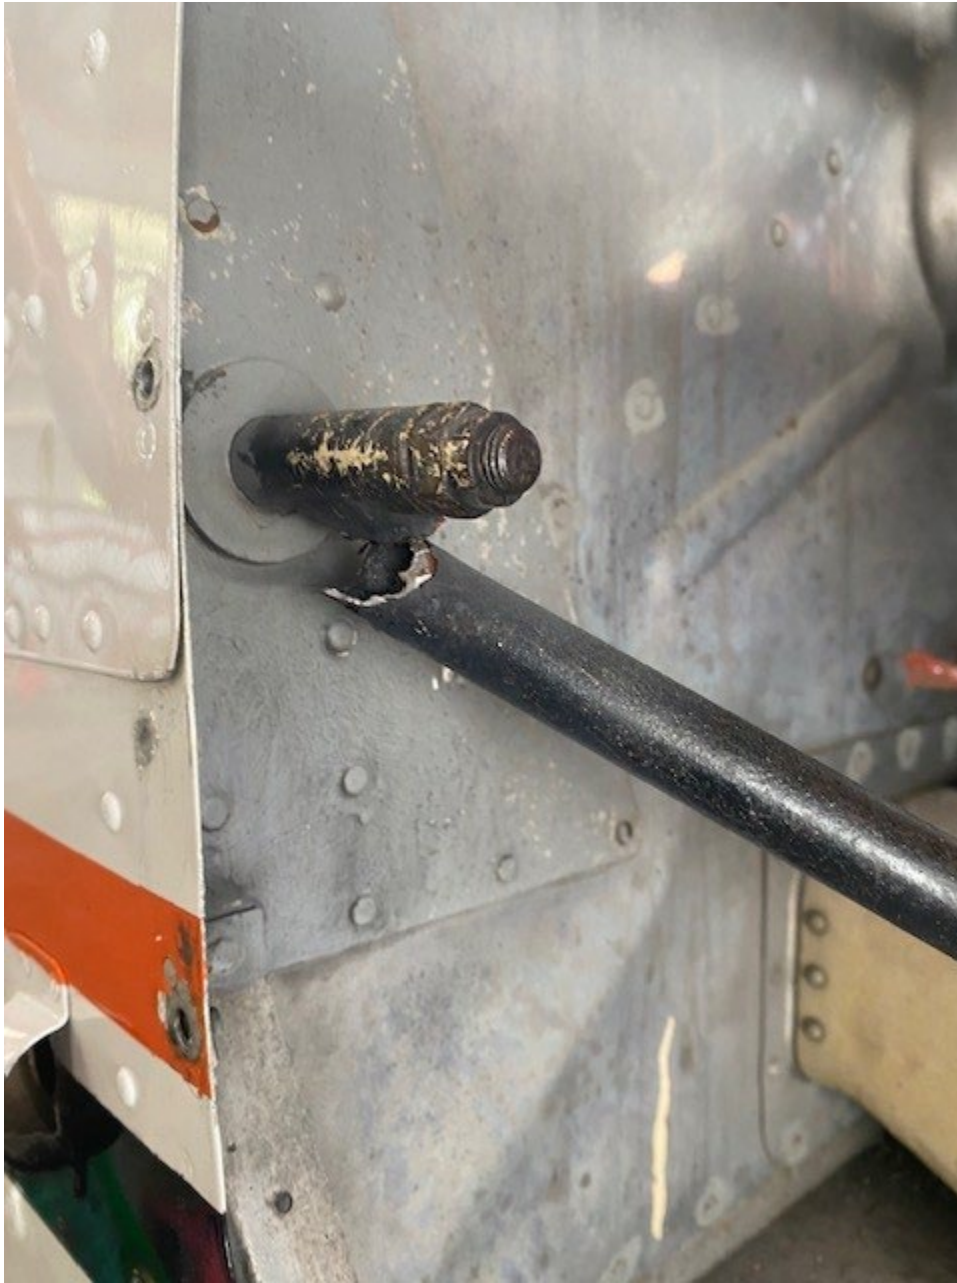
With respect to damage to the airplane, Mr. Howard reported one engine mount tube was bent, and one tube was fractured at a weld (Figure 3). The firewall sustained damage also.

**Figure 3: View Showing the Fractured Engine Mount Tube.**
