ERA24LA270

## INVESTIGATION PHOTOGRAPHS

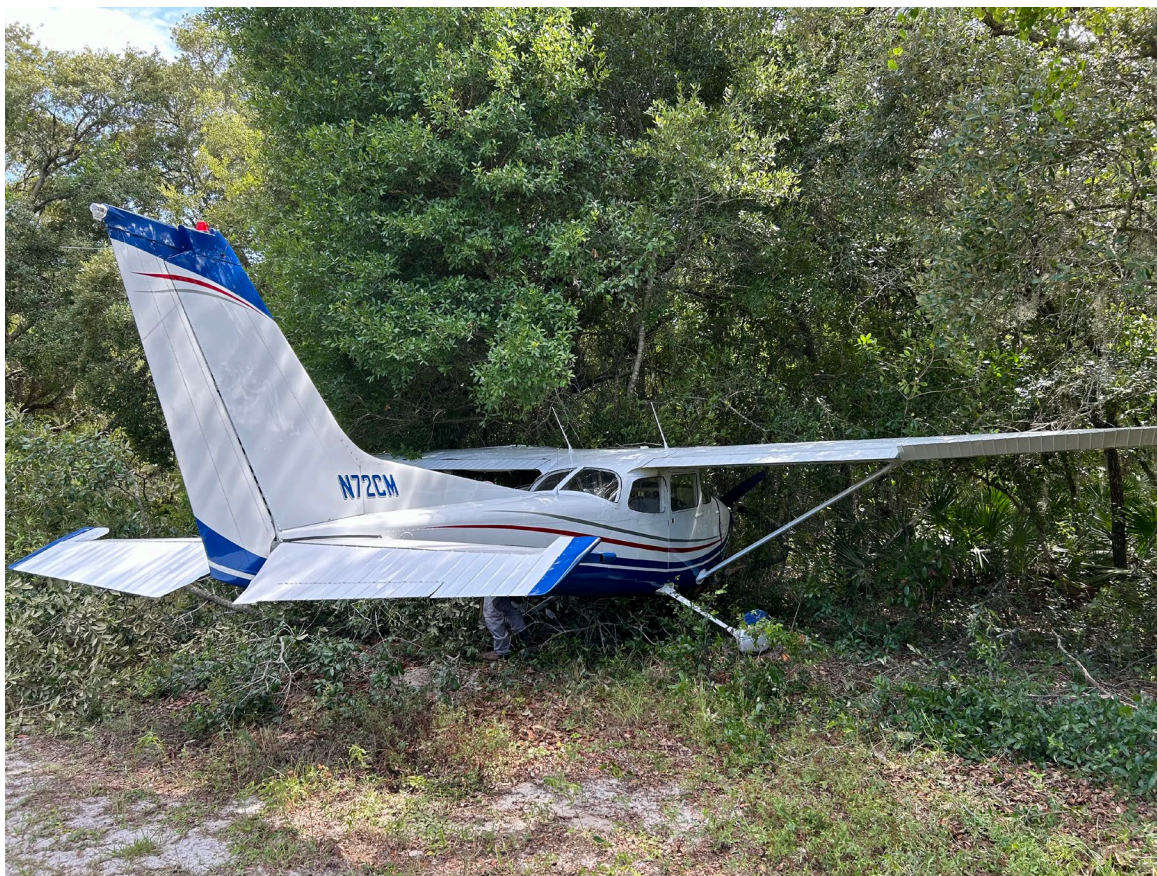
**Photograph 1 - Aircraft postaccident (Courtesy of FAA)**

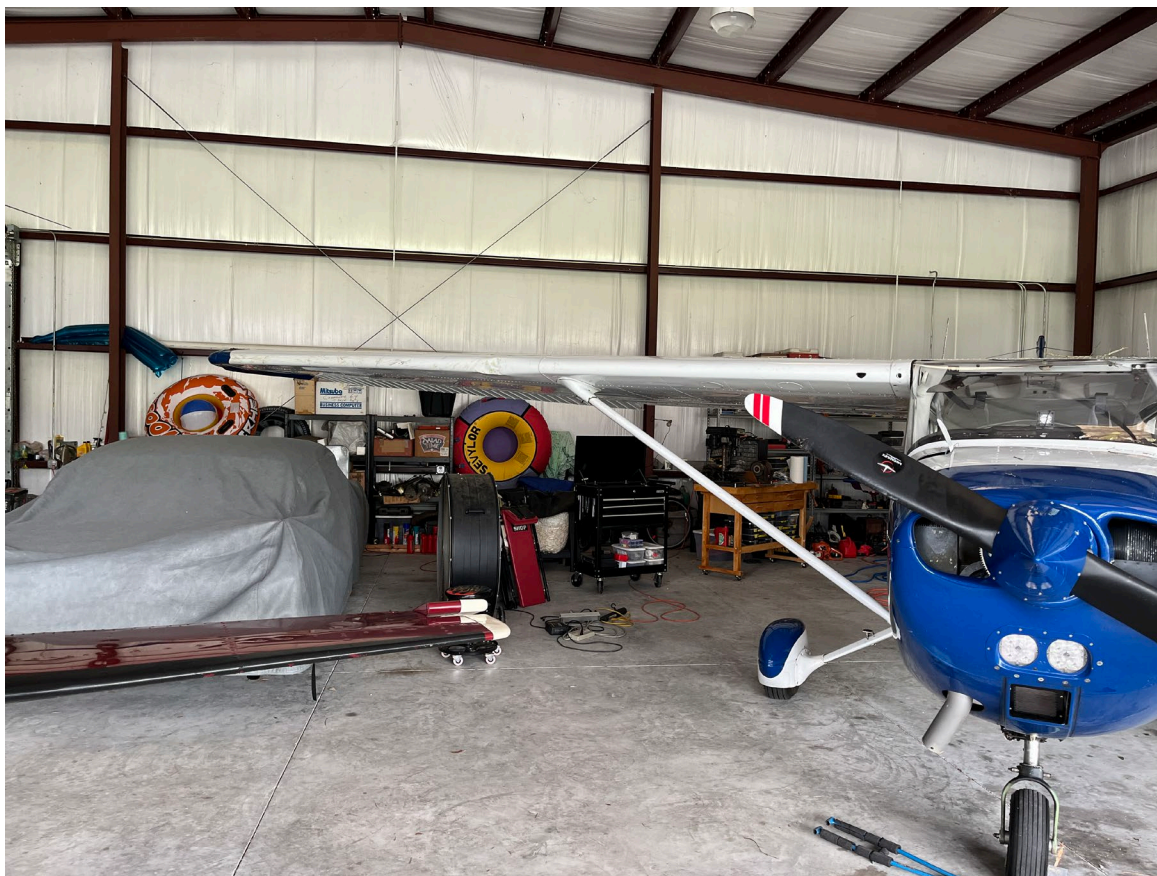
**Photograph 2 - Right Wing postaccident damage (Courtesy of FAA)**

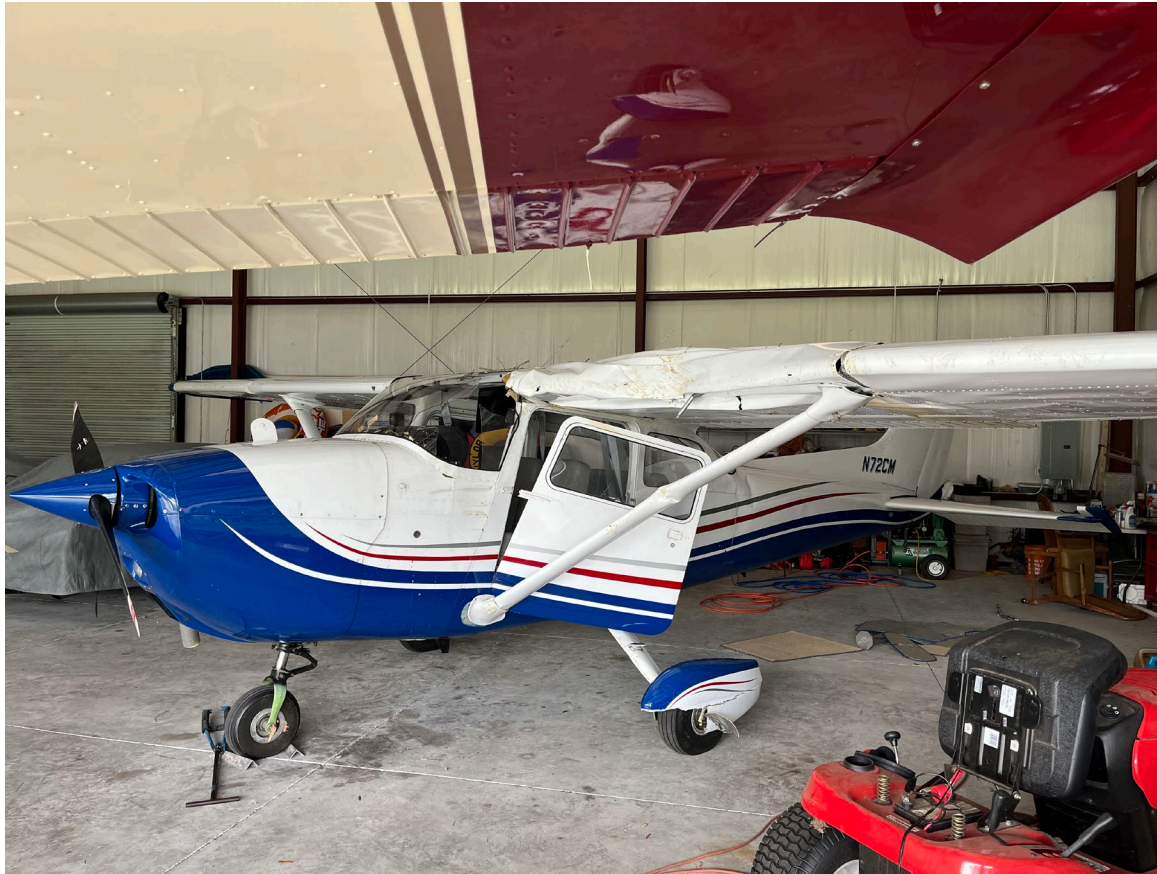
**Photograph 3 - Left side postaccident damage (Courtesy of FAA)**
