# National Transportation Safety Board

ERA24LA276

## **WRECKAGE EXAMINATION REPORT**

Location: New Ipswich, New Hampshire  
Date: June 25, 2024  
Time: 12:55 EDT  
16:55 UTC  
Airplane: Robert Snyder Searey (N453TS)

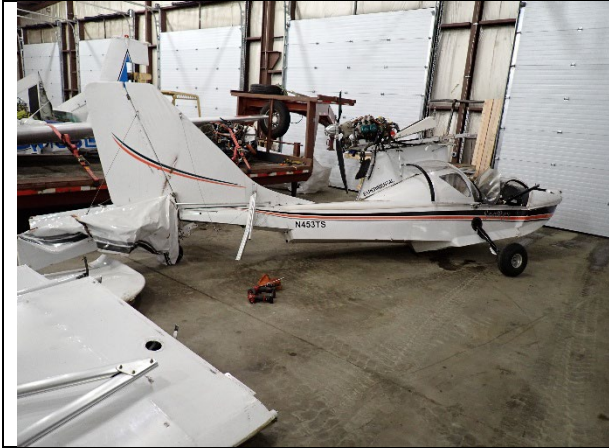
Photograph 1: Airframe overview

At the time of the examination, both wings had been removed from the airplane to facilitate recovery. The fuselage, empennage, and wings displayed impact damage signatures; however, the engine mounting section of the fuselage was undamaged. Flight control continuity was established for all flight controls from the cockpit controls to their respective flight control surfaces. The continuity of the throttle and choke control cables was established from the cockpit controls to both carburetors.

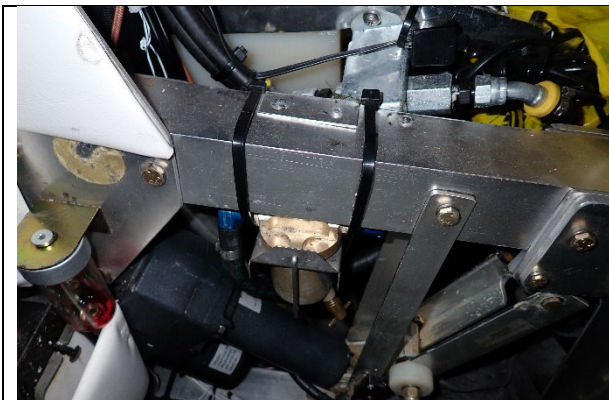
Photograph 3: Fuel strainer bowl installation

The airplane's fuel tank remained installed in the fuselage and contained approximately 2/3<sup>rd</sup> of a tank of fluid that had the odor and color consistency of automotive fuel. No placards were observed stating the approved fuel type or total fuel quantity. The fuel shutoff valve was found in the "OFF" position. The airplane was equipped with a shutoff valve for the fuel vent system which was also found in the "OFF" position. The airframe electrically driven fuel pump remained attached to its installation point and was undamaged. The fuel pump inlet and outlet fuel lines remained secured to their respective fuel fittings and the electrical wires were secure. The fuel pump was removed and connected to a 12V battery; the fuel pump operated normally. The fuel strainer bowl was secured to the airframe through zip ties and fuel lines. The inlet and outlet fuel lines were secure and there were no signs of fuel leaks. It was noted that the fuel line routing, and the strainer bracket design prevented the fuel bowl from being removed without removing the fuel line and removing the securing arm forcefully. The fuel bowl was removed and was full of fuel with the odor and color consistency of automotive fuel. The fuel screen was removed and a small amount of debris was noted in the screen; however, the screen was not obstructed.

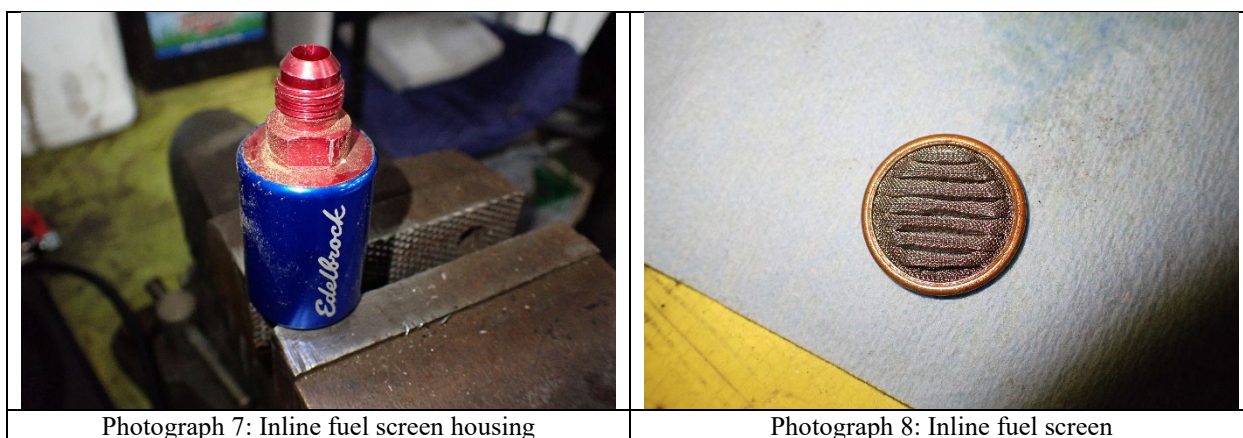
The fuel lines going to the engine were noted to be secure to the engine driven fuel pump and to the carburetors. Low pressure air was blown into the airframe and engine fuel lines, and it was noted that the lines were unobstructed. An inline fuel screen was located near the engine. The fuel screen was disassembled, and the fuel screen was noted to be clear of any contamination and was unobstructed.

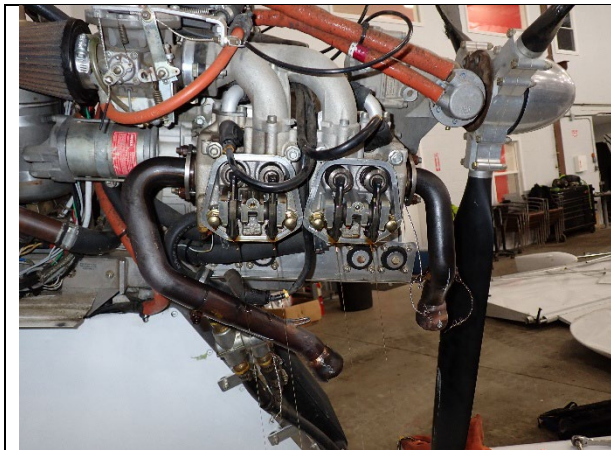
Photograph 9: No. 1, No.3 Cylinders

Continuity was established between the propeller shaft, gearbox, crankshaft, camshaft, connecting rods, and associated components by rotating the propeller shaft manually. There were no signs of binding within the internal components noted during rotation. Thumb compression and suction was established for all four of the cylinders and the rocker arms and valves operated normally during propeller shaft rotation. The cylinders were inspected using a lighted borescope; the piston faces,

cylinder walls, and valve heads displayed normal operating and combustion signatures and there were no signs of overheating of the cylinders. The oil filter was removed, cut open, and the filter pleats were inspected. There were no anomalies noted within the filter pleats.

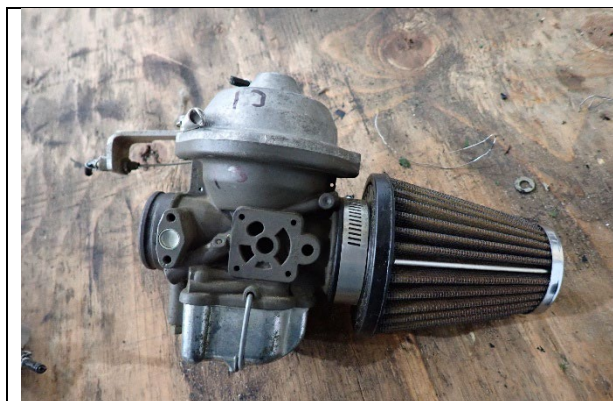
Photograph 13: No. 1, No. 3 Carburetor

The carburetors were removed from the engine to facilitate examination. The throttle arm carburetor for the No. 1 and the No. 3 cylinders was noted to be slightly bent and would contact the carburetor frame and bracket during operation. The throttle valve operated normally during throttle arm movement. The carburetor was disassembled, and the internal components were examined. The fuel bowl contained fuel that had the odor and color consistency of automotive fuel. The fuel bowl also

displayed signs of corrosion consistent with exposure to water; however, there were no signs of water within the fuel in the fuel bowl. Both floats remained intact and were capable of normal movement. The float needle valve remained installed and operated normally when manually manipulated. The needle valve was removed and the valve displayed normal seating signatures. The carburetor diaphragm was intact and pliable, and the jet needle was installed and displayed normal operating signatures. The main fuel jet was clear of any obstructions.

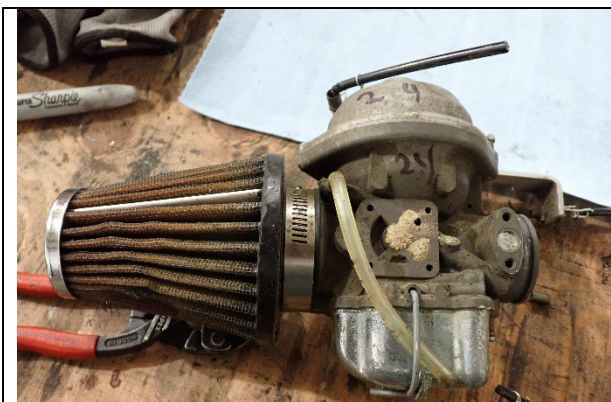
Photograph 17: No. 2, No. 4 carburetor

The throttle arm carburetor for the No. 2 and the No. 4 cylinders was noted to operate normally without contacting the rest of the carburetor. The throttle valve operated normally during throttle arm movement. The carburetor was disassembled, and the internal components were examined. The fuel bowl contained fuel that had the odor and color consistency of automotive fuel. The fuel bowl also displayed signs of corrosion consistent with exposure to water; however, there were no signs of water within the fuel in the fuel bowl. Both floats remained intact and were capable of normal movement. The float needle valve remained installed and operated normally when manually manipulated. The needle valve was removed and the valve displayed normal seating signatures. The carburetor diaphragm was intact and pliable, and the jet needle was installed and displayed normal operating signatures. The main fuel jet was clear of any obstructions.

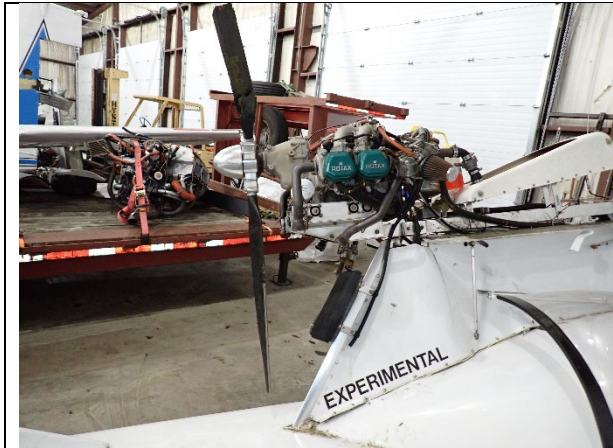
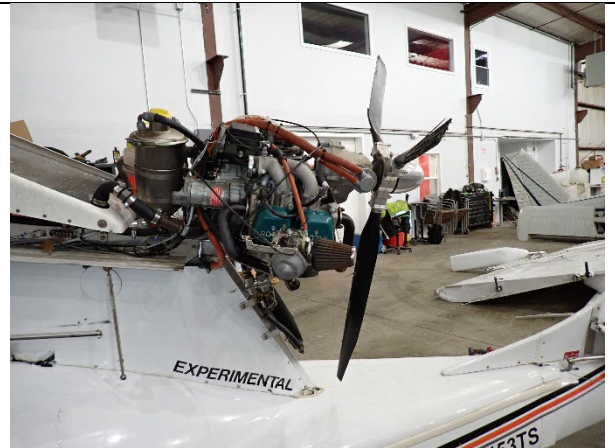
The engine remained attached to the airframe through its engine mounts, hoses, cables, and wires and displayed minimal damage. Both carburetors had disconnected from their respective induction hoses; however, both carburetors were undamaged.

All four exhaust risers remained attached to their respective cylinders; however, the No. 1, No 3, and the No. 4 exhaust risers were found to be loose at the attach point to the cylinder. The exhaust muffler and tailpipe had separated from the exhaust risers and was not with the wreckage. According to the FAA and the recovery personnel, the exhaust muffler and tailpipe assembly was not located at the accident site. Only one of the exhaust springs remained attached to the exhaust risers. The spring remained attached to some safety wire of the No. 2 exhaust riser. The rest of the exhaust risers contained varying amounts of safety wire attached to the exhaust spring brackets that were welded to the exhaust risers. Several of the exhaust spring brackets were noted to have deep gouges/grooves in the bracket that were consistent with excessive wear. The No. 1, No. 3, and the No. 2 exhaust risers displayed deformation around the exhaust riser end that would be inserted into the exhaust muffler and tailpipe assembly; the No. 4 exhaust riser end was undamaged.

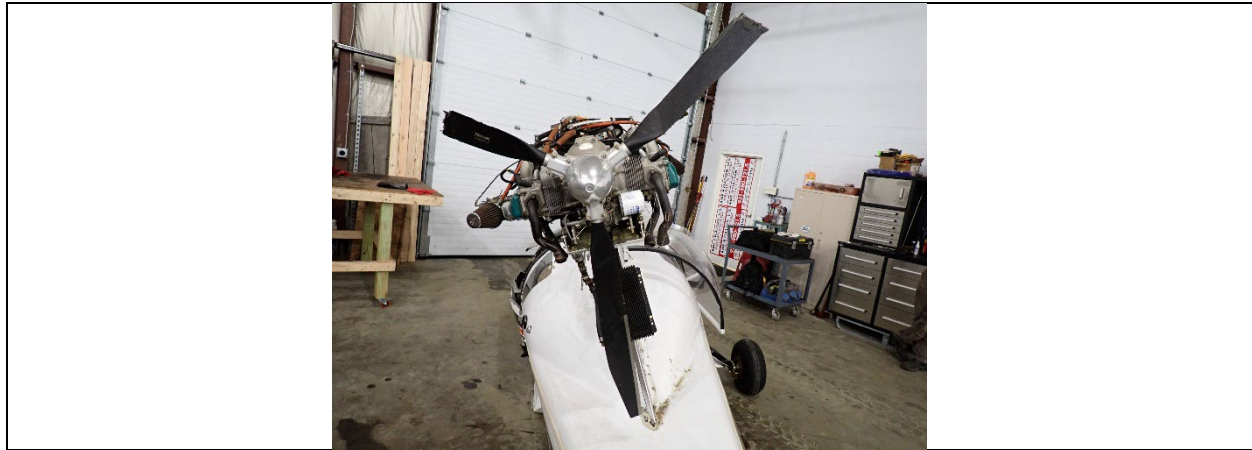
Photograph 32: Propeller overview

The three blade, fixed pitch propeller remained attached to the propeller shaft and the blades displayed impact damage signatures. One propeller blade was broken approximately in half, another blade was missing the blade tip and a large section of the cambered side of the blade, the third blade displayed only minor impact damage signatures. According to the recovery personnel, the separated portions of the propeller blades were not located at the accident site.
