ERA24LA277

## INVESTIGATION PHOTOGRAPHS

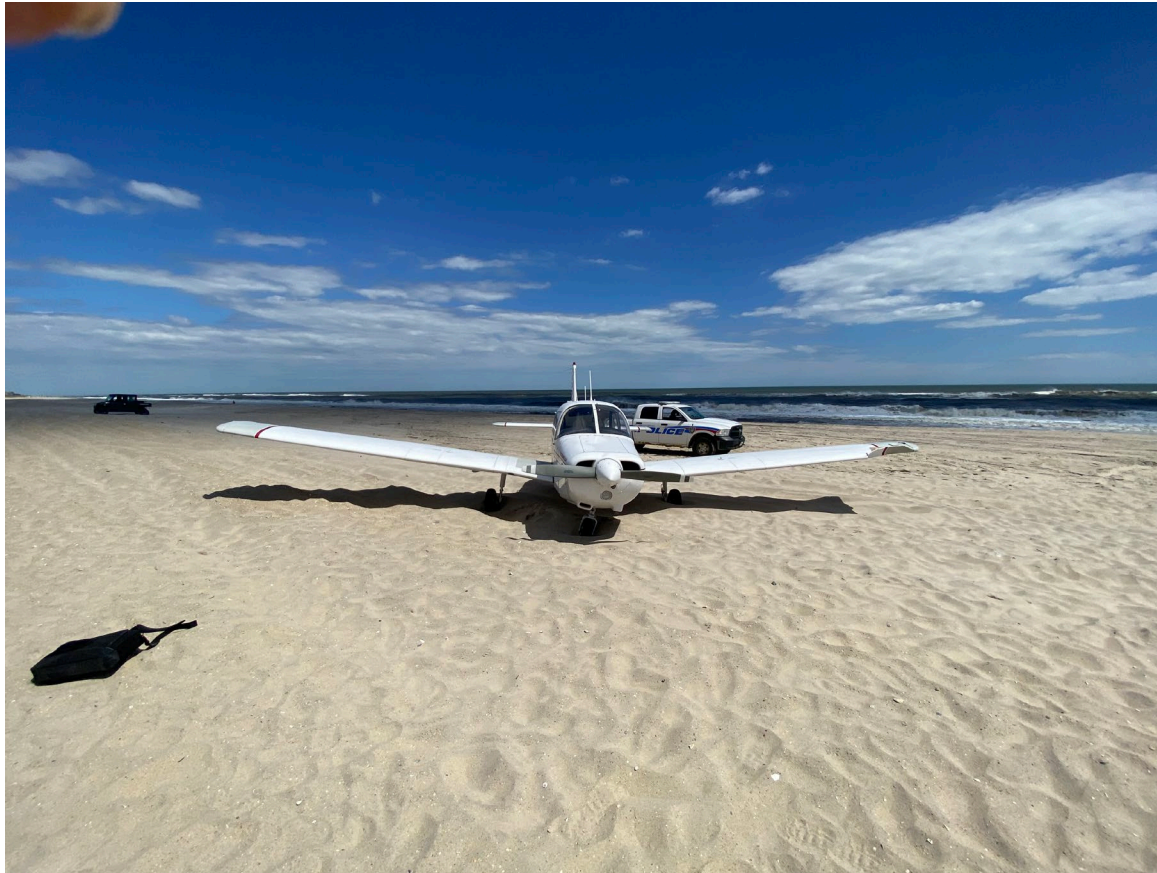
**Photograph 1 - Deformation noted to nose landing gear (Courtesy of FAA)**

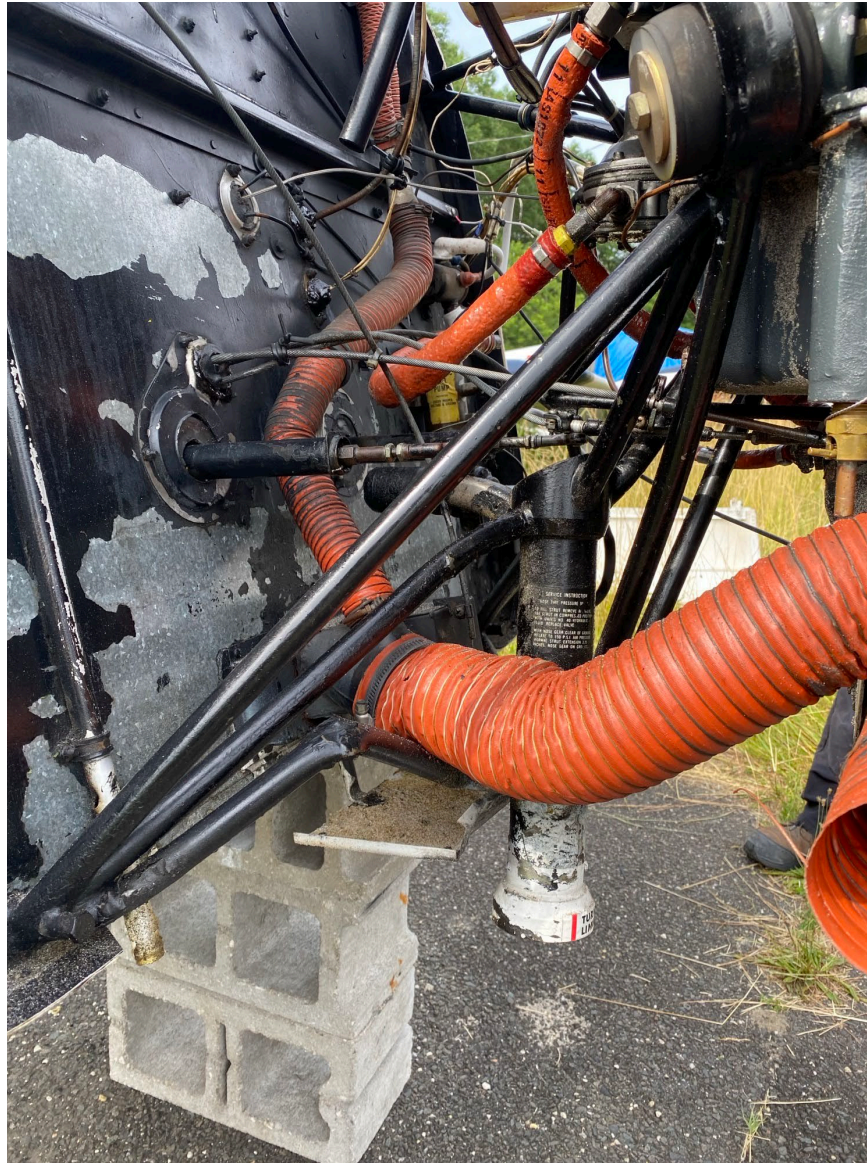
**Photograph 2 - Deformation noted to engine mount (Courtesy of FAA)**
