# National Transportation Safety Board

ERA24LA279

## **AIRFRAME AND ENGINE EXAMINATION**

Location: DeLand, Florida  
Date: June 26, 2024  
Time: 14:59 Local  
18:59 UTC  
Airplane: Alexander S Rolinski Aventura II  
Registration: N727TK

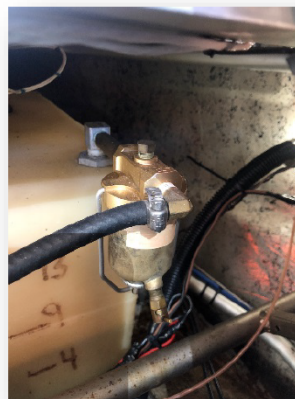
during transportation of the wreckage and was open to the environment. The tank was about half full of blue fuel that had the color and odor consistent with 100LL avgas. Visible debris contamination was found on the bottom of the tank and the internal fuel float system had broken off and was floating in the tank. The system has no fuel sump installed and no quick-access panel to check within the tank for water or debris contamination. The fuel tank pickup tube finger screen was in place with no visible blockage. While the POH provided a depiction of a fuel drain valve mounted to the bulkhead, no such installation was found on this airplane.

**Figure 1 - Excerpt from Aventura II POH depicting fuel drain valve installation.**

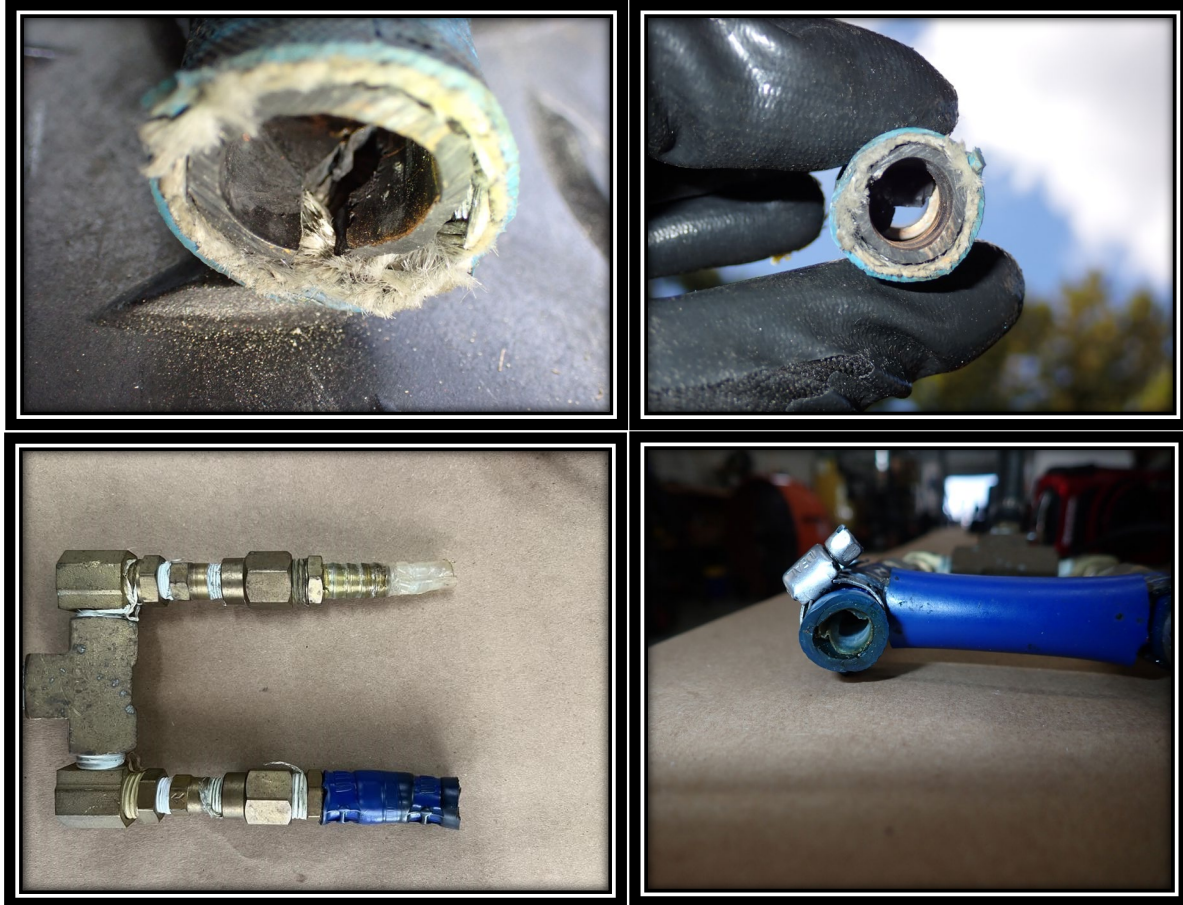
The wreckage was recovered to Florida Air Recovery in Jacksonville, FL and examined on October 17, 2024. One of the fuel lines routed into one of the electrically-driven fuel pumps was found to be loose, cracked, and partially obstructed. When the fuel pump was tested, air was heard entering through the loose-fitting attachment point and the pump would not pass any fuel. When the fuel pump was operationally checked with serviceable fuel lines, it operated normally.

The system had two electrically-driven fuel pumps installed in parallel. The fuel line from the pickup tube to the intake manifold was loose and able to spin by hand. One of the fuel intake manifold lines was loose and could be removed from the pump by hand. That same line appeared to have been internally damaged during installation and exhibited about a 75% internal blockage. PTFE thread sealant was used on all the attach point fittings throughout the inlet and outlet manifolds. Some of the fuel lines were not consistent with FAA-approved aviation-rated flexible fuel hoses and two of the lines had plastic internal sleeves that were cracked and misshapen within.

**Figures 2 through 5 - Blocked and broken manifold lines for electric-driven fuel pump**

During function testing, a vacuum leak was detected, which prevented the fuel pumps from drawing fuel from the tank. Each pump was removed from the damaged lines and function tested with new lines. The first pump, manufactured by Pierburg (Model 06T270, SN 07.0190) is the same type of pump used with the Rotax 914 engine. The pump was functionally tested and operated normally. The second pump had no visible markings or identification on the exterior. The pump was functionally tested and operated normally.

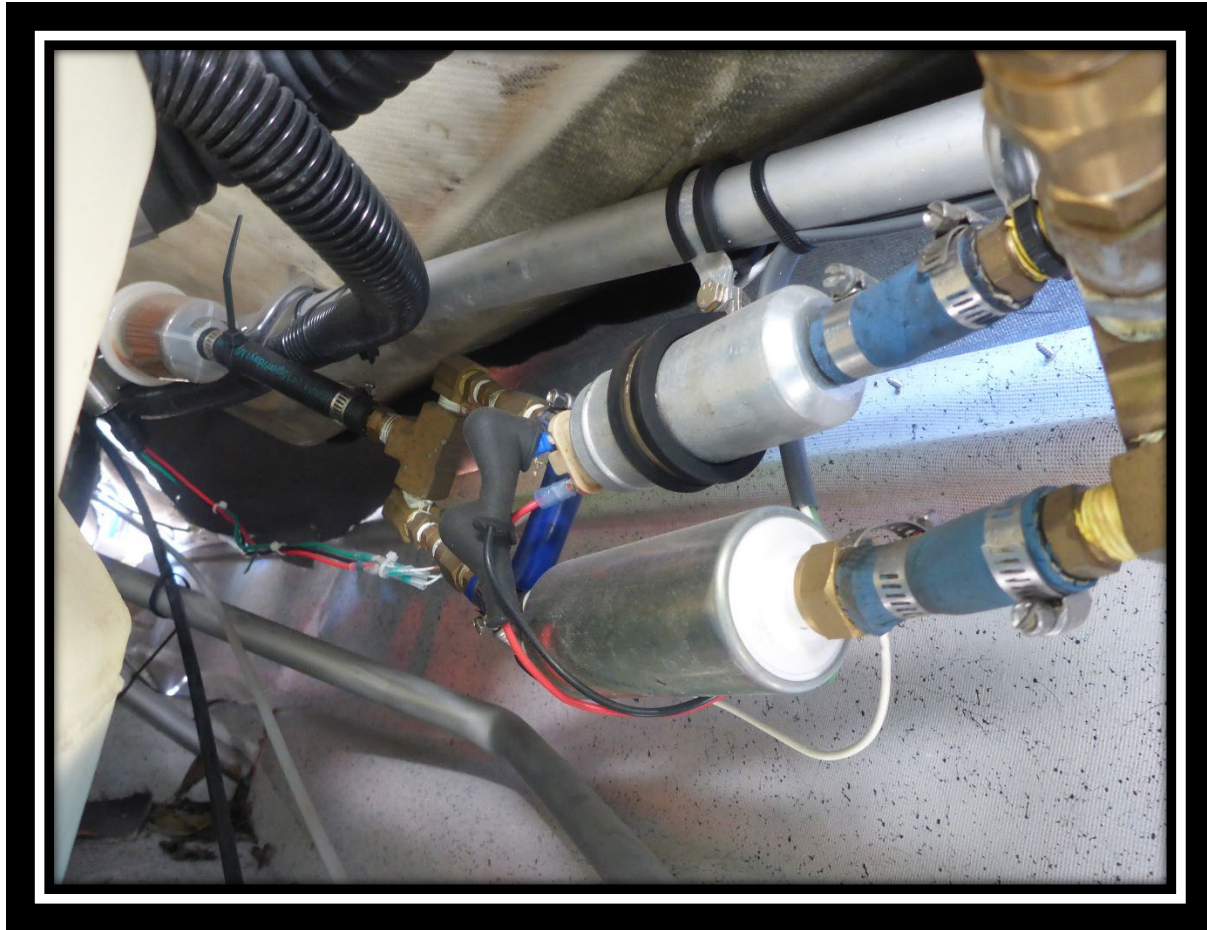
The fuel filter was transparent, and some fuel visibly remained inside. The contents were poured into a jar and tested negative for water contamination with water-finding paste.

**Figure 6 - Fuel pumps and fuel filter installations**
