Investigator Name: Leah D. Read  
Title: Sr. ASI  
Division: ERA

**Subject:** ERA24LA284

**N94NF Crash Statement, 6/30/24 approximately 10:13 EDT**

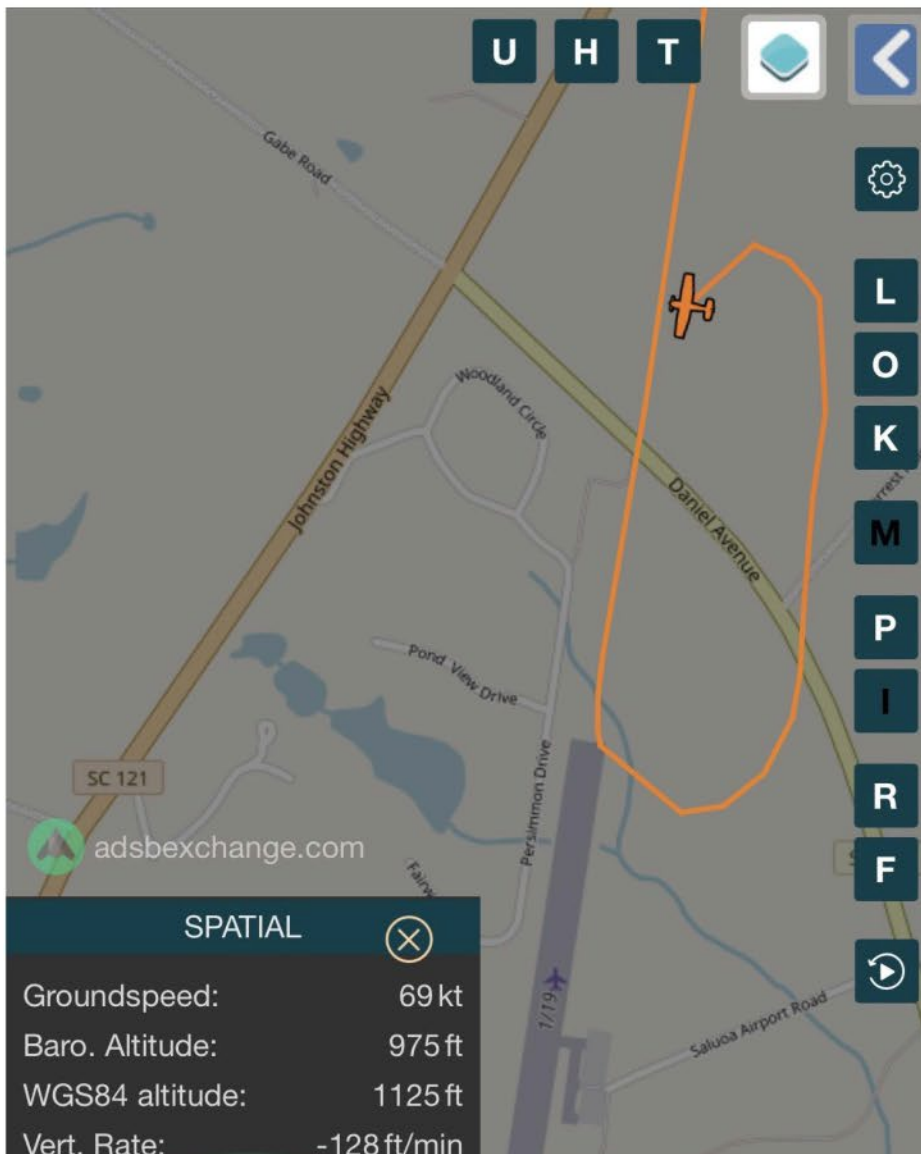
Post crash Review of ADS-B data, including ground track, airspeed and altitude reveals this overhead was performed with gentle radius turns with correct and controlled air speed and gentle rollout on final, approximately 2500' from the touch down point. The last available ADS-B data point reveals a gentle rollout onto final with ground speed of 69 kts. (The landing configuration stall speed for the RV-9A is 45 kts. And MSL altitude of approximately 1000' and AGL altitude of 400' - 500'.

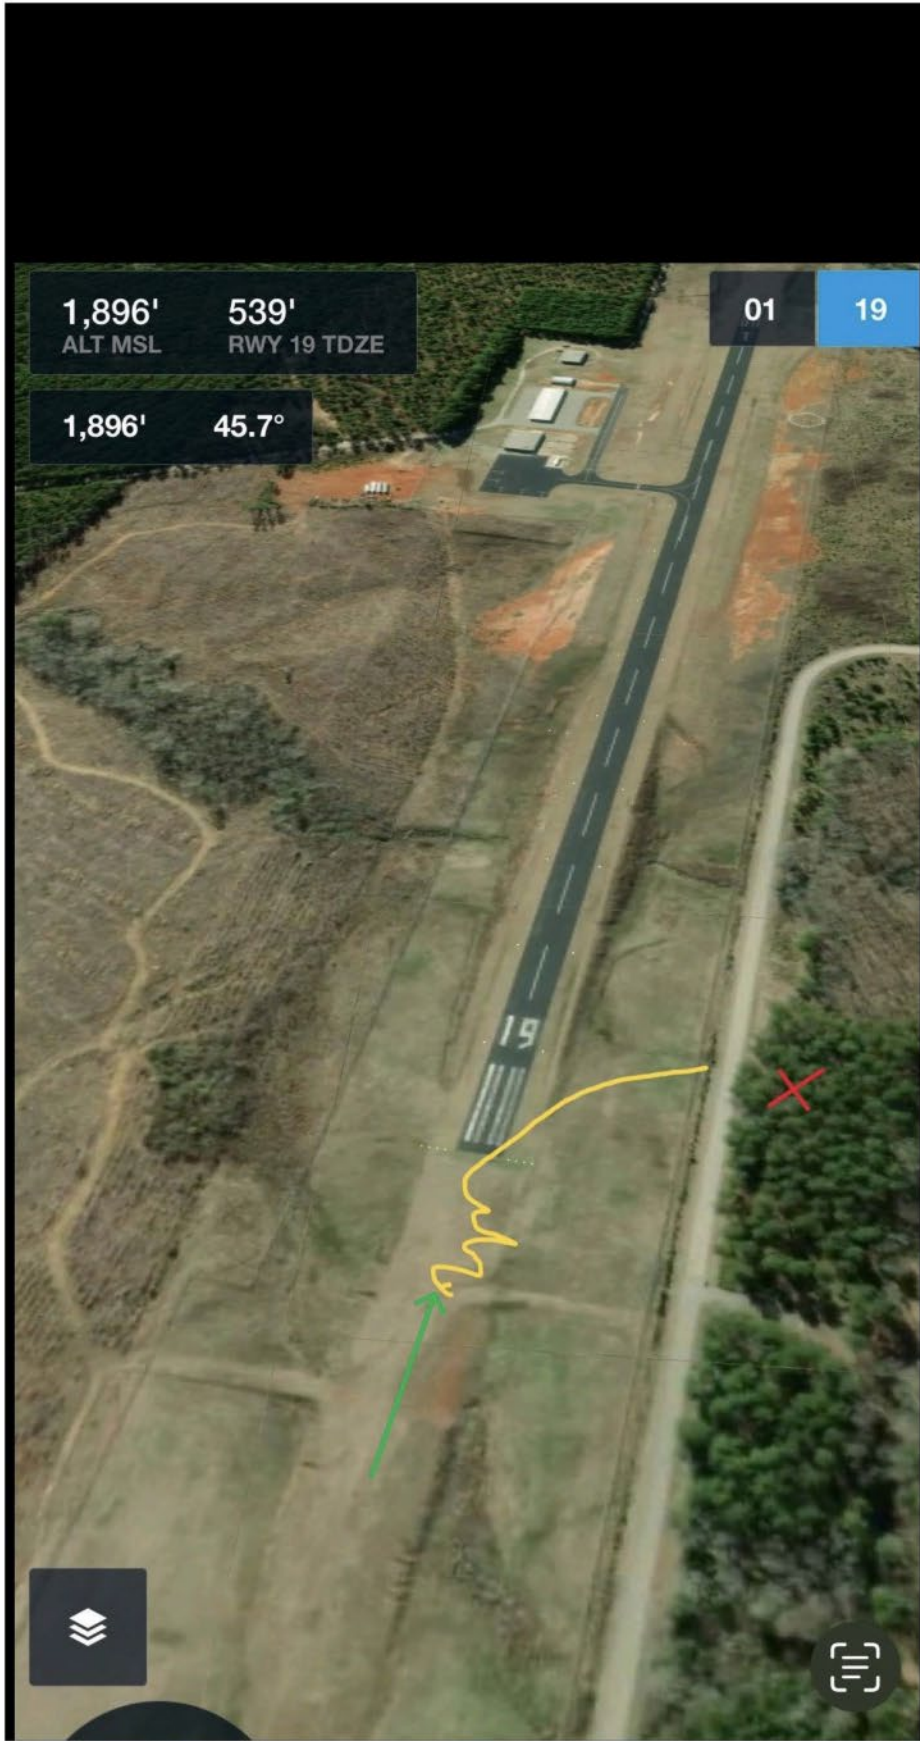
Image from ForeFlight "3D" image. The green line is controlled flight on short final. The yellow line is approximately where loss of controlled flight occurs with down draft and weather vaning to the right and occurs approximately where a road cuts through the forest and may have been a factor in the change of incident wind.
