ERA24LA287

## INVESTIGATION PHOTOGRAPH

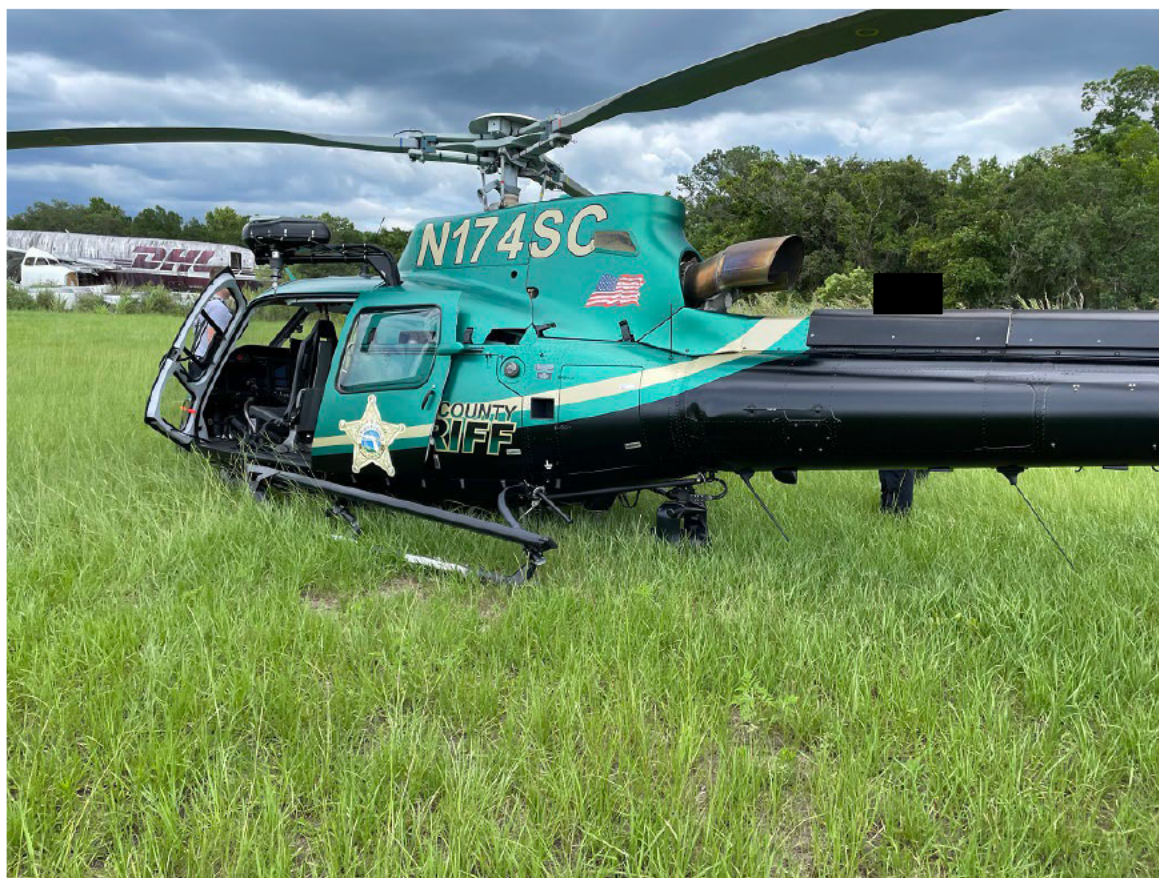
**Photograph 1 - Main Wreckage With Tailboom Damage (Courtesy of FAA)**
