ERA24LA289

## INVESTIGATION PHOTOGRAPHS

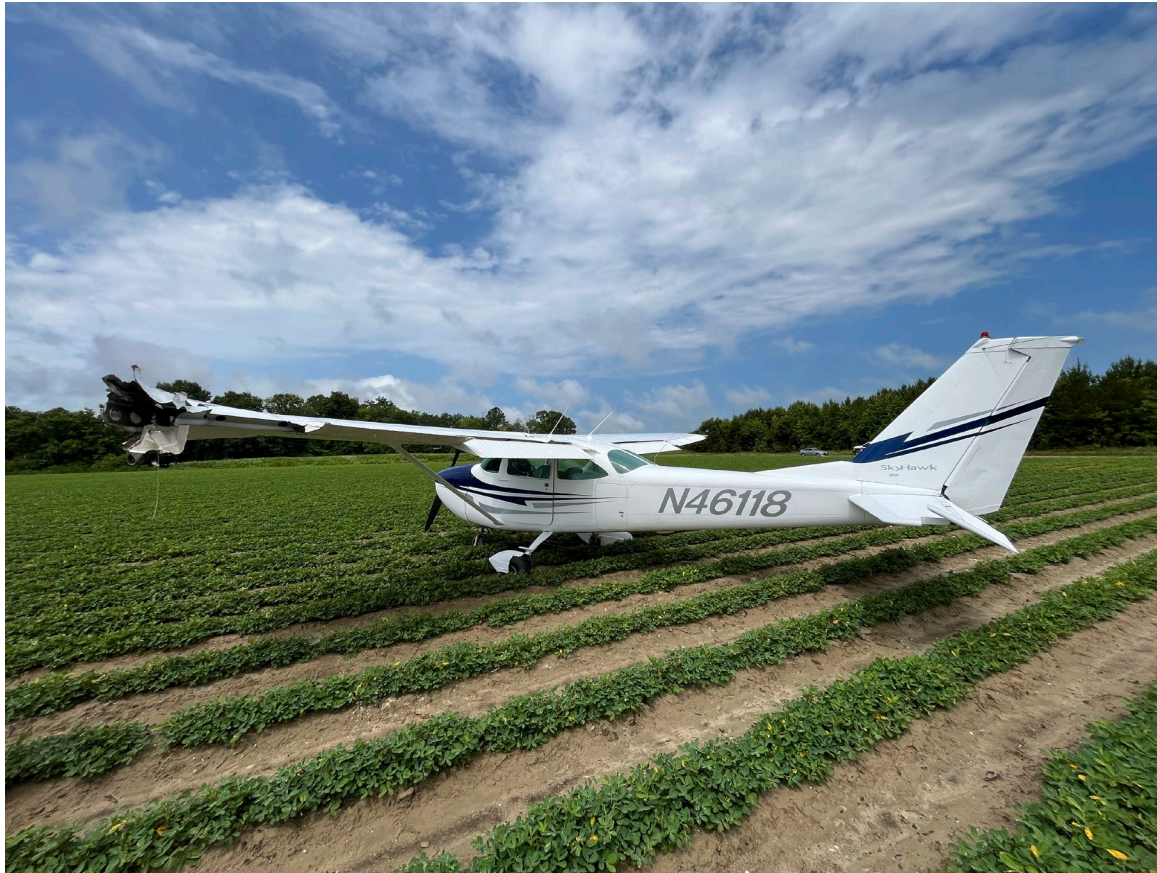
**Photograph 1 - Left wing impact damage and aileron separation noted (Courtesy of FAA)**

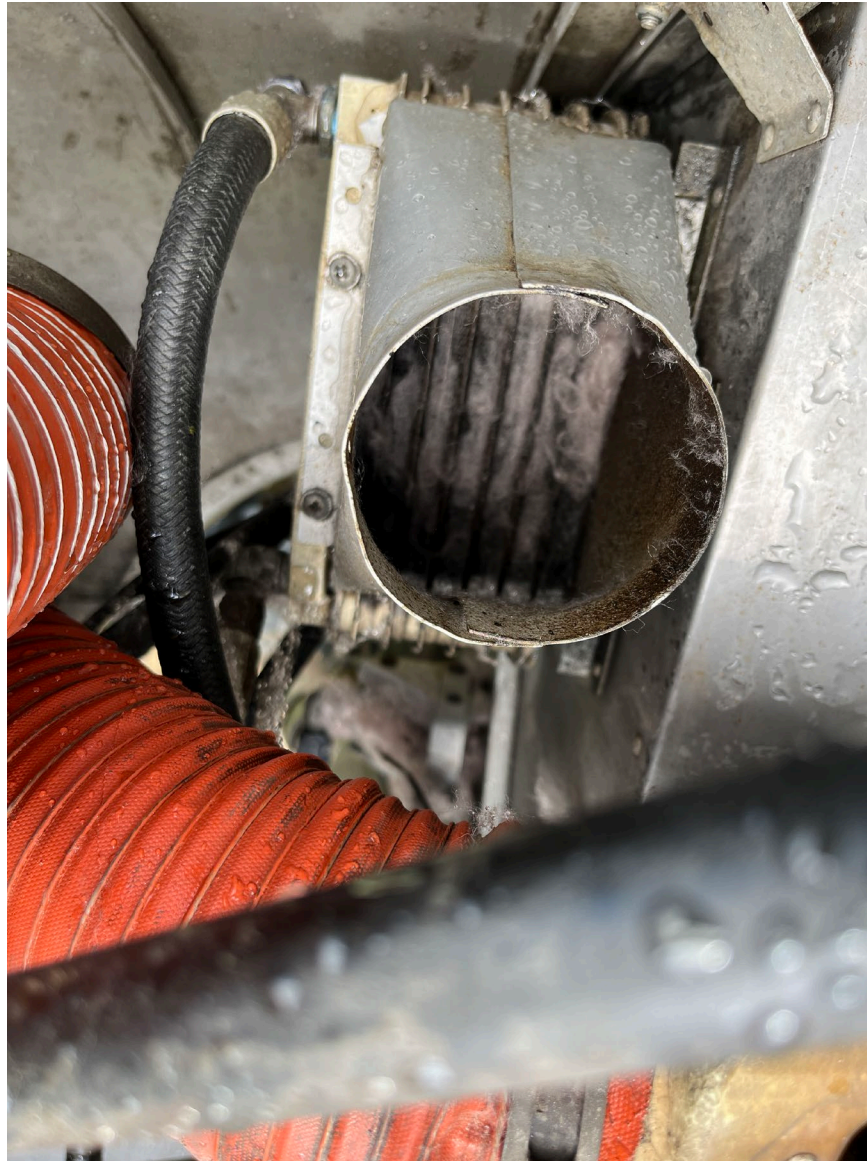
**Photograph 2 - oil cooler obstructed with a residential-type insulation (Courtesy of FAA)**

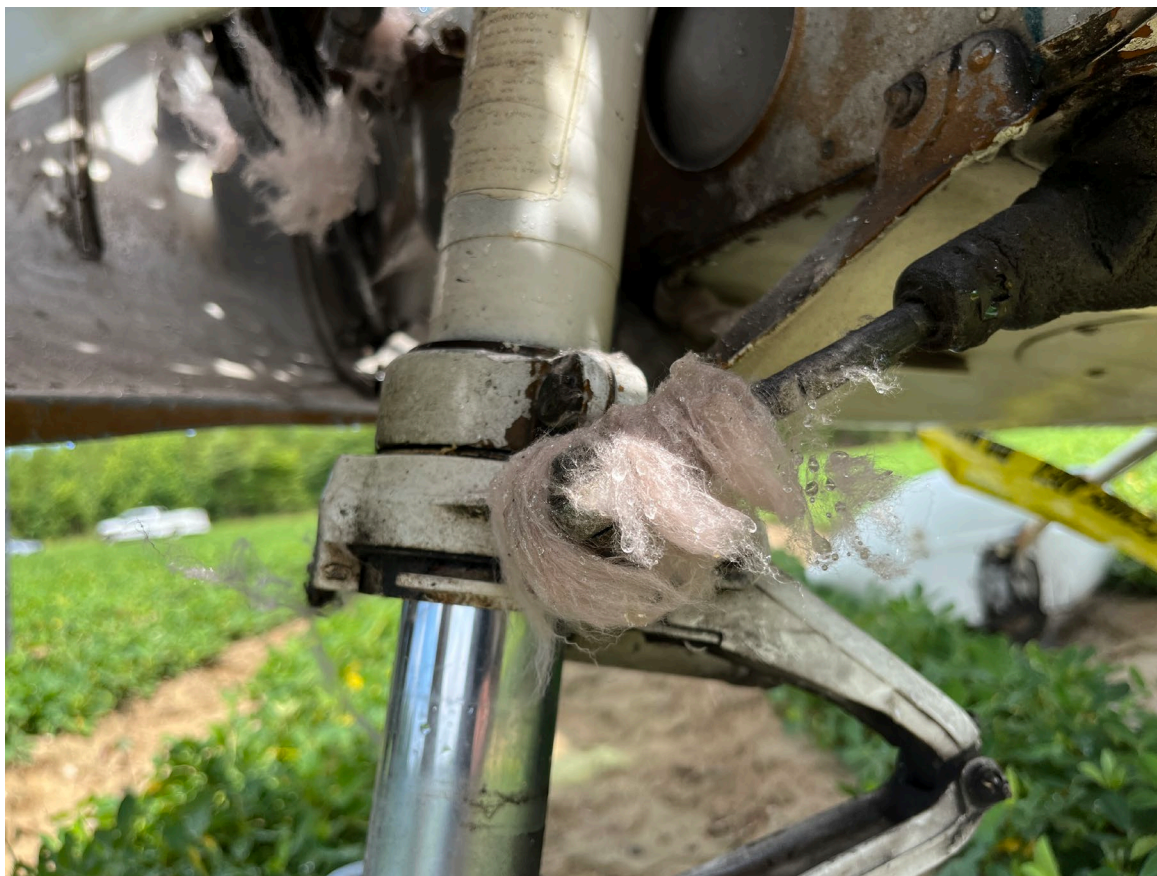
**Photograph 3 - Residential-type insulation noted on nose landing gear (Courtesy of FAA)**

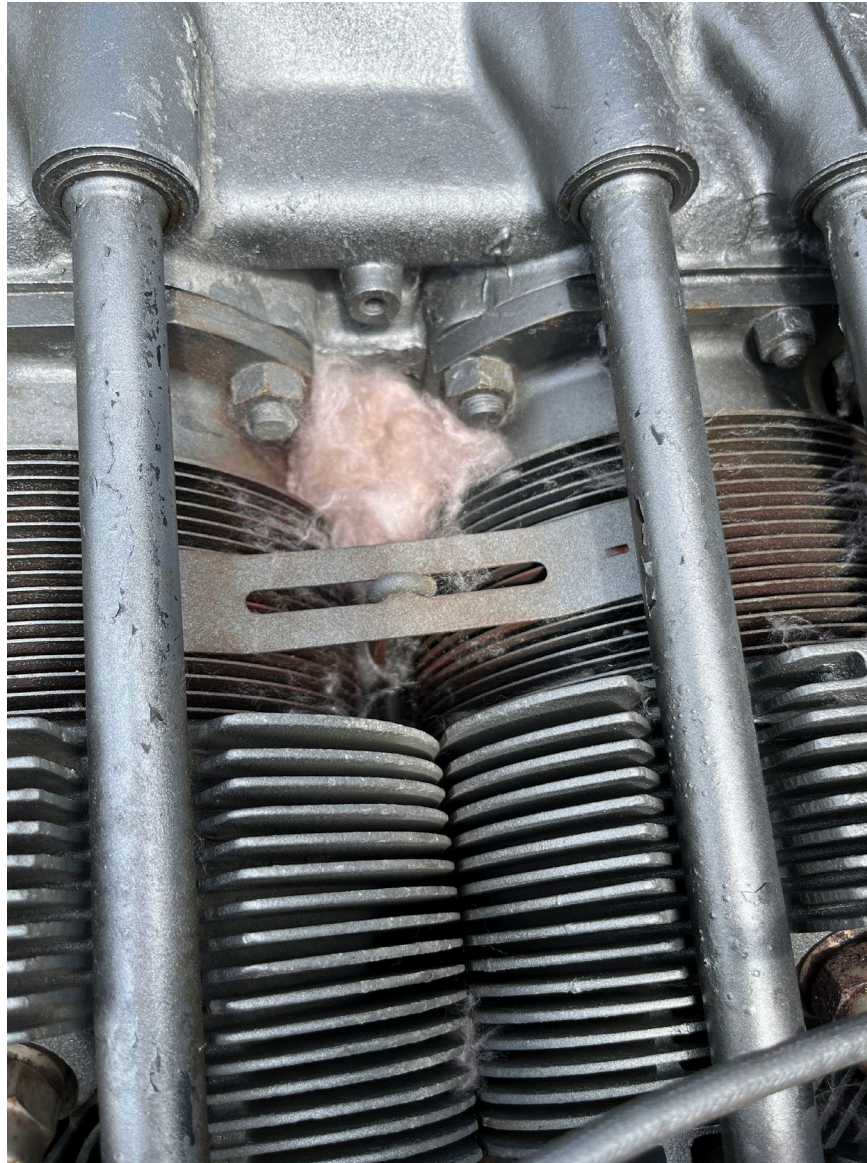
**Photograph 4 - Residential-type insulation noted in engine area (Courtesy of FAA)**
