# N865HC RIC

Photo's Dated: July 2, 2024

Cessna Citation 525

Serial number- 525-0616

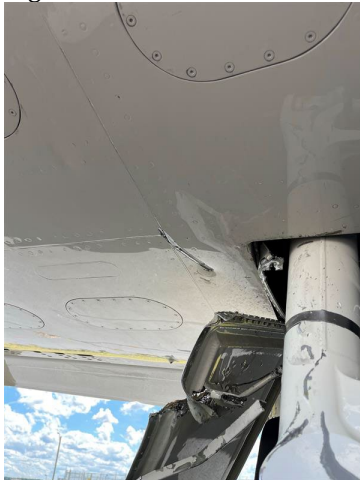
1. Wing to body fairing panels

Right of centerline on bottom of aircraft with gouges and dents.

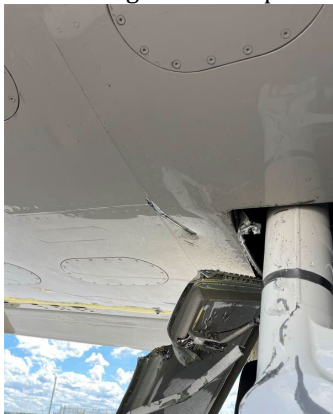
2. Right wing, bottom side, outboard of right main landing gear.

Lower wing structural panels gouged from forward moving impact damage.

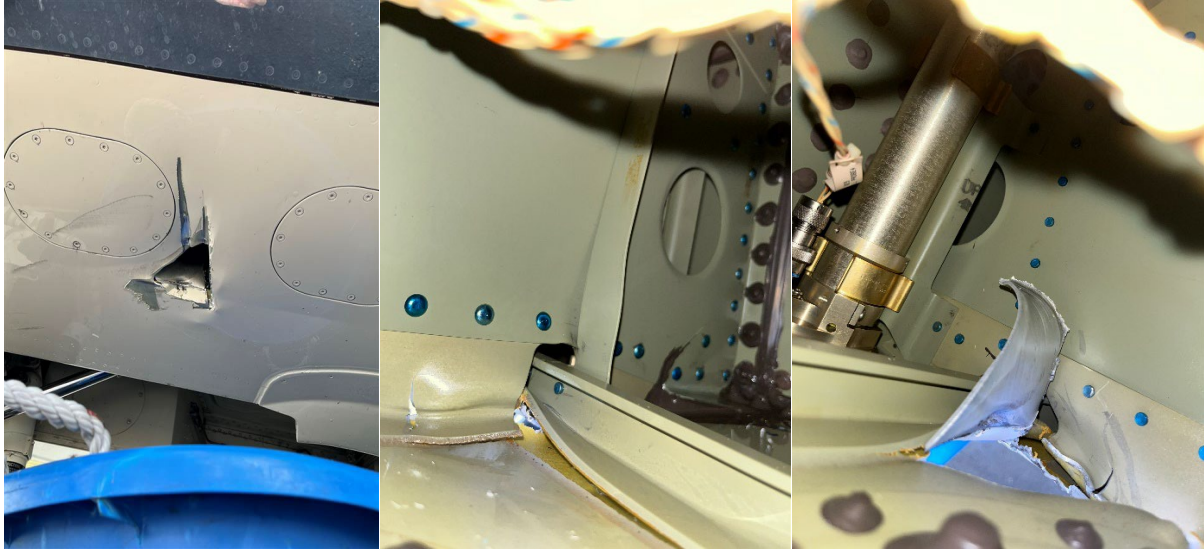
3. Right wing, bottom side, forward of main landing gear.

Wing panel structure puncture into wing fuel tank and possible forward wing structural stringer. Undetermined condition of the wing structure other than evident structural surface contact to component from impact damage.

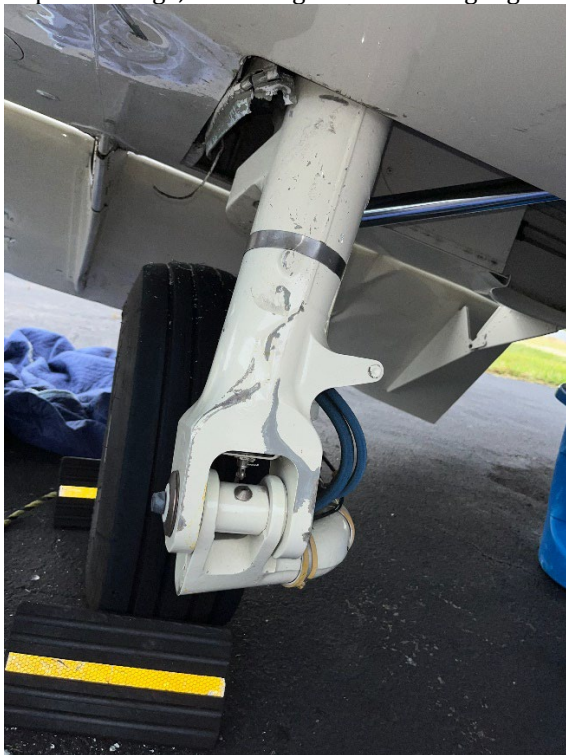
4. Right main landing gear.

Impact damage, consisting of a dent and gouge of main landing gear.

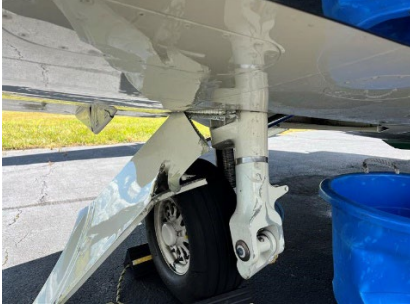
5. Right main landing gear flying gear door.  
Impact damage to the gear flying door and hinge connected at main landing gear wheel well that compromised attachment structure.

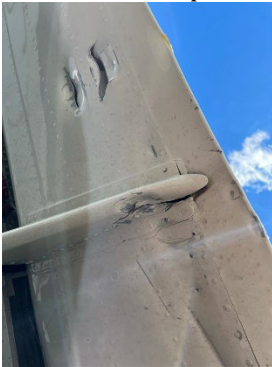
6. Right wing trailing edge flap, inboard pylon.  
Creased from impact damage.

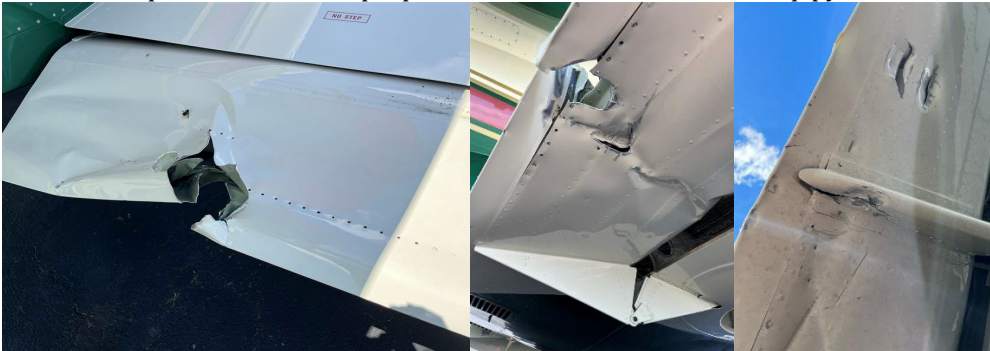
7. Right wing trailing edge flap.  
Creased and punctured in multiple places, outboard of the inboard flap pylon.
