**MEMORANDUM FOR RECORD**

**Subject:** ERA24LA293, Tire Inspection and Secondary Trim Settings

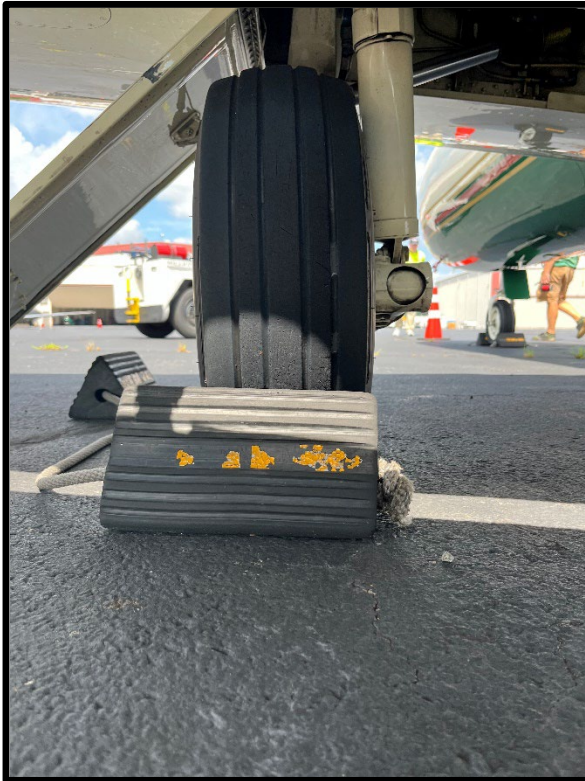
Inspector Harness of the FAA was asked to inspect the tires and the secondary trim settings for the investigation. He reported that on July 23, 2024, he and a mechanic from a local fixed base operator inspected the tires for condition and tread depth. The inspector reported that, "All of the tires were in good condition, had the proper inflation, and the tread depth was within limits according to the mechanic. There were no signs of any discrepancies." The inspector also reported, "... there was no indication of reverted rubber hydroplaning on the [main landing gear] tires" Figures 1 and 2. Each main landing gear tire tread was reported to be 5/32 inch.

**Figure 1: Left Main Tire**

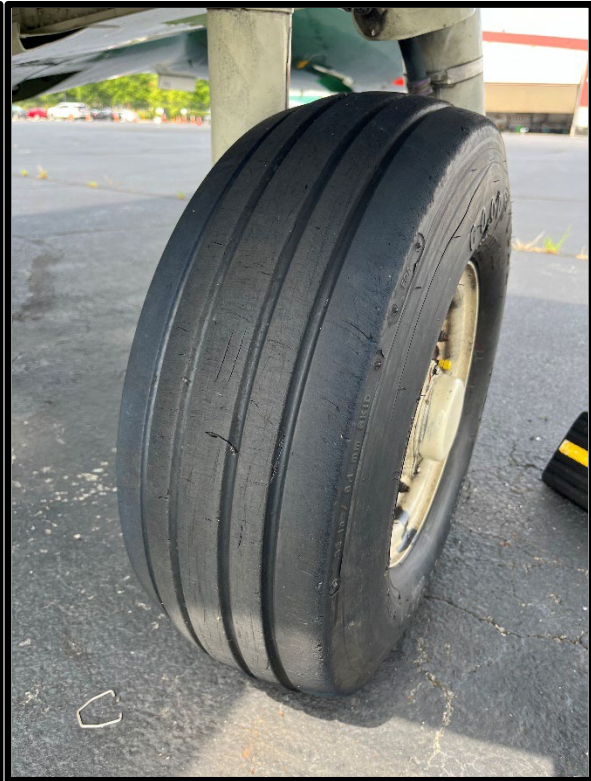
**Figure 2: Right Main Tire**
