# National Transportation Safety Board

ERA24LA311

## **EXAMINATION SUMMARY**

Location: Beaufort, North Carolina  
Date: July 21, 2024  
Time: 1933 EDT  
2333 UTC  
Airplane: N9581S, Champion 7ECA

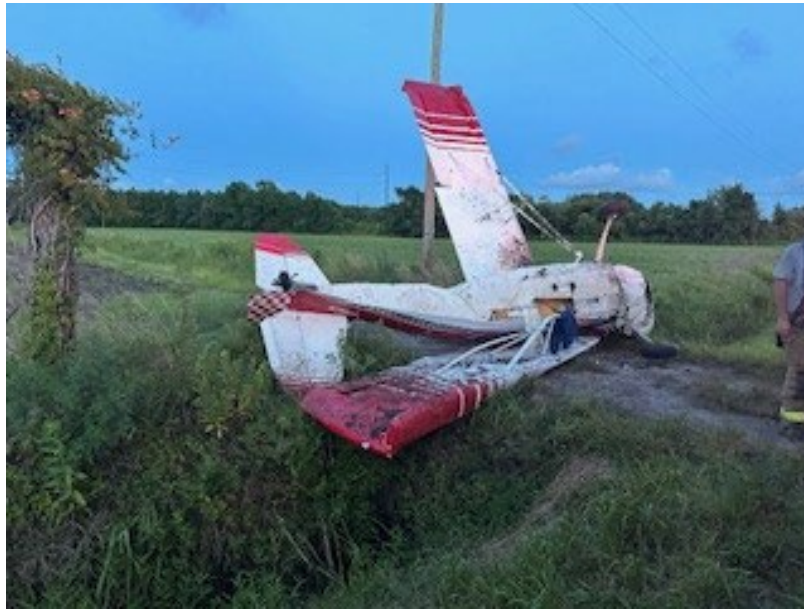
The on-site examination by an FAA inspector revealed that during the landing, the airplane's left wing struck a pole, and the airplane came to rest inverted about 3-miles northwest of MRH. The left wing and engine were partially separated from the fuselage. Both wings and fuselage sustained substantial damage. The inspector reported that there was no odor of fuel observed at the accident site and no fuel was recovered from airplane.

Photograph of accident site (Provided by FAA).

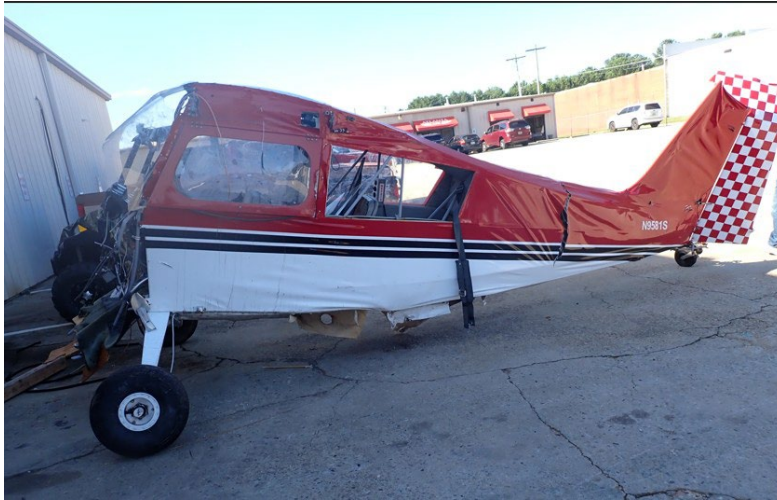
## 2.1 Fuselage

Impact damage was noted to the fuselage. The firewall was separated from the fuselage. There was no evidence of an oil or fuel leak observed on the fuselage.

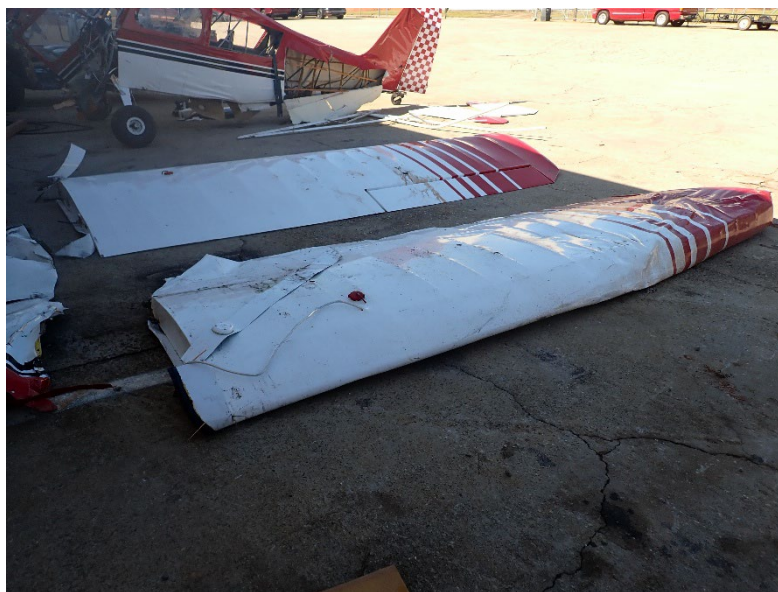
## 2.3 Wings

Left and right wings were removed to facilitate recovery. Deformation was noted to the left- and right-wing lift struts. Both wings exhibited leading-edge impact damage. The aileron control cables were recovery separated at the wing root areas. The ailerons remained attached and control continuity established from the wing root to the ailerons.

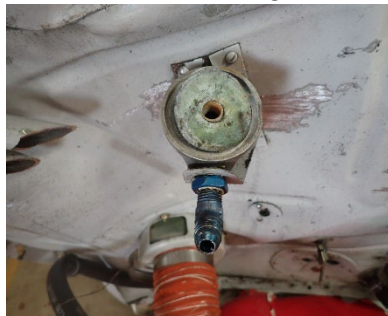
Photograph of gascolator screen.

with low-pressure air. The gascolator bowl was impact separated from the housing. Corrosion was observed on the gascolator filter screen. Fuel line continuity was established from the wing root to each fuel tank during field test with low-pressure air. There were no obstructions noted to the fuel system vent or supply lines.

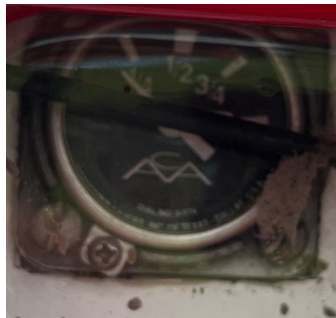
Photograph of empty right fuel tank reading (Provided by FAA).

The right wing was positioned to simulate a level flight position. With the right fuel tank empty, the fuel gauge indicated a level of about 7/32nds and indicated 15/32nds when 5-gallons of fuel was added.

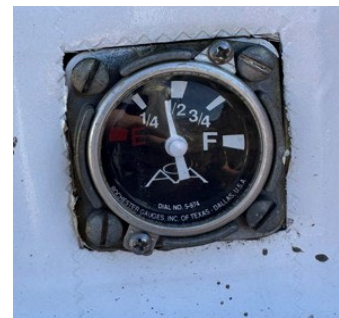
Photograph of reading with 5-gallons added.

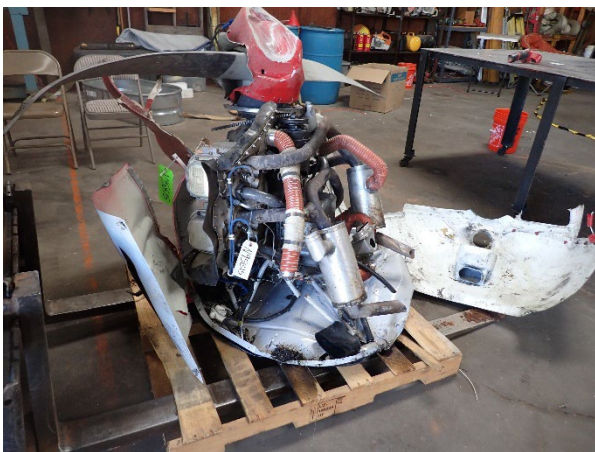
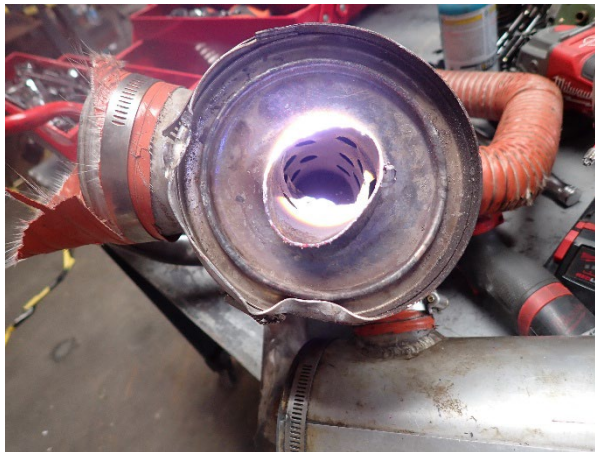
### 3.0 Engine Examination

The engine was a Lycoming O-320-A2B, rated at 150 horsepower at 2,700 rpm. The engine remained attached to the engine mount. Oil was observed within the engine oil sump, and the oil pump suction screen and oil filter media were absent from debris. Crankshaft continuity to the rear gears and valvetrain continuity was established during hand rotation of the attached propeller. Compression and suction were observed from all four cylinders during crankshaft continuity check. There were no anomalies noted to the interior of the cylinders during examination via illuminated borescope.

A reduced lift compared to the exhaust rockers was noted to the four intake rocker arms during the valvetrain continuity check. Removal of cylinder Nos. 2 & 4 revealed pitting of the camshaft followers and abrasion was noted to the camshaft's intake lobes.
