ERA24LA313

## INVESTIGATION PHOTOGRAPHS

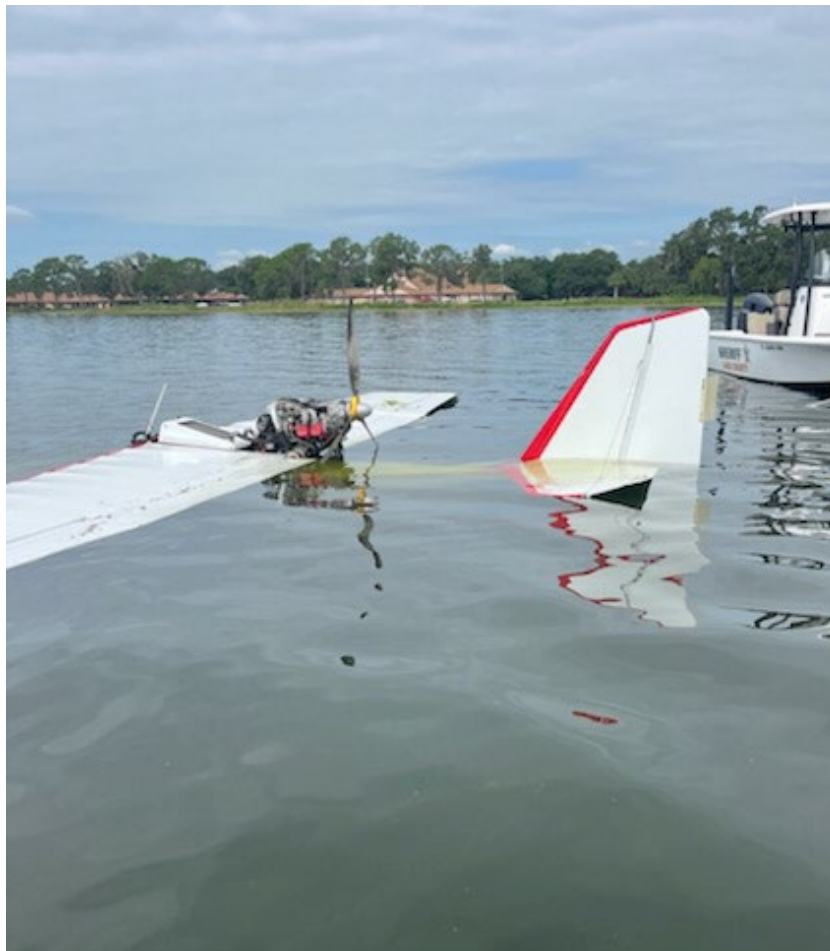
**Photograph 1 - Postaccident view of submerged aircraft (Courtesy of FAA)**

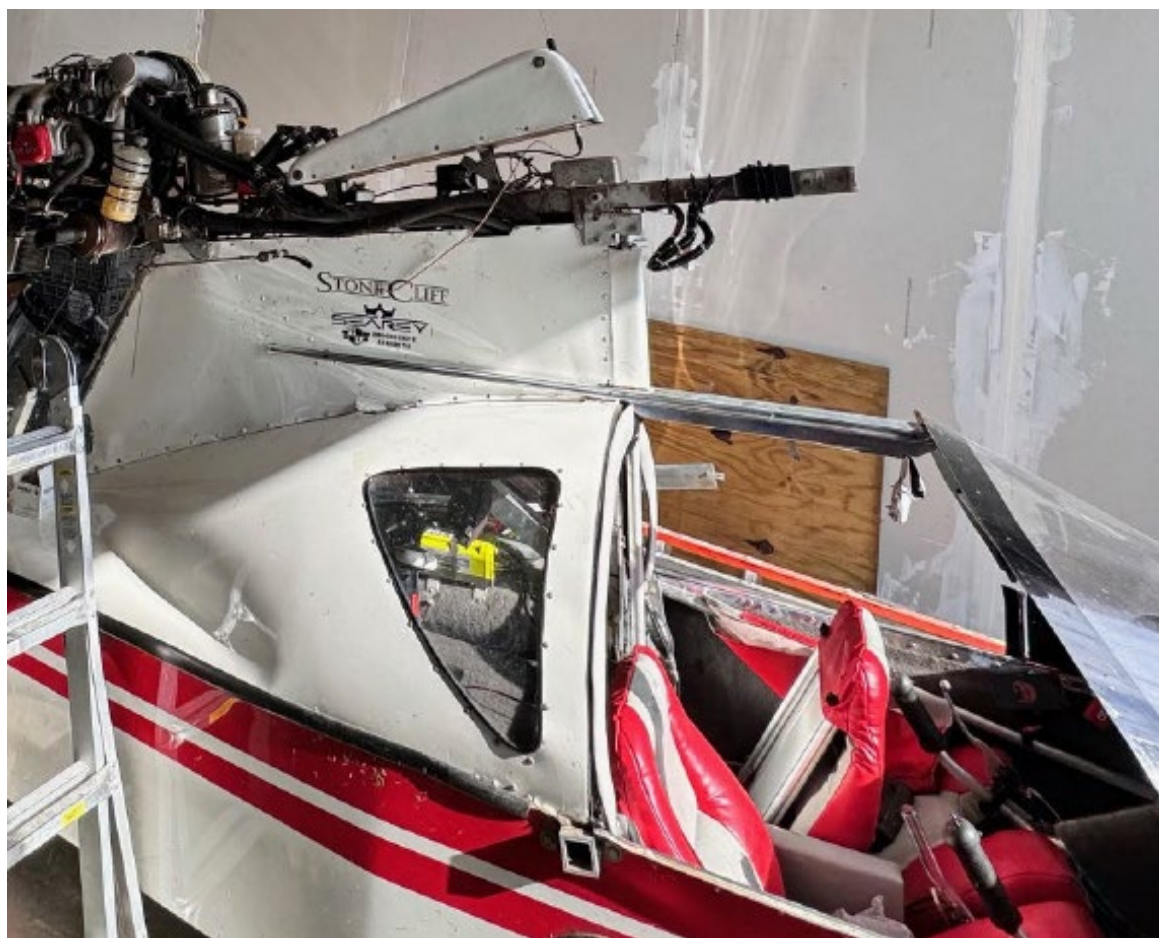
**Photograph 2 - Impact damage - bent aircraft structure (Courtesy of FAA)**

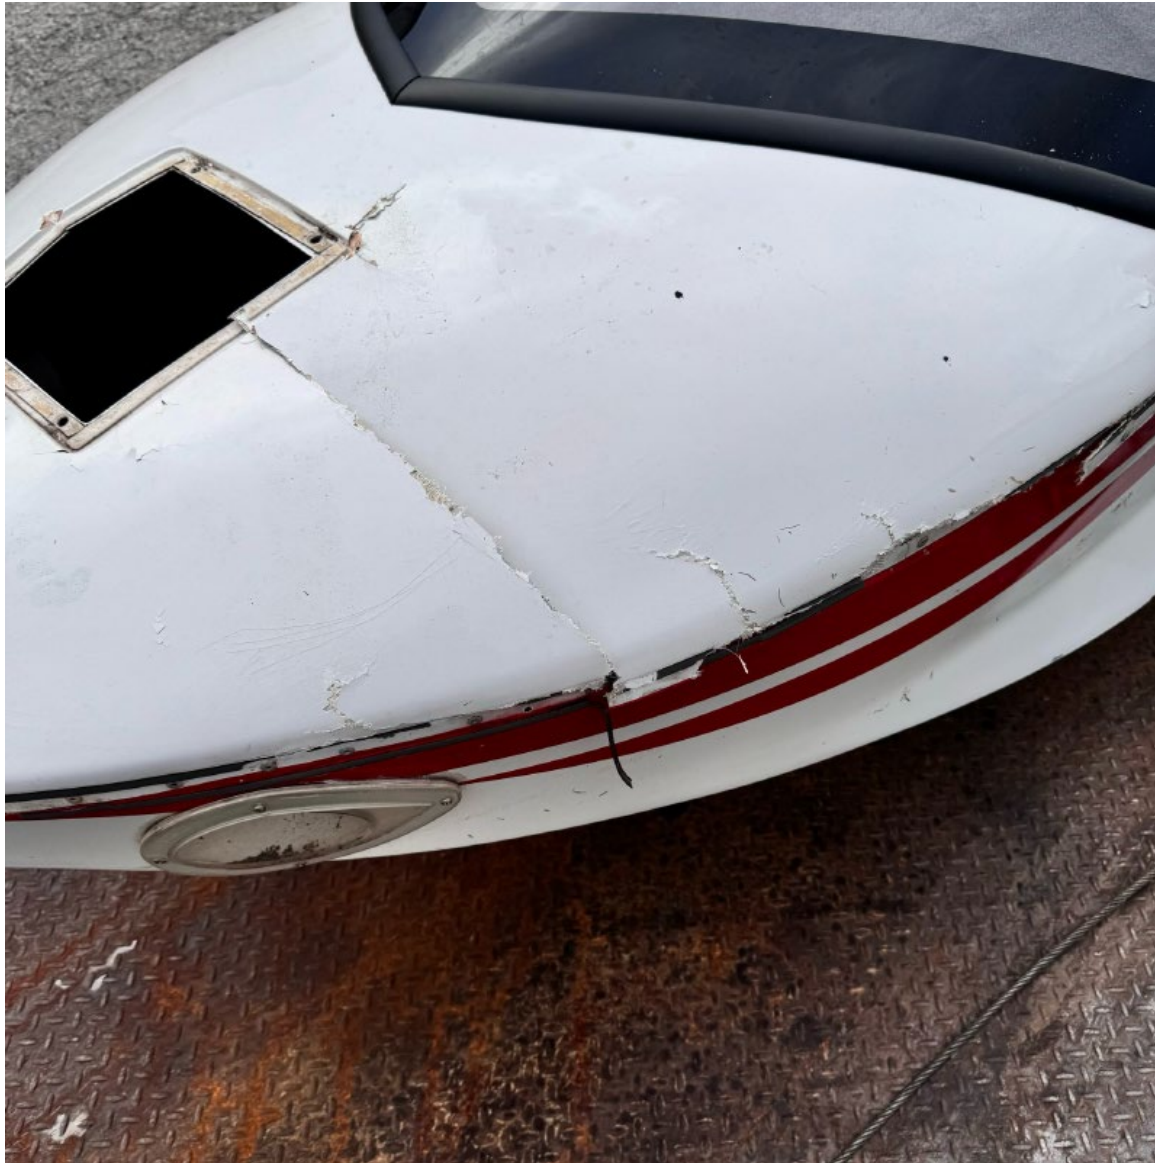
**Photograph 3 - Impact damage - cracked forward hull (Courtesy of FAA)**

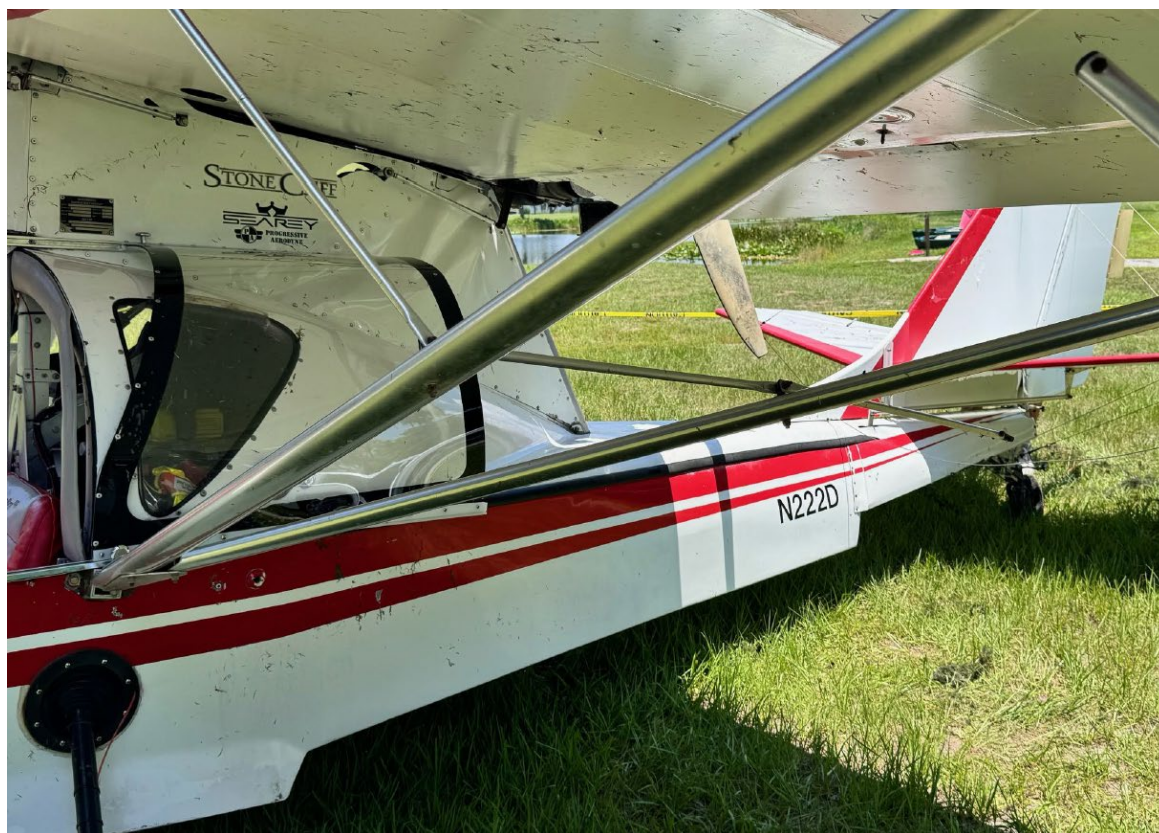
**Photograph 4 - Impact damage - bent aircraft structure (Courtesy of FAA)**
