ERA24LA316

## INVESTIGATIVE PHOTOS

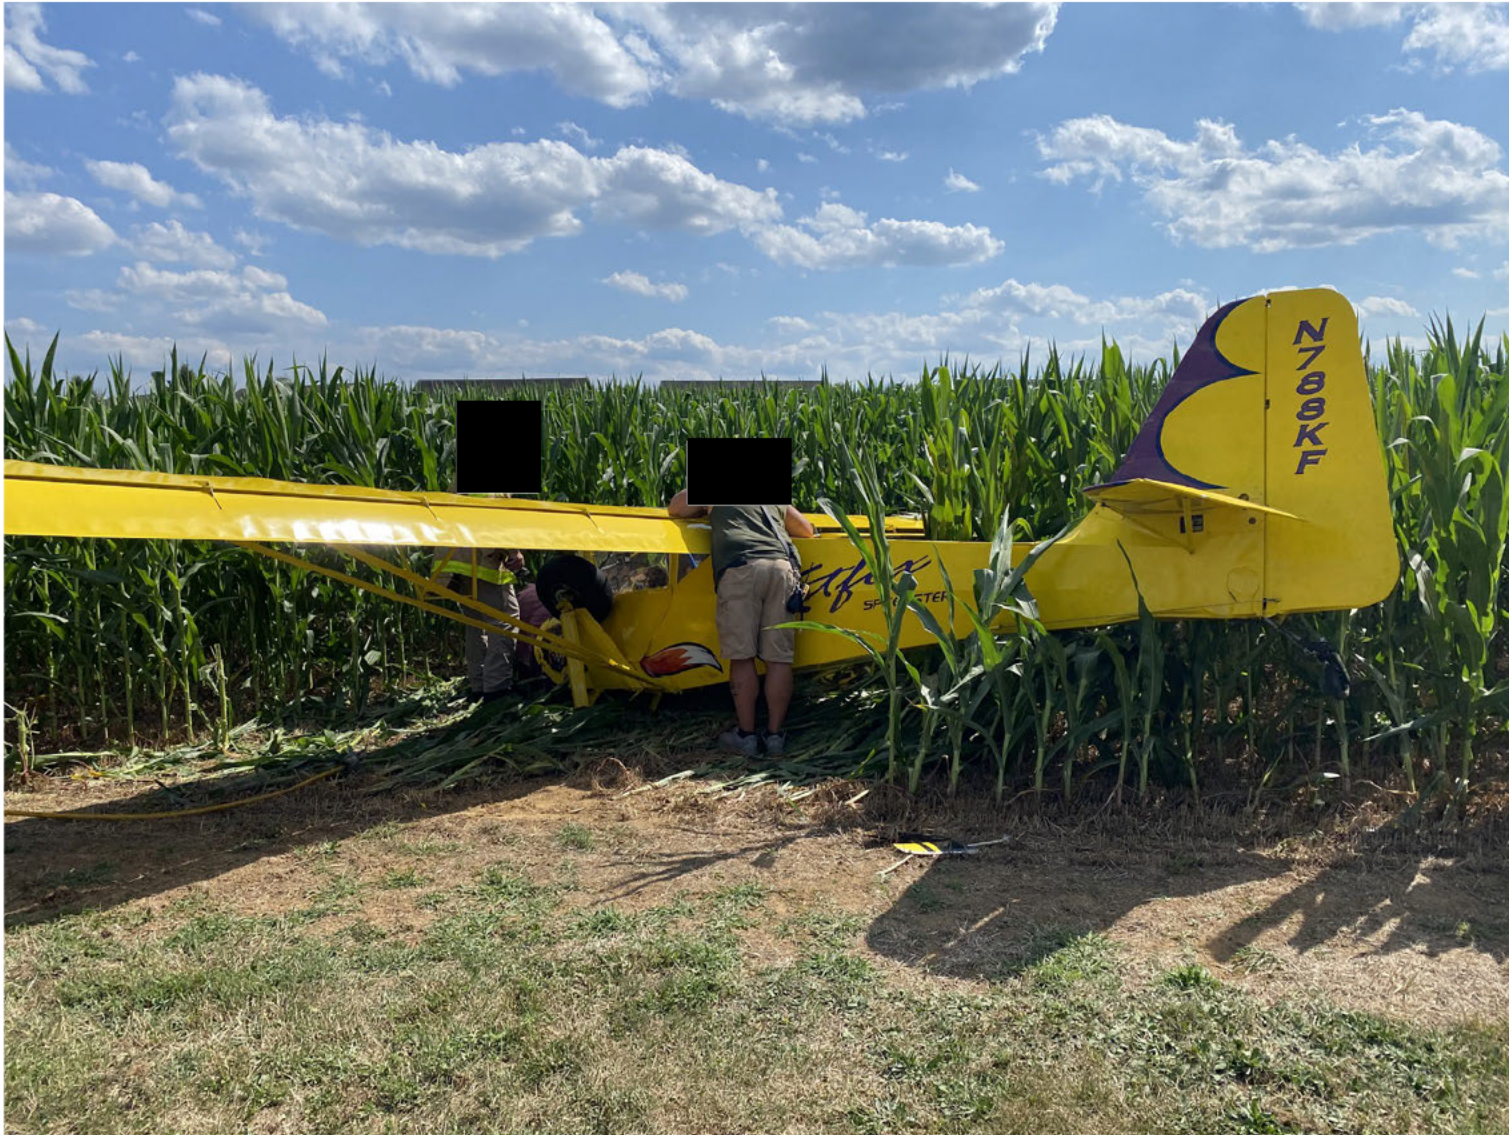
**Photograph 1 - Main wreckage (Courtesy of FAA)**

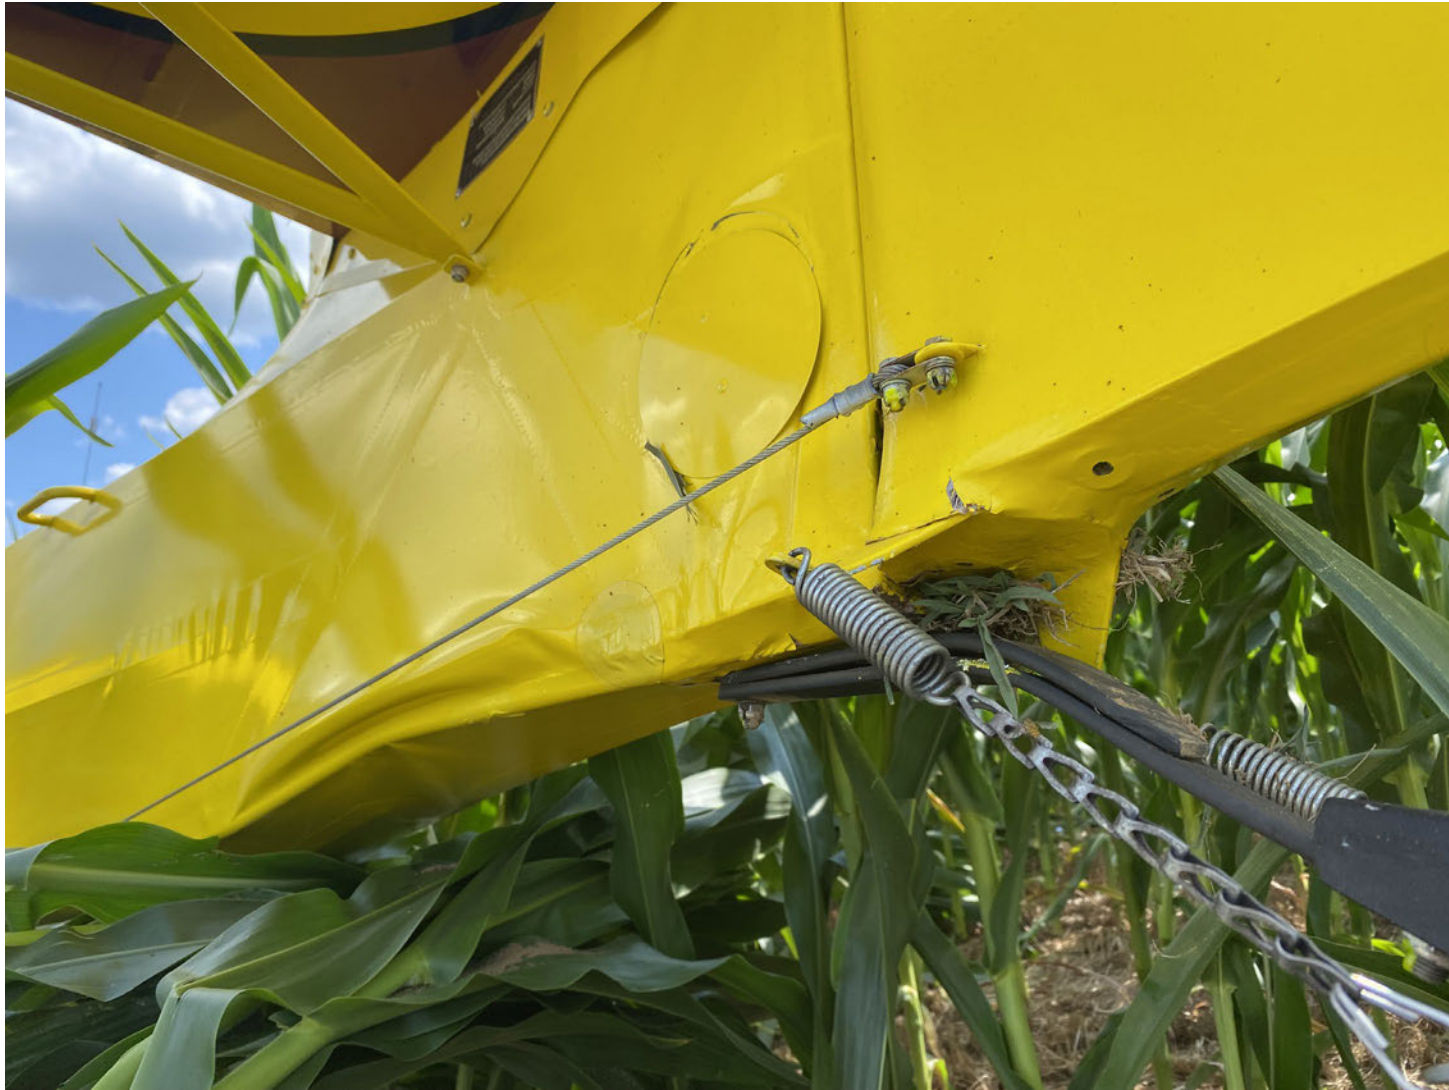
**Photograph 2 - Damaged empennage (Courtesy of FAA)**

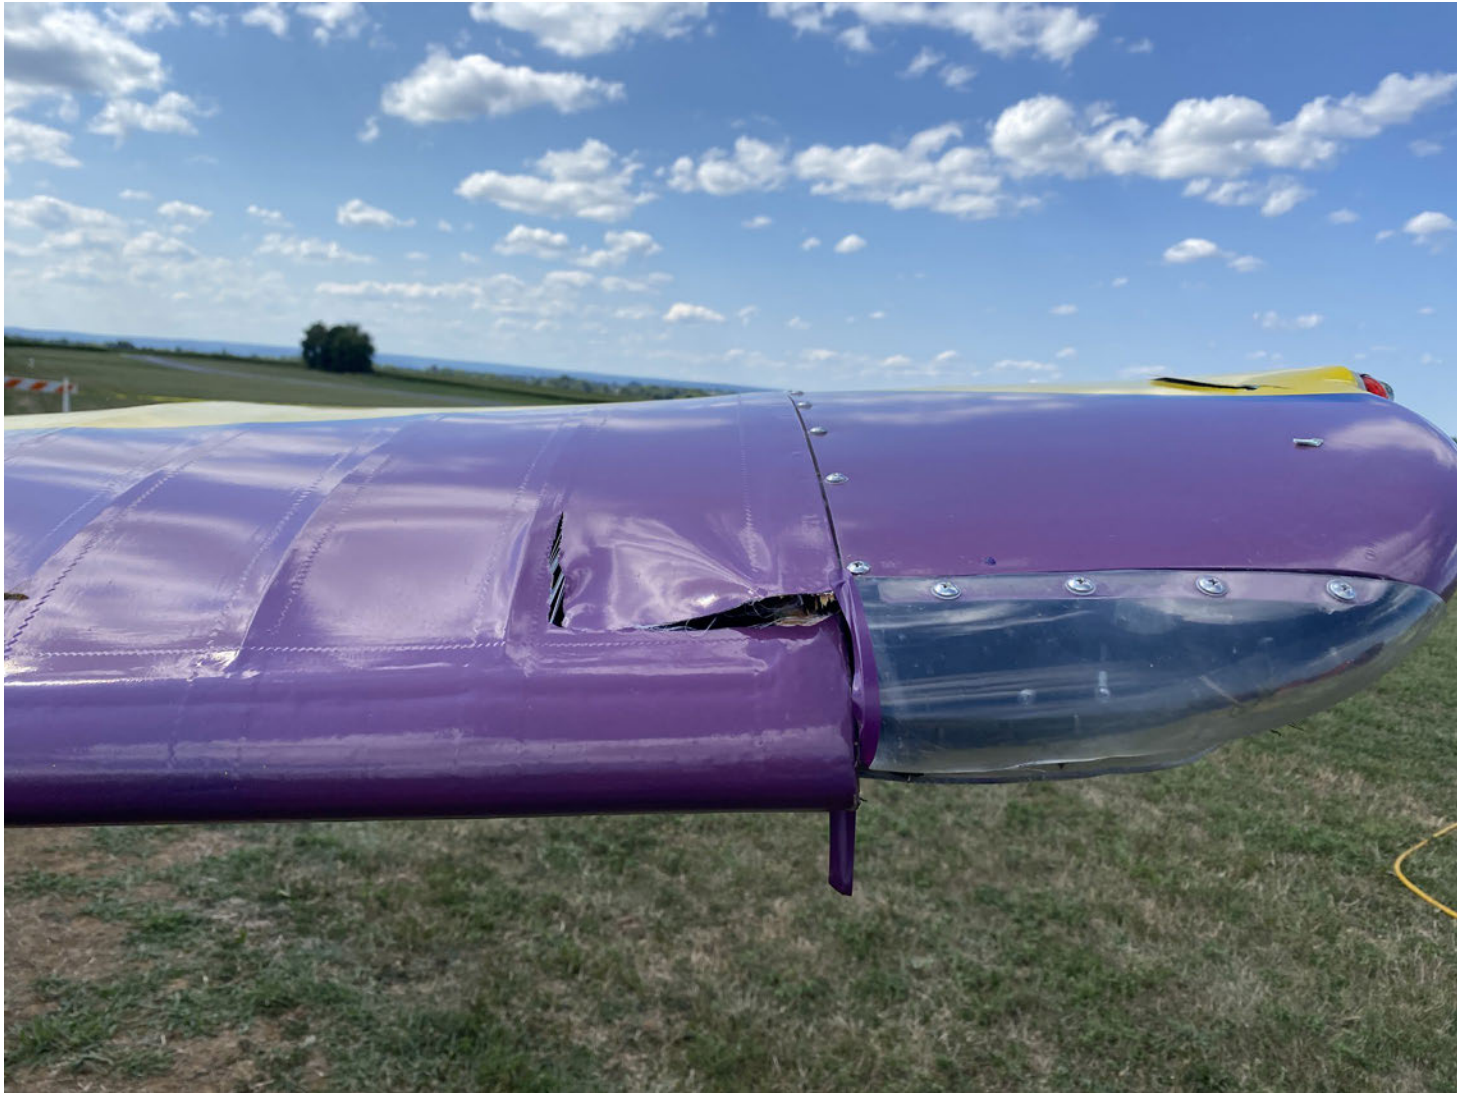
**Photograph 3 - damaged left wing tip (Courtesy of FAA)**

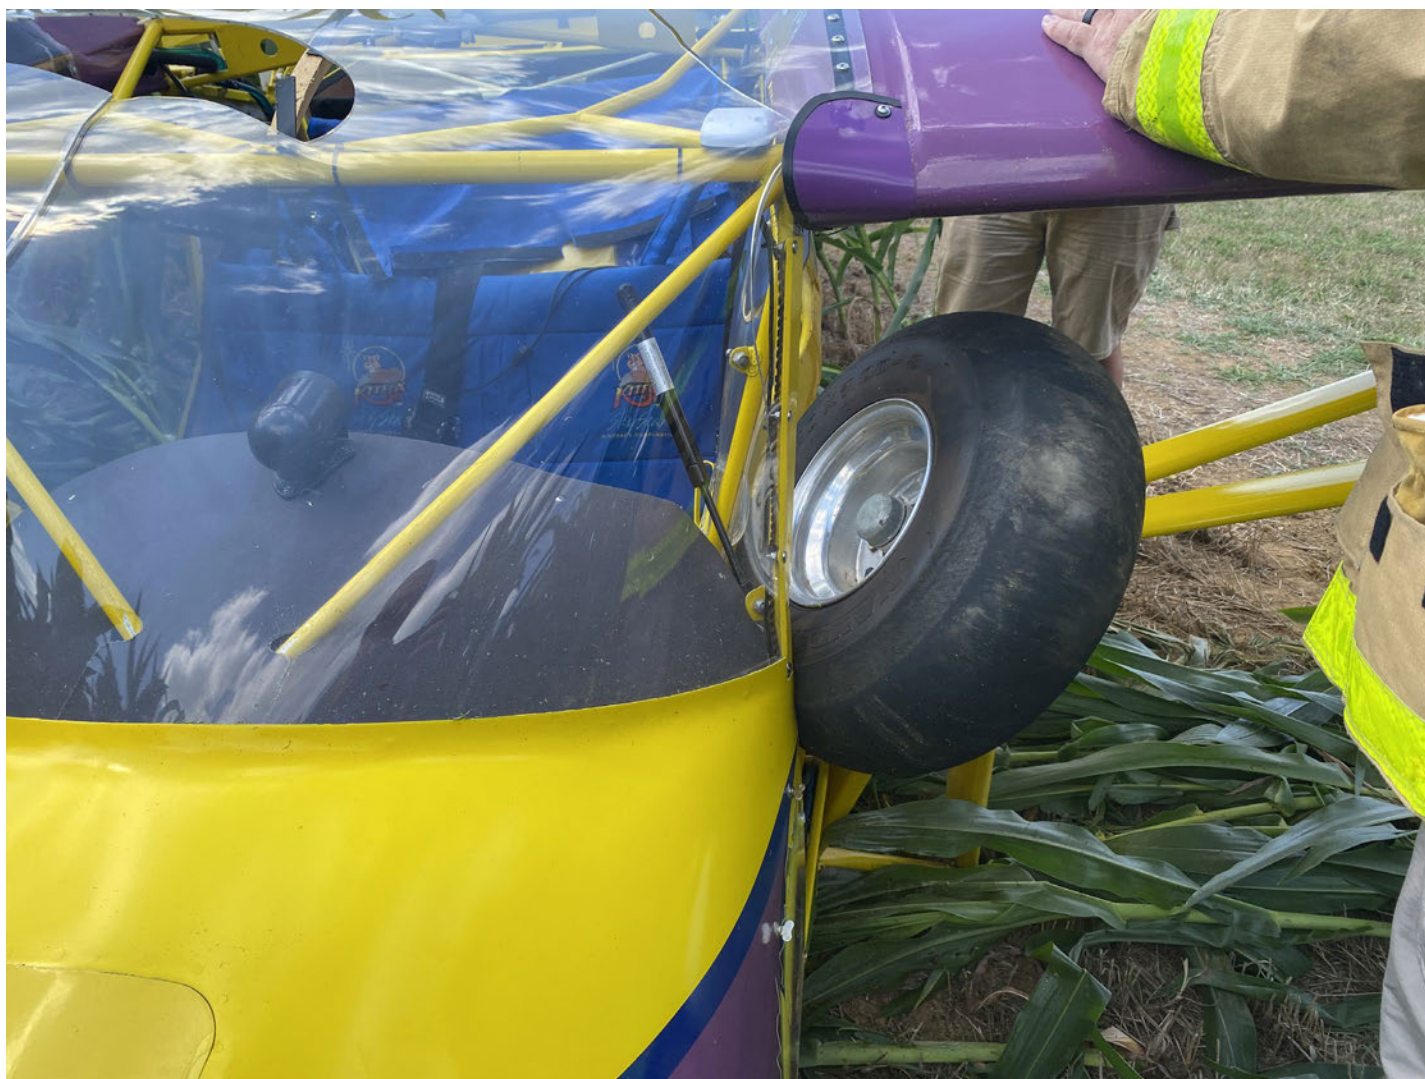
**Photograph 4 - Damaged main landing gear (Courtesy of FAA)**

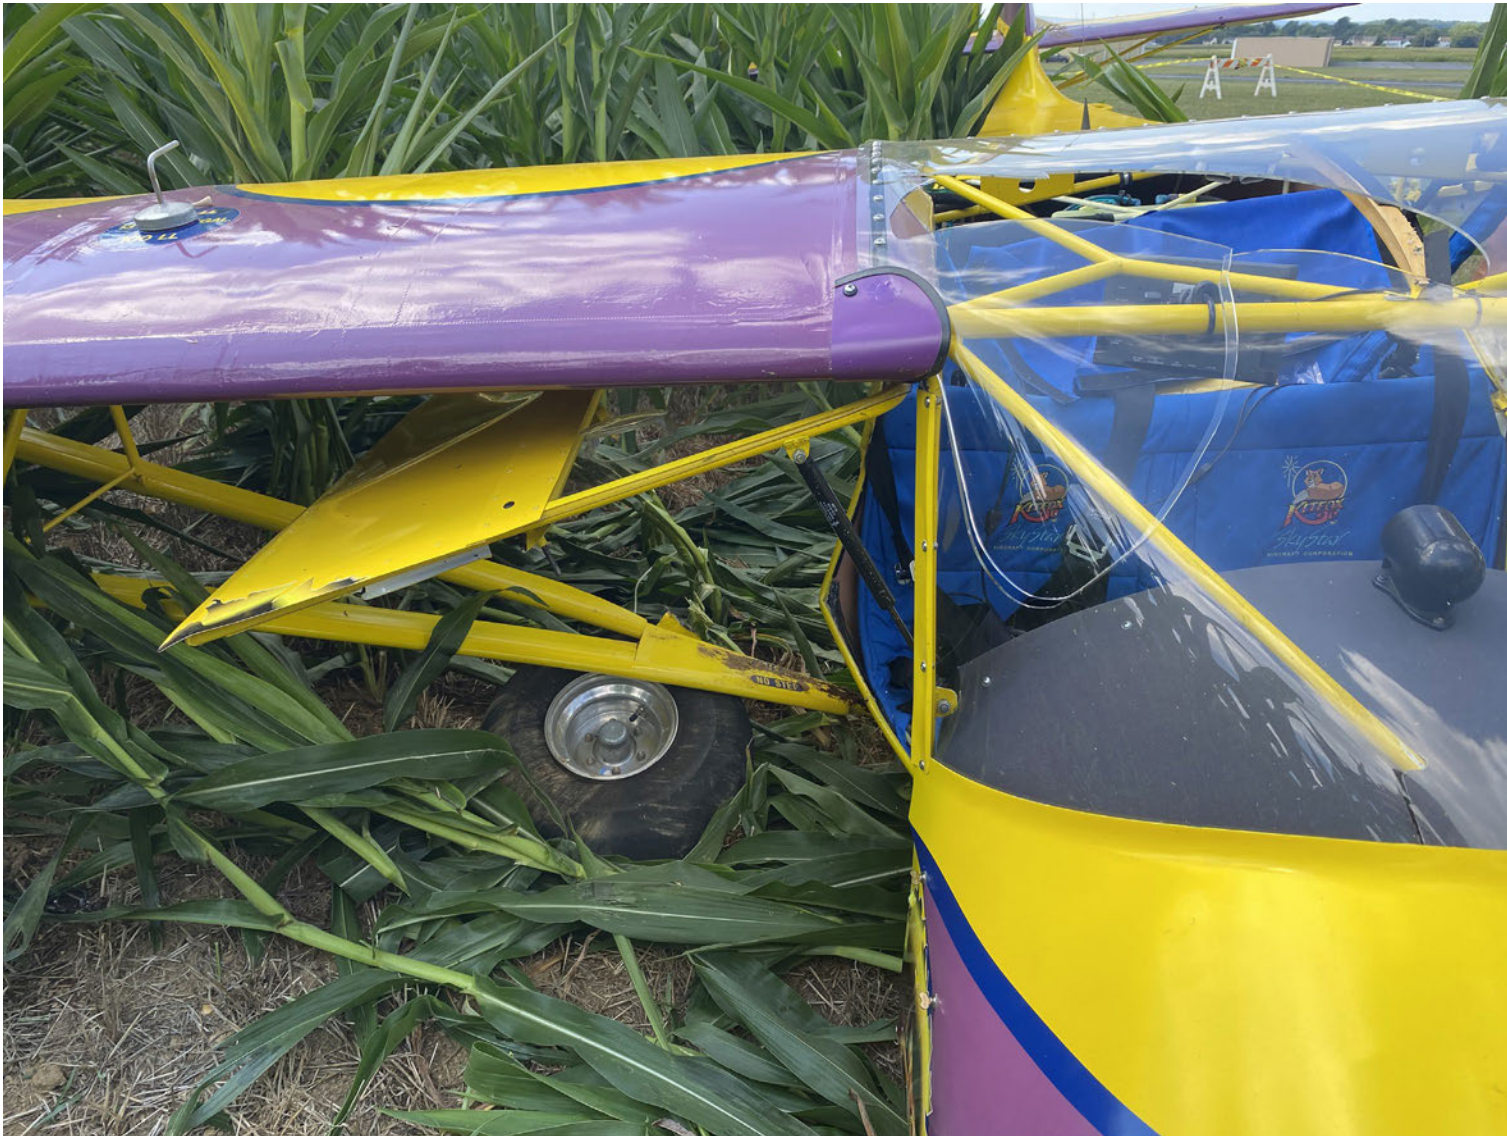
**Photograph 5 - Damaged main landing gear (Courtesy of FAA)**
