ERA24LA325

## INVESTIGATION PHOTOGRAPHS

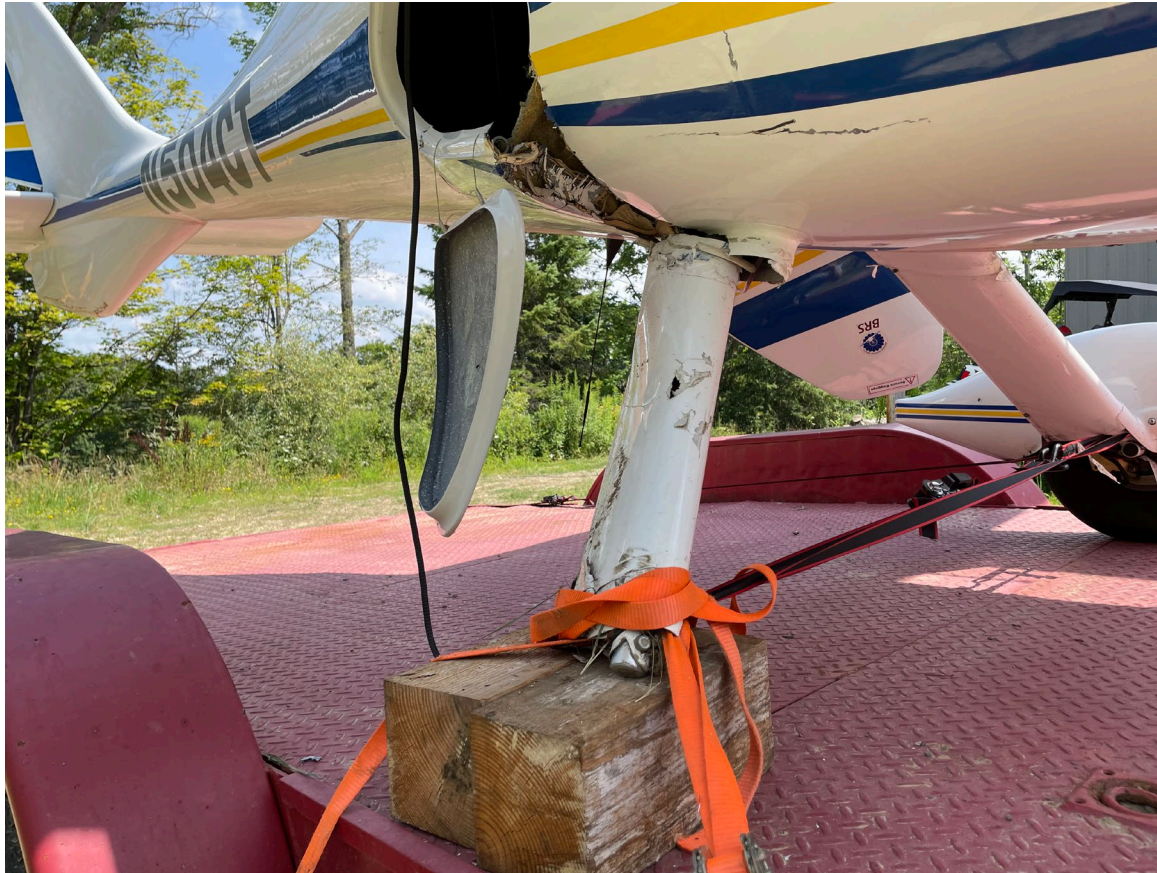
**Photograph 1 - Postaccident damage right side lower fuselage (Courtesy of FAA)**

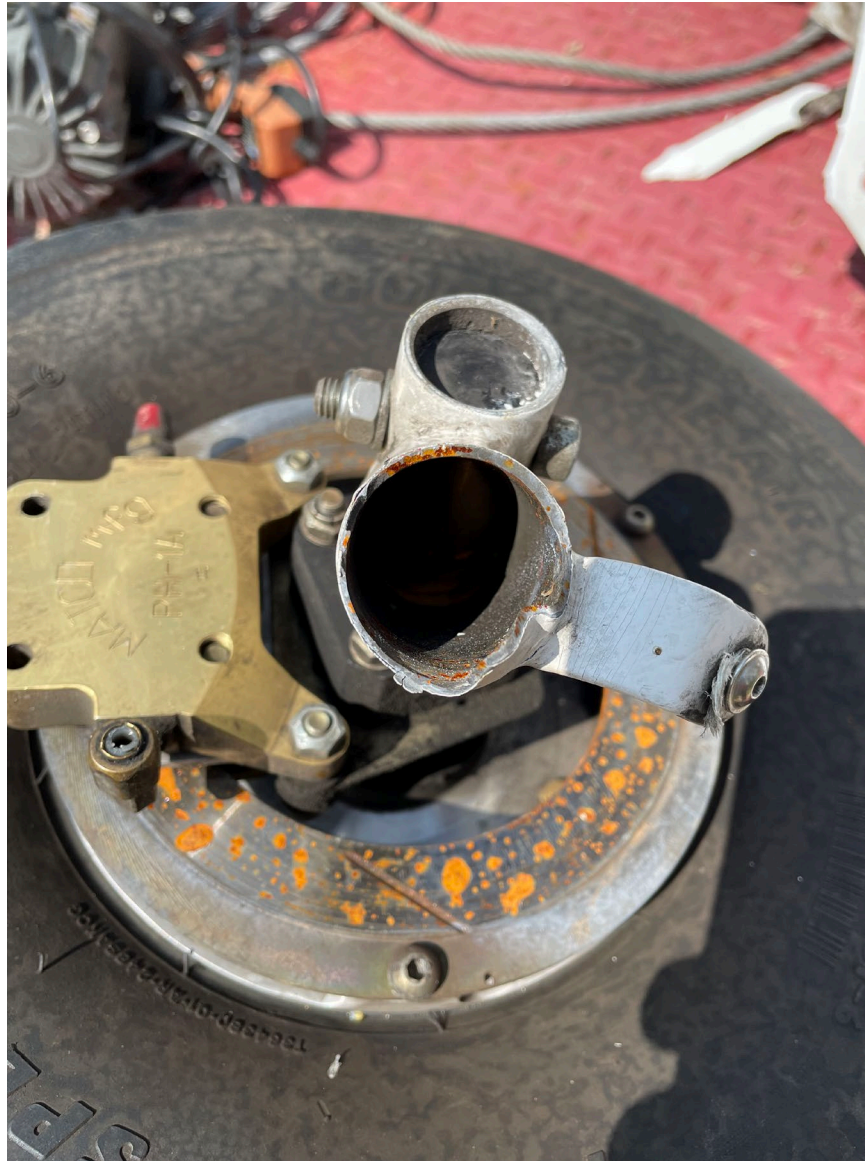
**Photograph 2 - Postaccident damaged main wheel attach fitting (Courtesy of FAA)**
