ERA24LA332

## INVESTIGATION PHOTOGRAPHS

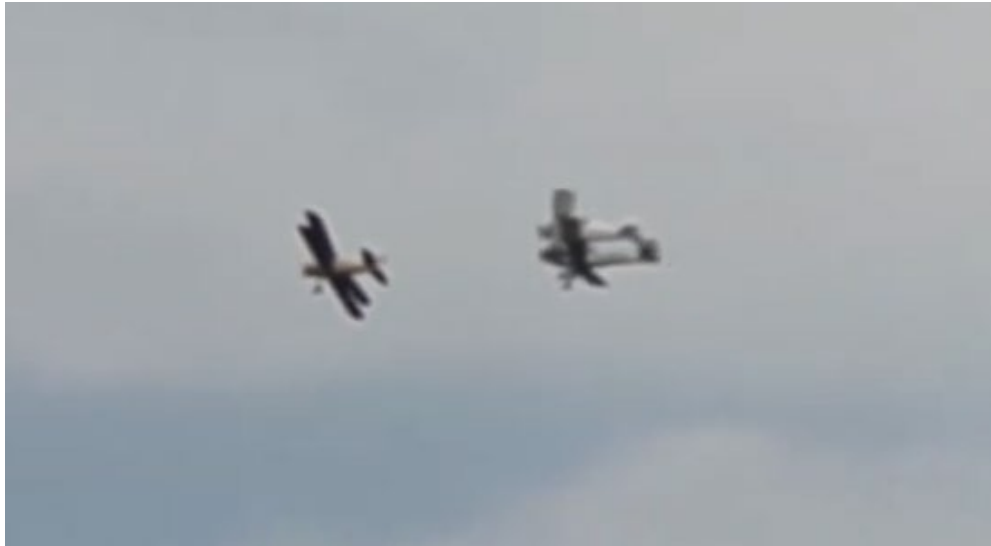
**Photograph 1 – Screen capture of midair collision video (Courtesy of FAA)**

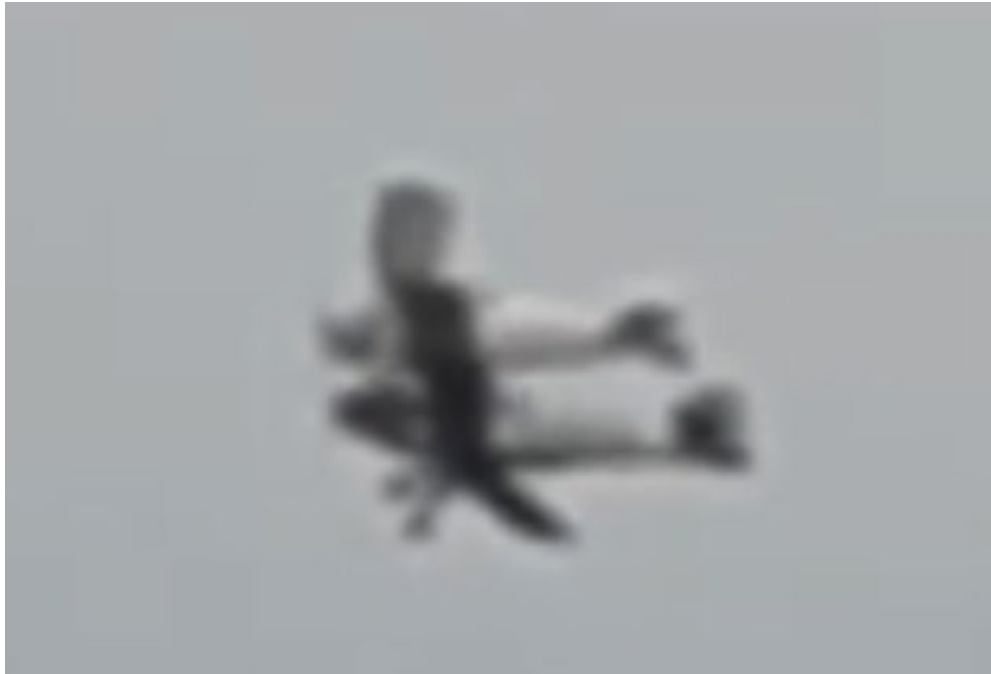
**Photograph 2 – Screenshot of midair collision video (Courtesy of FAA)**

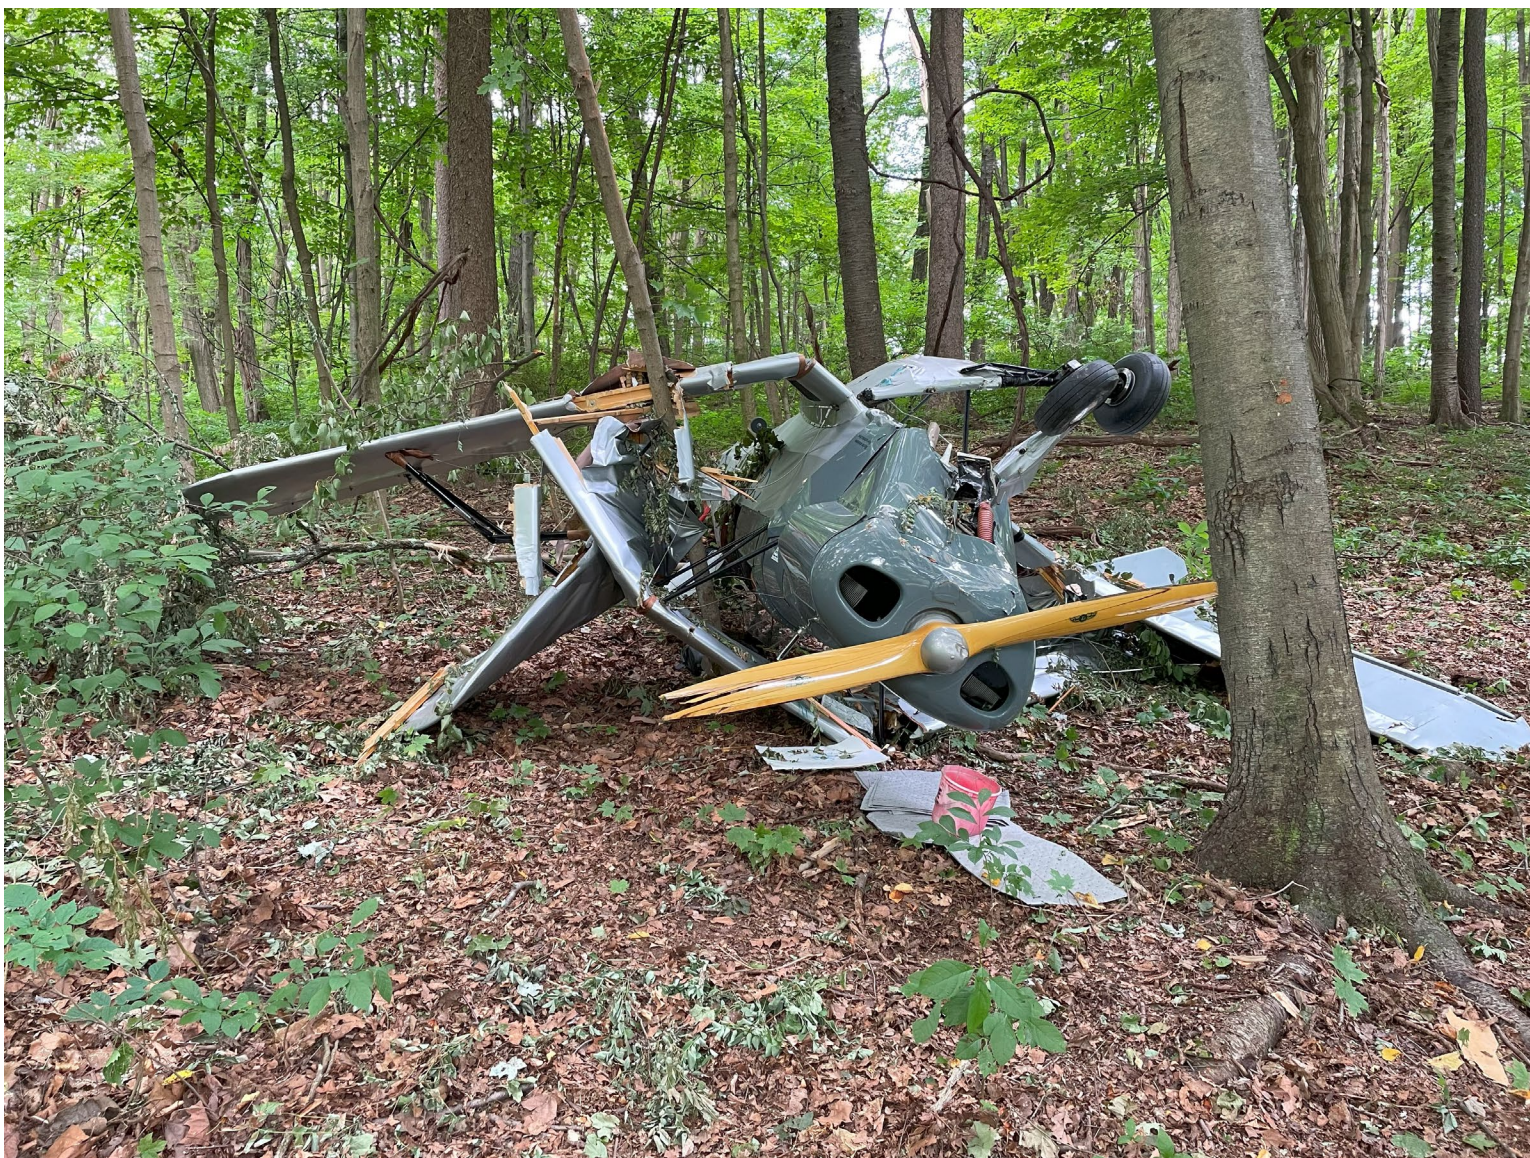
**Photograph 3 – N1041U wreckage at the accident site (Courtesy of FAA)**

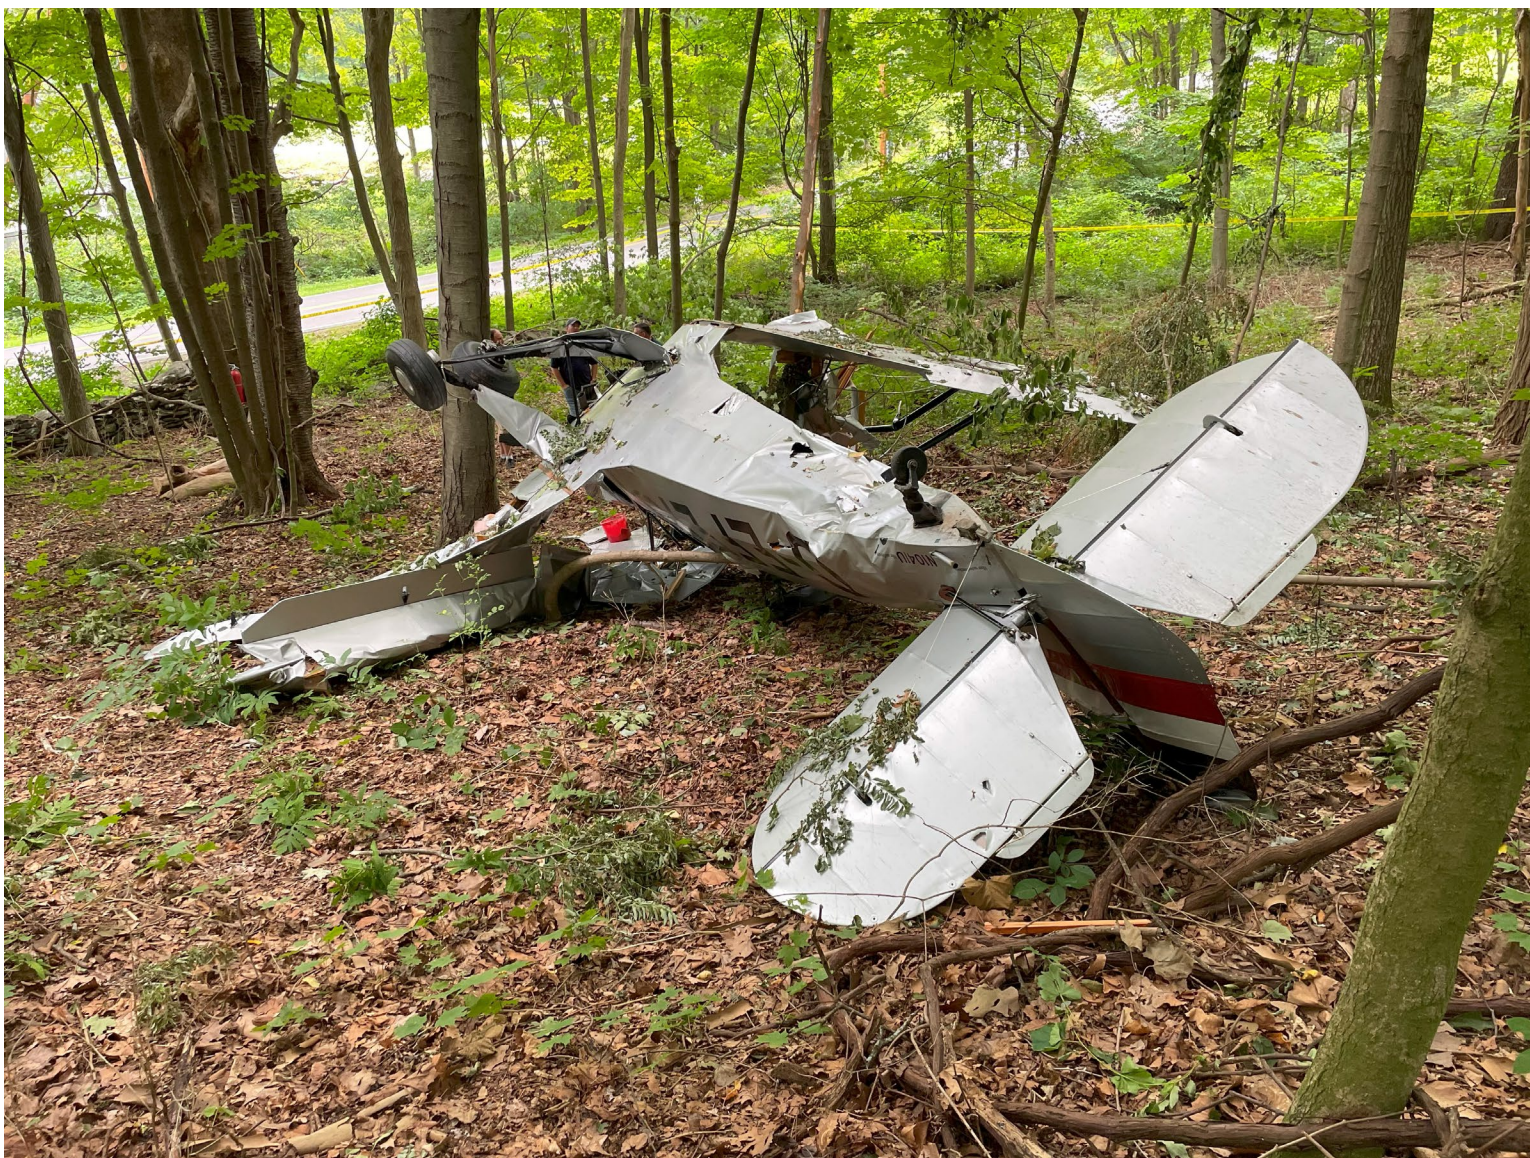
**Photograph 4 – N1041U wreckage at the accident site (Courtesy of FAA)**

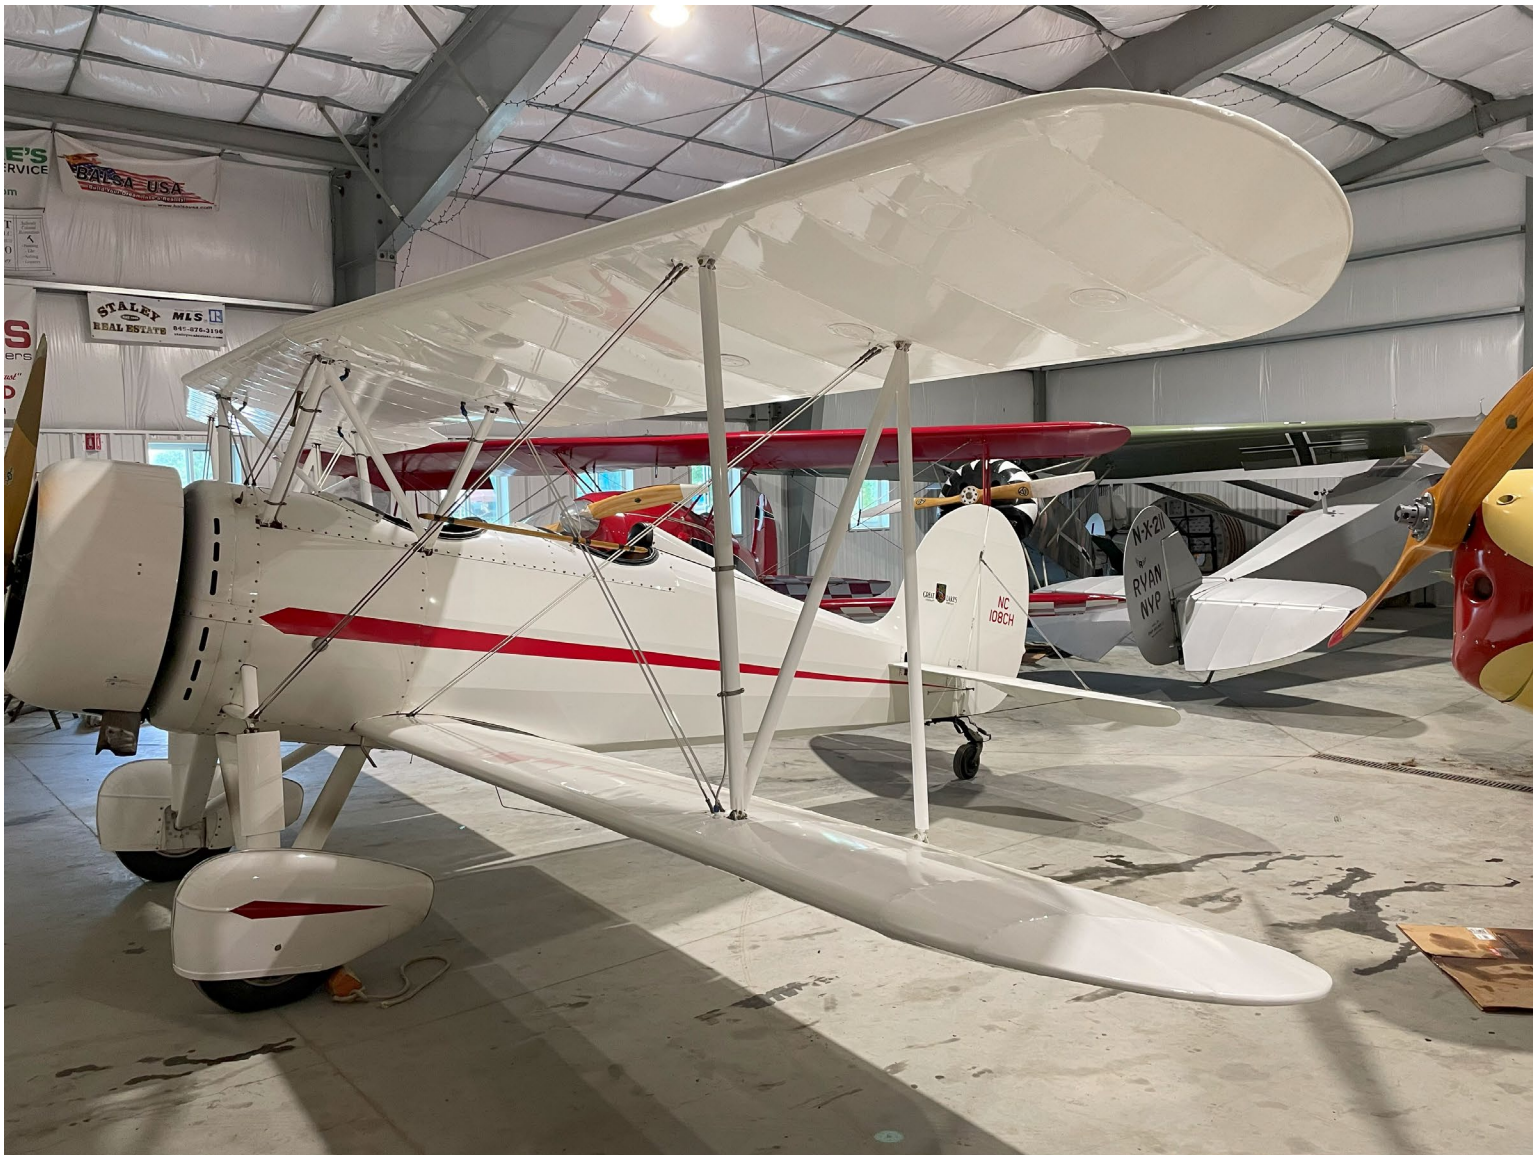
**Photograph 5 – N108CH after midair collision (Courtesy of FAA)**

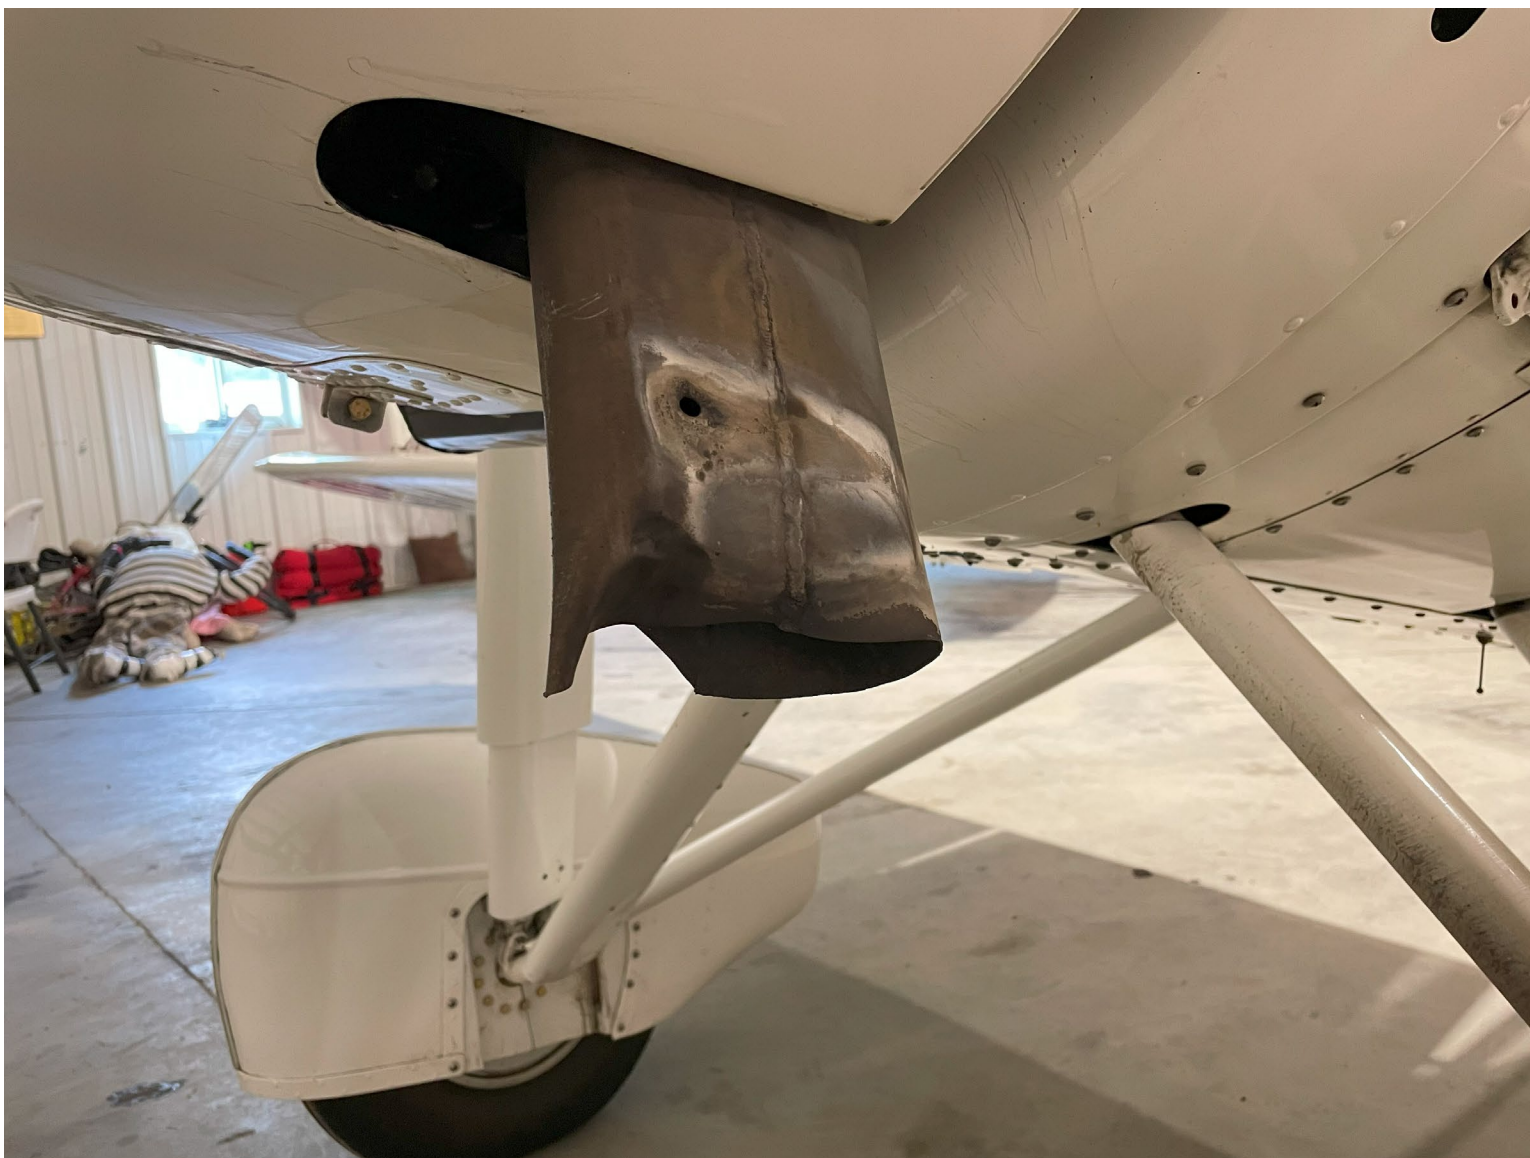
**Photograph 6 – Damage to exhaust pipe of N108CH (Courtesy of FAA)**

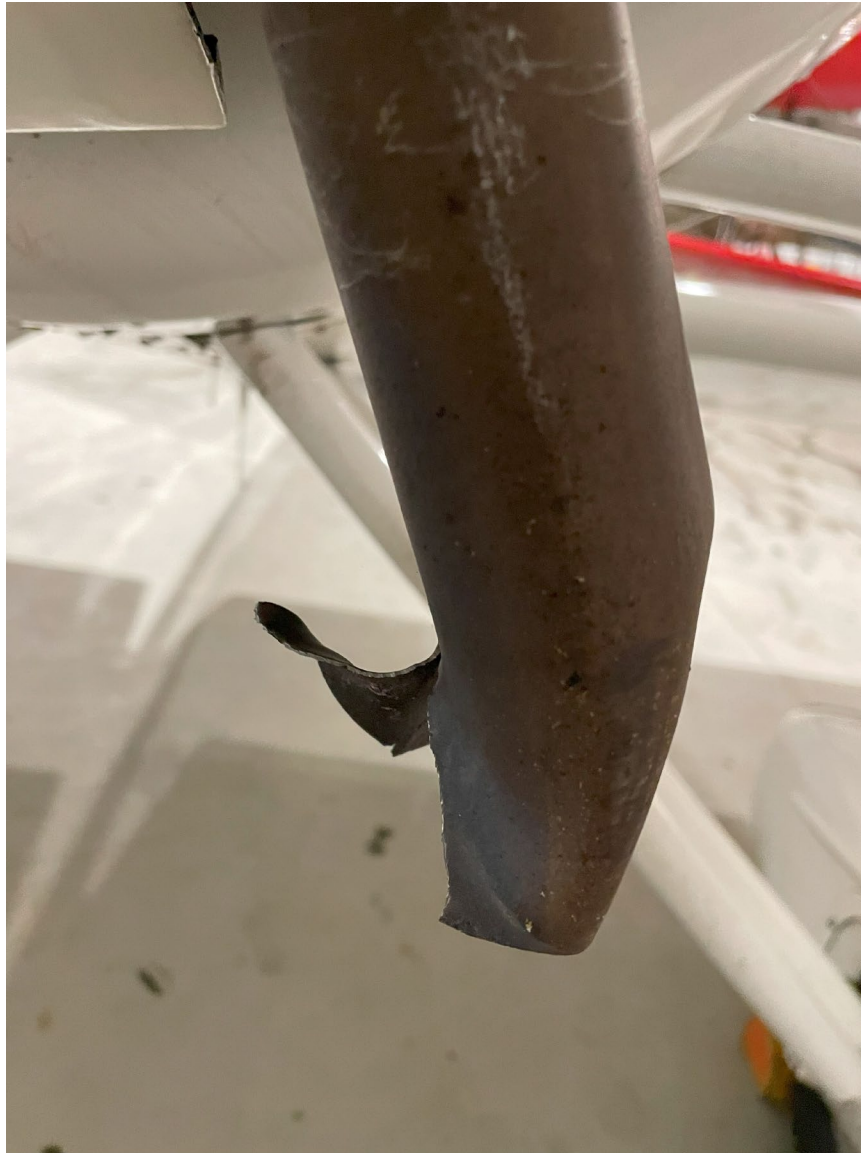
**Photograph 7 - Damage to exhaust pipe of N108CH (Courtesy of FAA)**

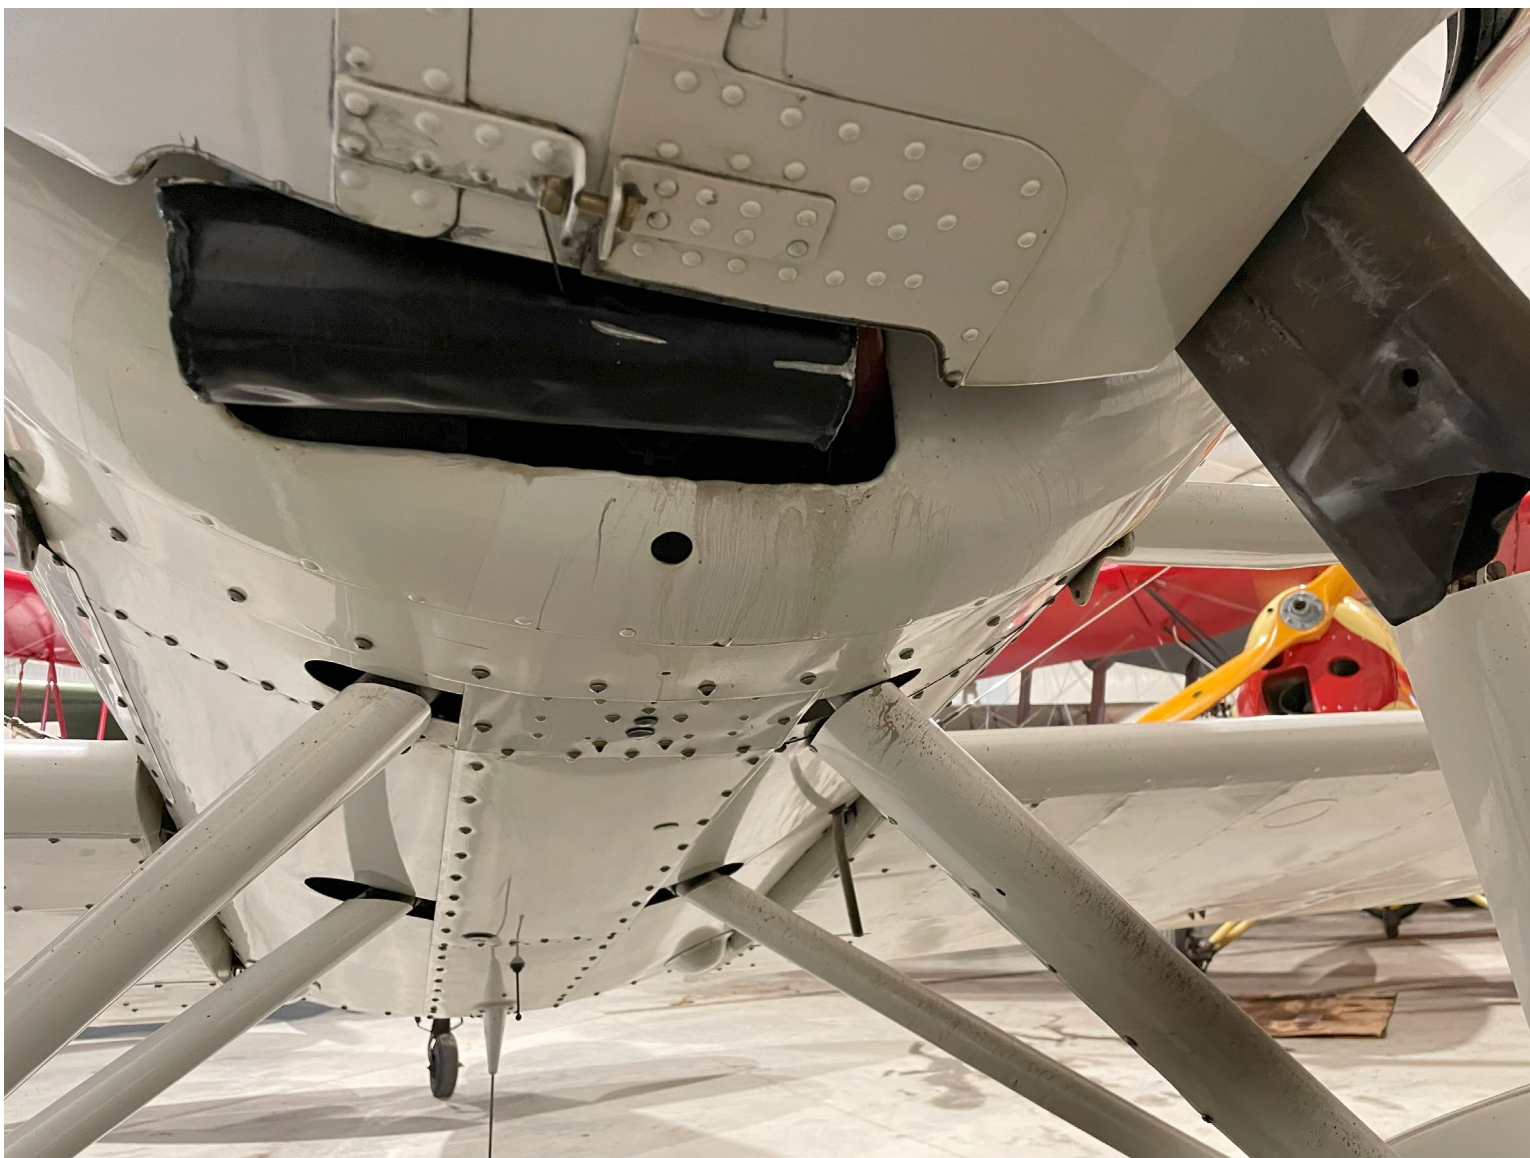
**Photograph 8 – Damage to N108CH (Courtesy of FAA)**
