# National Transportation Safety Board

ERA24LA333

## **MATERIALS LABORATORY**

Location: Egg Harbor City, NJ  
Date: July 31, 2024  
Vehicle: Cirrus SR20 (N124RR)  
Investigator: Aaron McCarter

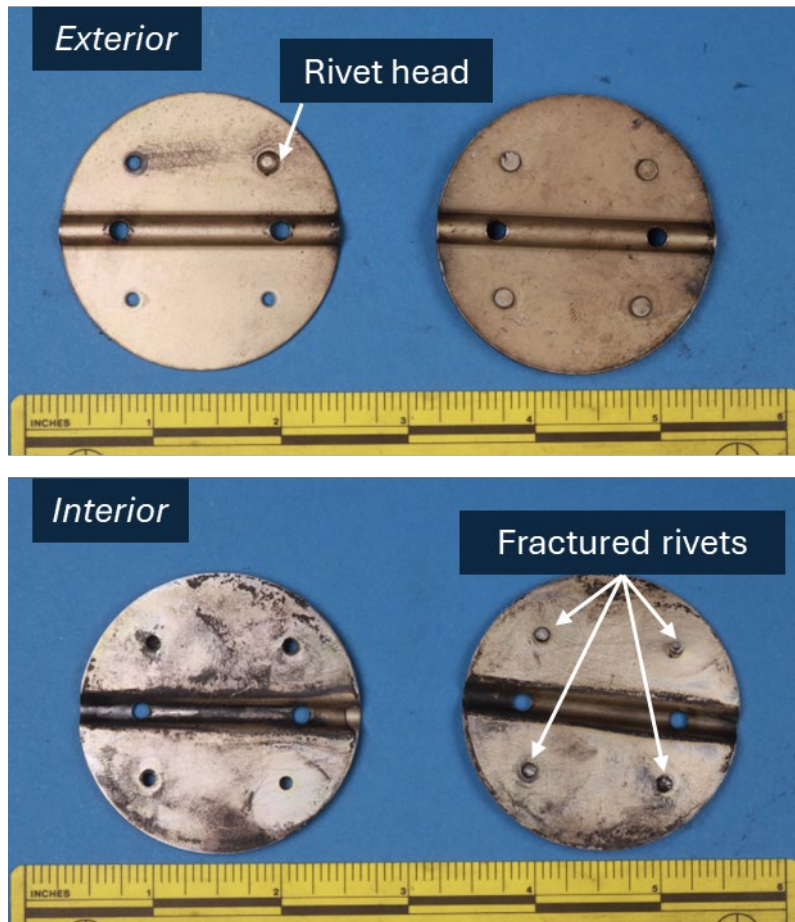
The pieces of the valve as received are shown in Figures 1 and 2. One half of the valve contained four fractured rivets embedded into the surface. These fracture surfaces were visible on the interior of the valve. All the broken rivets protruded approximately 0.11 inch above the interior face, as measured with digital calipers. One rivet head remained attached to the other half of the valve. Later cleaning of the valve caused the rivet head to detach, and it was found that the fracture surface was approximately level with the exterior surface of the valve.

**Figure 1.** Metal halves of the butterfly valve as received. (Top) Outer surfaces. (Bottom) Inner surfaces.

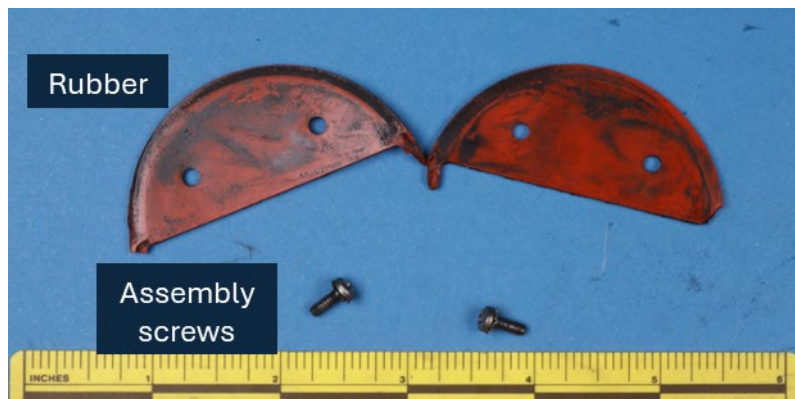
**Figure 2.** Rubber padding and screws from the butterfly valve as received.

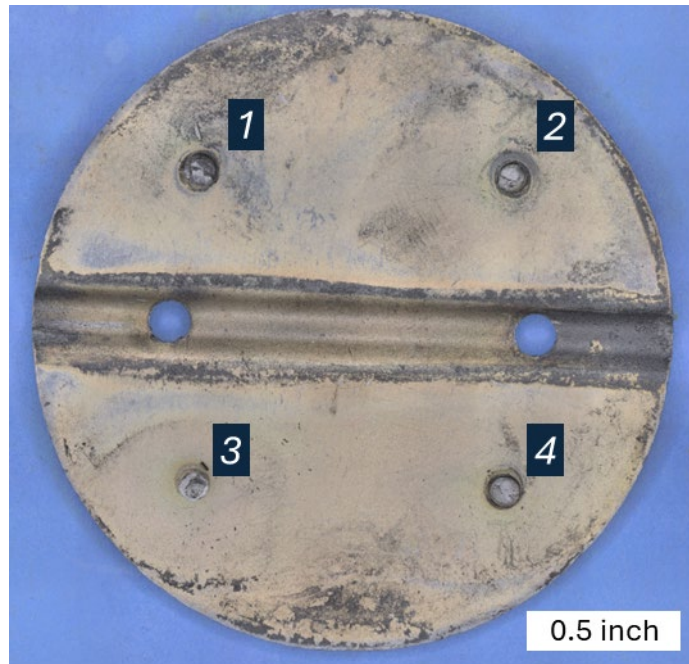
The valve halves were cleaned in an ultrasound bath with acetone. Examination of the rivet fracture surfaces under an optical stereoscope showed striations on all four surfaces, interspersed with shiny planes consistent with rubbing or contact post-fracture. The rivets were arbitrarily labeled 1 through 4 (as displayed in Figure 3) and were examined using a field-emission scanning electron microscope (SEM).

**Figure 3.** Valve and rivet fracture surfaces after cleaning with acetone.

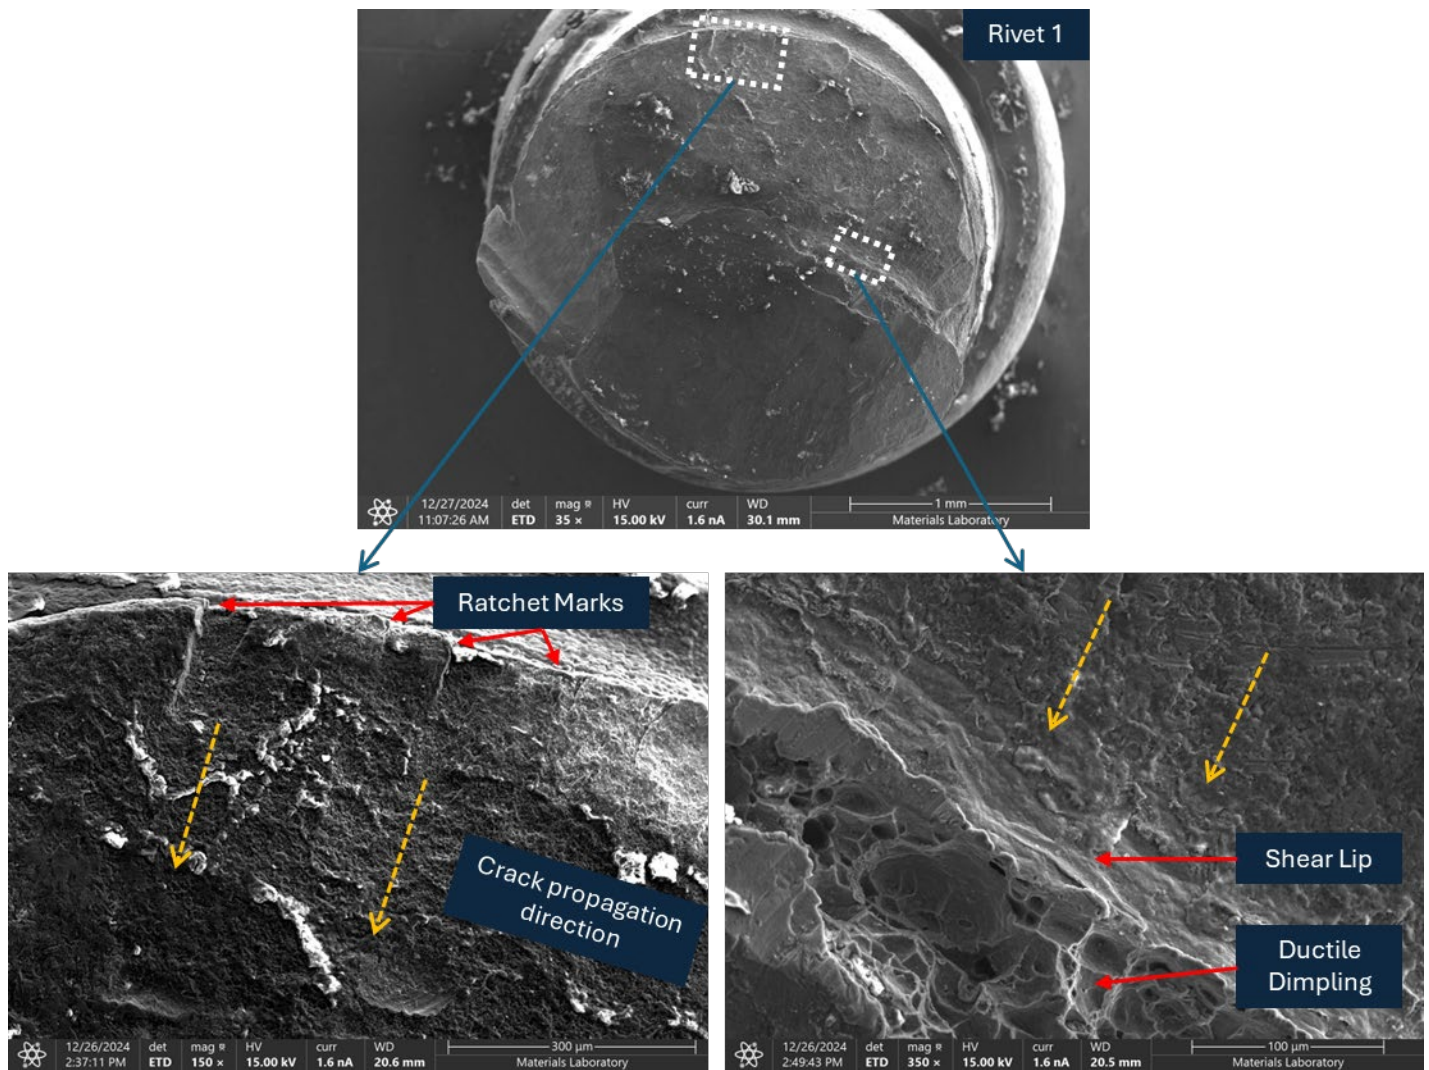
Secondary electron (SE) micrographs of the rivets are shown in Figures 4 - 7. All four fracture surfaces showed striations consistent with fatigue crack propagation alongside small areas of ductile dimples consistent with final overstress failure. Rivets 1, 2, and 3 also showed ratchet marks, indicating multiple cracks originating from the outer edge of the rivet. The fracture surface features, including the location and shape of the ductile dimpling surfaces were consistent with bending or torsion-bending stresses on the rivets.

**Figure 4.** (Top) SE micrograph of the Rivet 1 fracture surface. (Bottom left) Ratchet marks on the outer edge of the fracture surface. Striations indicate the direction of crack propagation towards the center of the rivet. (Bottom right) The boundary between crack progression striations and the ductile dimpling consistent with overload failure.

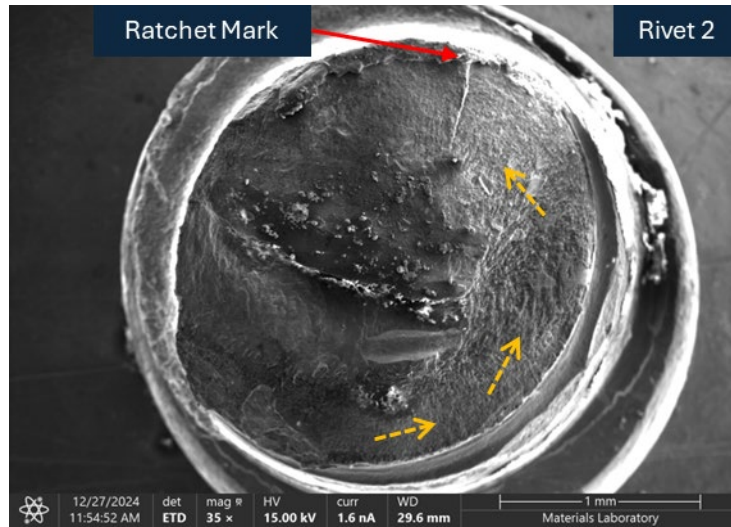
**Figure 5.** Crack progression striations and ratchet marks visible on Rivet 2. Orange lines indicate the direction of crack progression.

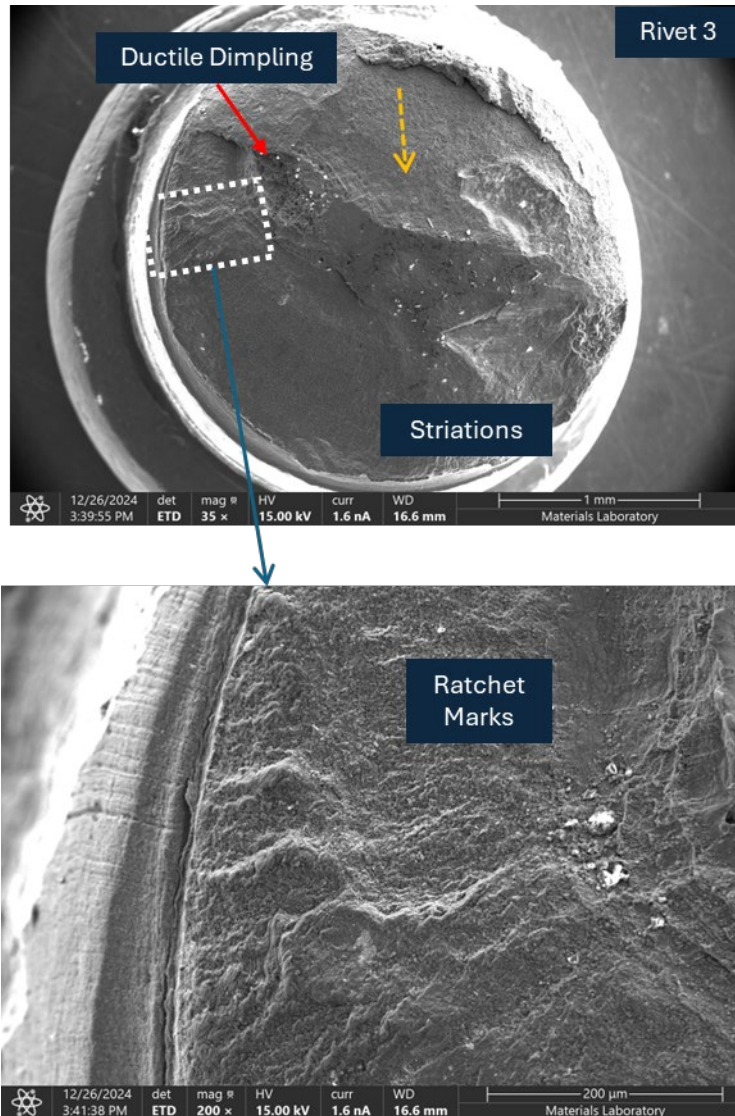
**Figure 6.** (Top) Crack progression striations progressing from the outer edges of Rivet 3. Ductile dimpling was observed near the center of the rivet. Orange lines indicate the direction of crack progression. (Bottom) Ratchet marks on the outside edge of the fracture surface.

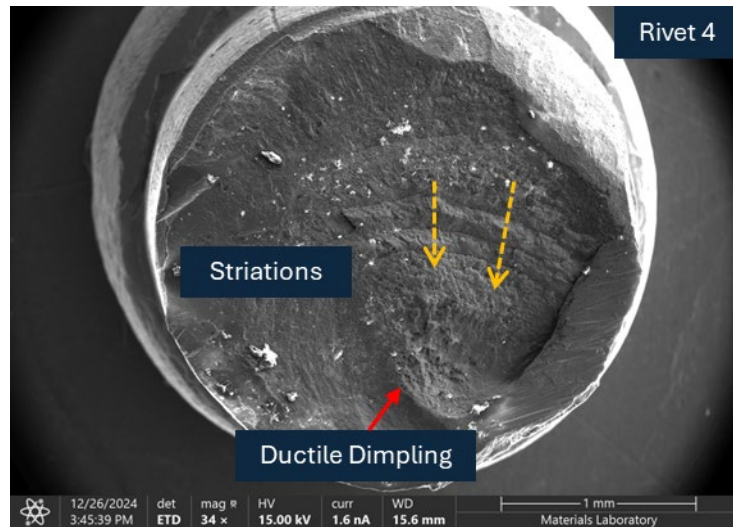
**Figure 7.** Crack progression striations on the fracture surface of rivet 4, consistent with torsion-bending fatigue. Orange lines indicate the direction of crack progression.

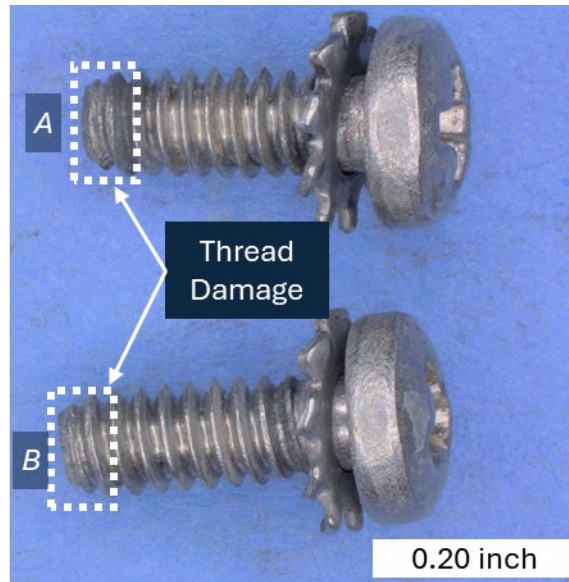
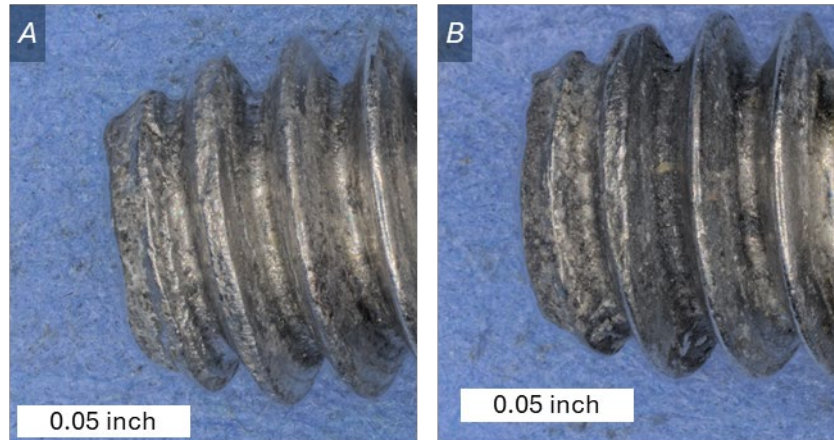
The assembly screws were cleaned in an ultrasound bath with acetone and examined for thread damage. Smearing and blunting consistent with contact damage were noted on the final two threads of each screw (Figure 8).

**Figure 8.** (Top) The final two threads in both screws were damaged. (Bottom images) close-up of the damage areas labeled in the top images. The crests of the final two threads show smearing damage.
