ERA24LA333

## INVESTIGATION PHOTOGRAPHS

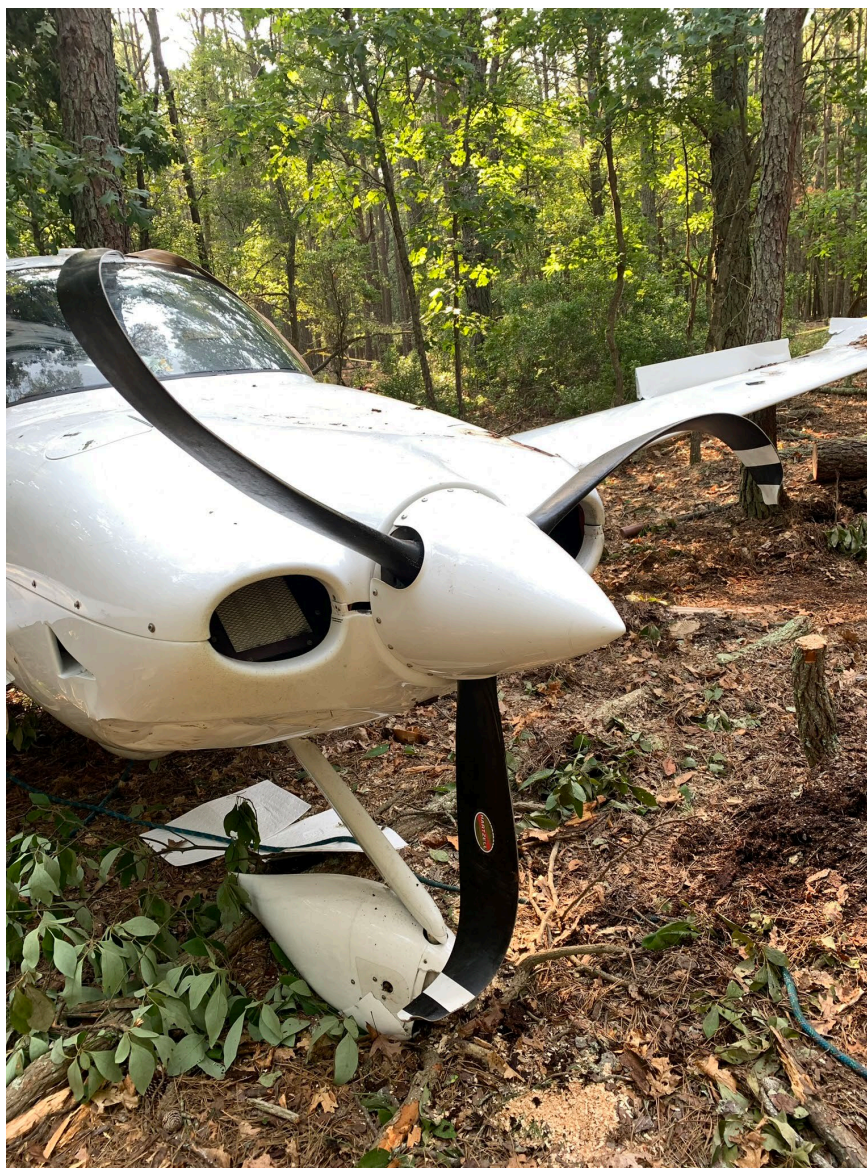
**Photograph 1 - View of propeller and wing damage. (Courtesy of FAA)**

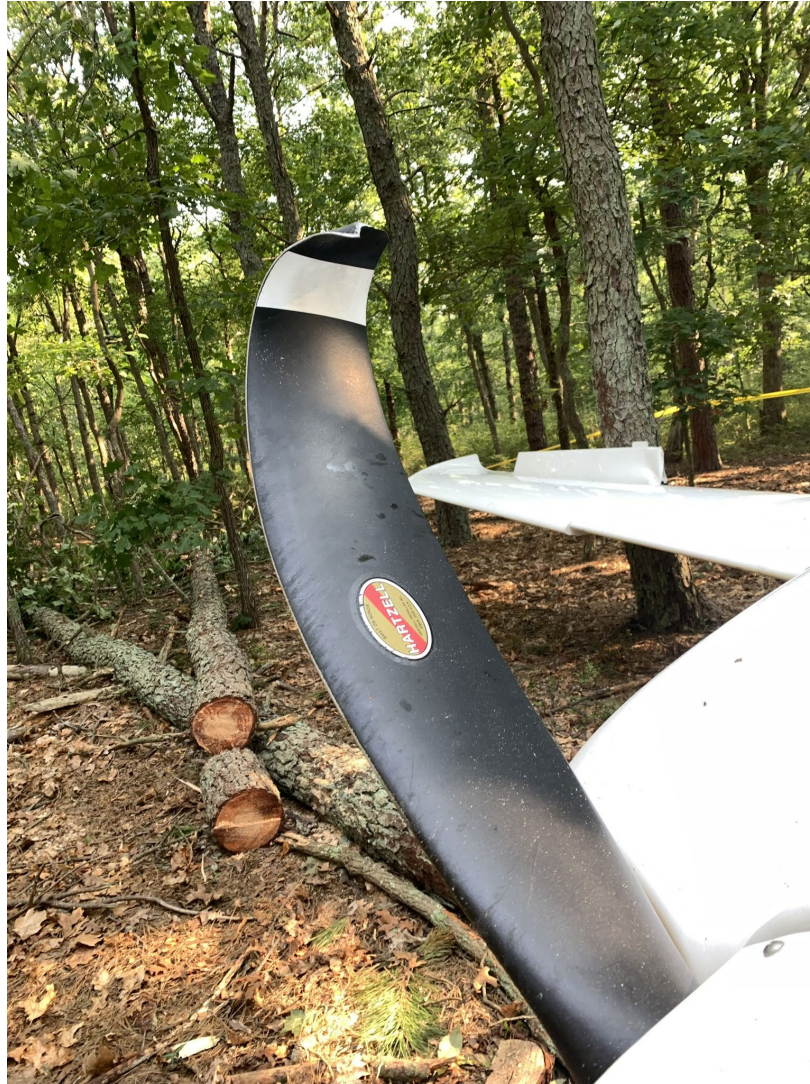
**Photograph 2 - Closeup view of propeller damage. (Courtesy of FAA)**

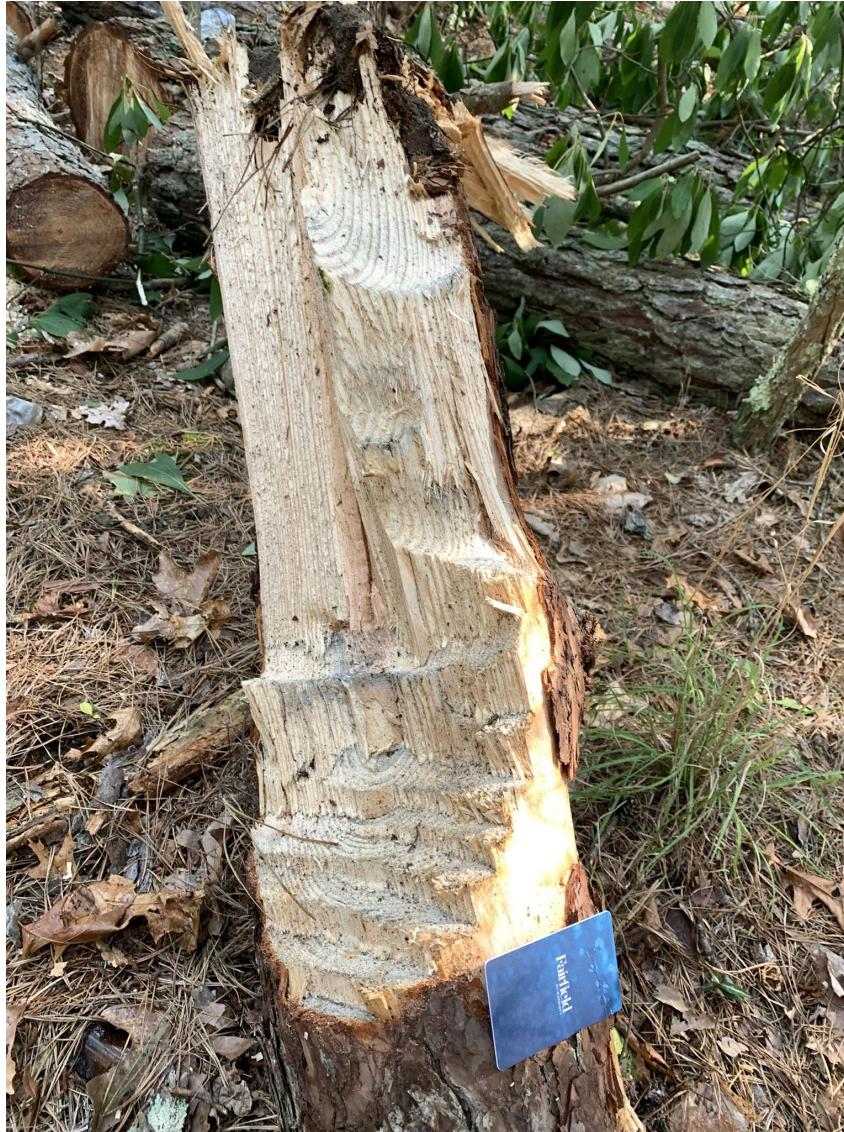
**Photograph 3 - View of tree damage indicative of propeller slice marks. (Courtesy of FAA)**

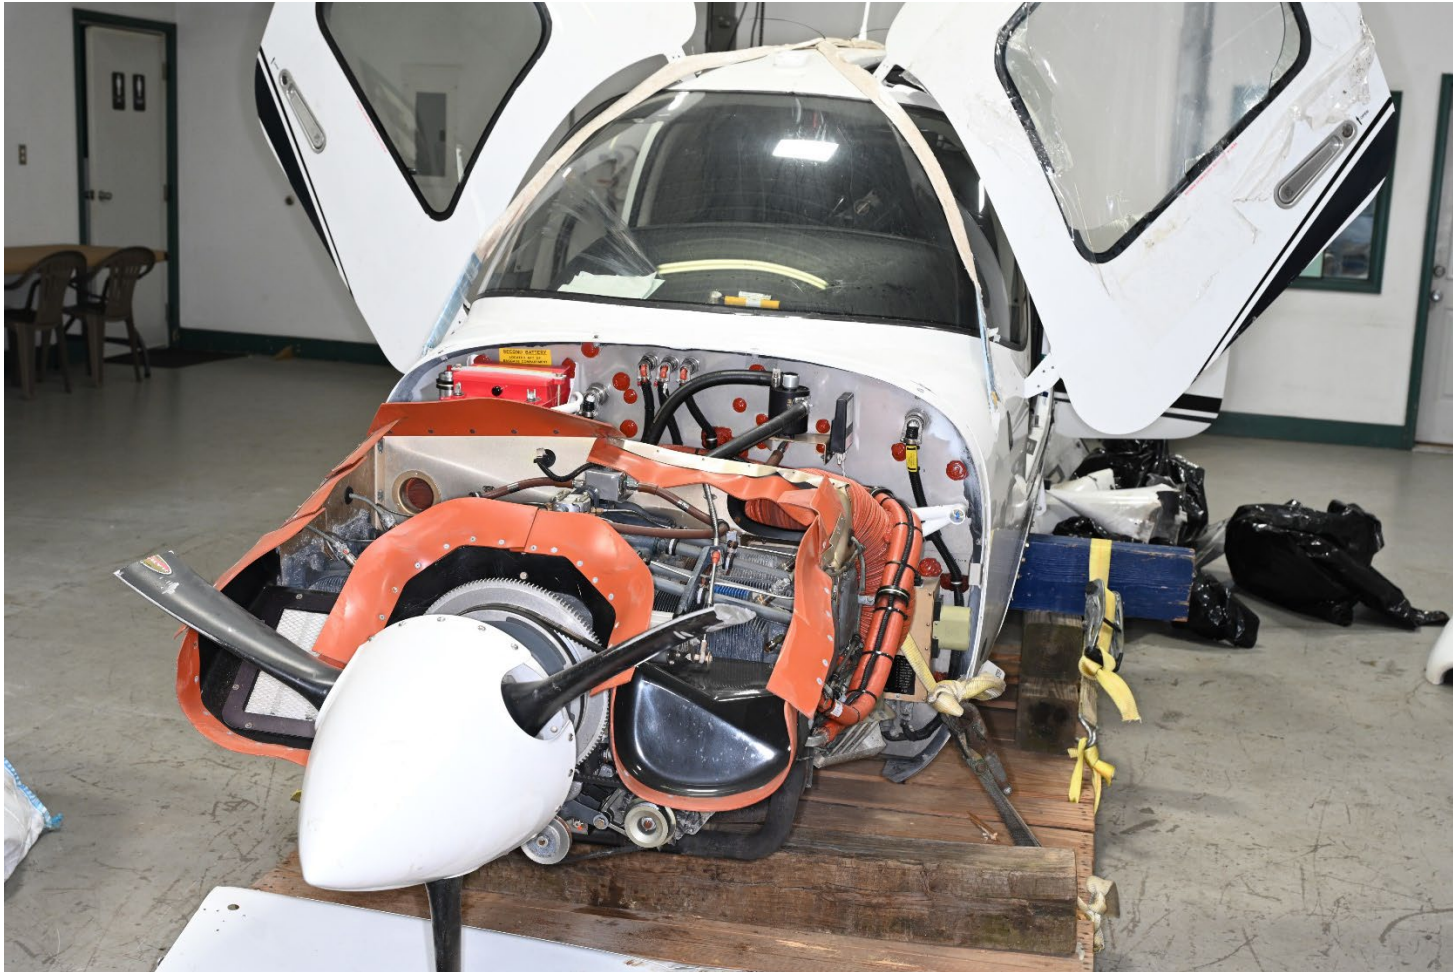
**Photograph 4 - Airplane prior to full examination. Note propellers cut off equally to facilitate safe engine run. (NTSB)**

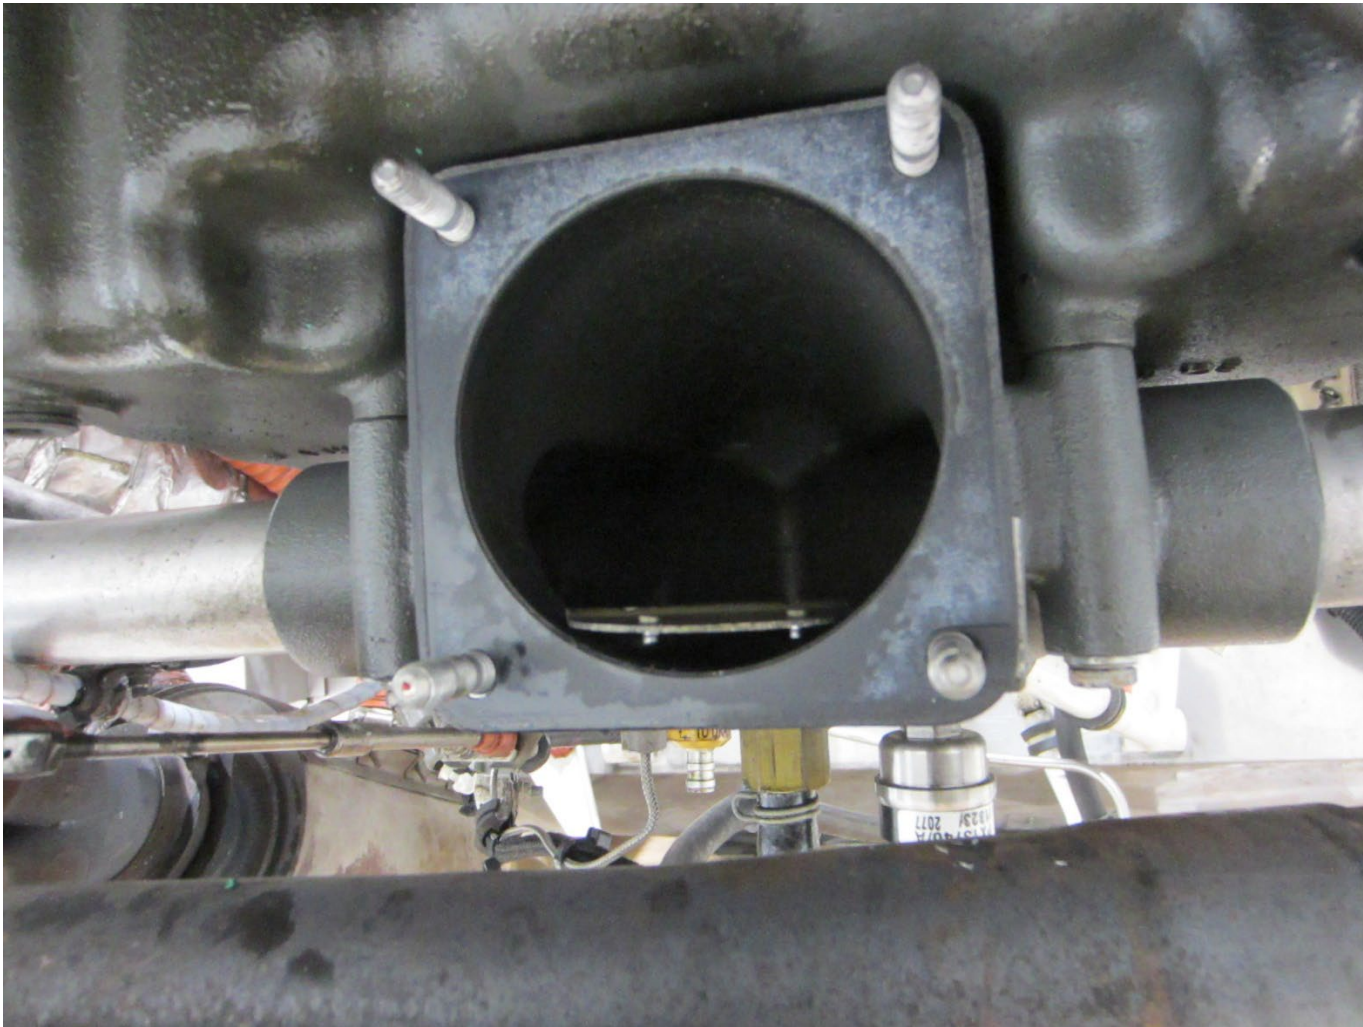
**Photograph 5 - Alternate air valve (half) located in induction housing. (NTSB)**

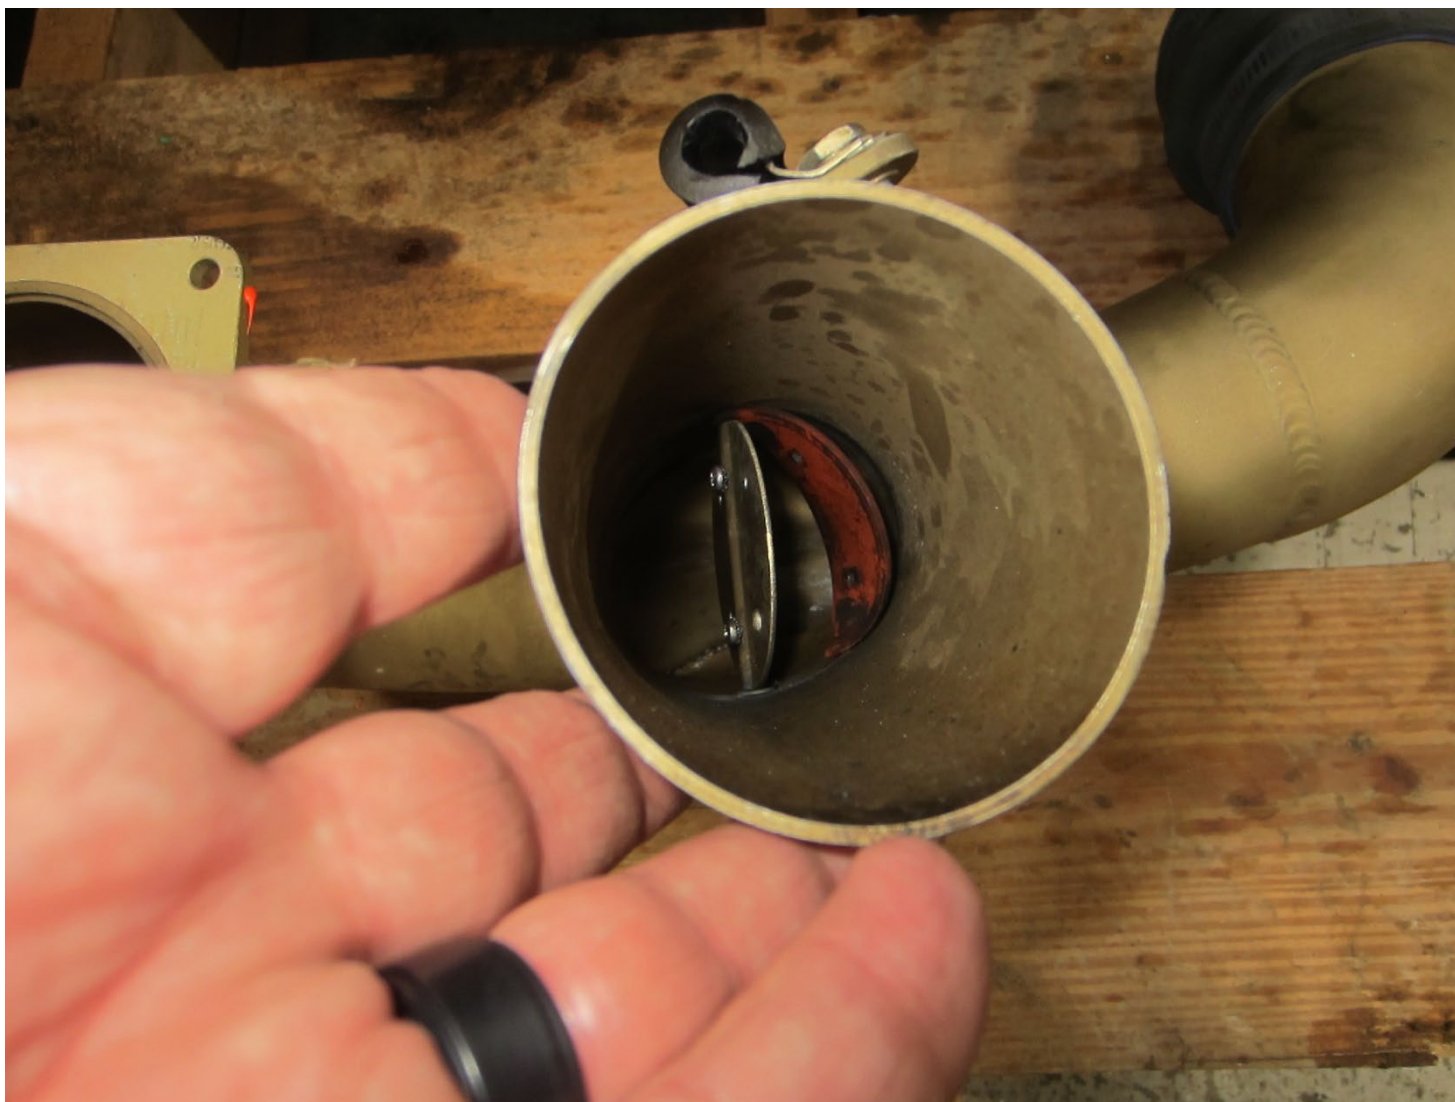
**Photograph 6 - Half of the alternate air valve partially installed in induction tube. (NTSB)**
