# National Transportation Safety Board

ERA24LA333

## EXAMINATION

Location: Egg Harbor, NJ  
Date: July 31, 2024  
Examination: September 4/5, 2024  
Time: 1540 est.  
1940 (UTC)  
Airplane: Cirrus SR-20 N124RR

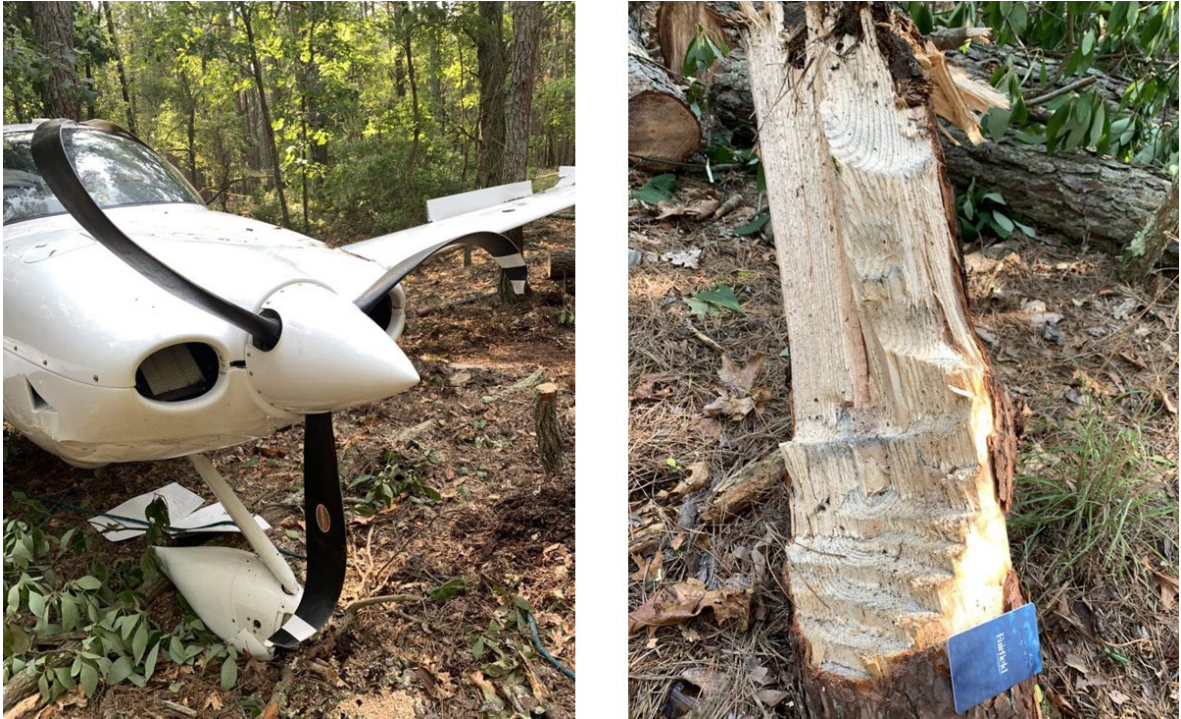
Lat/Log 39.508922 -74.546326 Hilly wooded terrain outside of Egg Harbor City, NJ.

**Figure 1 Accident site, damage and tree propeller chopping/cutting marks.**

About two inches of the blade tips were separated from two of the blades. The blade tips exhibited twisting toward the blade faces. Recovery personnel reported that tree limbs with angular cuts consistent with propeller blade contact were observed at the accident site.

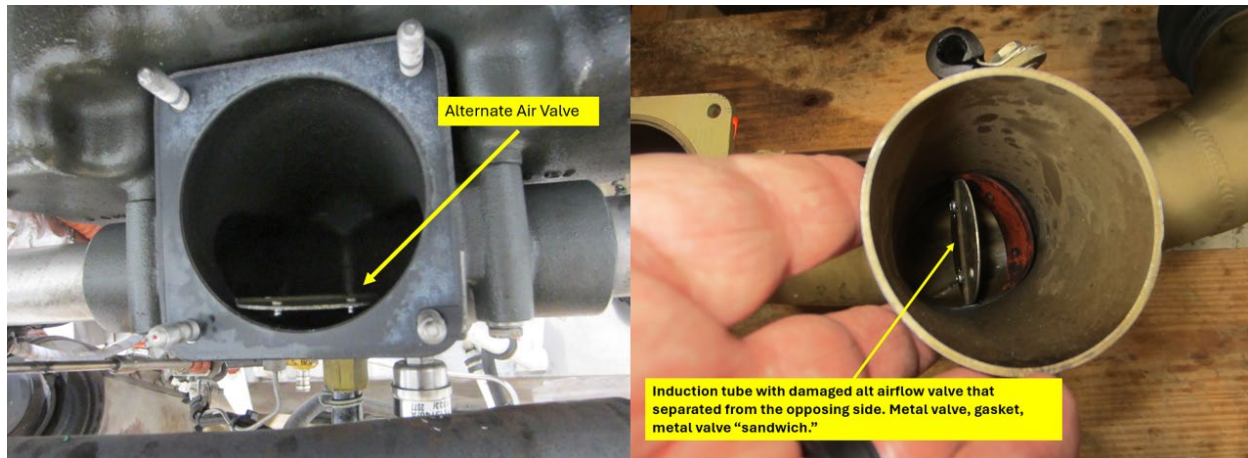
The fuel injector servo was removed revealing a circular aluminum disc floating freely and unattached inside the engine induction housing assembly as shown in figure 2. Further examination revealed that the rivets attaching the two portions of the induction alternate air valve were separated. One of those portions was identified as the disc observed in the induction housing assembly. The opposing half was still

partially installed on its respective mount/actuator inside the induction tube. The valve and induction tube will be sent to the NTSB Materials Lab for examination.

**Figure 2 Alternate air valve as discovered during the examination.**

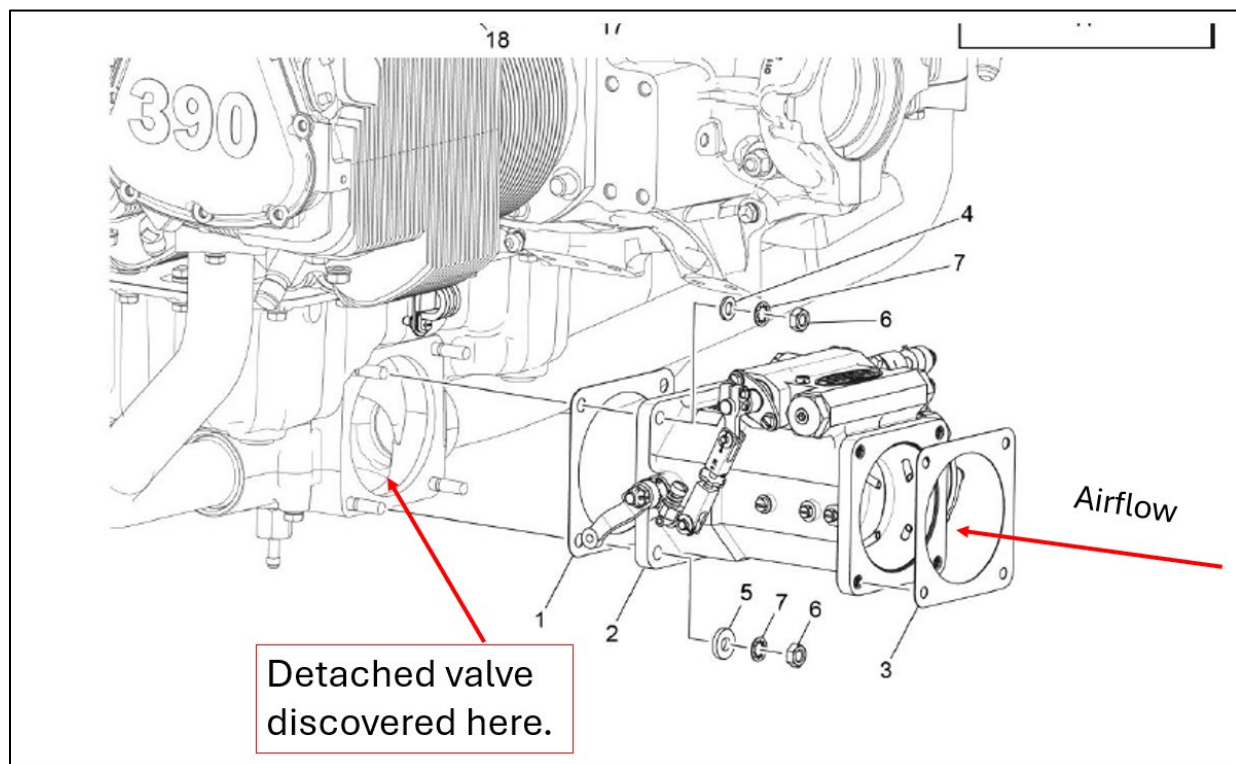
**Figure 3 Engine and induction system diagram showing location of valve as discovered.**
