ERA24LA335

## INVESTIGATION PHOTOGRAPHS

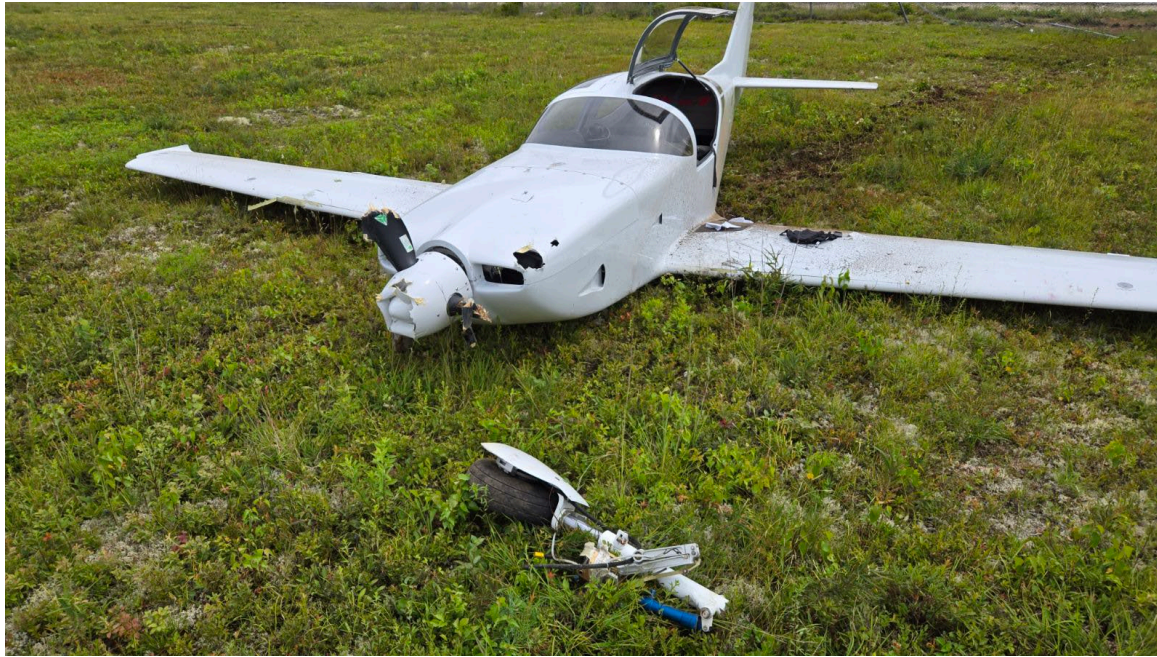
**Photograph 1 - Main Wreckage (Courtesy of FAA)**

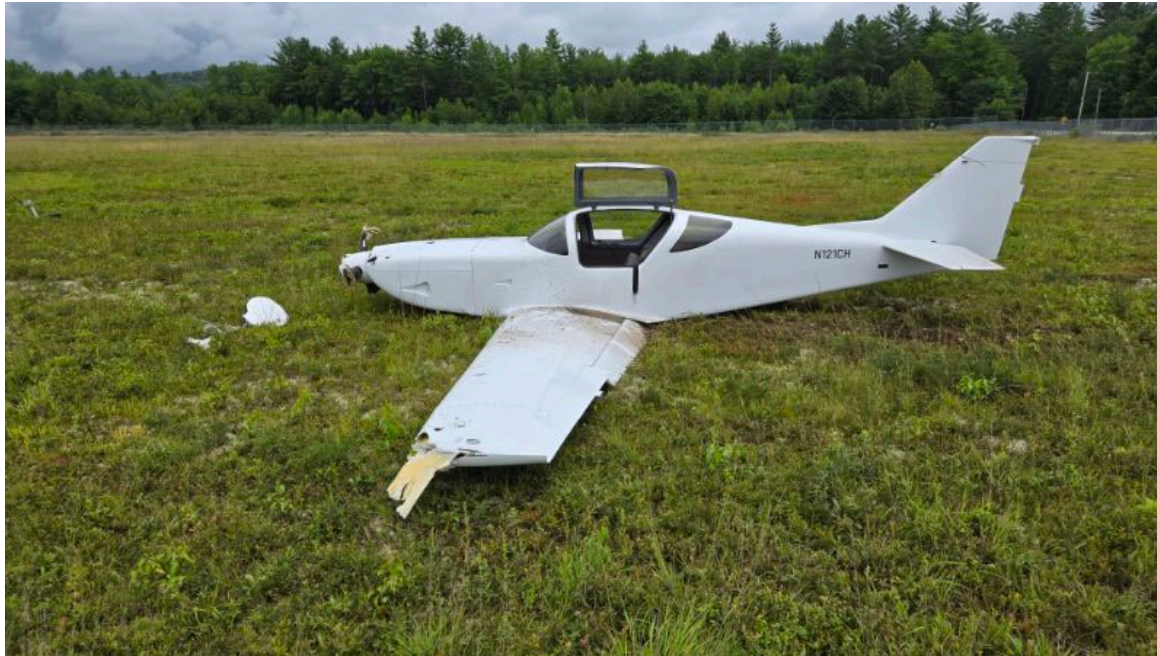
**Photograph 2 - Main Wreckage (Courtesy of FAA)**

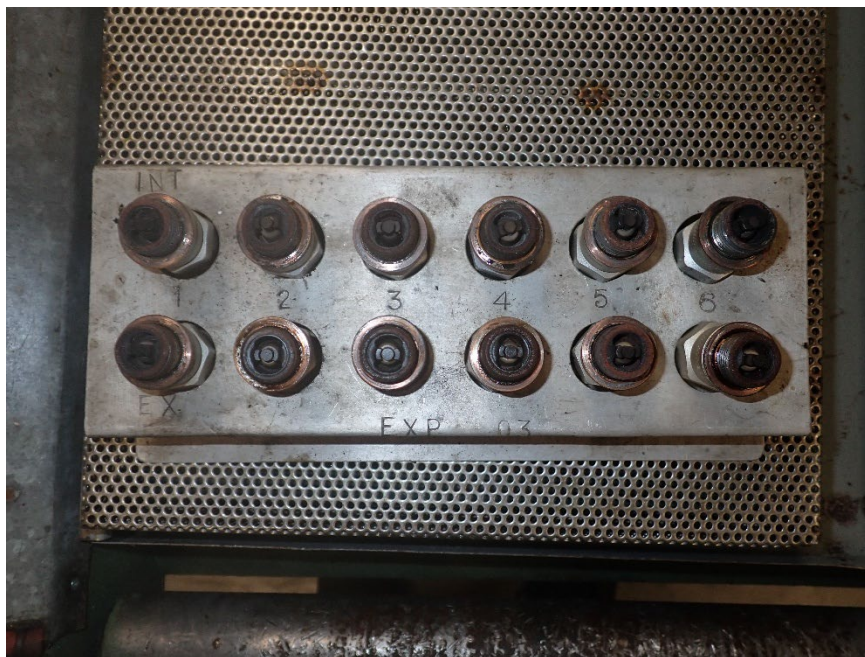
**Photograph 3 - Spark plugs showing carbon fouling on cylinder No. 6. (Courtesy of Lycoming)**

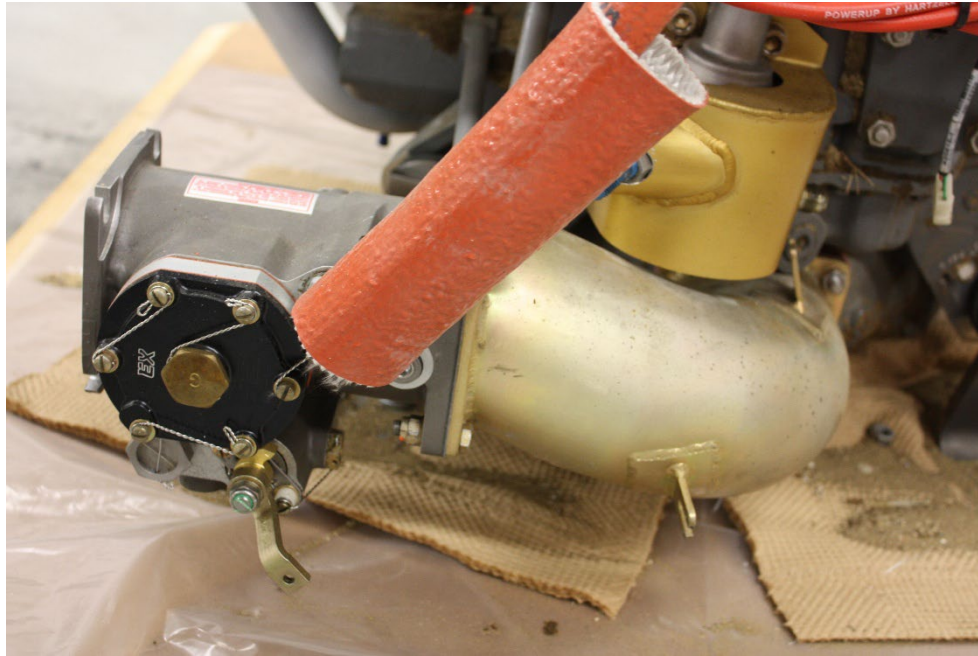
**Photograph 6 - Fuel servo mounted to intake horn (Courtesy of NTSB)**
