ERA24LA337

## INVESTIGATION PHOTOGRAPHS

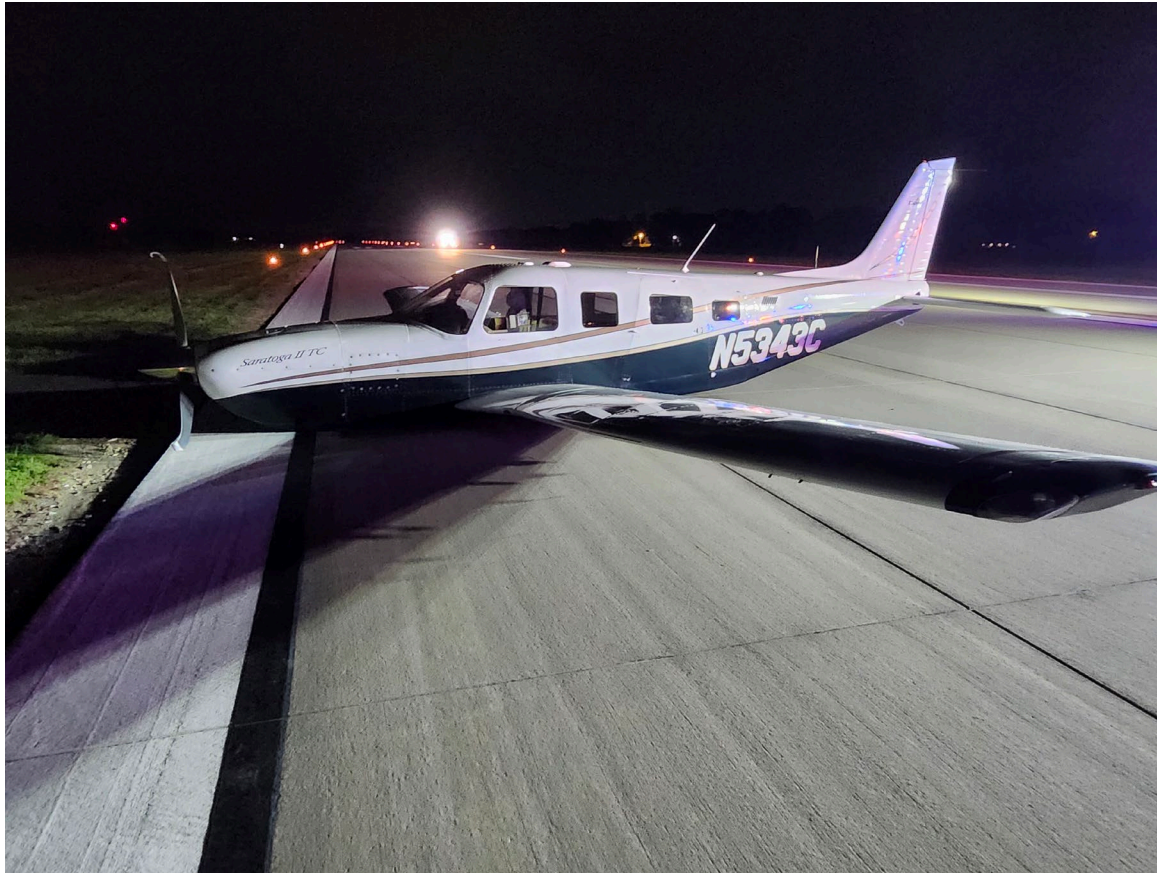
**Photograph 1 - Postaccident view of airplane (Courtesy of Pilot)**

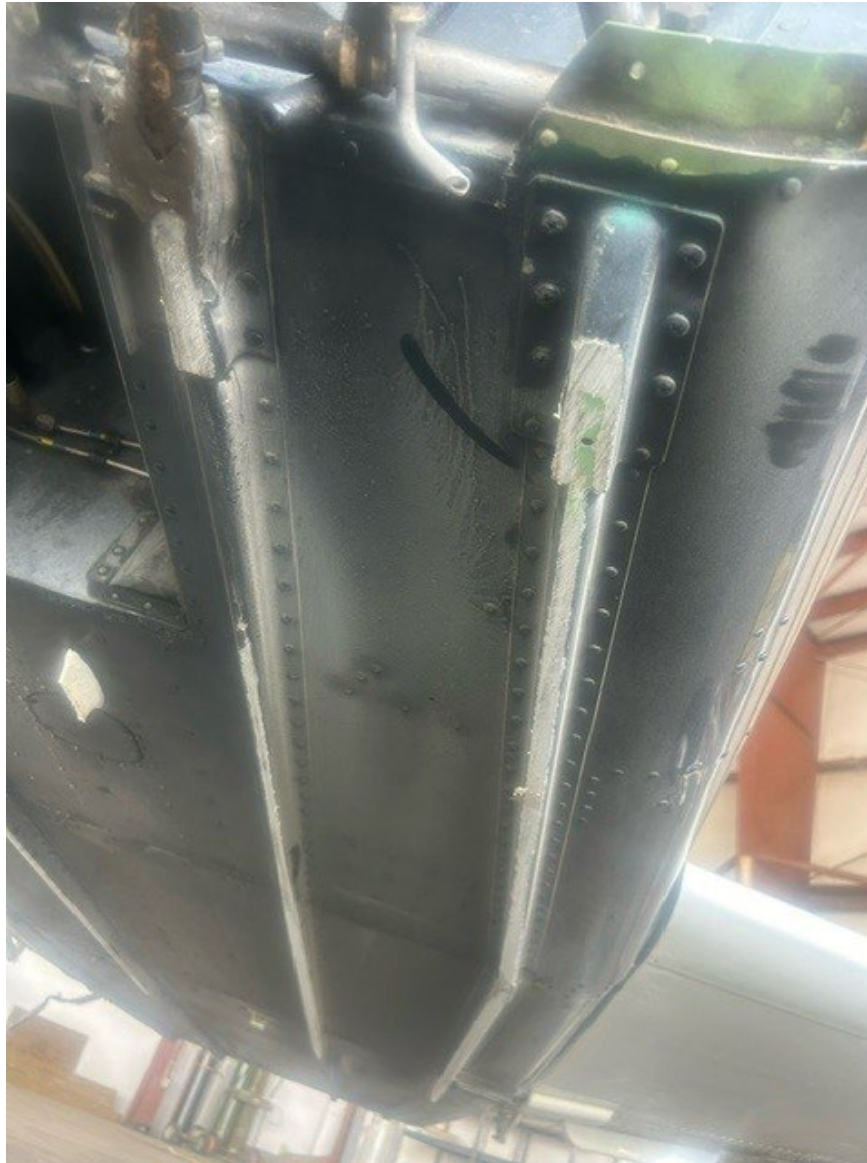
**Photograph 2 - Damage to external longerons (Courtesy of FAA)**

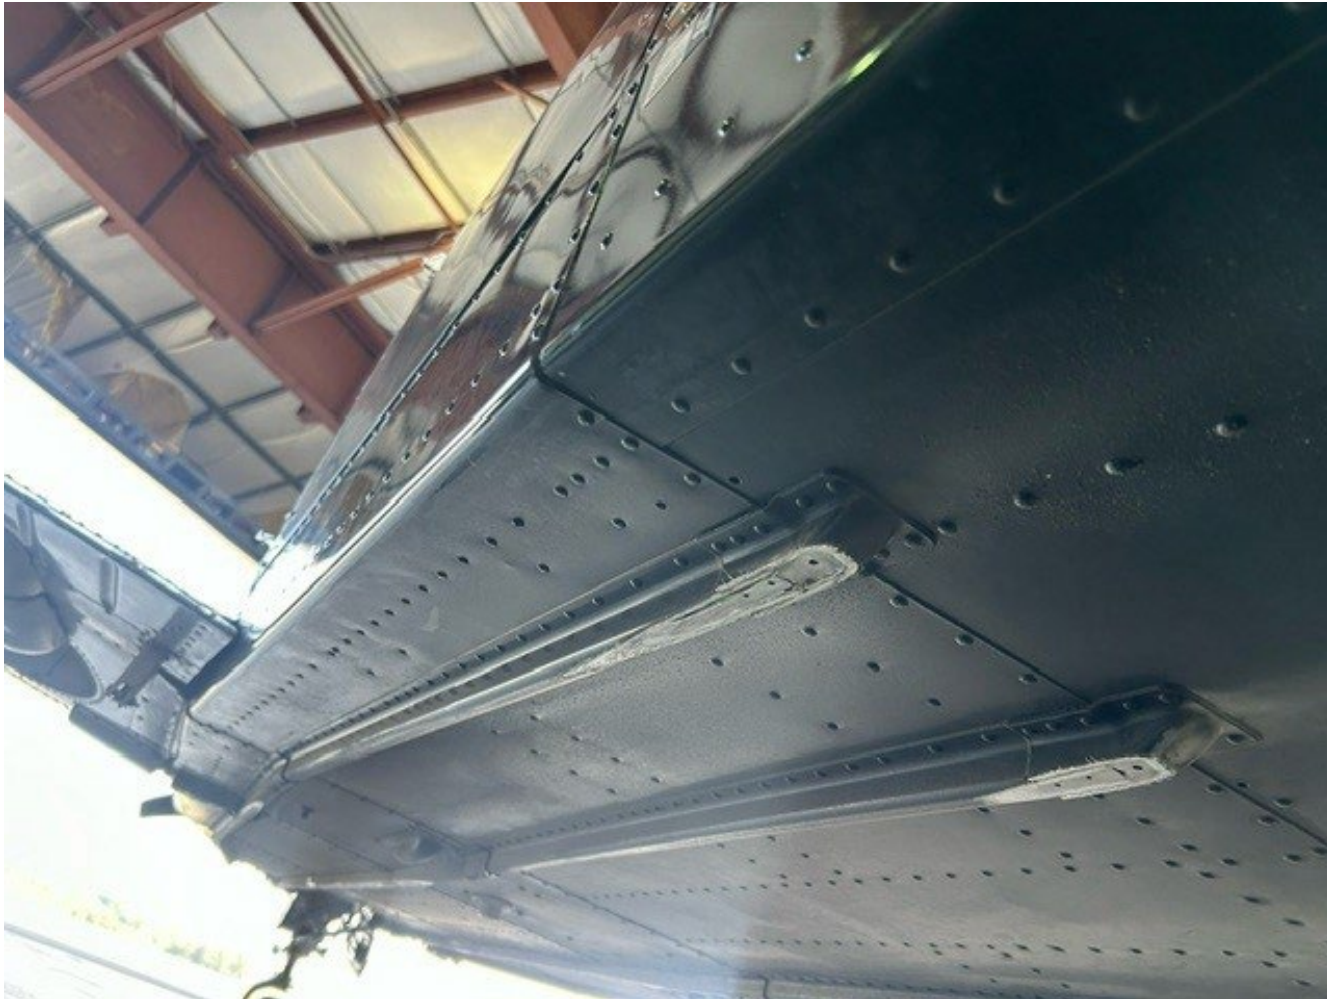
**Photograph 3 - Damage to external longerons (Courtesy of FAA)**

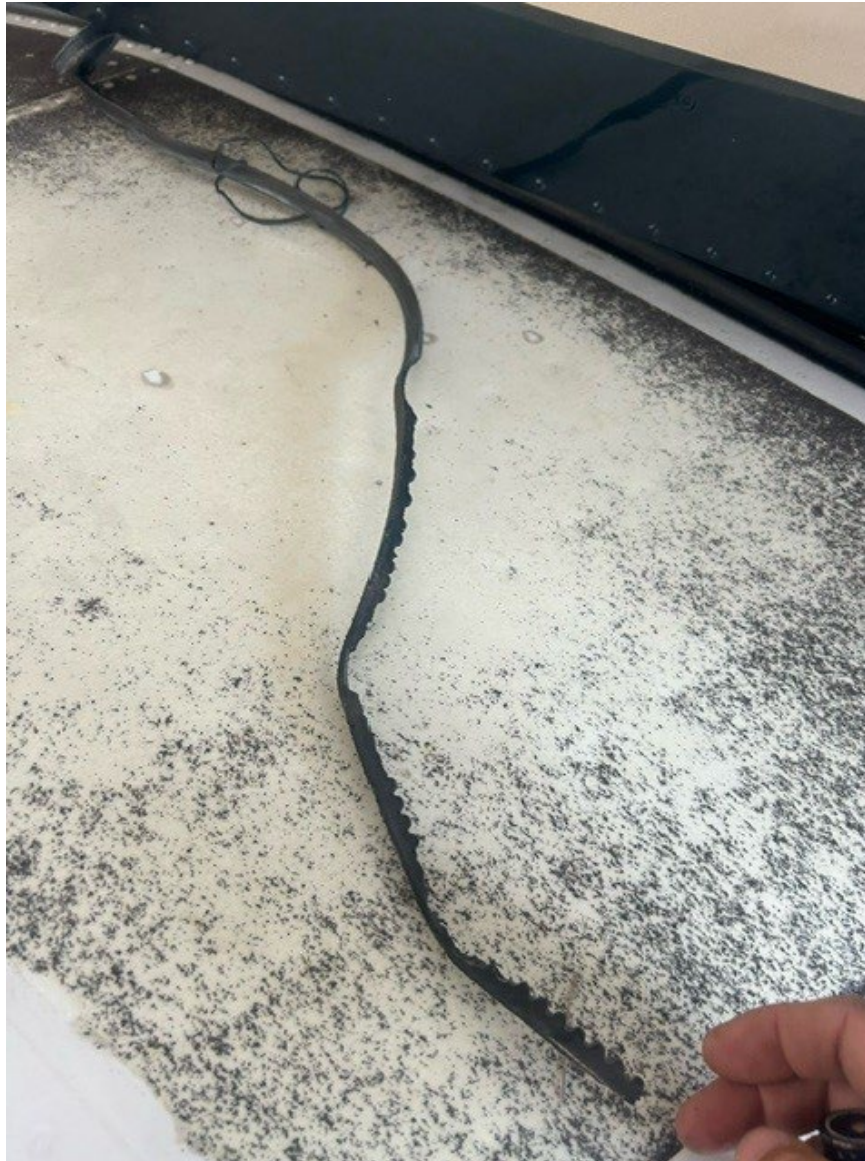
**Photograph 4 - Shredded alternator belt (Courtesy of FAA)**

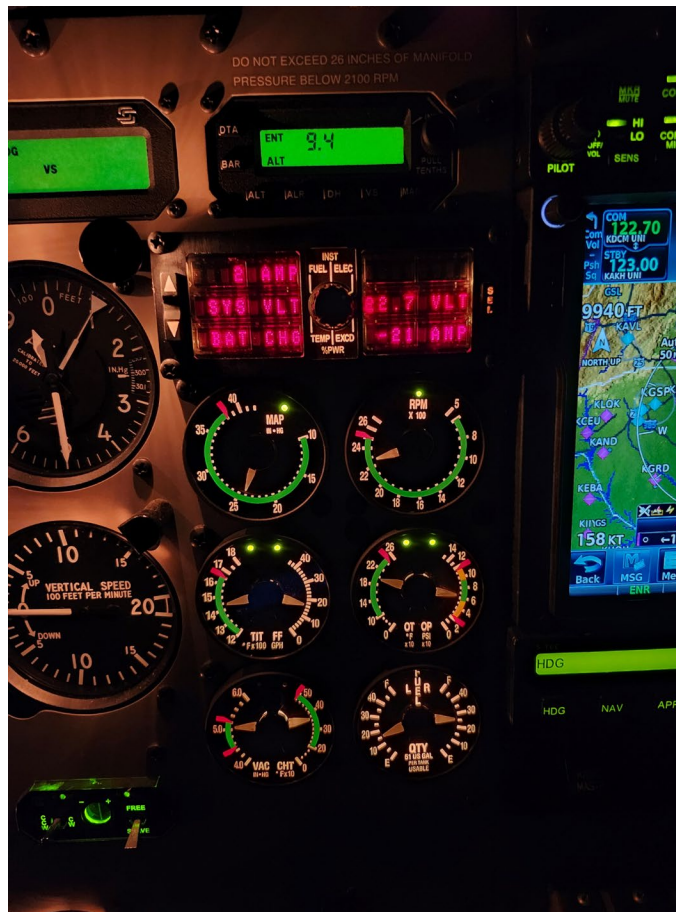
**Photograph 5 - Electrical power depiction after alternator failure and before battery failure in flight (Courtesy of Pilot)**
