ERA24LA339

## INVESTIGATION PHOTOGRAPHS

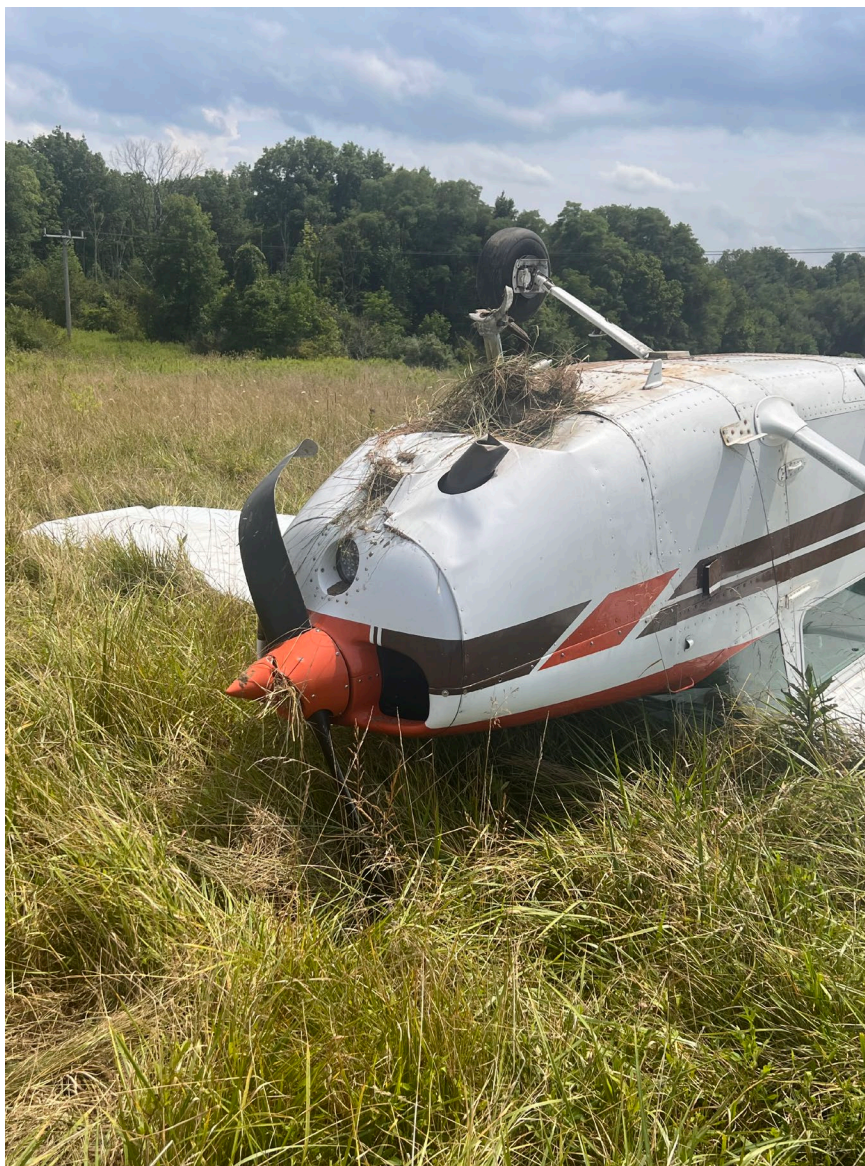
**Photograph 1 - Airplane front postaccident (Courtesy of FAA)**

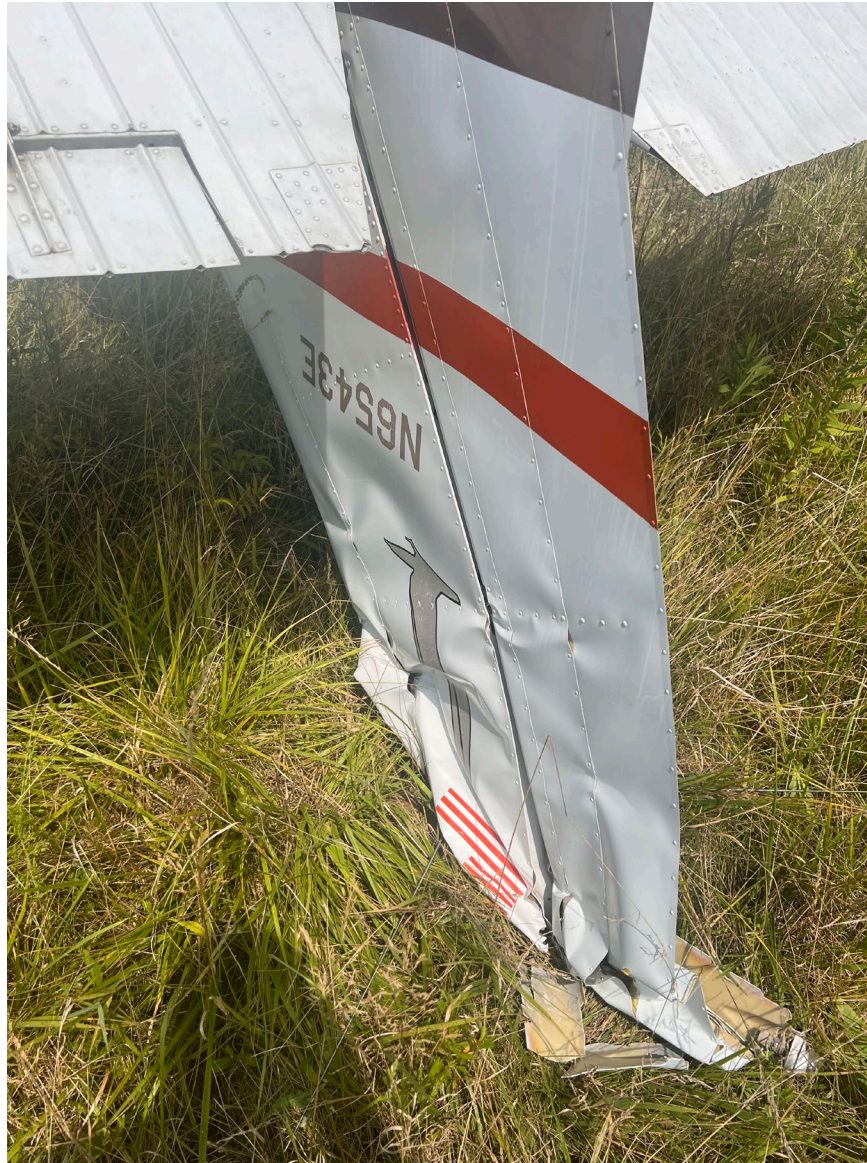
**Photograph 2 - Vertical stabilizer and rudder postaccident (Courtesy of FAA)**
