# National Transportation Safety Board

ERA24LA341

## **WRECKAGE EXAMINATION**

Location: Jacksonville, FL  
Date: August 7, 2024  
Time: 1544 EDT  
1944 UTC  
Airplane: N2376L; Beech 23

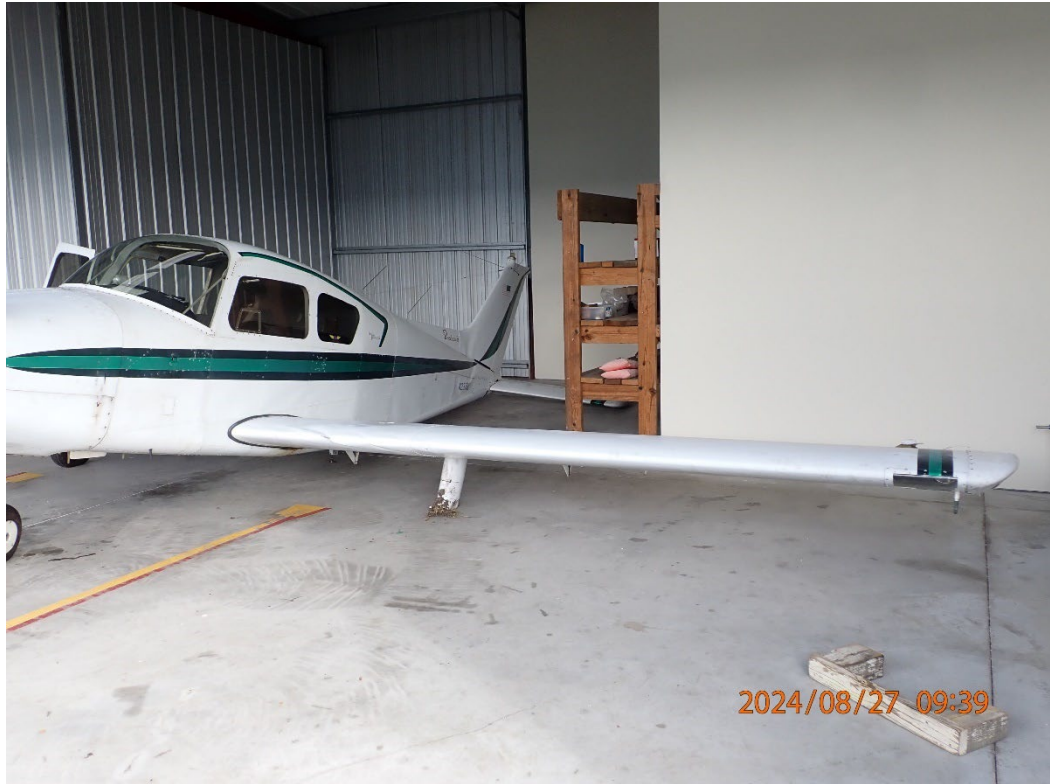
The fuselage remained intact, and the left side of the fuselage exhibited some wrinkling to the skin near the tail. The right side of the fuselage was undamaged. The rotating beacon on the bottom of the airplane was impact damaged.

**Photo 1: View of the left side of the fuselage.**

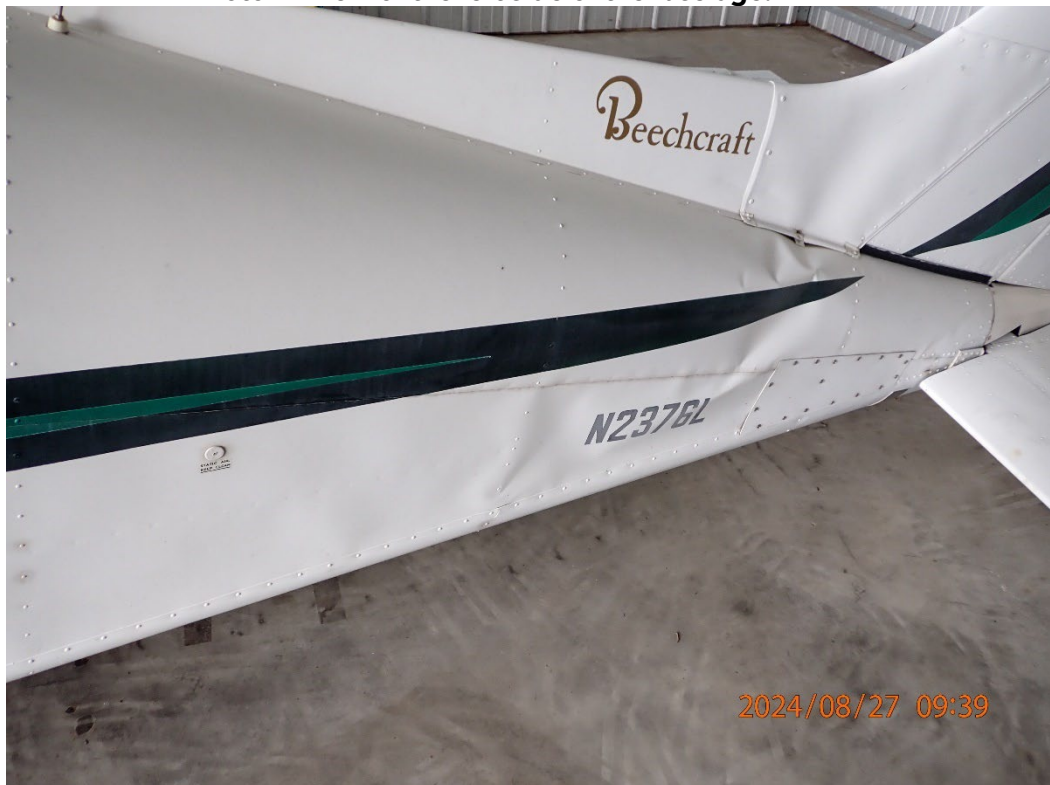
**Photo 2: View of damage to the left side of the fuselage.**

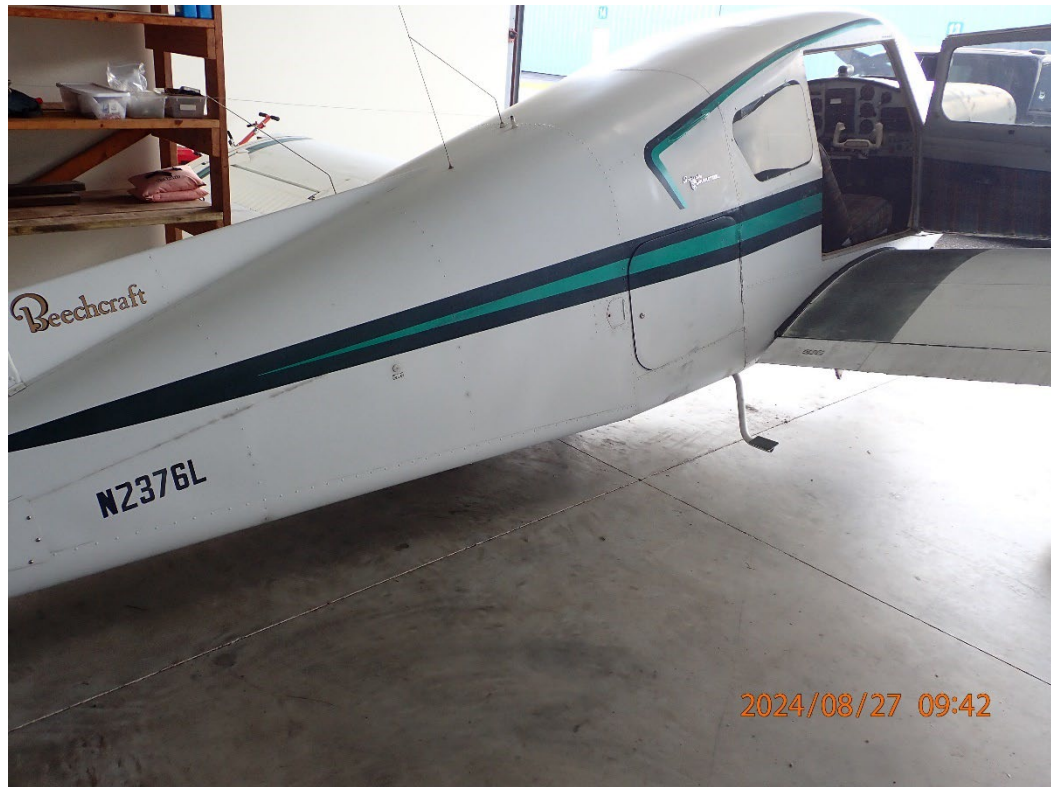
**Photo 3: View of the right side of the fuselage.**

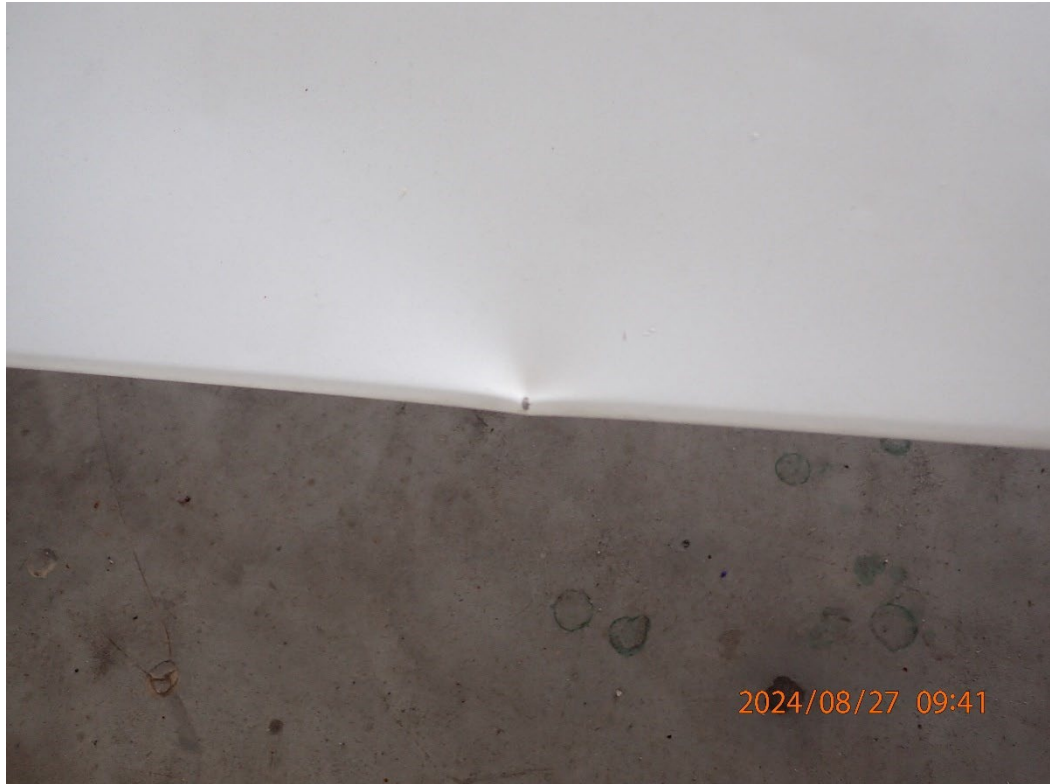
The stabilator, rudder, and stabilator trim tab all remained attached at all of their respective attachment points. The vertical stabilizer, rudder and stabilator were undamaged. The stabilator trim tab exhibited slight damage to the trailing edge about 8 inches to the right of the centerline. Control continuity was confirmed from all three flight control surfaces to their respective controls in the cockpit.

**Photo 8: View of damage to the trailing edge of the right stabilator trim tab.**

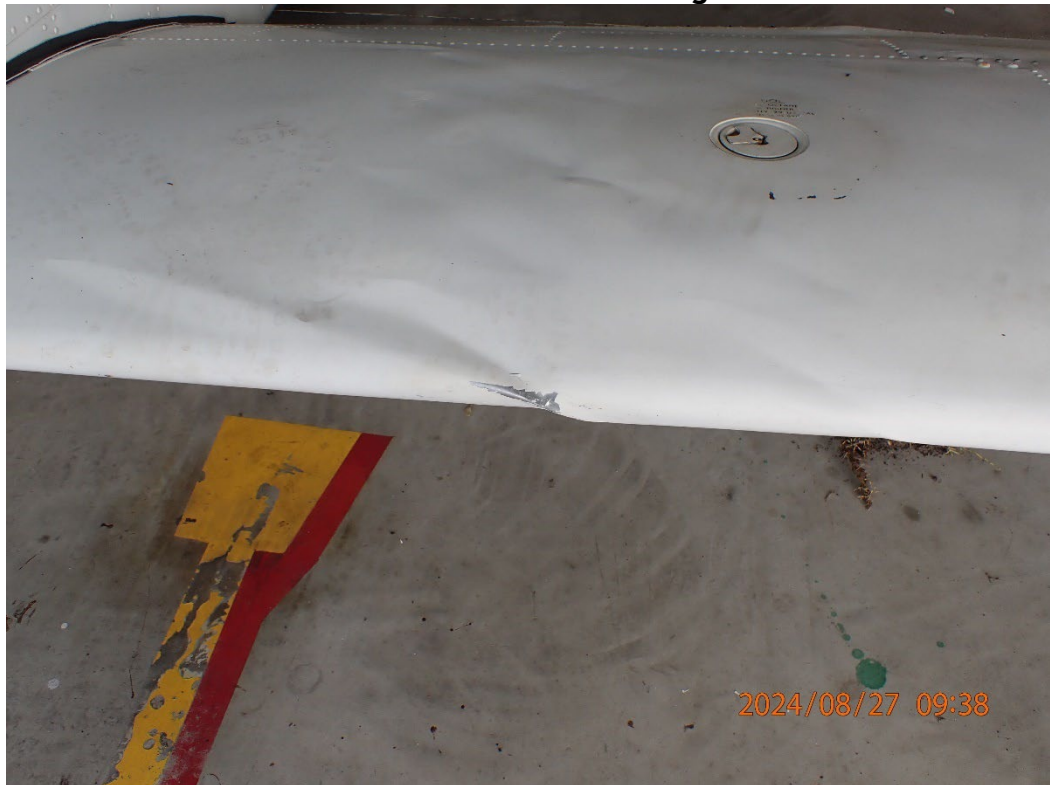
The left wing remained attached to the fuselage at all attachment points. The left wing exhibited wrinkling of the skin near the wing root. The leading edge and wing tip of the left wing exhibited impact damage. The left flap and aileron remained attached at their respective attachment points. Control continuity was confirmed from the left aileron to the flight controls in the cockpit. The left flap was found in the UP position.

**Photo 13: View of damage to the left wing.**

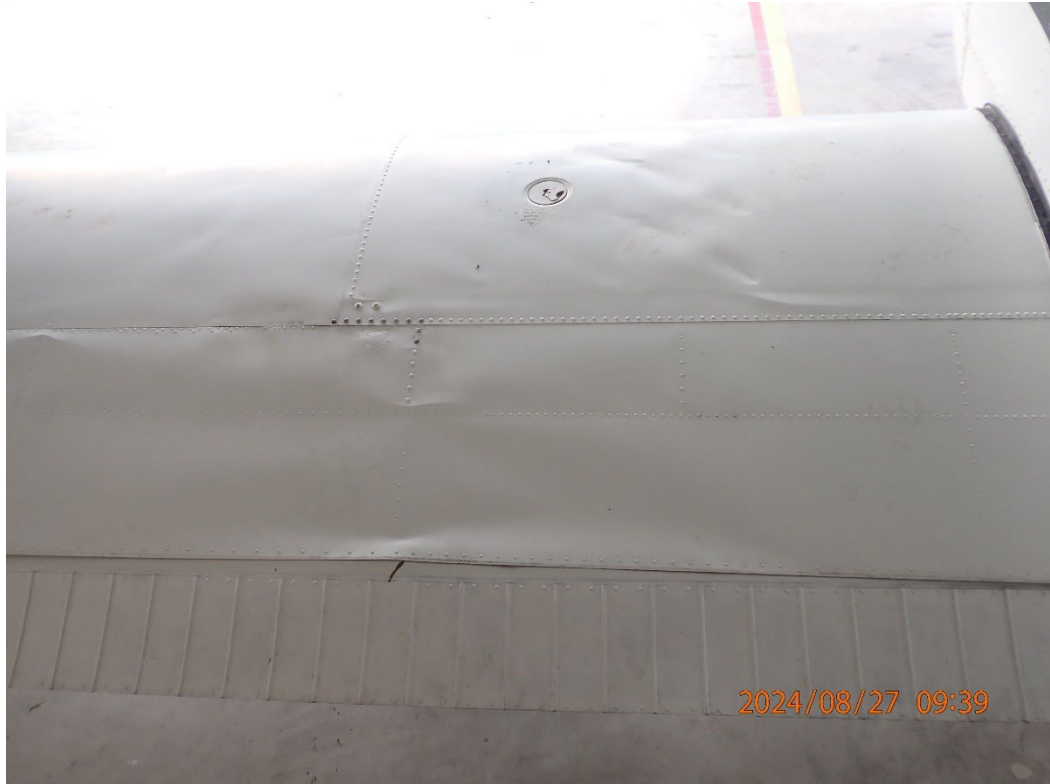
**Photo 14: View of damage to the left wing.**

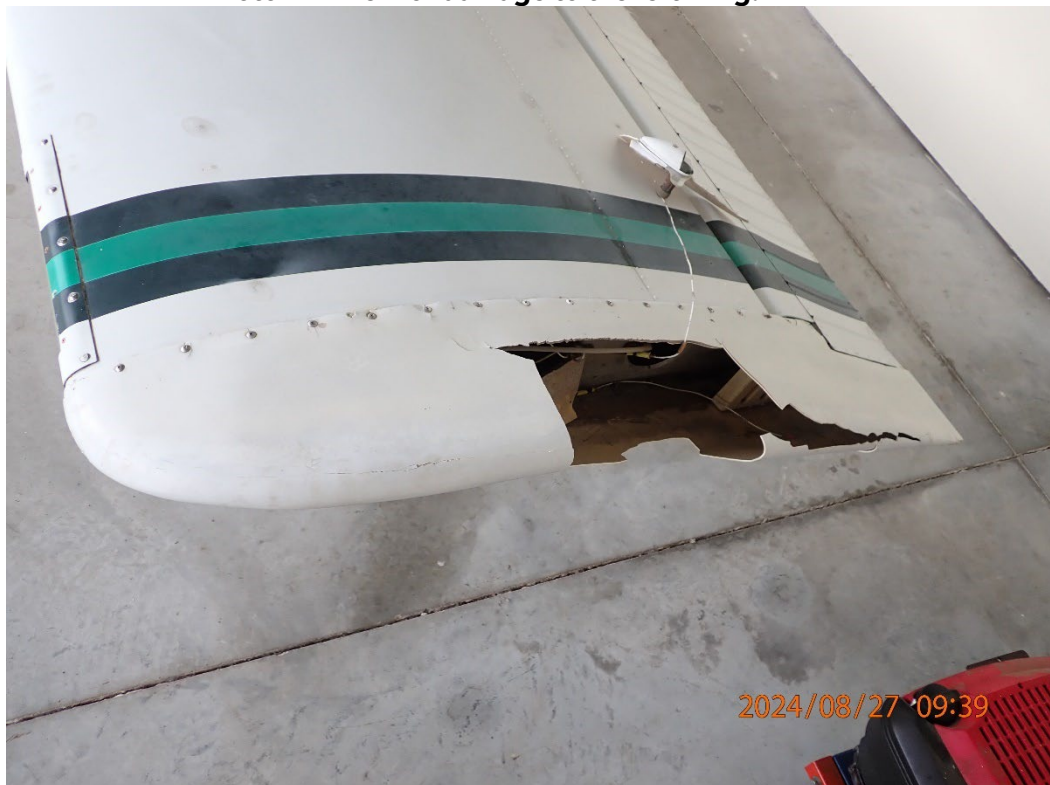
**Photo 15: View of damage to the left wing tip.**

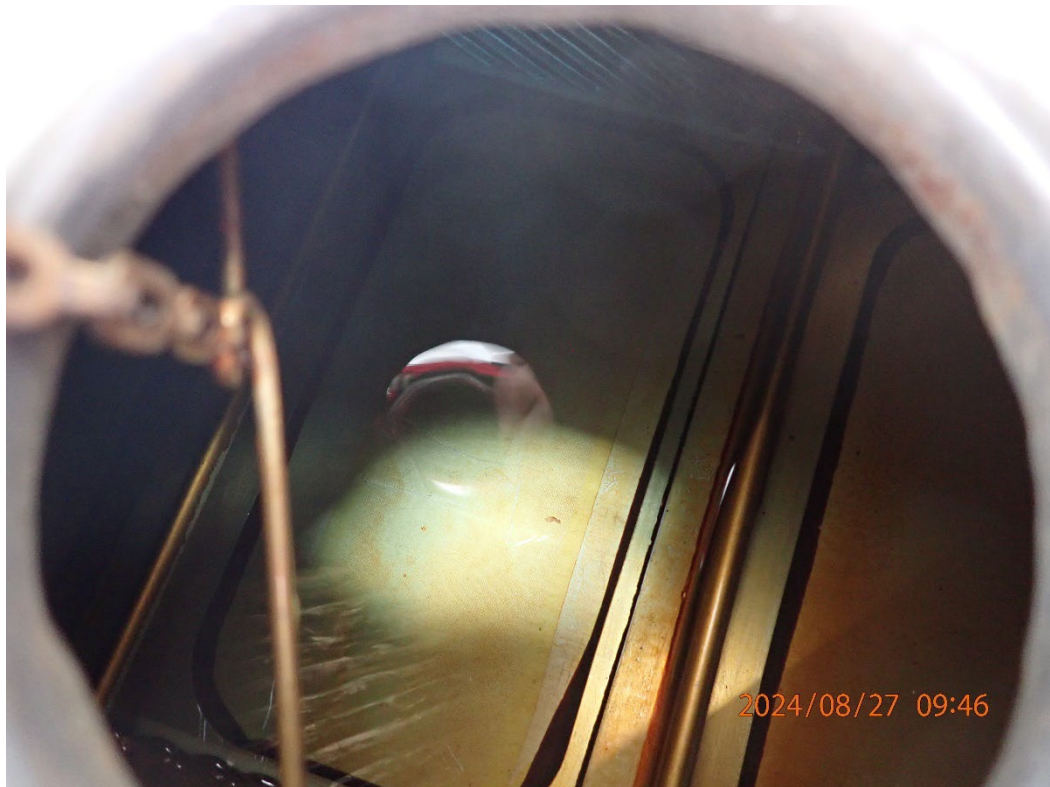
The right and left fuel tank caps were secure in place on their respective wings. The right wing fuel tank was opened, and fuel was present that exhibited the appearance of 100LL aviation fuel. The right wing fuel tank was sumped and about 1.5 tablespoons of water were found. The left wing fuel tank was opened, and fuel was present that exhibited the appearance of 100LL aviation fuel. The left wing fuel tank was sumped and no water was found. The fuel strainer was sumped and no water was found. The fuel selector in the cockpit was selected to the right fuel tank. The fuel selector moved smoothly from the right to the left detent and back again.

**Photo 25: View of the inside of the right wing fuel tank.**

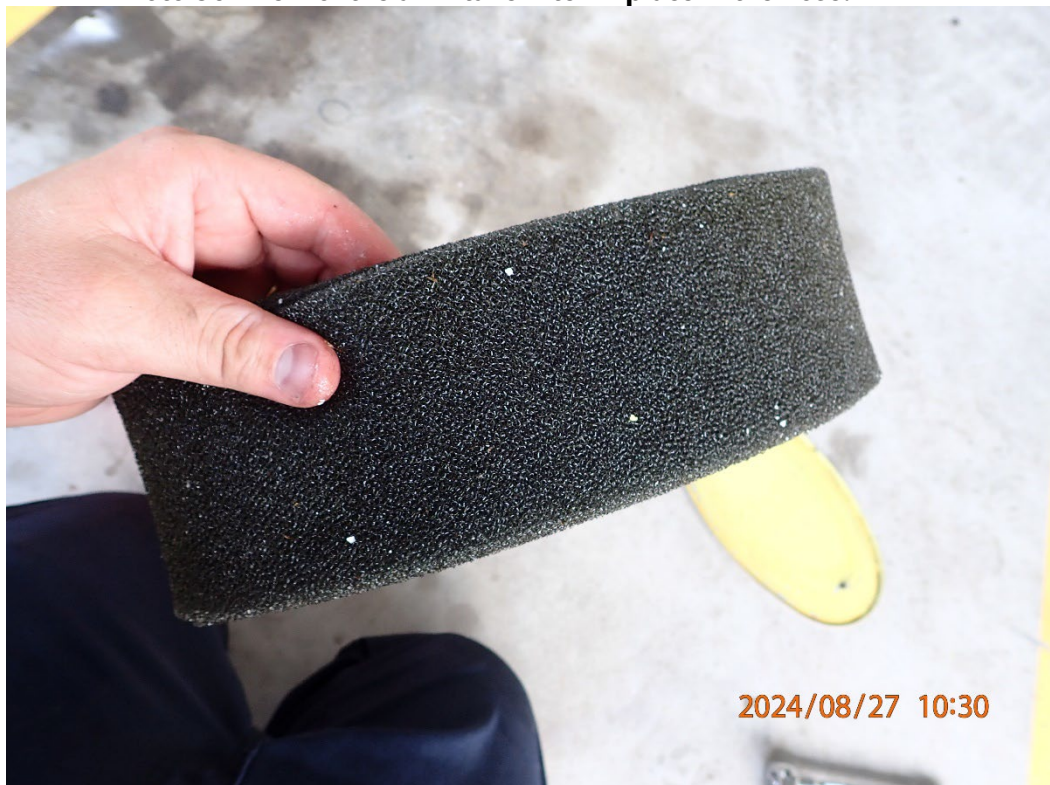
The induction and exhaust system were undamaged. The air intake filter was removed and examined and was not obstructed.

**Photo 31: View of the unobstructed air intake filter.**

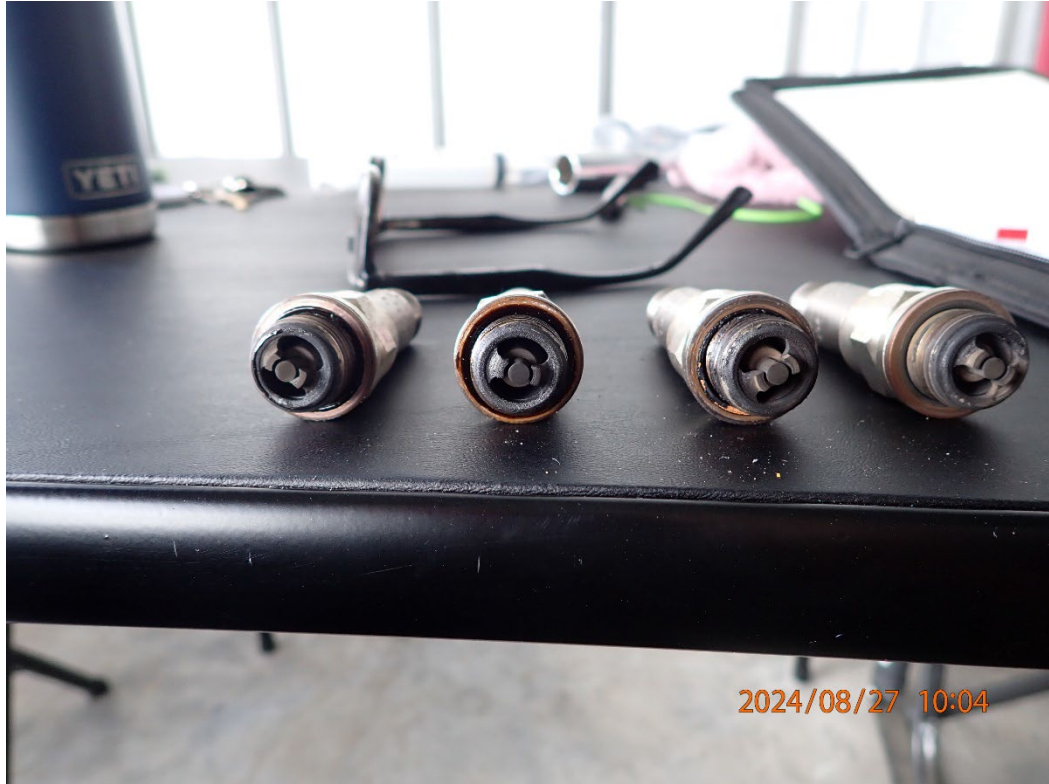
The ignition leads were undamaged. The top spark plugs were removed and exhibited normal wear when compared to the Champion Aerospace Aviation Check-A-Plug chart.

**Photo 35: View of the 1-4 top spark plugs.**

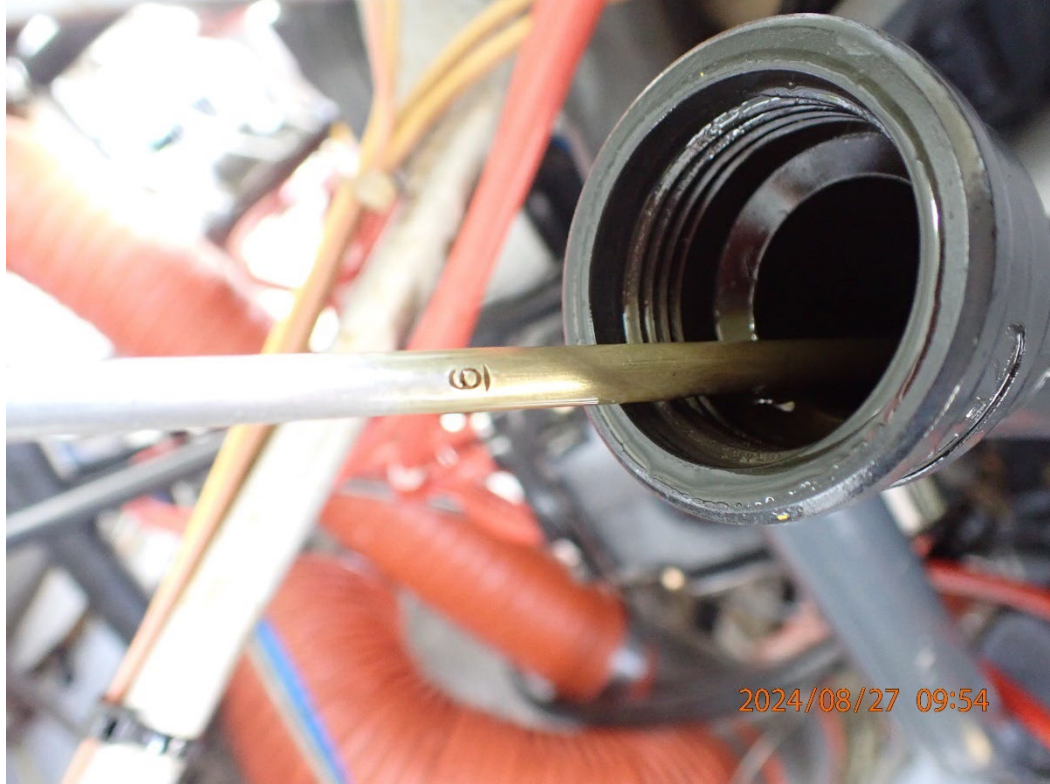
The oil sump was undamaged. The oil filter remained attached to the accessory case and was undamaged. The oil dipstick was removed and exhibited about 6 quarts of oil.

**Photo 38: View of the oil dipstick.**
