# National Transportation Safety Board

ERA24LA341

## **ENGINE EXAMINATION**

Location: Jacksonville, FL  
Date: August 7, 2024  
Time: 1544 EDT  
1944 UTC  
Airplane: N2376L; Beech 23

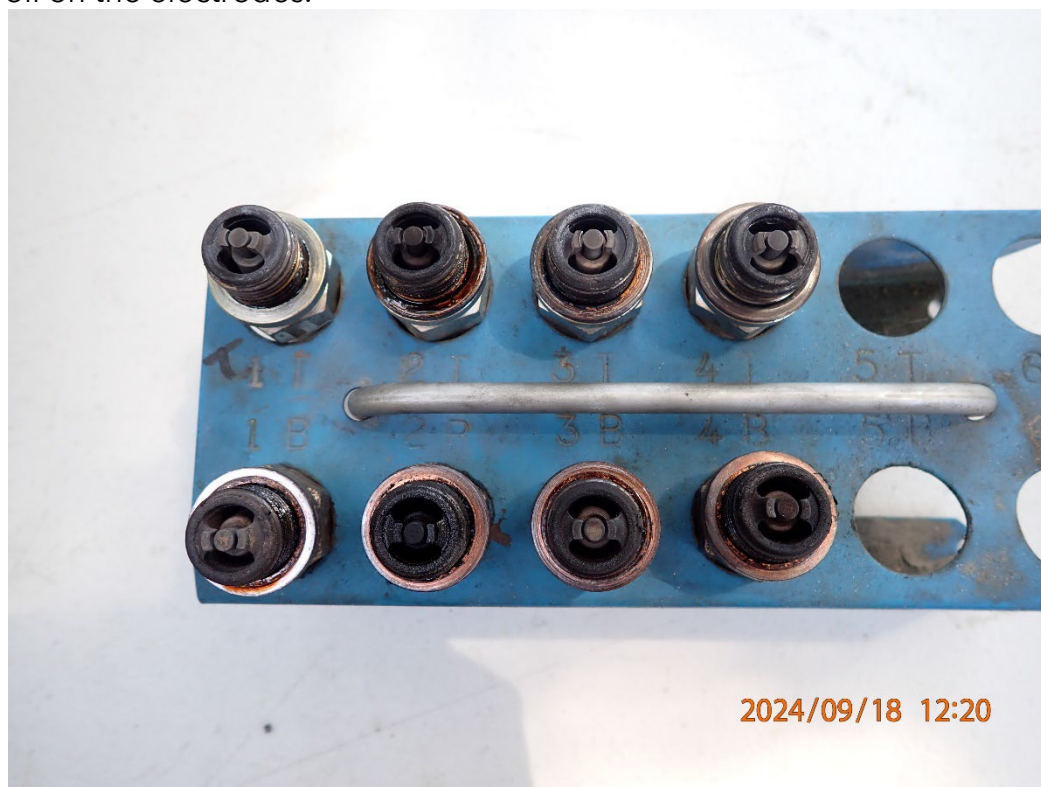
The ignition harness was undamaged. All sparkplugs were secure in their respective cylinders. The ignition system was operationally checked during the engine run and operated normally. The top and bottom spark plugs were removed and were dark grey in color and exhibited normal wear. The No. 2 bottom spark plug exhibited oil on the electrodes.

**Photo 1: View of the sparkplugs removed from the engine.**

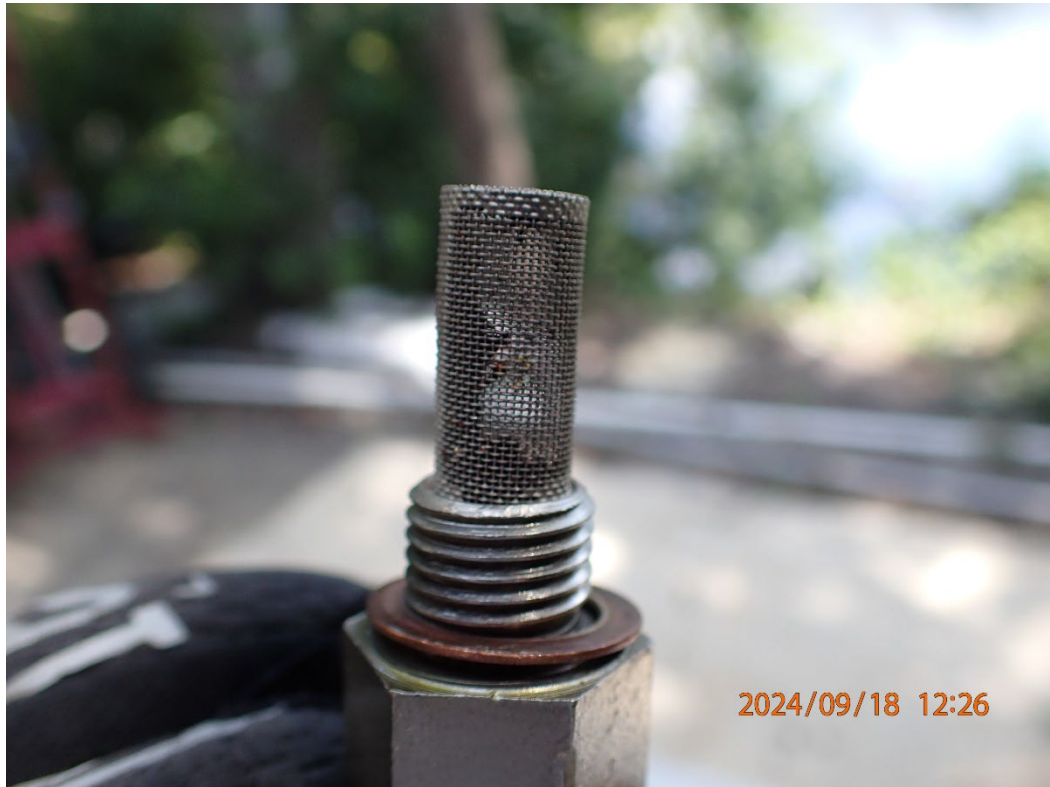
The carburetor remained attached to the engine and no damage was noted. The throttle, mixture and carburetor heat cabled remained attached to their respective control arms on the carburetor and induction air box. The engine was started and run at various power settings up to full throttle. After the engine run the carburetor fuel inlet screen was removed and a small amount of dark granular material observed in the screen. The engine driven fuel pump remained attached to the engine and no damage was noted. The engine started and ran normally. The pump was not removed.

**Photo 2: View of the carburetor fuel inlet screen.**

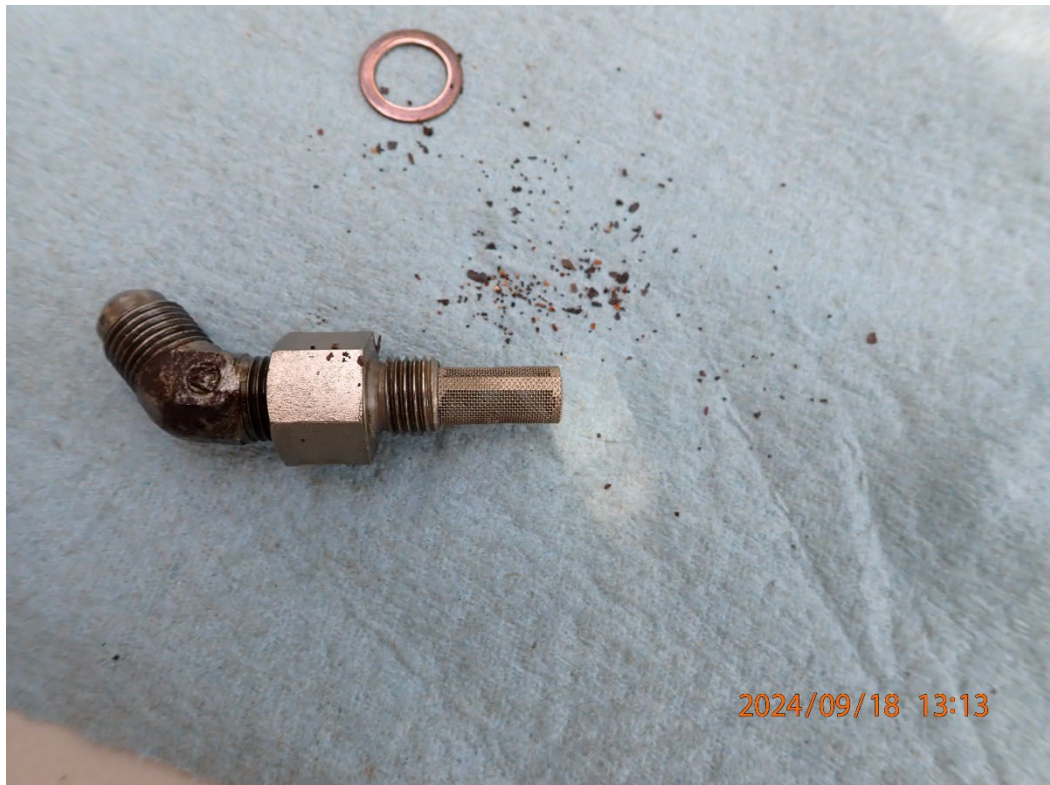
**Photo 3: View of the carburetor fuel inlet screen with debris from in the screen.**

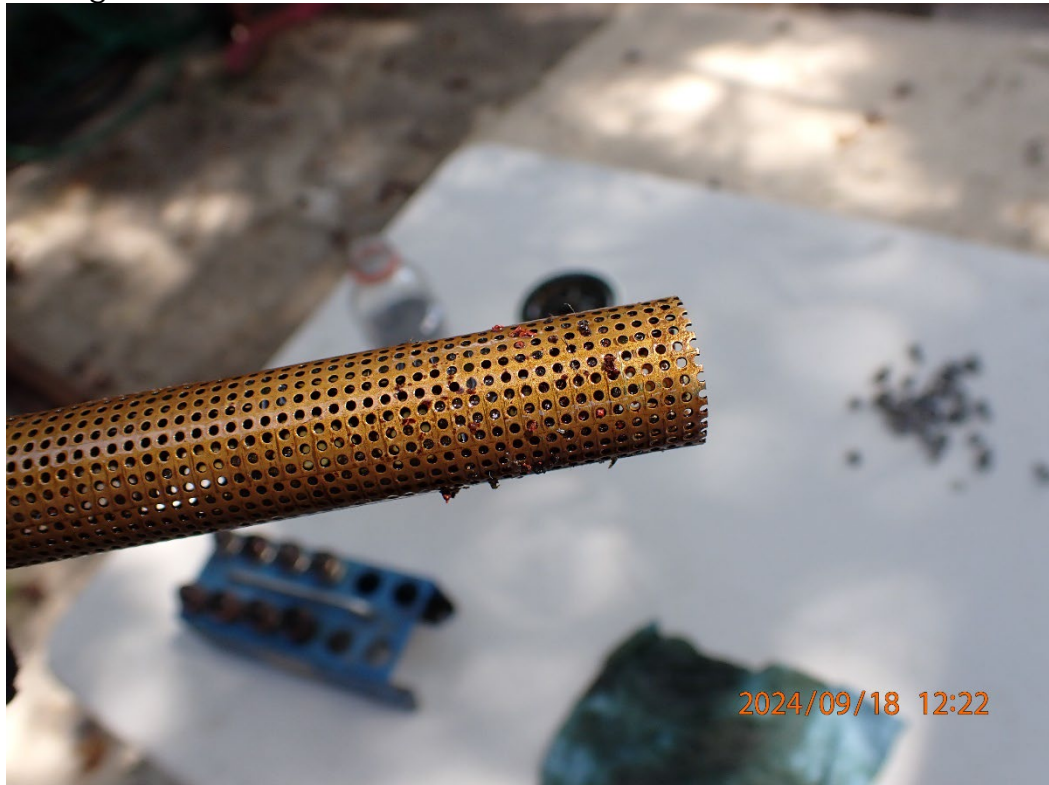
The dipstick indicated about 7 quarts of oil. The oil suction screen was removed and examined, it exhibited minimal amounts of debris consistent with sealant material. The oil filter was dated 8/1/23 and was removed and cut open for examination. The filter media contained a small amount of metallic debris consistent with a recent engine field overhaul.

**Photo 4: View of the oil suction screen.**

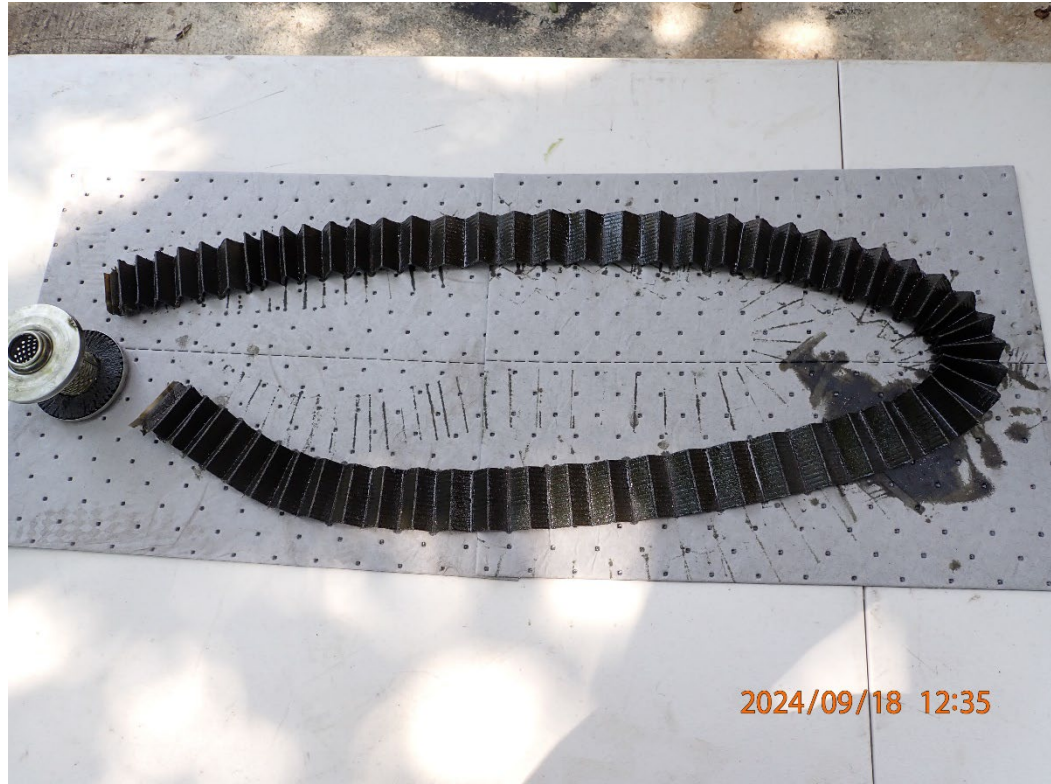
**Photo 5: View of the oil filter cut open for examination.**

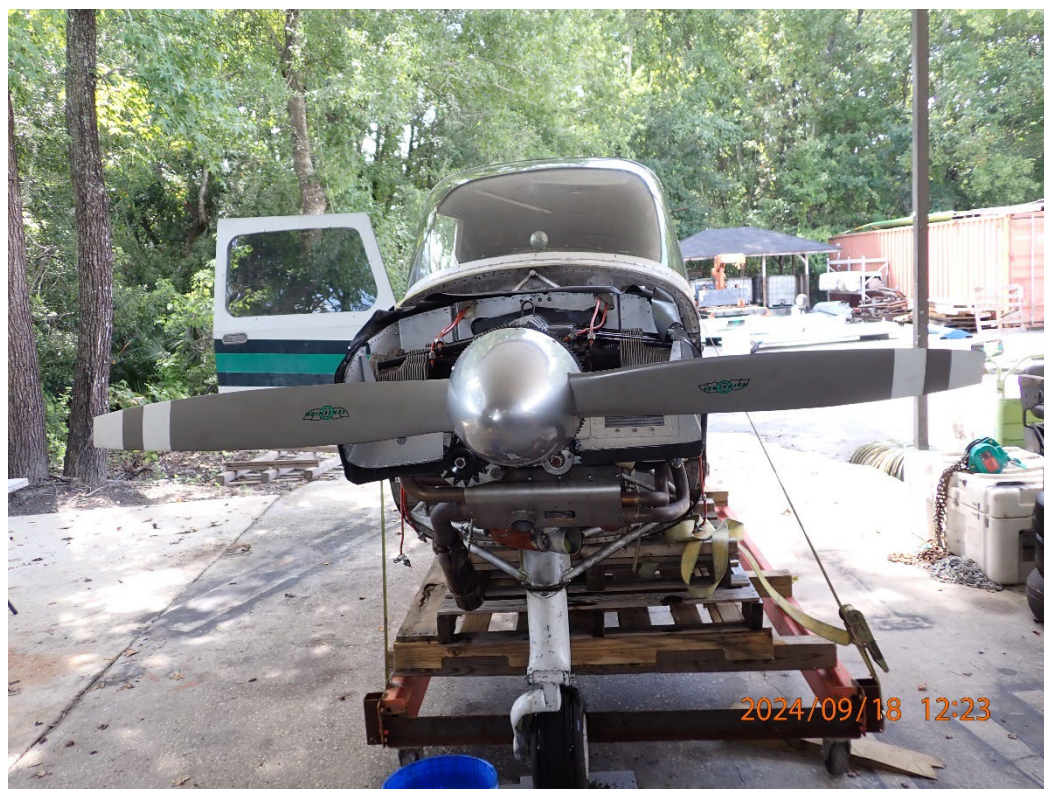
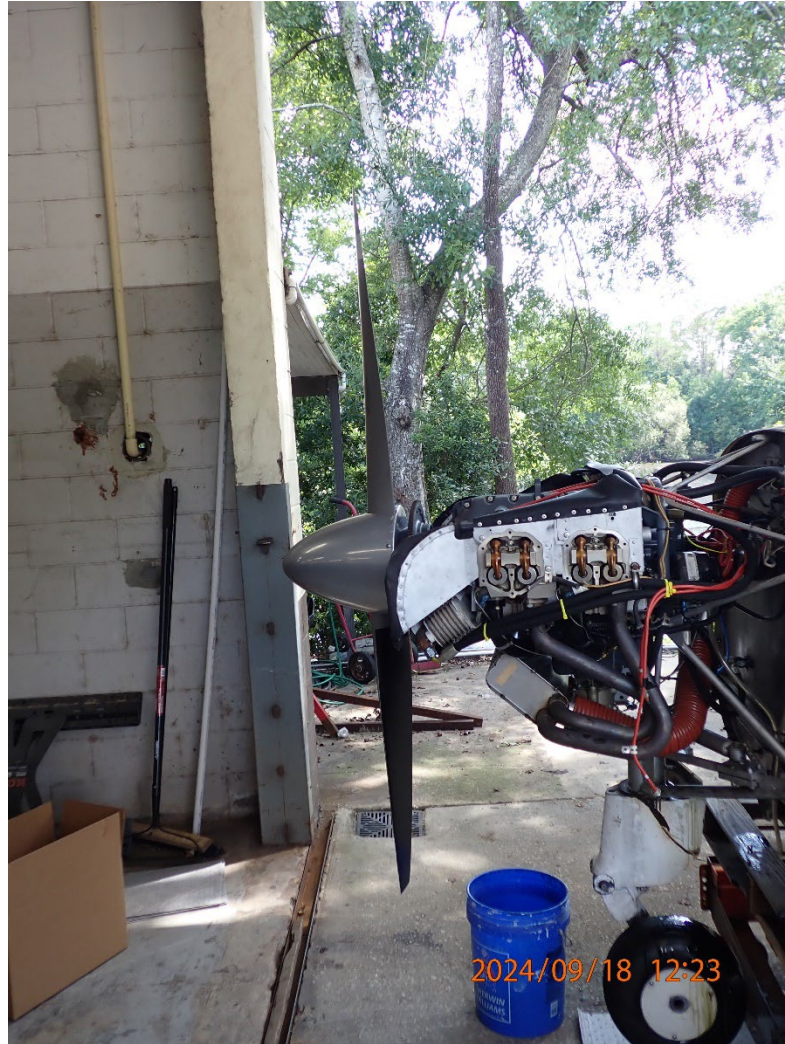
The propeller was undamaged and remained secure to the engine crankshaft flange.

**Photo 6: View of the undamaged propeller.**

**Photo 7: View of the undamaged propeller.**
