ERA24LA345

## INVESTIGATION PHOTOGRAPHS

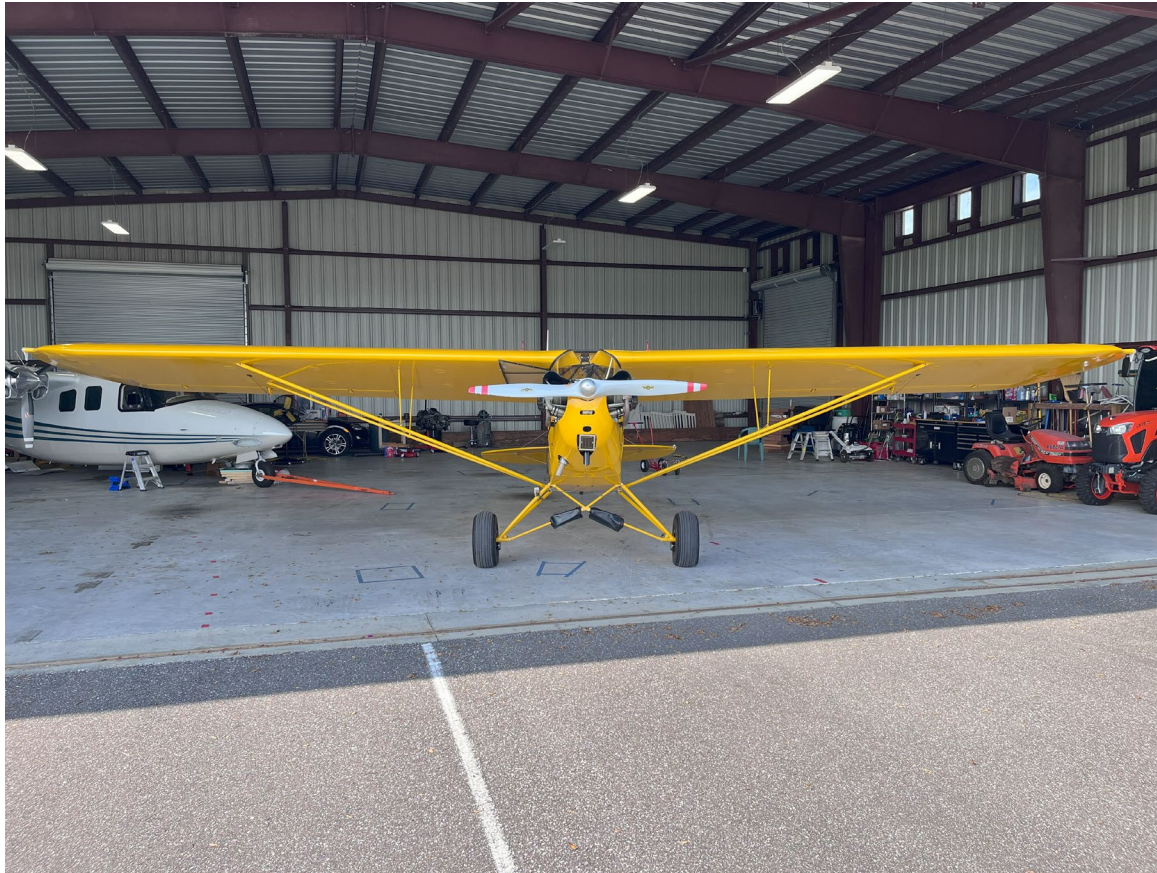
**Photograph 1 - Digital Photograph From Owner. Front View of the Airplane Following Recovery**

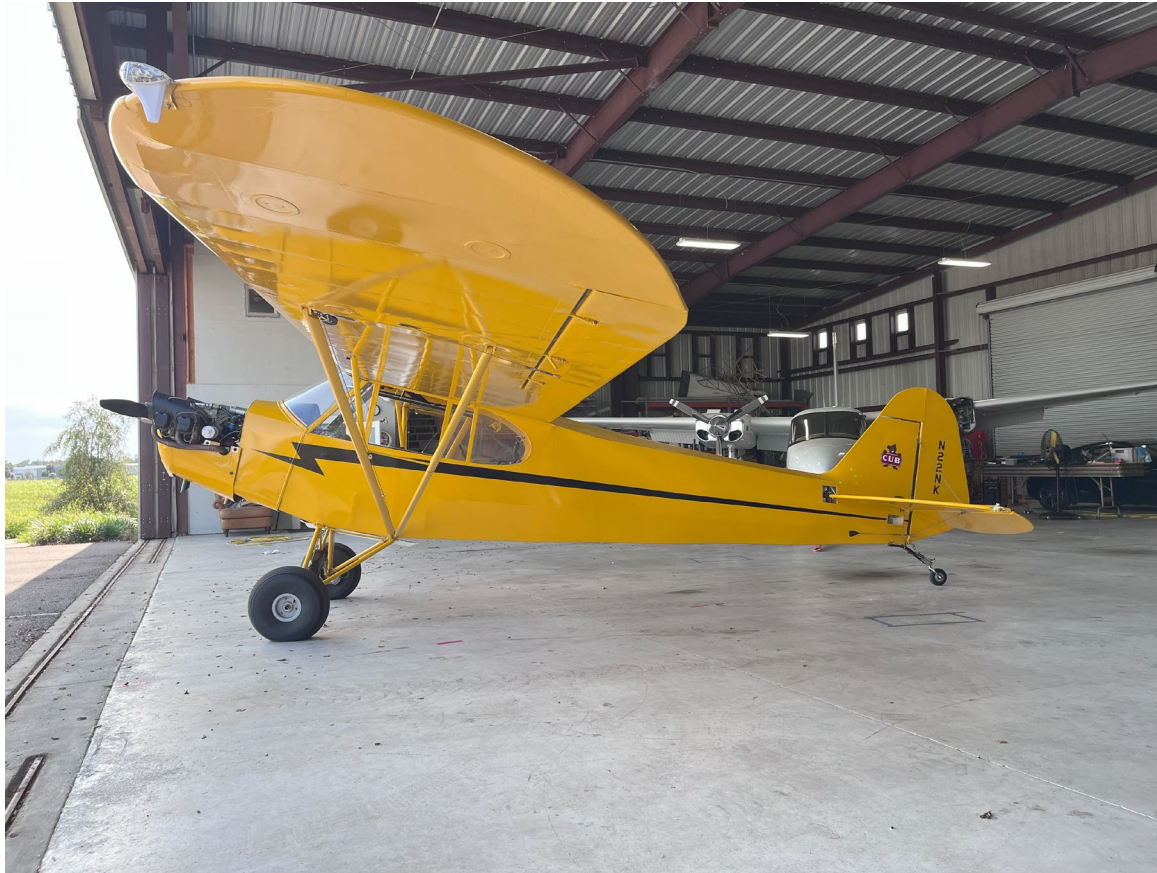
**Photograph 2 - Digital Photograph From Owner. Left Side View of the Airplane Following Recovery**

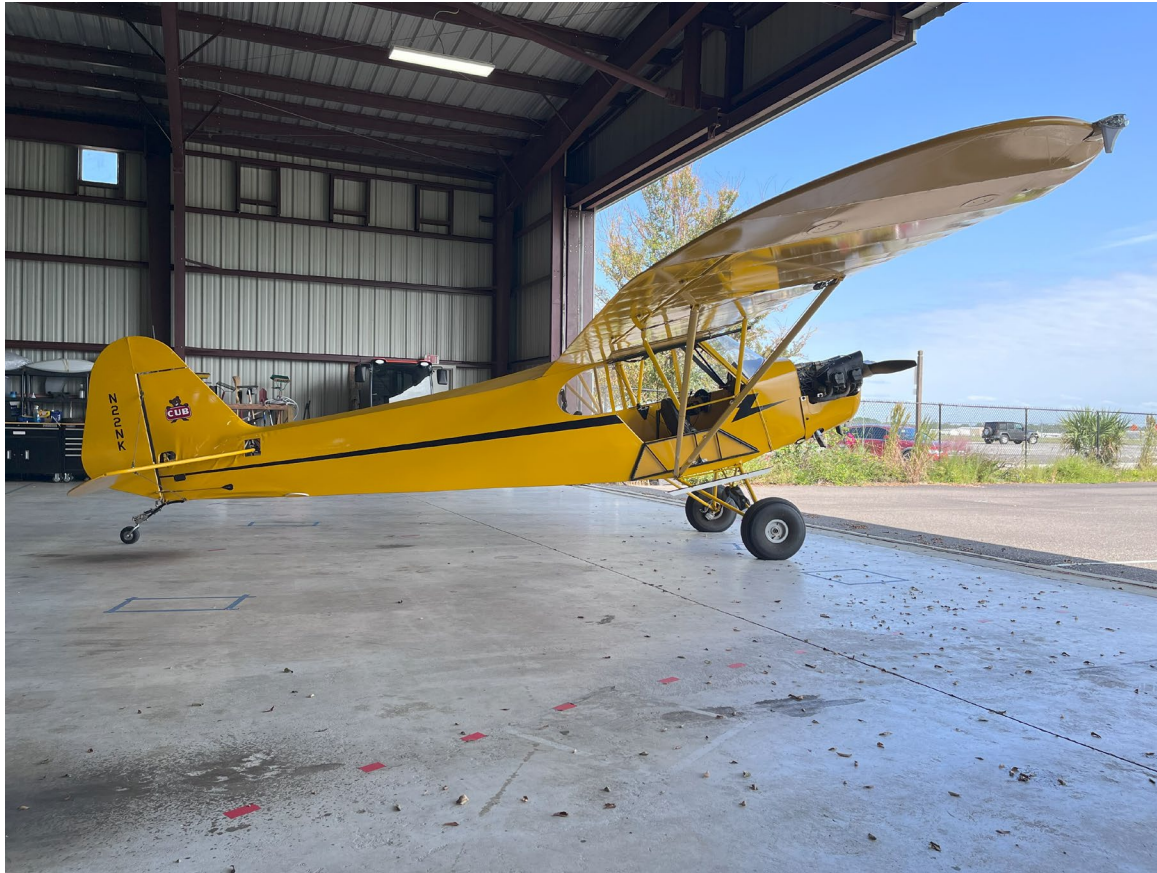
**Photograph 3 - Digital Photograph From Owner. Right Side View of the Airplane Following Recovery**

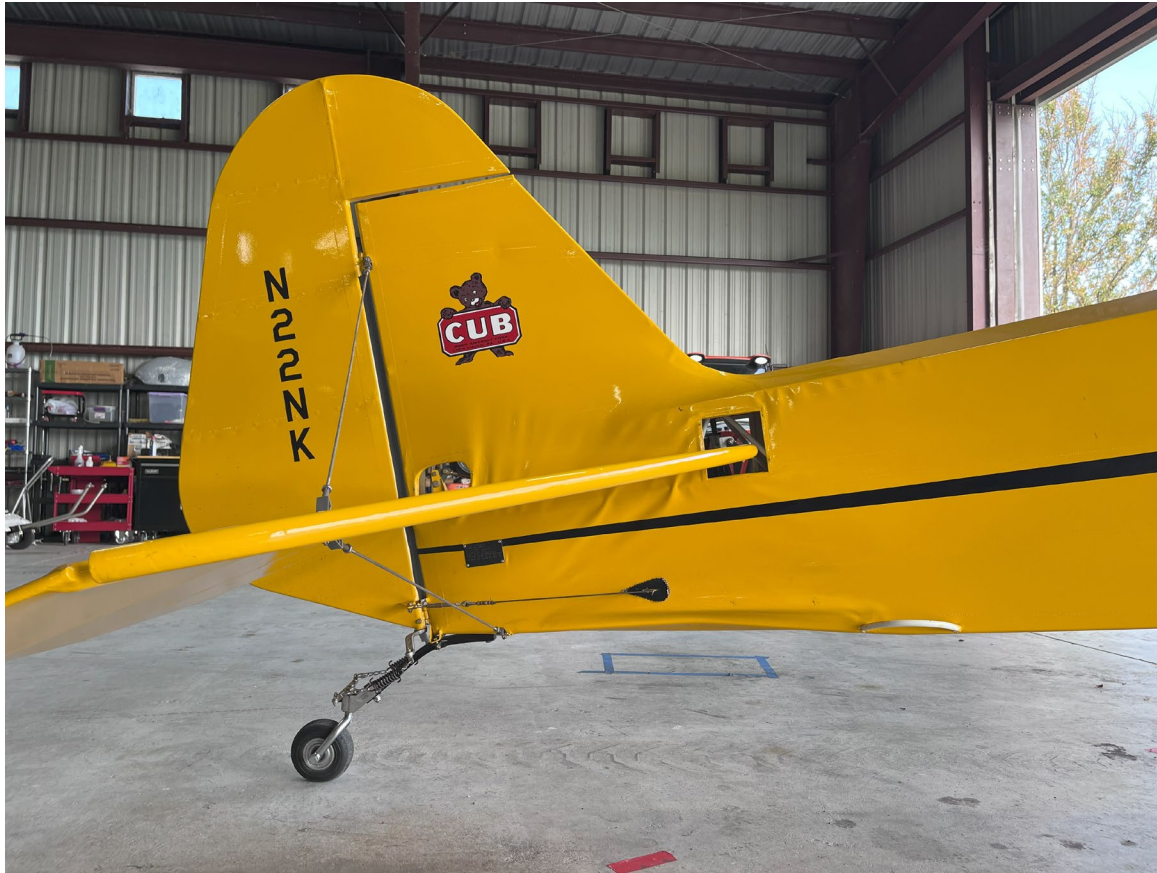
**Photograph 4 - Digital Photograph From Owner. Right Side View of the Aft Empennage. Note the Wrinkle in the Fabric on the Lower Fuselage Tubing**
